# Revisiting the MV Estonia Accident Using Numerical Simulations with a Statistical Approach

Shinwoong Kim \*

Hamburg Ship Model Basin, Bramfelder Strasse 164, D-22305 Hamburg, Germany; valanto@gmx.de

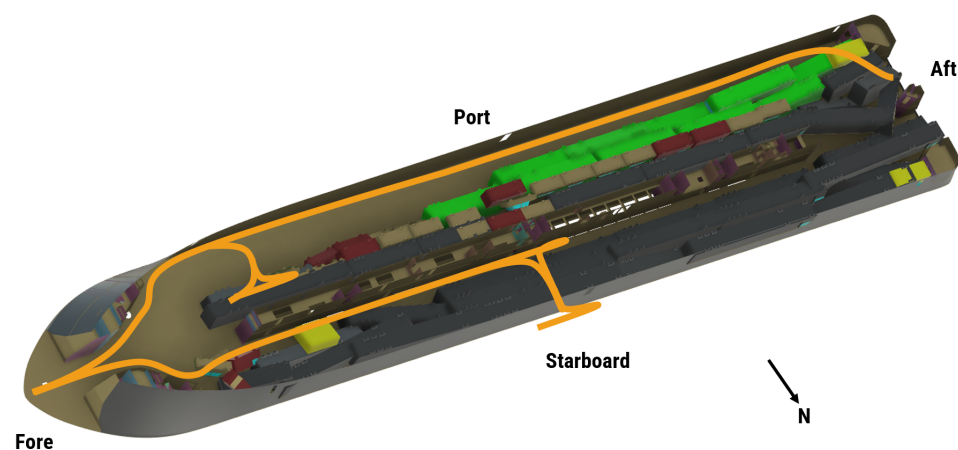
**Figure 1.** Reconstructed cargo shift status in the vehicle deck space of a grounded ship from ROV observations [22].

In reality, the ROV had a field of view of only a few meters, which made it difficult to obtain a full and three-dimensional view of the vehicle deck space. As presented in Figure 1, ROV observations on the port side, along the inner hull showed that all cargo, including trucks, trailers, and cars, had shifted towards the center casing. Consequently, the ROV had only a limited access to the casing, and apart from the two foremost doors in the bow section, the opening conditions of the remaining doors could not be identified.

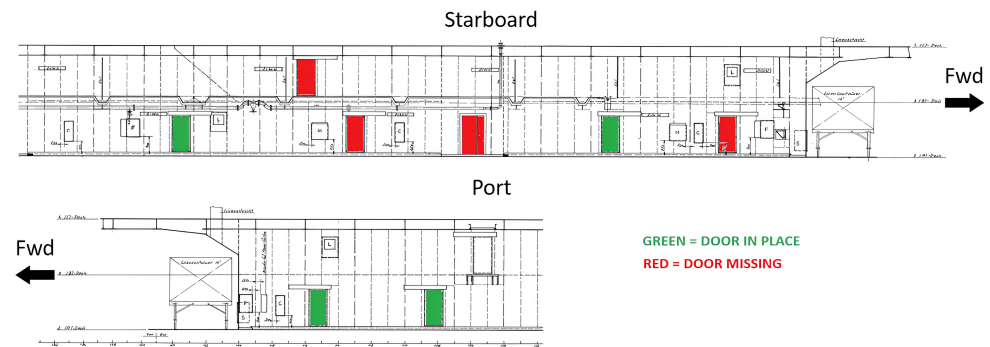
As the ship heeled to starboard during the accident, all cargo on the starboard side shifted toward the outer wall, allowing the ROV to take video along the center casing (see Figure 1). The ROV confirmed the opening conditions of six forward center casing doors, but information on the remaining aft doors is still missing. Figure 2 shows ROV observations of the center casing door conditions on both sides of the MV Estonia wreck.

**Figure 2.** Opening conditions of the doors at the forward center casing on the vehicle deck: doors on the starboard (**top figure**) and port side (**bottom figure**).

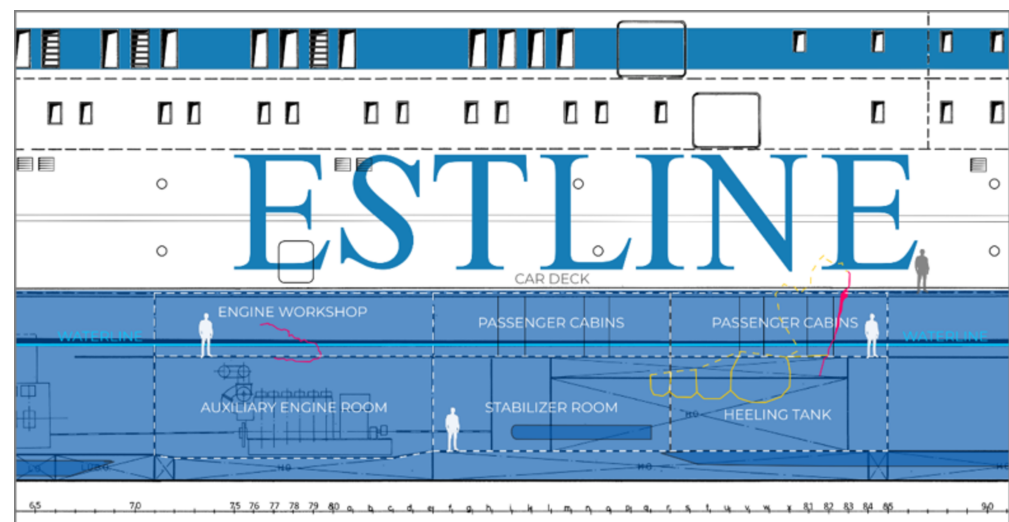
Figure 3 highlights the location of the two newly identified side damages on the starboard side, marked in red near the waterline. One dent or small damage, located between building frames 76 and 80, would open into the engine workshop: However, no crew member reported any collision or water ingress there [4], so this damage is not modeled in the present study.

**Figure 3.** Location of the starboard side damages as viewed by ROV and marked (in red) on the vessel GA plan. The forward damage (NSD on the right) is included in the simulations, the protruding aftward damage (on the left) is not [23].

Another new side damage (denoted as NSD in the present study) extends across building frames 82 to 83 and, in the vertical direction, connects to three different internal compartments: The vehicle deck, the compartment for cabins, and the starboard side heeling tank. The corresponding damage opening areas, respectively, are  $0.54 \text{ m}^2$ ,  $0.60 \text{ m}^2$ , and  $0.099 \text{ m}^2$ . Detailed descriptions of the openings and leaks modeled on the damaged vessel in this study can be found in [4].

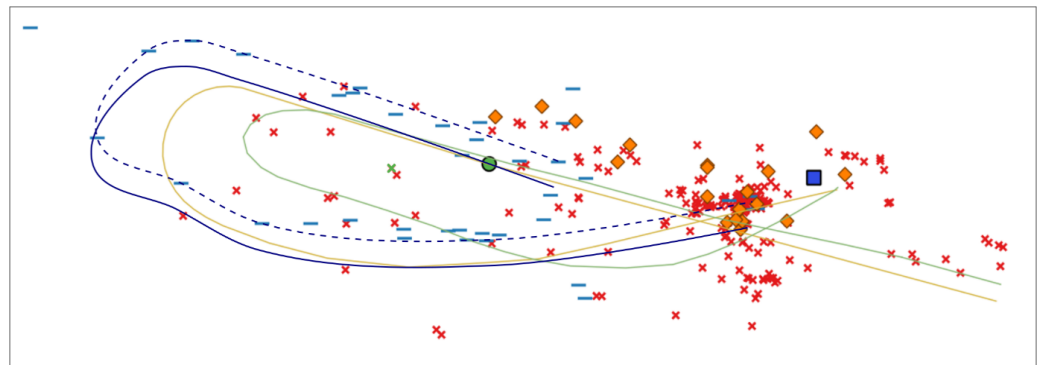
The obtained distribution of debris and possible tracks is shown in Figure 4. The JAIC track is green, the HSVA track (2008) [5] yellow. Blue targets are elongated objects that are connected with a dashed blue curve. When this curve is shifted south to go through the visor location (green dot), one can see the comparison with the HSVA track of 2008. The difference is that with the blue curve, the western extent of the curve lies roughly 300 m to the west. In addition, a part of the ramp railing (green cross) was found 485 m west of the visor location. The shipwreck is marked by a blue square. Possible life raft containers are marked with orange [22].

**Figure 4.** Possible tracks of the MV Estonia during the capsizing and sinking process [22].

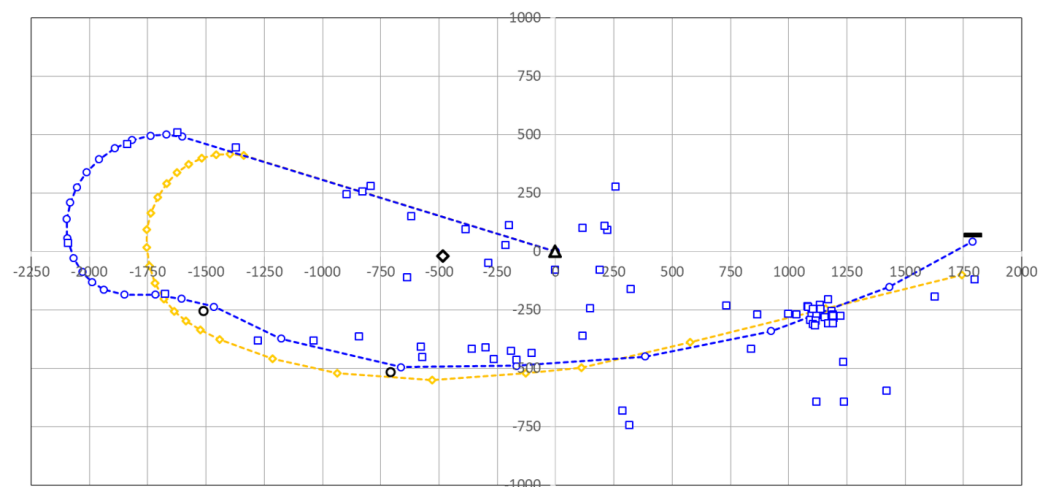
The bow visor, the shipwreck itself and two additional solitary objects were assumed to have sunk rapidly enough to not have been significantly moved by the current. Thus, their positions on the seabed were used directly in plotting the new HSVA track. The solitary objects were assumed to have dropped to the starboard side of the vessel, as the ship heeled to that side. The position of the railing of the ramp on the seabed does not fit into anything else. It is likely that during the accident, the bow visor tore the railing from the ramp. These objects are marked with black in Figure 5.

**Figure 5.** The yellow curve shows one of the old HSVA tracks, and the blue curve, the newly constructed HSVA track, both under the influence of current and wind. The blue markers show the elongated objects moved 180 m against the current. The black diamond marks the railing, the triangle the visor and the bar the shipwreck.

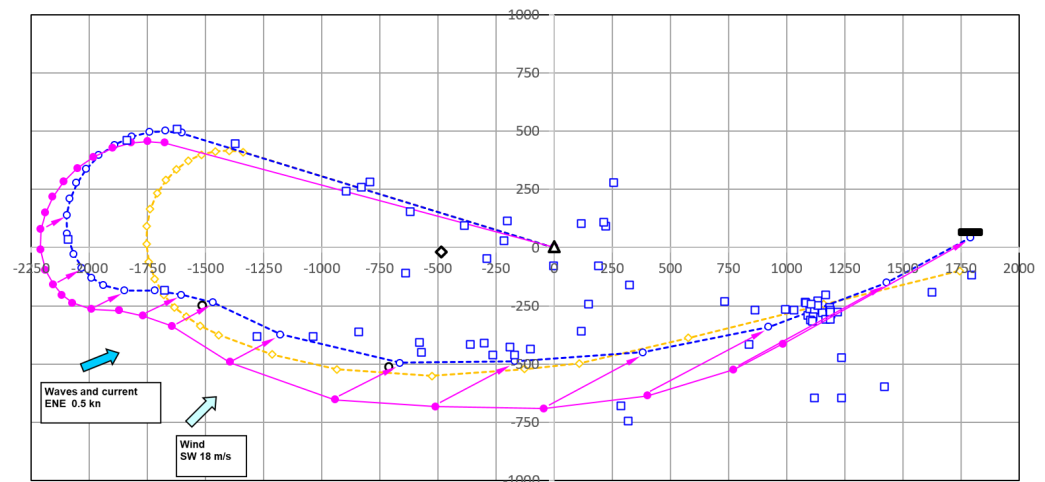
Figure 6 shows the track of the ship through water, showing the actual heading, without the effect of current and wind. The ship speeds along the HSVA tracks, old and new, are based on the loss of kinetic energy of the ship through its resistance in calm water as the ship advances. This speed reduction was computed by HSVA already in 2008. The effect of the accumulation of flood water in the ship is coarsely taken into account in this speed calculation. Further, it is known that with its initial speed and driven by the surface current and wind the vessel completed its track in ca. 40–45 min, that is, in the time gap between the loss of the visor and the final sinking of the vessel. With these restrictions the leeway in defining the speed reduction of the vessel is rather small, which should provide a fairly good accuracy.

**Figure 6.** The yellow curve shows one of the old HSVA tracks, the blue curve the newly constructed HSVA track. The pink curve shows the actual (new) track of the ship through water without the effect of current and wind.

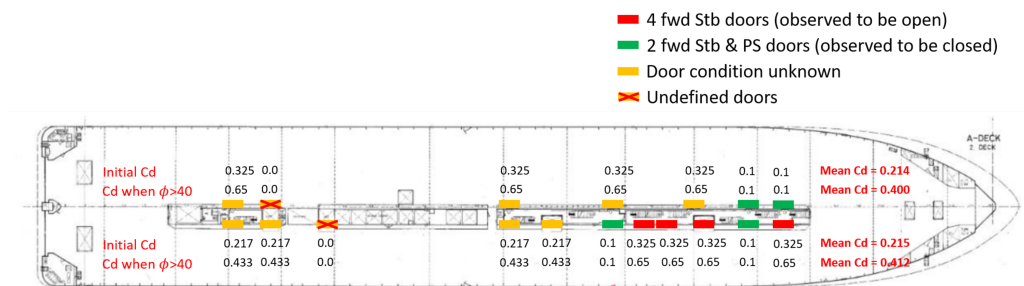
As presented in Figure 7, two of the seven doors on the port side and two of the eleven doors on the starboard side were found to be in place in the ROV survey carried out by ESIB in 2023. The opening conditions of the other doors remain unknown due to the limited view of the ROV to the center casing often blocked by displaced vehicles:

**Figure 7.** Modeled condition of the center casing doors.

Since the 2023 ROV investigation, it is known that the two foremost doors on the port side of the center casing are still closed on the MV Estonia wreck on the seabed. Therefore, they are assumed to be closed throughout the capsizing process, but leaking with discharge coefficient  $C_d$  of 0.1. Instead of the original assumption that one third of the remaining four doors on the port side of the center casing are open in the beginning [5], it is assumed that half of these four doors are open in the beginning, which leads to an overall discharge coefficient  $C_d$  of  $0.65/2$ , that is, 0.325 for these doors. In addition, it is assumed that these doors open completely, once the heeling angle reaches  $40^\circ$ . See Figure 7 for illustration.
