# NDT-Based Condition Assessment and Structural Safety Evaluation of a Reinforced Cement Concrete Water Tank in a Coastal Region: A Case Study

Marakkath Nidhi \*, Praveena Jagatheesan and Shimol Philip \*

Department of Civil Engineering, National Institute of Technology Puducherry, Karaikal 609609, India; praveena.j1803@gmail.com

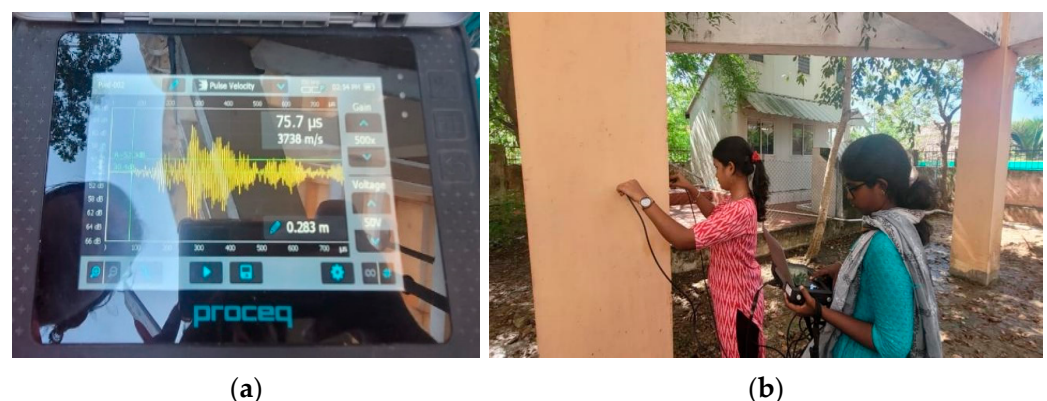
**Figure 4.** UPV test in the RCC water tank in Thirunallar: (a) UPV instrument; (b) UPV measurement on beams.

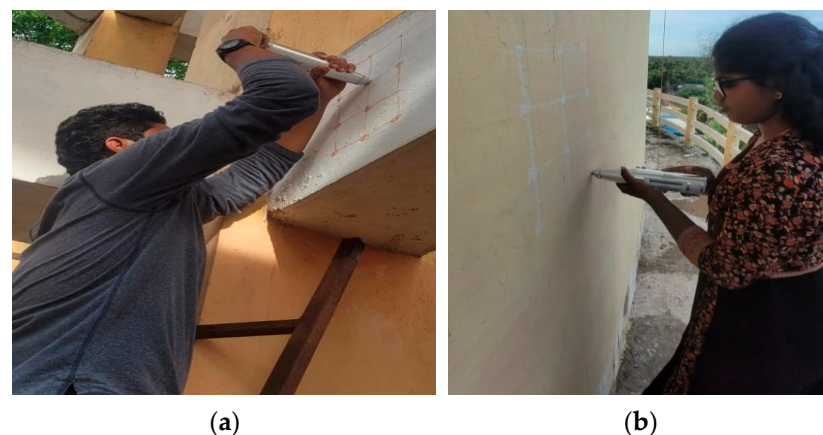
**Figure 5.** Rebound hammer test on the RCC water tank in Thirunallar: (a) beam element; (b) wall of water tank.

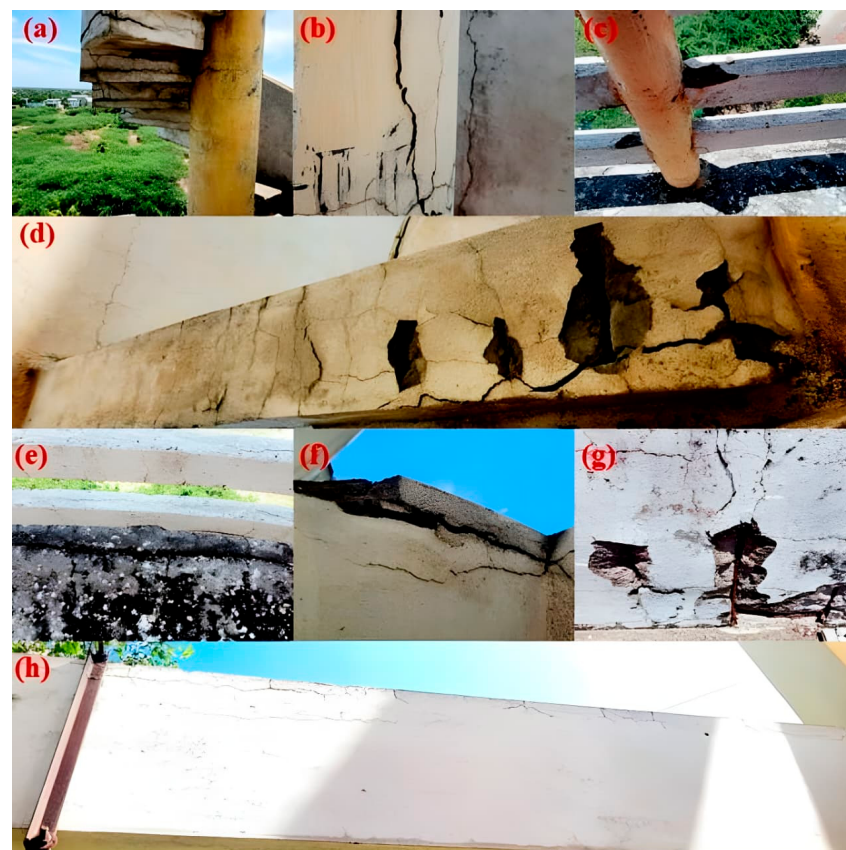
The condition of the RCC water tank, as assessed by visual inspection, is illustrated in Figure 10. The visual inspection of the RCC water tank at Thirunallar clearly shows severe damage to the tank and its structural components. The rebars are delaminated at multiple locations, indicating ongoing corrosion. The safety railings of the elevated water tank are damaged and partially deteriorated. Severe concrete spalling and large cracks were found throughout the stairs, which indicates concrete distress. The beams supporting the stairs had evident cracks, which are also due to concrete distress at the connections. Both the tank wall and the columns supporting the stairs had larger cracks. Some areas also showed vegetation growth, indicating prolonged moisture exposure and inadequate maintenance. Also, the tank showed signs of prolonged exposure to moisture. There were darkened walkways around the tank, revealing consistent water seepage, and it also had large cracks spanning its entire width. Visible surface separation along the slab's edge joint was also observed, indicating that the tank was improperly maintained. Additionally, the lower structure of the water tank was less exposed to the environment, as the nearby residential structures served as a barrier to the RCC water tank. However, the elements at the higher levels were found to have more visible defects, including cracks, surface deterioration, and corrosion of reinforcements.

**Figure 10.** Photographs of the RCC water tank obtained during visual inspection: (a) cracked and spalled spiral stair case of the water tank; (b) vertical crack in the water tank's lower level column; (c) surface concrete breaking off from the tank's railing support exposing the corroded reinforcement; (d) staircase beam: concrete spalling with exposed reinforcement due to corrosion; (e) tank top rail: surface cracking and minor edge spalling; (f) tank steps: surface scaling and deterioration due to moisture; (g) tank staircase wall: cracking with plaster delamination; (h) tank beam: minor surface cracks at the top of the beam.

The visual inspection of the RCC water tank at Thirunallar clearly shows severe damage to the tank and its structural components. The rebars are delaminated at multiple locations, indicating ongoing corrosion. The safety railings of the elevated water tank are damaged and partially deteriorated. Severe concrete spalling and large cracks were found throughout the stairs, which indicates concrete distress.

- Localized Concrete Restoration: The removal of spalled or lower-quality concrete, treating exposed reinforcement, and repairing the section with polymer-modified mortar, thereby restoring the protective cover.

- The exposed slabs, stairs, and surfaces of the tank can be waterproofed to reduce the loss of long-term durability.
- Structural cracks can be sealed and rehabilitated using epoxy injection and flexible sealant to prevent further moisture penetration and deterioration of concrete.

- The edges of the deteriorated stairs and other access elements can be repaired to restore surface integrity.
- Vulnerable reinforcement zones can be cleaned and treated with corrosion protection measures such as passivation and protective coatings.

- Observed biological growth and surface contaminants must be removed, and the protective coatings can be applied to avoid degradation due to environmental actions.
