Corrosion and Conservation Management of the Submarine HMAS AE2 (1915) in the Sea of Marmara, Turkey

Ian D. MacLeod

Western Australian Maritime Museum, Victoria Quay Drive, Fremantle, WA 6160, Australia;
ian.macleod@museum.wa.gov.au

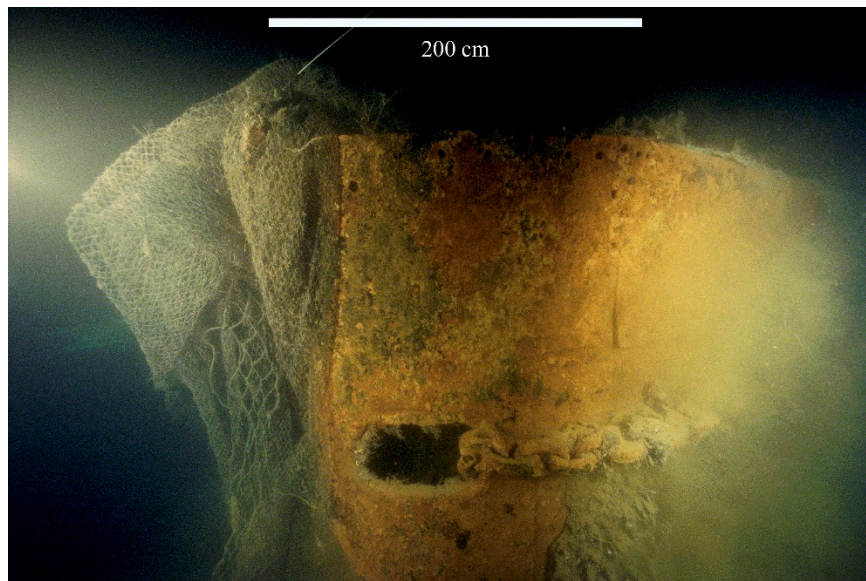
The submarine lies on the bottom of the Sea of Marmara with a silt mound coming half-way up the hull. Images of the wreck at www.submarineinstitute.com show that a combination of corrosion and trawler net damage has holed the thin plate sections at the bow and on the combing (structure that covers a range of fittings to streamline the water flow) behind the conning tower, leaving the structural frames exposed (Figures 3 and 4). The drop camera used in 2007 showed that the non-ferrous metal fixtures on the interior of the conning tower were covered in a thin layer of concretion from the galvanic protection afforded by the surrounding iron objects [7]. The interior of the conning tower was made of bronze to make sure that the magnetic compass would not be affected by the proximity of ferrous metals. The hatch cover, ladder, control valves and steering gear were all made of brass or bronze. Owing to the confined nature of the seawater inside the vessel it is likely that the massive banks of batteries will be involved in long-range or proximity corrosion that will have affected the electric motors and the diesel engines used for recharging the battery banks [8].

Figure 3. Trawler net damage on the AE2 submarine.

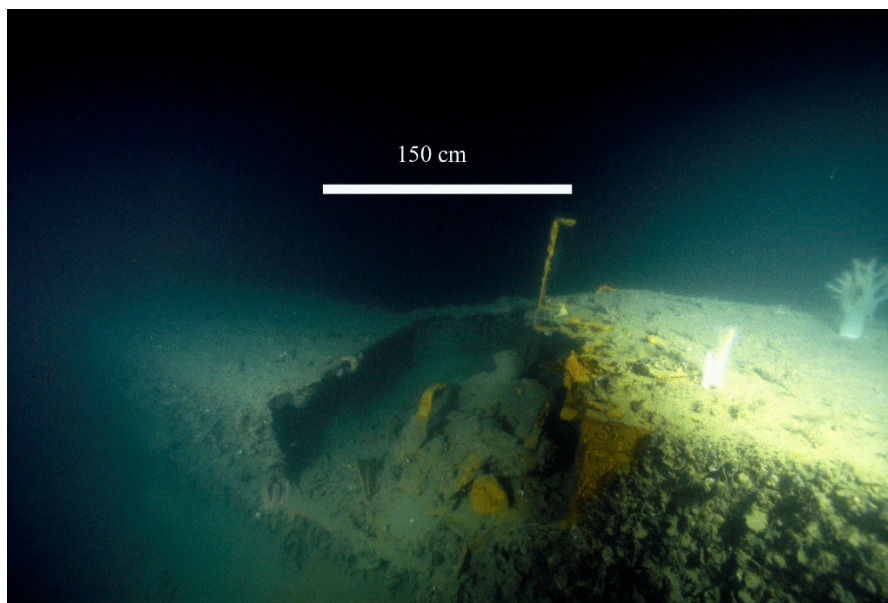
Figure 4. Corrosion damage to the casing of the AE2; yellow shows active corrosion.

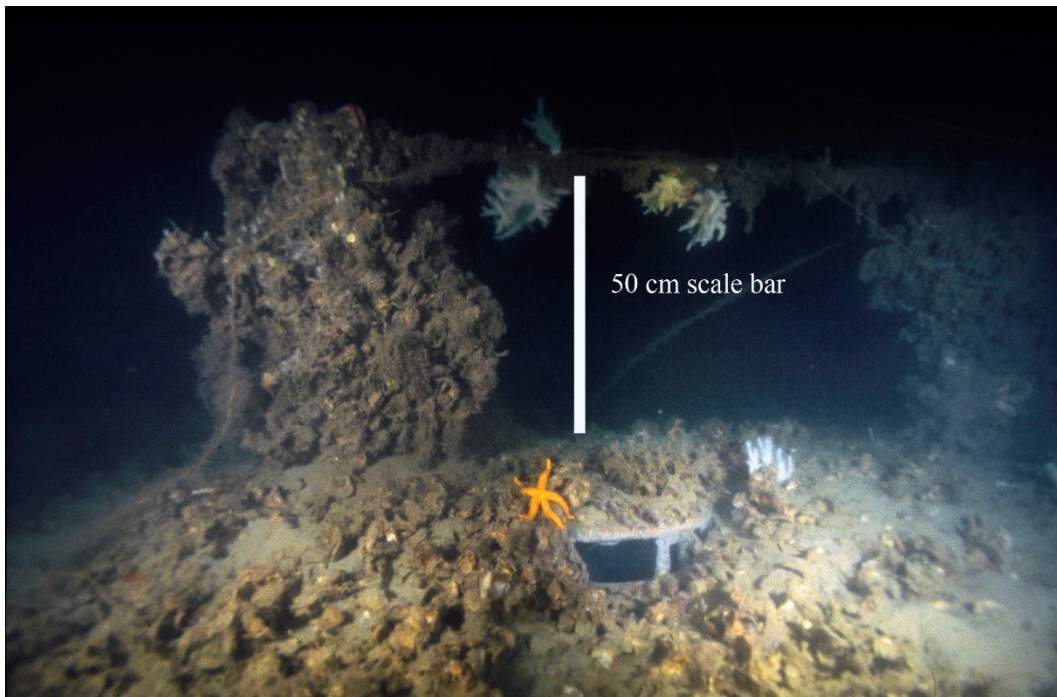
Based on the drop camera study, it was deemed likely that the hatch cover could be opened, since cathodic protection from the hull will have prevented major corrosion attack on the hinge mechanism. The opening of the main hatch to allow the ROV to enter the submarine was delayed underwater when divers found that there was 25–35-mm-thick concretion on the hatch mechanism, some 15 times thicker than expected. Because the higher salinity environments have higher total mineral content, the alkalinization of the hinge resulted in a massive concretion deposit (Figure 5). The bond around the spindle and hinge brackets was broken using a combination of de-concreting tools and a hydraulic jack. A chain block was needed to gently ease the hatch open for the first time in over 100 years. Cathodic current from reduction of oxygen on the non-ferrous metals makes the surface more alkaline (Equation (1)). In the case of the AE2 the outcome was the precipitation of massive calcareous deposits.

Figure 5. Concreted main hatch way showing the 10 cm gap for insertion of the drop camera and the very thick marine concretion deposits.

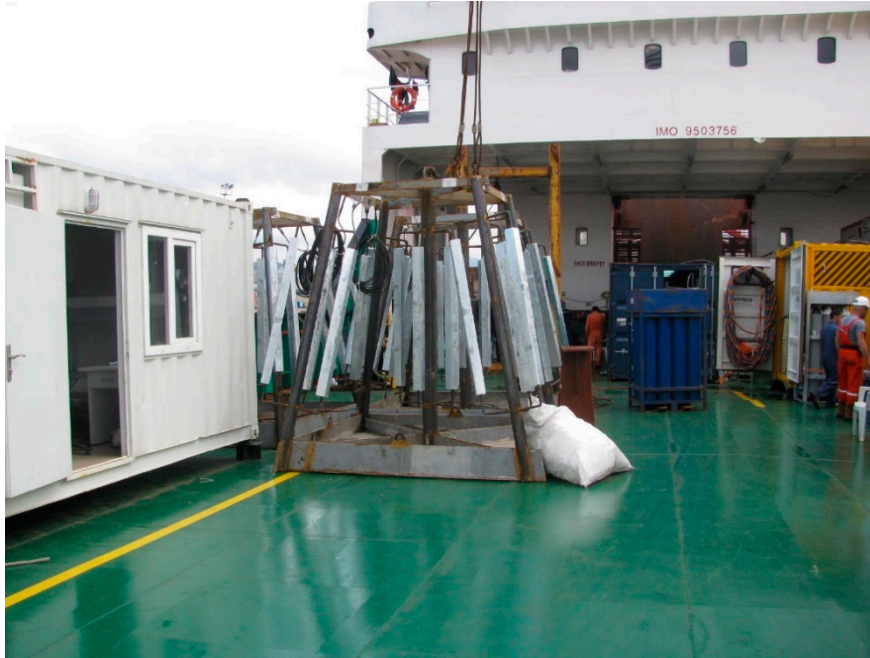
Figure 9. View of assembled anode pods prior to attachment to AE2.

The anode pods were assembled on a 2.6 m sided square base, which was filled with concrete to prevent them sinking into the silt. The supporting structure weighed 0.5 tonnes, giving an aggregate weight of around 1.5 tonnes to each pod. Each anode ($150 \times 7.5 \times 7.5$ cm) had a central iron core, to which insulated current-carrying cables were attached (Figure 10). The distal end of the cable was attached to the submarine using an industrial three bolt system, as used in the cathodic protection of gas and oil production facilities. The 17 anodes on each pod had a geometric surface area of 7.84 m^2 . In order to achieve a good spread of protection through the length of the boat, one pod was attached aft near the rear hydroplane, one amidships at the conning tower and one up forward on the windlass (Figure 10). With an estimated geometric surface area of approximately 660 m^2 for the submarine and with the area of the anodes at 23.5 m^2 , the industry standard ratio of approximately 30 times object to

anode ratio was achieved. This ratio helps to avoid damage to the submarine if it was over-protected, as this could produce too much hydrogen pressure, which would blast off the protective concretion and lead to excessive consumption of anodes.

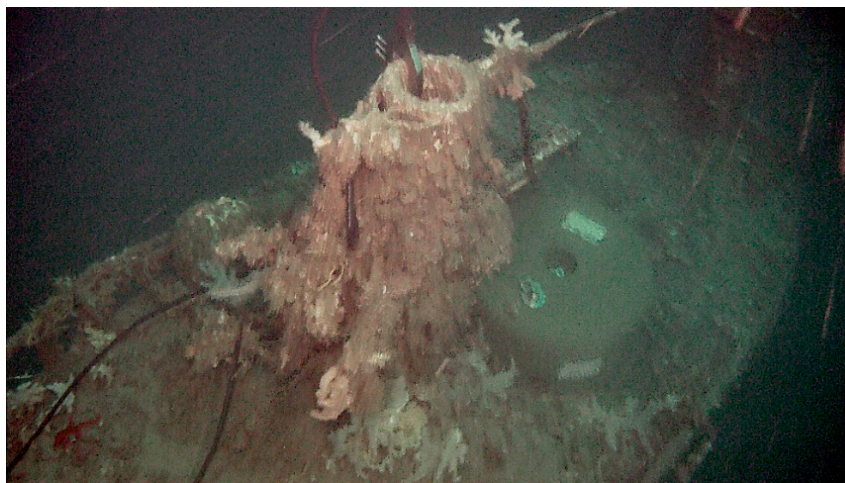
Figure 10. Clamp and cable arrangements for central anode pod connection to the conning tower. Note the replica hatch is in the “locked down” position.

Prior to attaching the anode cables with clamps to the submarine, the surfaces were hydro-blasted to remove small areas of concretion from the metal surface to get ohmic connections. The elapsed time at each attachment point was measured from the time at which the pods were attached and the time when the E_{corr} measurements were taken. The observed voltages were dependent on the logarithm of the elapsed time between anode attachment and voltage measurement. The linear regression analysis gives Equation (6), which had an R^2 of 0.9648 with an associated equation,
