Documenting Change on the SS *Thistlegorm*, Red Sea, Egypt: Using Underwater Photogrammetry to Record Natural Deterioration and Human Impacts on a World War II Shipwreck

Simon Brown¹ and Jon C. Henderson^{2,*}

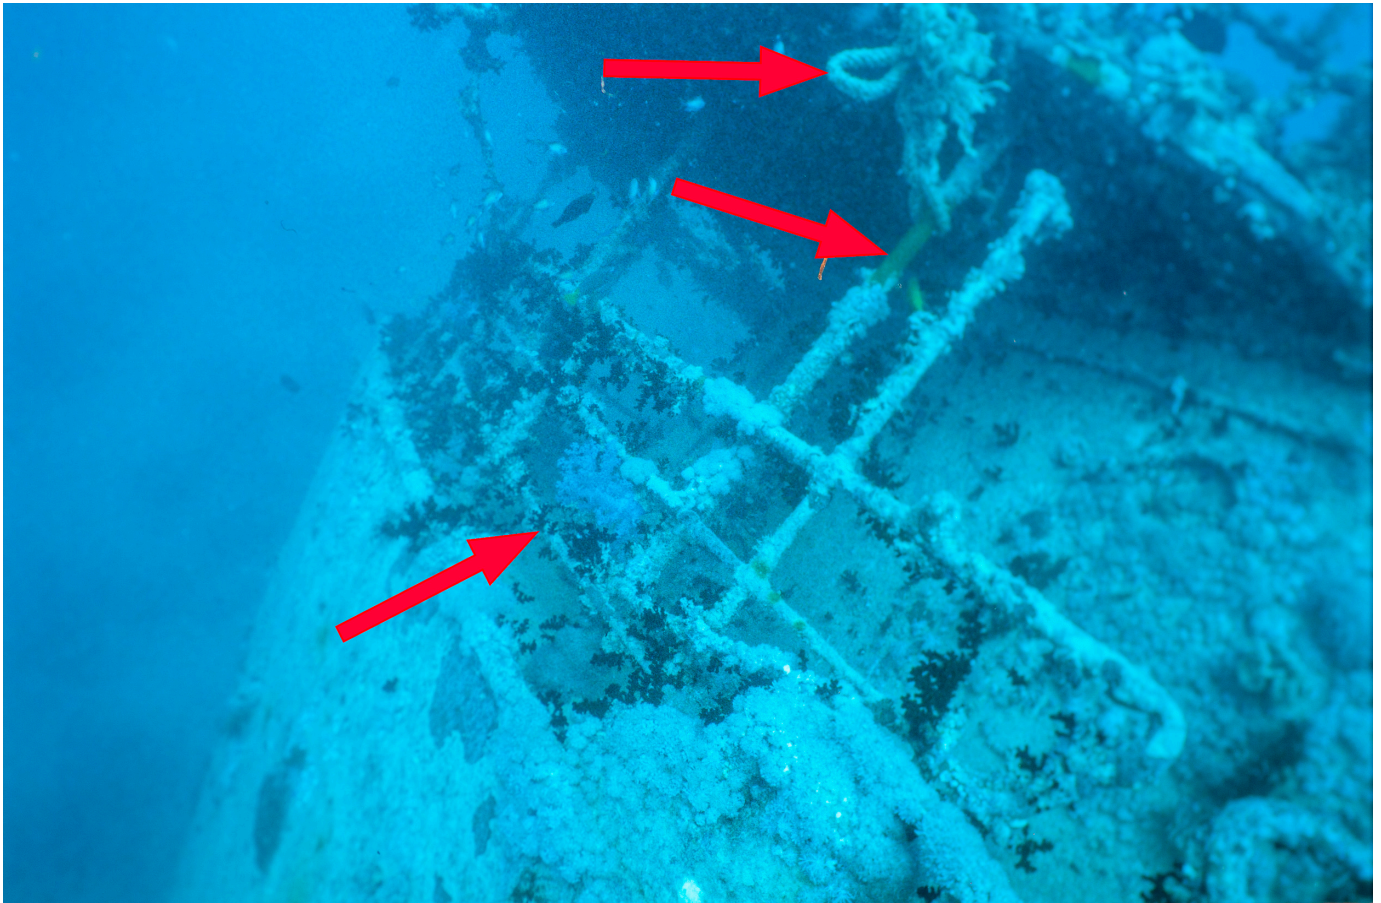
Even before Hawkins' visit, dive vessels had been mooring directly onto the structure of the *Thistlegorm*. Her images document mooring lines tied to the bow anchor winch and deck railings, with rope loops around vertical stanchions visibly scraping away protective coral and exposing fresh rust, indicating the early stages of corrosion accelerated by this practice (Figure 3). The near-complete loss of railings along the ship's bow—still intact in Hawkins' photographic record—can be traced, at least in part, to historical mooring practices.

Figure 3. A still from 1992 revealing the early effects of mooring practices on the wreck. Note the fresh red oxidation on the vertical support. Lower arrow points to railings that are now missing (photo: Caroline Hawkins).

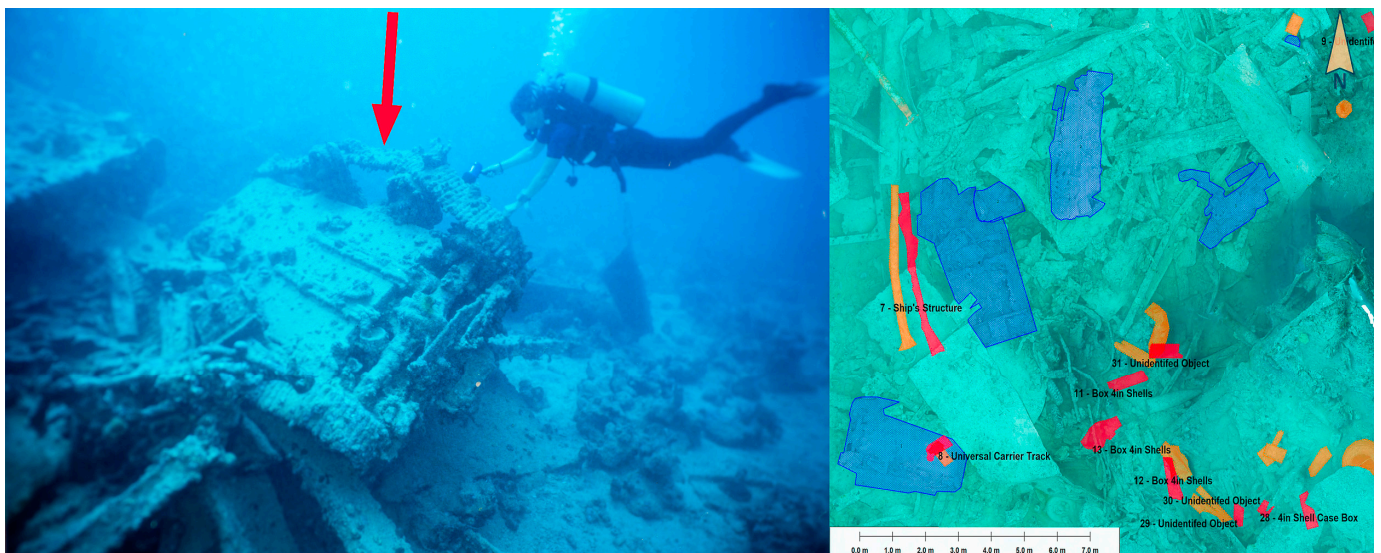
Hawkins' photographs also capture various structural and artefactual elements that have since been lost or displaced. A deck-mounted ventilator behind the bridge on the starboard side, recorded in 1992, is now missing, while a similar ventilator found aft of the stern may have been moved or, more likely, displaced during the explosion in 1941 in Hold No. 4. Significant changes are observable in the remains of the Stanier 8F heavy freight locomotive located on the port side of the wreck. In 1992, a section of the locomotive's mainframe was still attached to the smokebox; today, this piece lies separated on the seabed, confirming its origin as part of the locomotive's structure and providing evidence of progressive fragmentation and loss of features, including potential removal of non-ferrous pipework. A large Brockhouse trailer, noted resting near Hold No. 5 in the 1992 images, was no longer on deck by 2017. The only similar trailer matching its design and suspension is now found approximately five metres from the wreck on the seabed, illustrating artefact displacement likely caused by environmental forces or human intervention. Hawkins' images also record an inverted Universal Carrier with its left-hand track still in place within Hold No. 4. By 2017, this track was missing, with only a small section remaining beneath the vehicle. This fragment was later recorded in shifted positions during the 2017 and 2022 surveys, highlighting the ongoing movement of artefacts within the wreck (Figure 4).

Figure 4. Left: Universal Carrier track recorded in situ in 1992 (photo: Caroline Hawkins); Right: Hold No. 4 inverted Universal Carrier on left (Blue hatch) with track section shown in their 2017 (Orange) and 2022 (Red) positions.

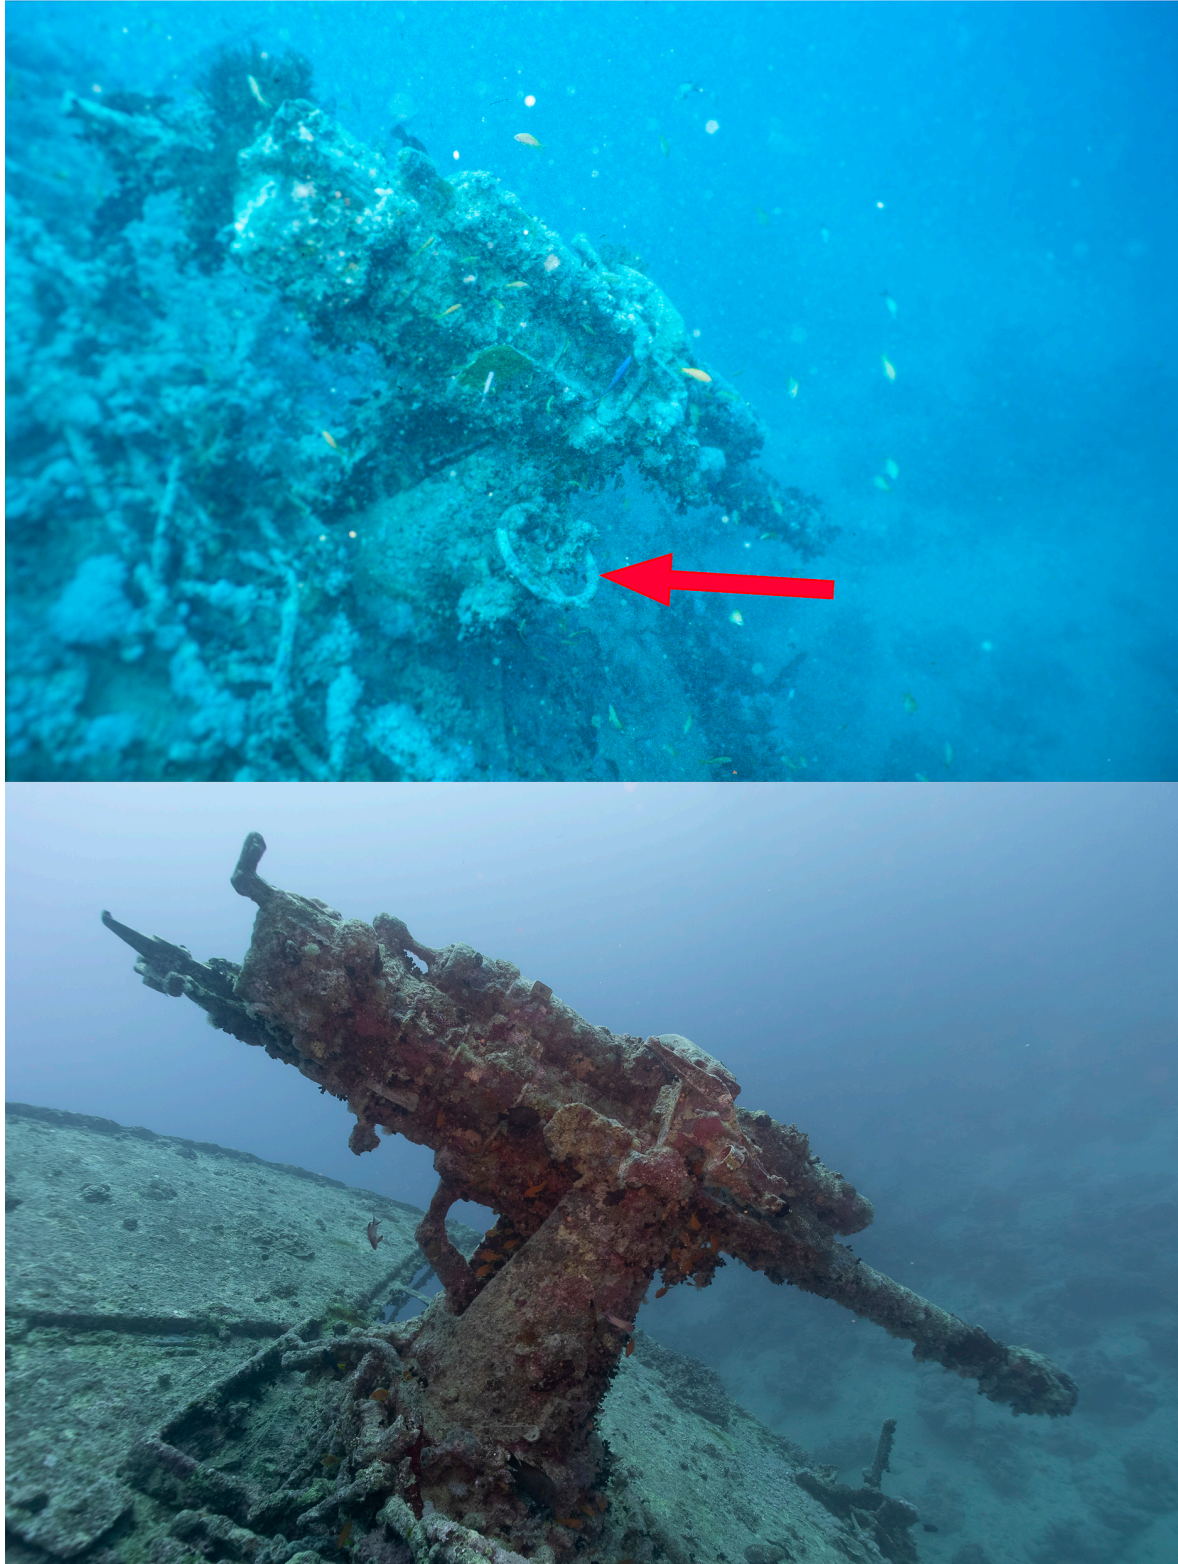
There is also evidence of the removal of smaller fixtures, presumably collected by divers as souvenirs. The traverse handwheel of the low-angle stern gun, present in Hawkins' 1992 images, is now no longer in place and cannot be traced nearby (Figure 5). Hawkins' 1992 photograph of the captain's bathroom shows the bathtub with both taps present; by 2018, one of the taps had been removed (Figure 6).

Figure 5. **Top:** stern low-angle (4 in) gun traverse wheel in situ as recorded in 1992 (photo: Caroline Hawkins). **Bottom:** today the handwheel is no longer present (photo: Alicia Johnson).

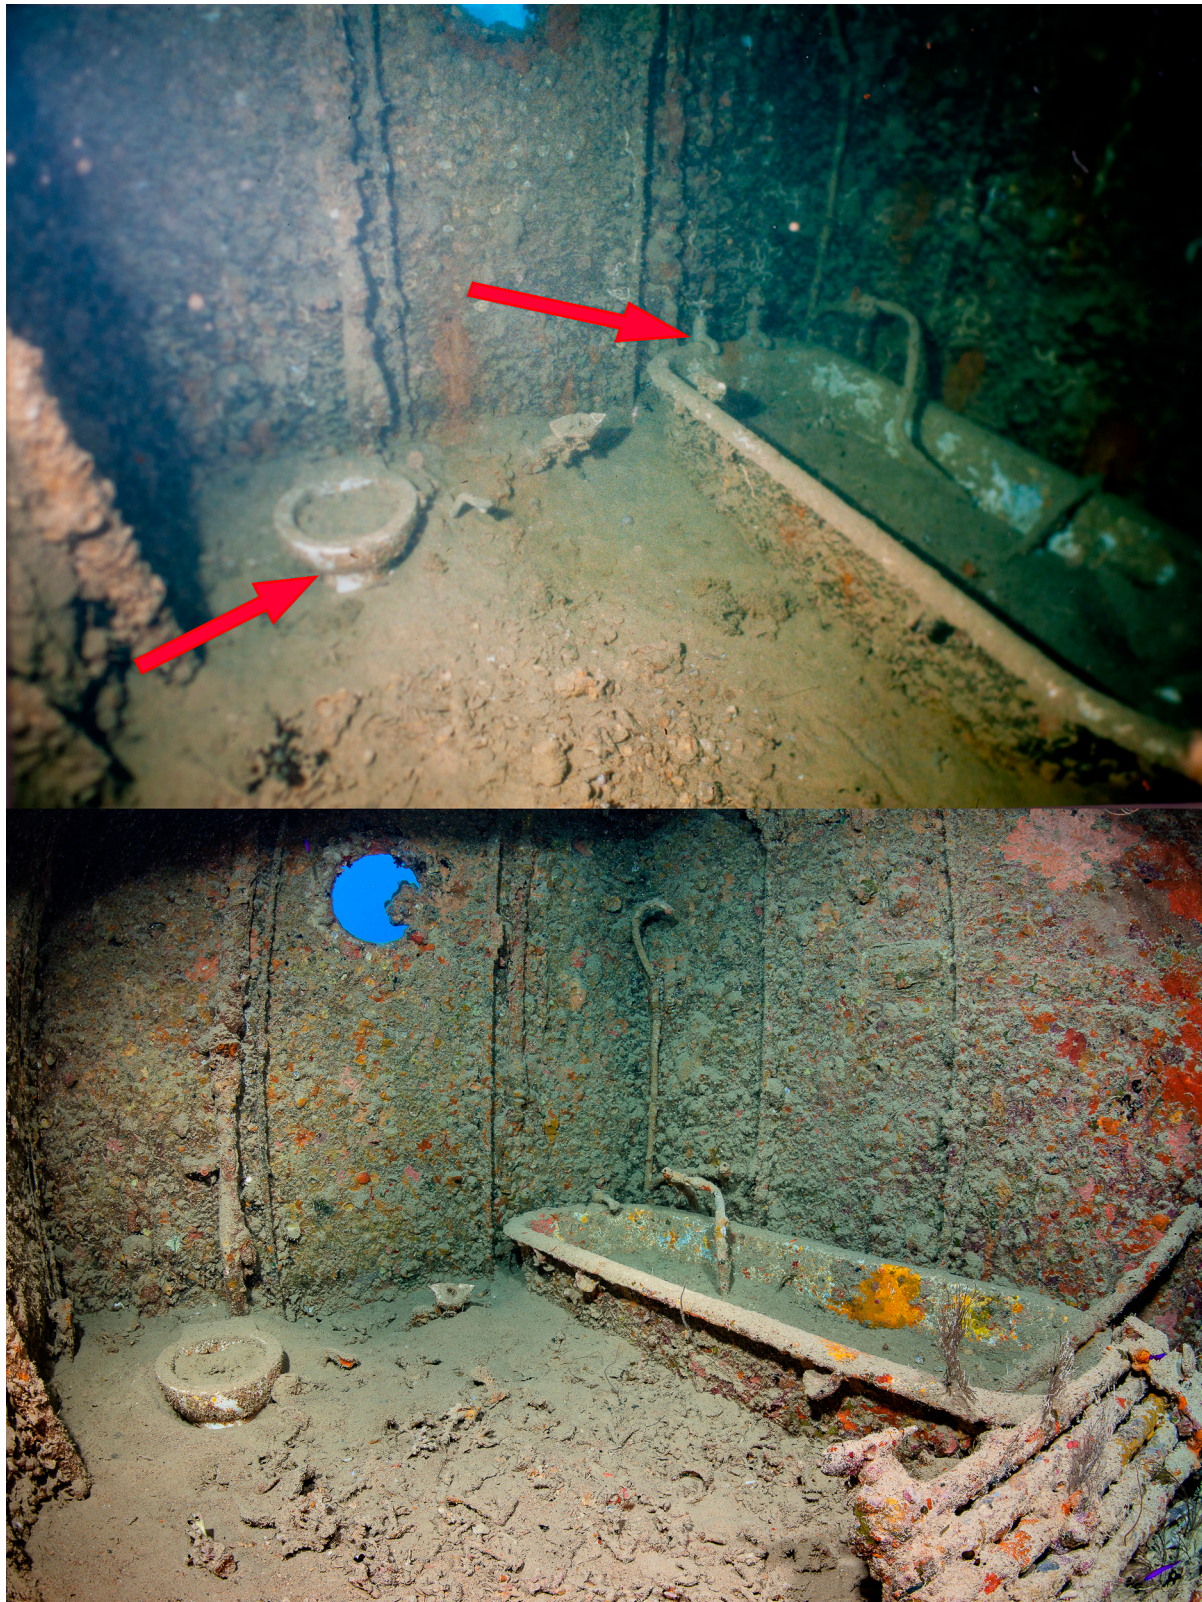
Figure 6. **Top:** Bathtub and head in Captain's House in 1993 (photo: Caroline Hawkins) **Bottom:** Image from 2018 shows missing tap and changes in the depth of silt relative to the head (photo: Alex Mustard).

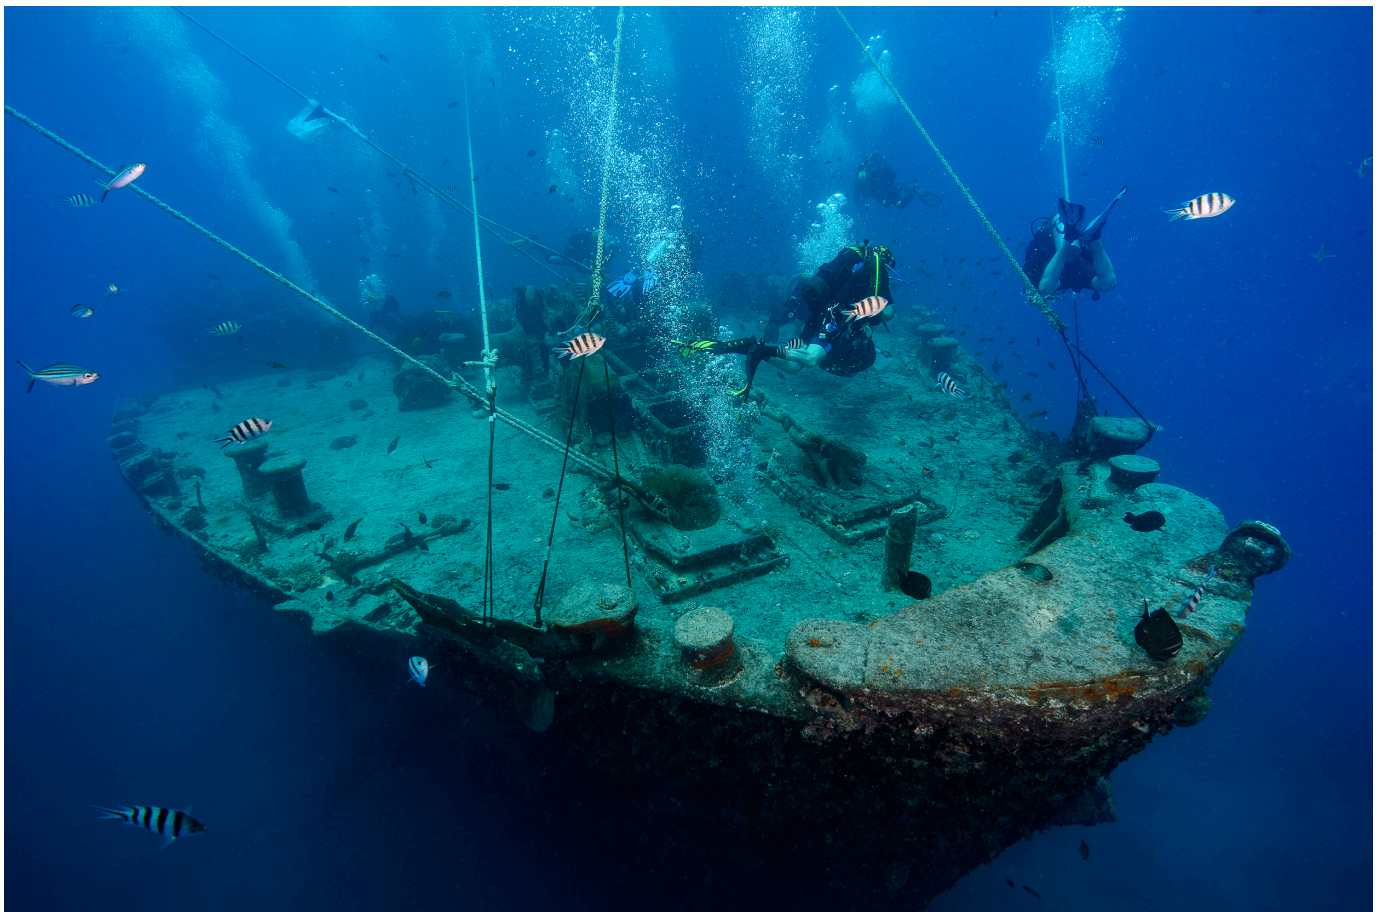
One area of ongoing concern captured in Mustard's images is dive vessel mooring practice on the wreck. Comparisons between photographs taken in 1992 and those from 2013 reveal a significant increase in the number of mooring lines securing vessels to the structure, with images showing the use of steel hawsers, the anchor chain, and the deck winch as attachment points (Figure 7). While deck mooring bollards likely cause less harm than other methods, the use of steel hawsers—often deployed to prolong the life of nylon ropes—has accelerated surface erosion on these fixtures. This is evident in images showing bollards with ropes looped around them, eventually leading to weld failures and displacement of the bollards themselves (Figure 8).

Figure 7. Mooring lines, including the use of steel hawsers, securing dive vessels to the bow of the SS *Thistlegorm*. This image was taken in 2013 and shows a mooring line attached to the port anchor chain (photo: Alex Mustard).

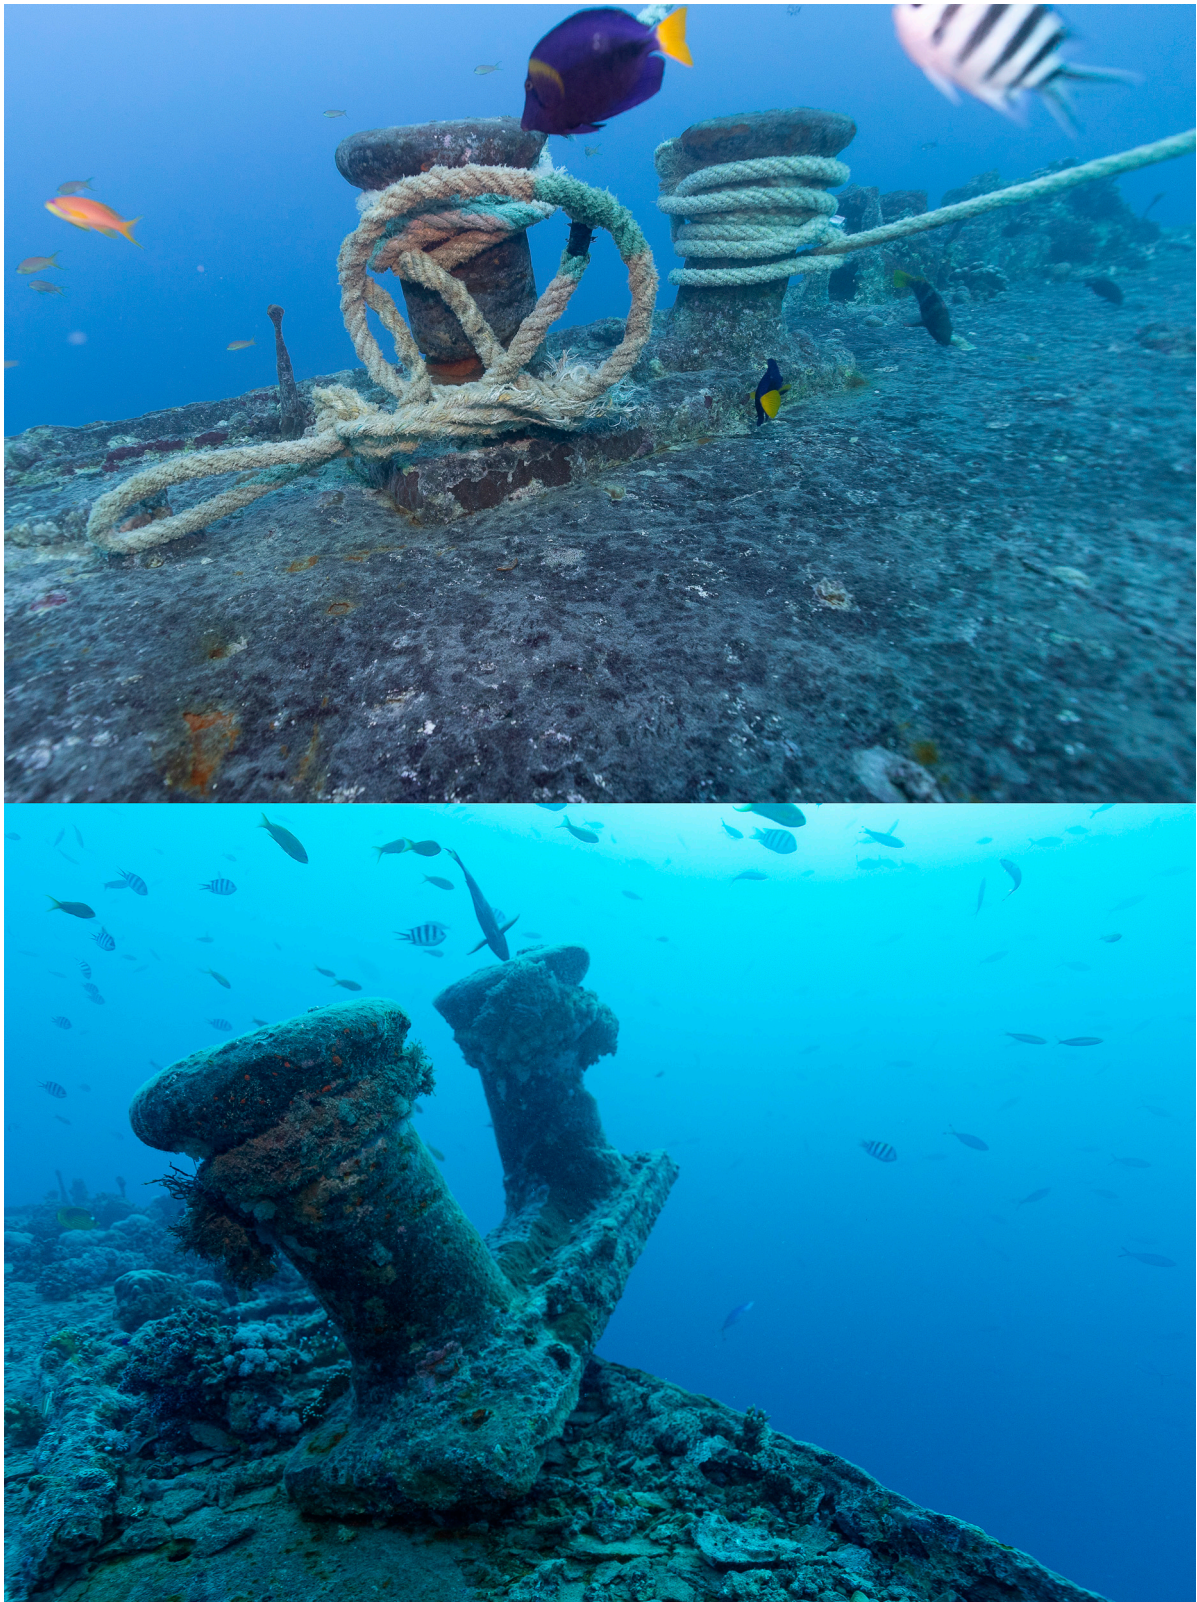
Figure 8. **Top:** Dive vessel mooring lines secured to a deck bollard on the bow in 2017. In absence of alternatives using the deck bollards remains a common approach but is not sustainable (photo: Alicia Johnson). **Bottom:** By 2023 this bollard has become displaced following failure of the welds securing it to the deck. Note the mooring line around the nearest bollard (photo: Alicia Johnson).

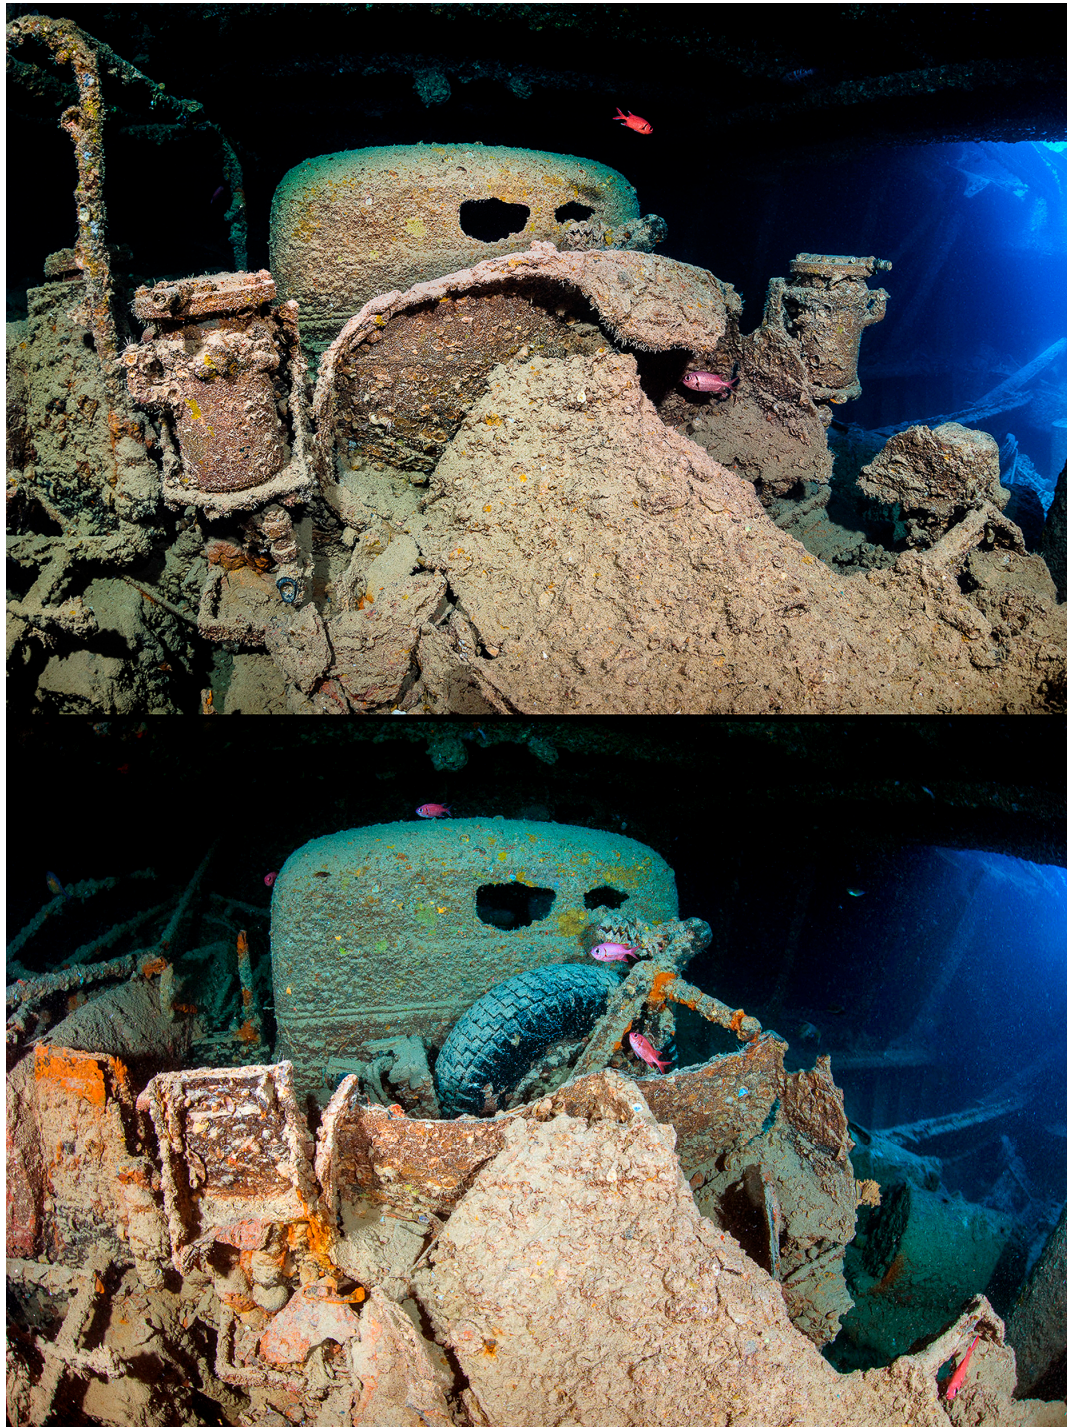
tankers are found on the upper cargo deck [3] (p. 110) and photographs reveal each have been subject to the recent targeted removal of non-ferrous metals (Figures 9 and 10). The removal of these non-ferrous filters was likely motivated by the scrap value of the materials, a pattern mirrored by the simultaneous removal of brass fuel valves from Albion AM463 refueler trucks located nearby (Figure 11). As no known preserved examples of these refueler trucks exist elsewhere, the *Thistlegorm's* refuellers represent the last surviving examples of this type. The removal of these brass fittings in early 2015 underscores the vulnerability of the site to opportunistic artefact collection, erasing irreplaceable elements of the wreck's historical fabric.

Figure 9. Bedford OCY tankers with fuel filters in situ (top) and removed (bottom). This deliberate damage was done in approx. January/February 2015 (Photos: Alex Mustard).

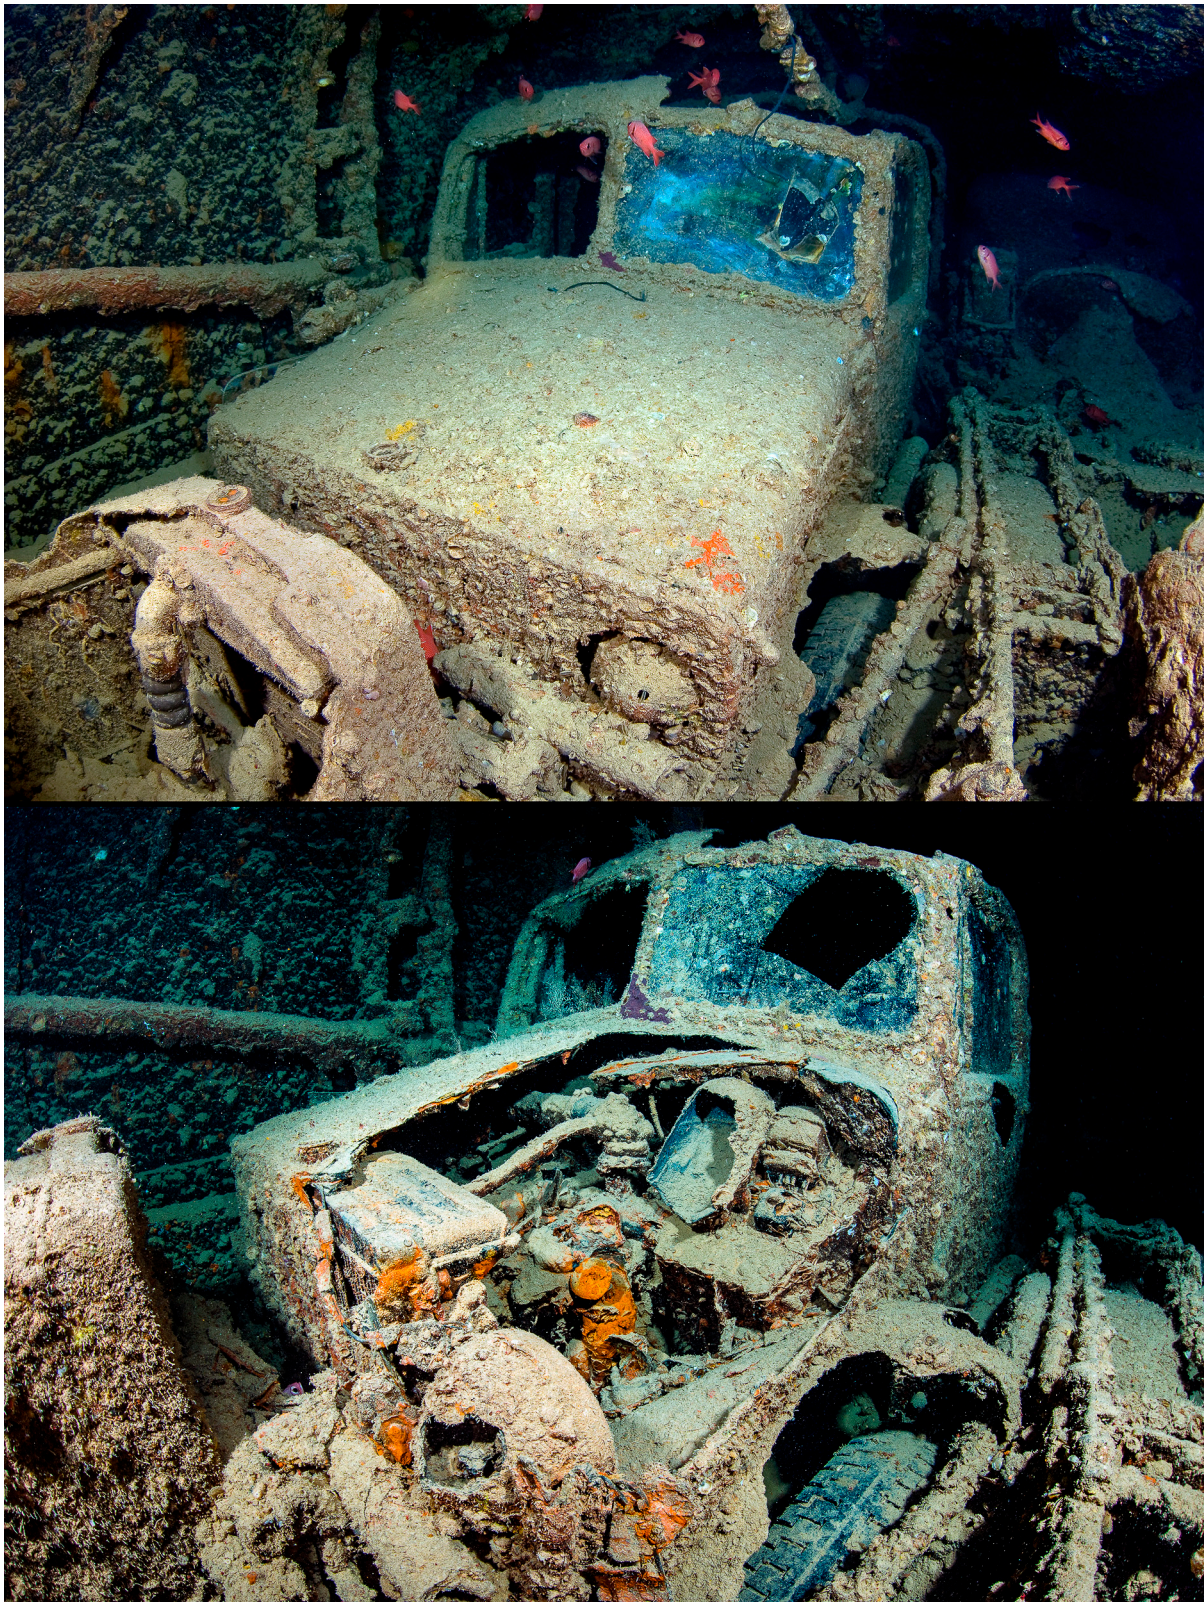
Figure 10. Bedford OCY tanker with bonnet intact (**top**) and damaged (**bottom**). This deliberate damage was done in approx. January/February 2015 (Photos: Alex Mustard).

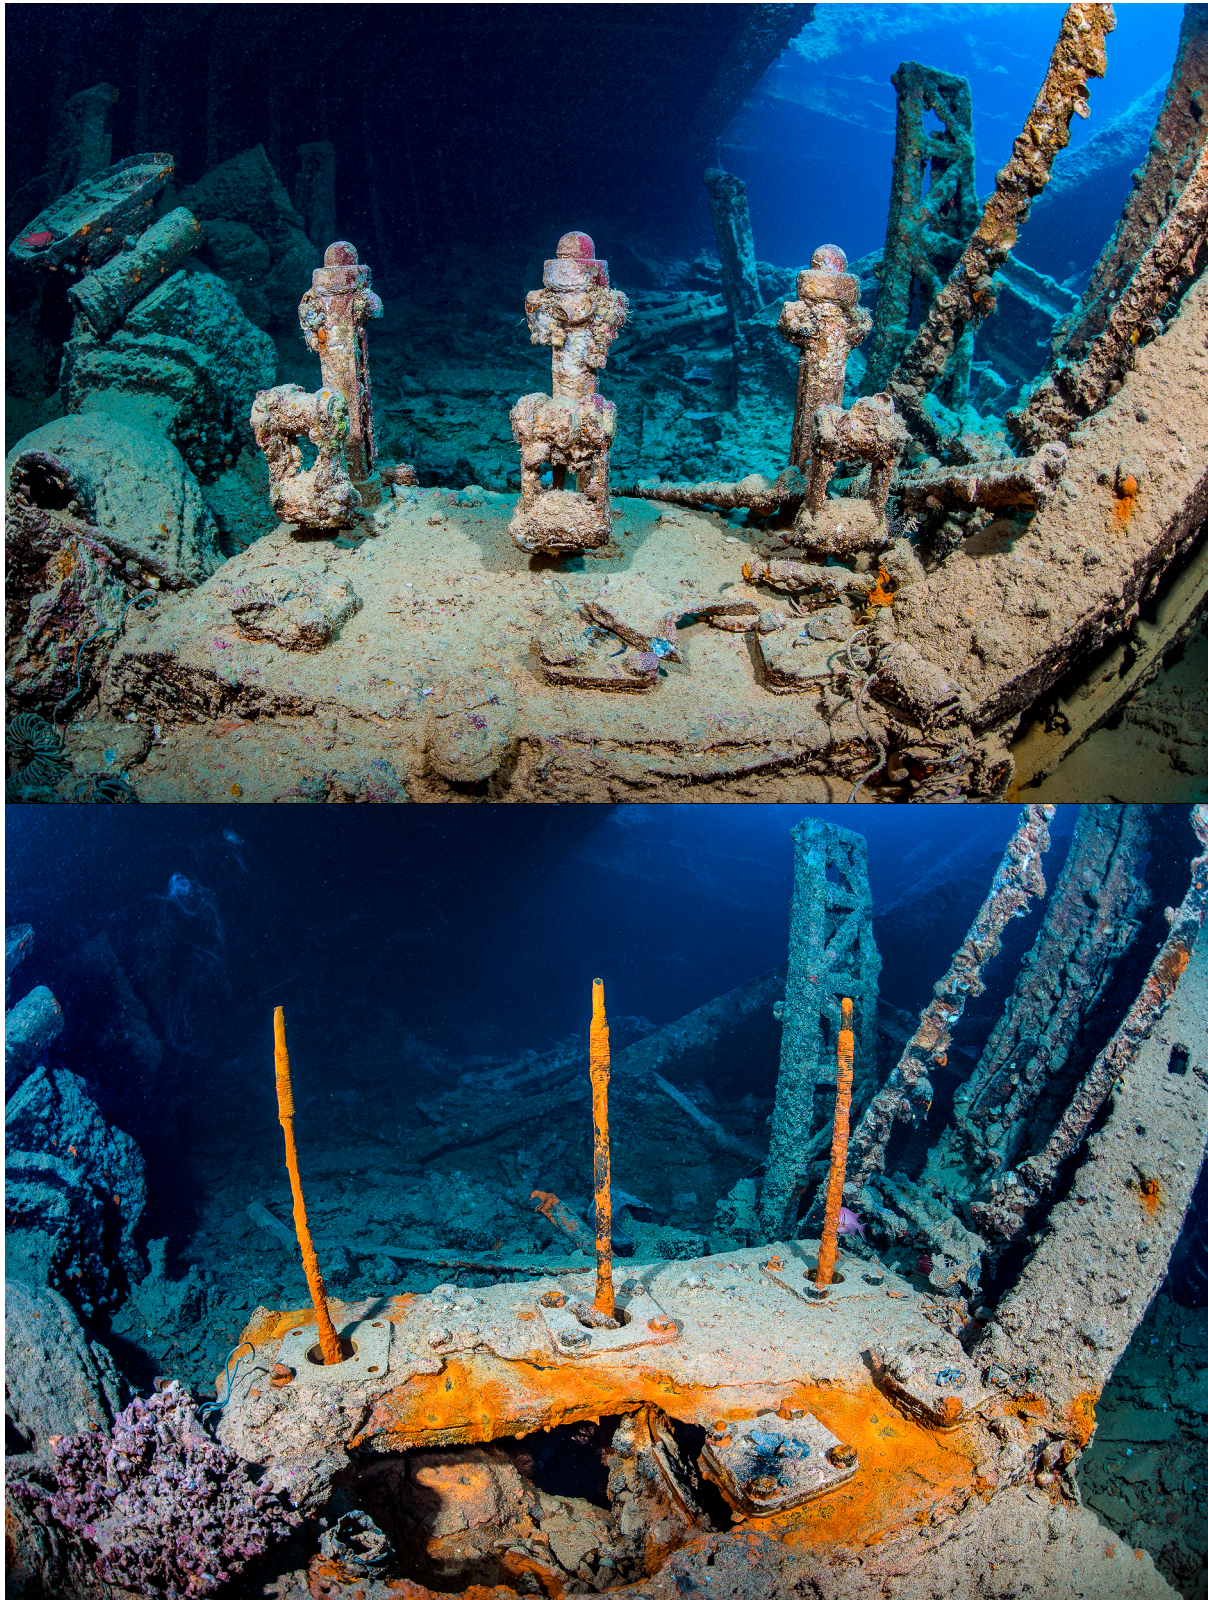
Figure 11. Removal of non-ferrous components from the Zwicky aircraft refuelling system. This deliberate damage was done in approx. January/February 2015 (Photos: Alex Mustard).

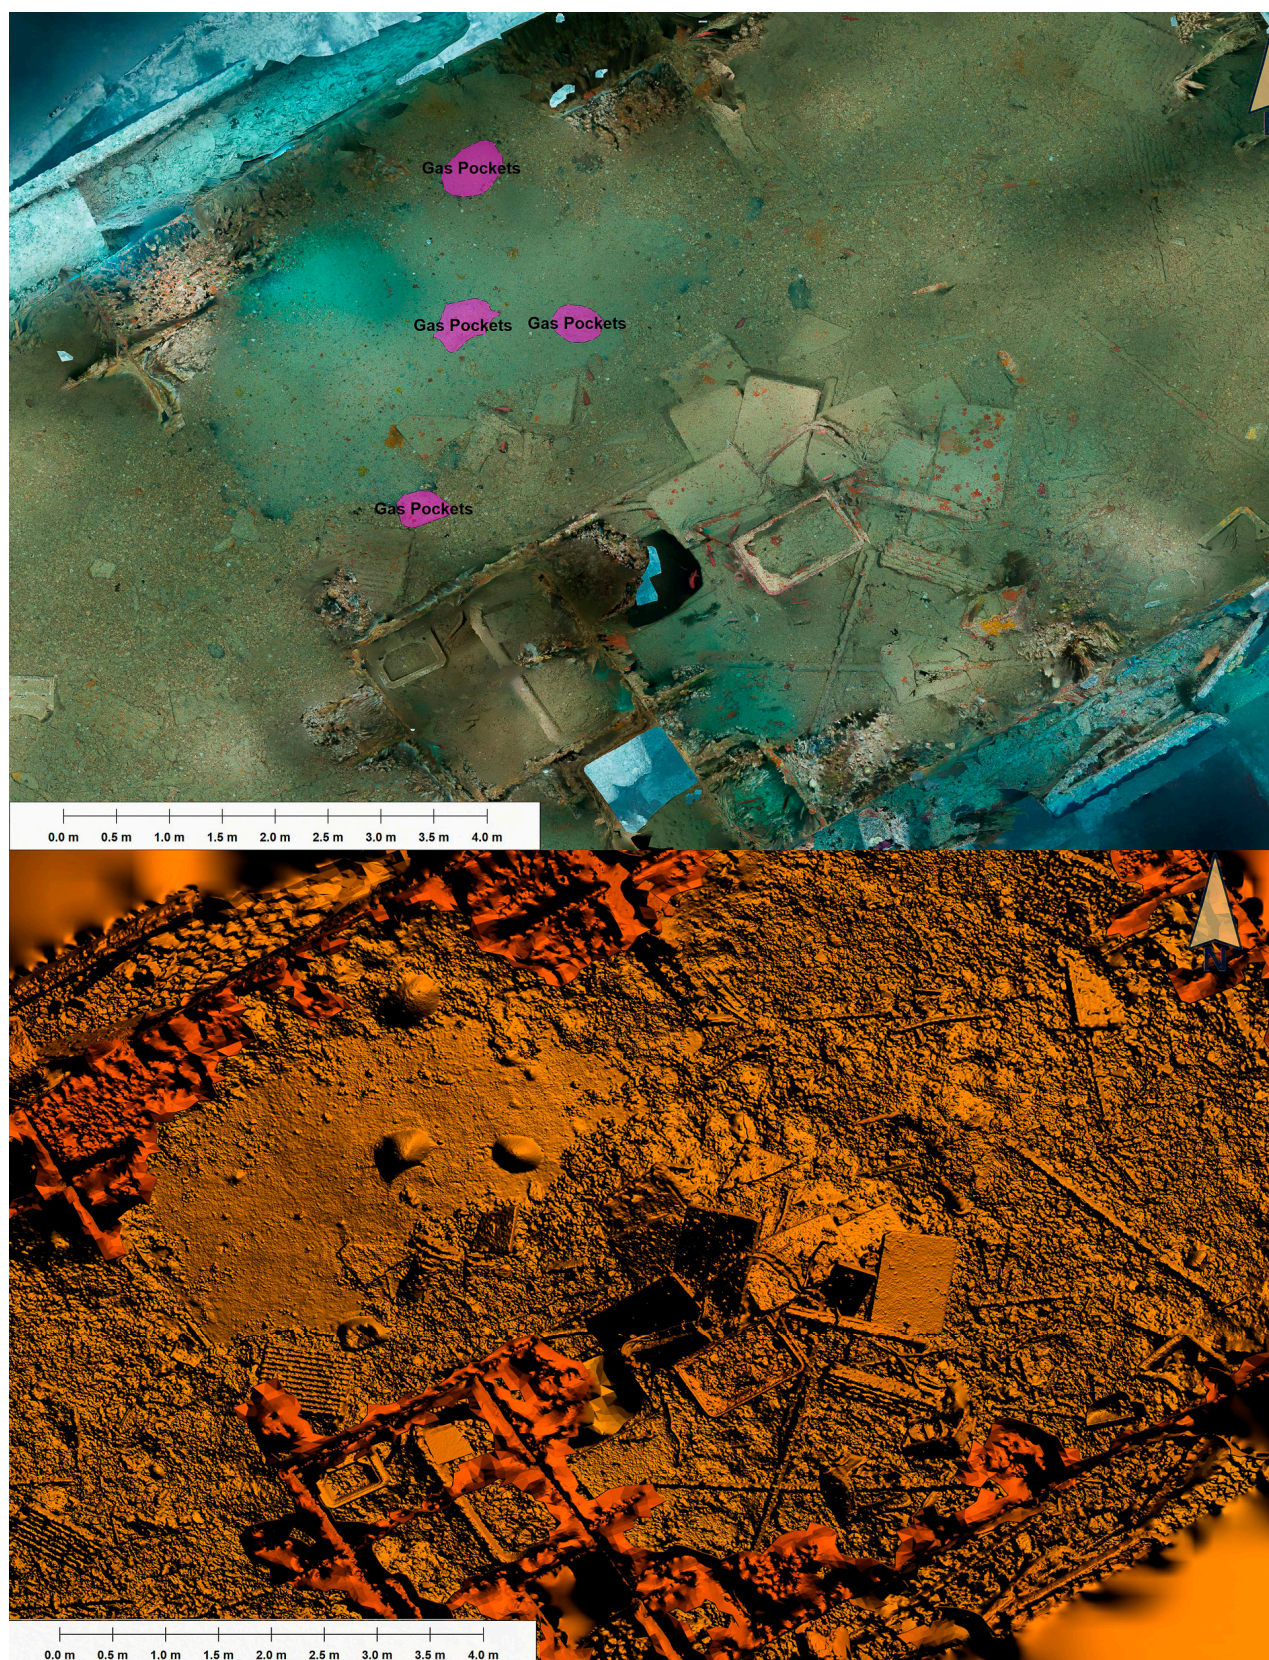
Evidence for this can be seen in The Saloon House where the floor carries evidence of damage by exhaled gas. The floor covering appears to be a type of linoleum, bonded directly to the steel deck. Several patches of floor covering have separated from the deck and an air pocket formed between deck and linoleum, creating a domed effect on an otherwise flat floor. It is believed a pocket of gas, collected on the ceiling of the upper cargo deck, has accelerated corrosion until a hole has formed and allowed gas to vent under the linoleum (Figure 14).

Figure 14. Top: Photogrammetry of the Saloon House floor showing pockets of gas trapped under the floor covering. **Bottom:** DEM of the Saloon House—note the cones of trapped gas causing local deformation in the floor covering.

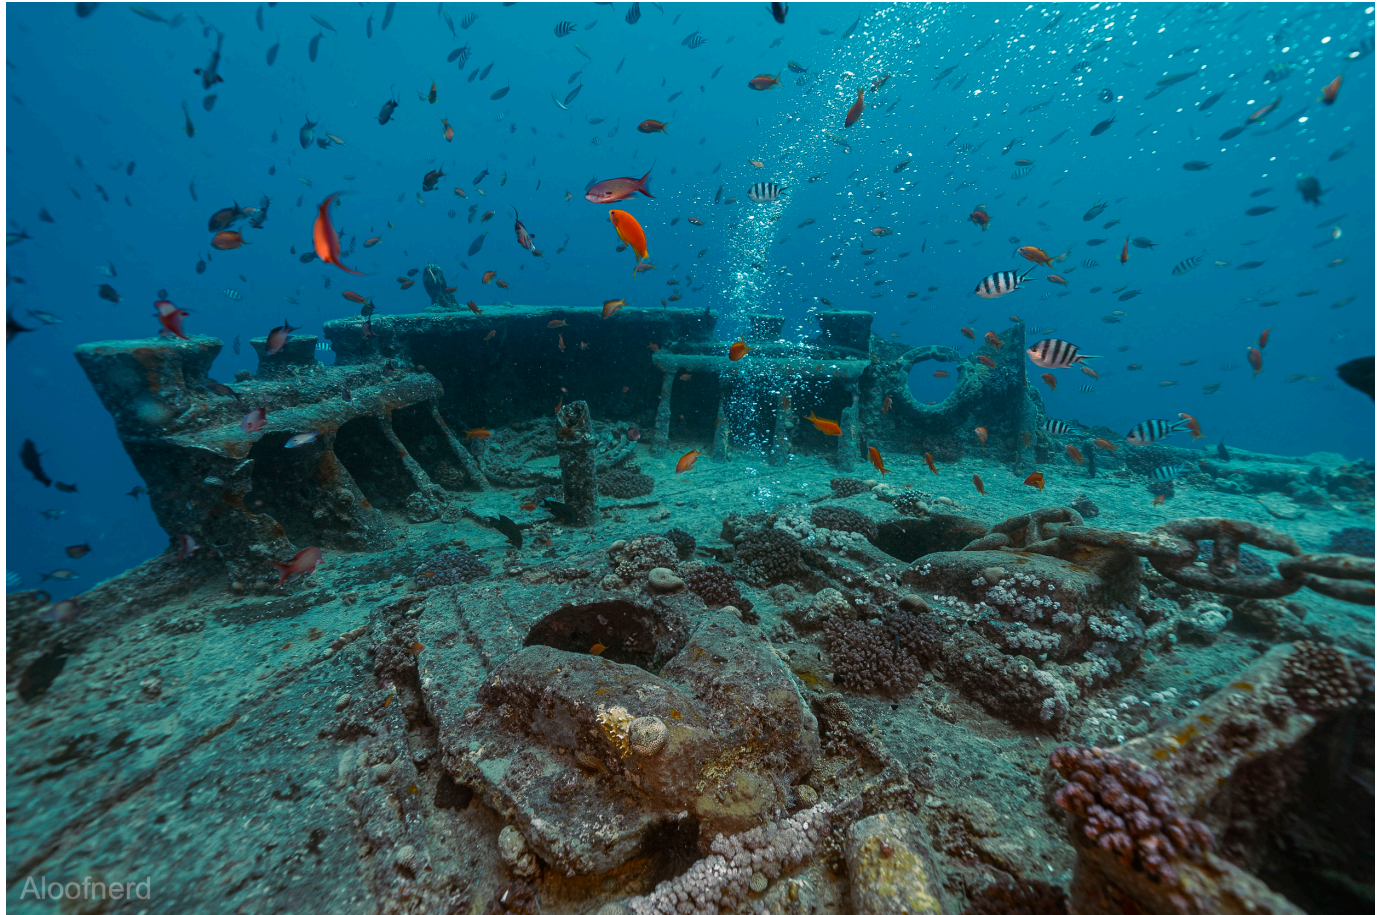
The overall impact of exhaled gases and its impact on the steel structure of the wreck, especially when enriched with higher oxygen levels from Nitrox use, is unknown [17]. Given the popularity of the cargo holds and the impracticality of enforcing a ban on diver penetration, managing this form of degradation remains a challenge for future conservation efforts (Figure 15).

Figure 15. Exhaled gas venting from the forecandle room at the bow. Gases consistently vent from the interior of the wreck due to the high volumes of diver traffic. Note that by 2022 the port anchor chain was no longer present in the hawser pipe and had detached to the seabed. The 2017 survey records it in place (Photo: Alicia Johnson).

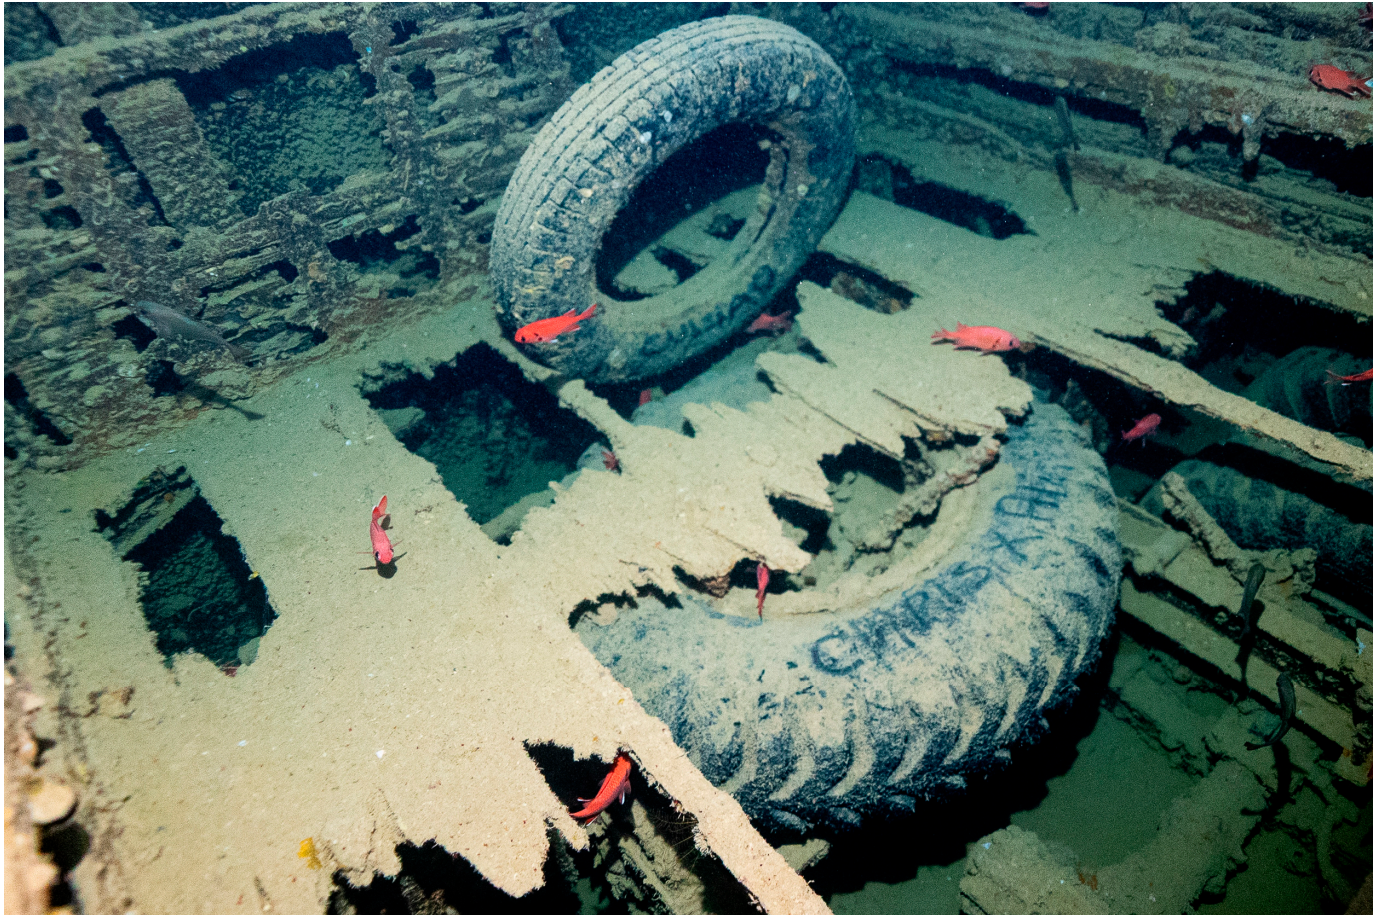
Figure 16. Tyres carried as loose cargo and those fitted to vehicles have been subject to graffiti in the silt. Whilst low impact, this kind of behaviour suggests the wreck is not respected as cultural heritage (Photo: Alicia Johnson).

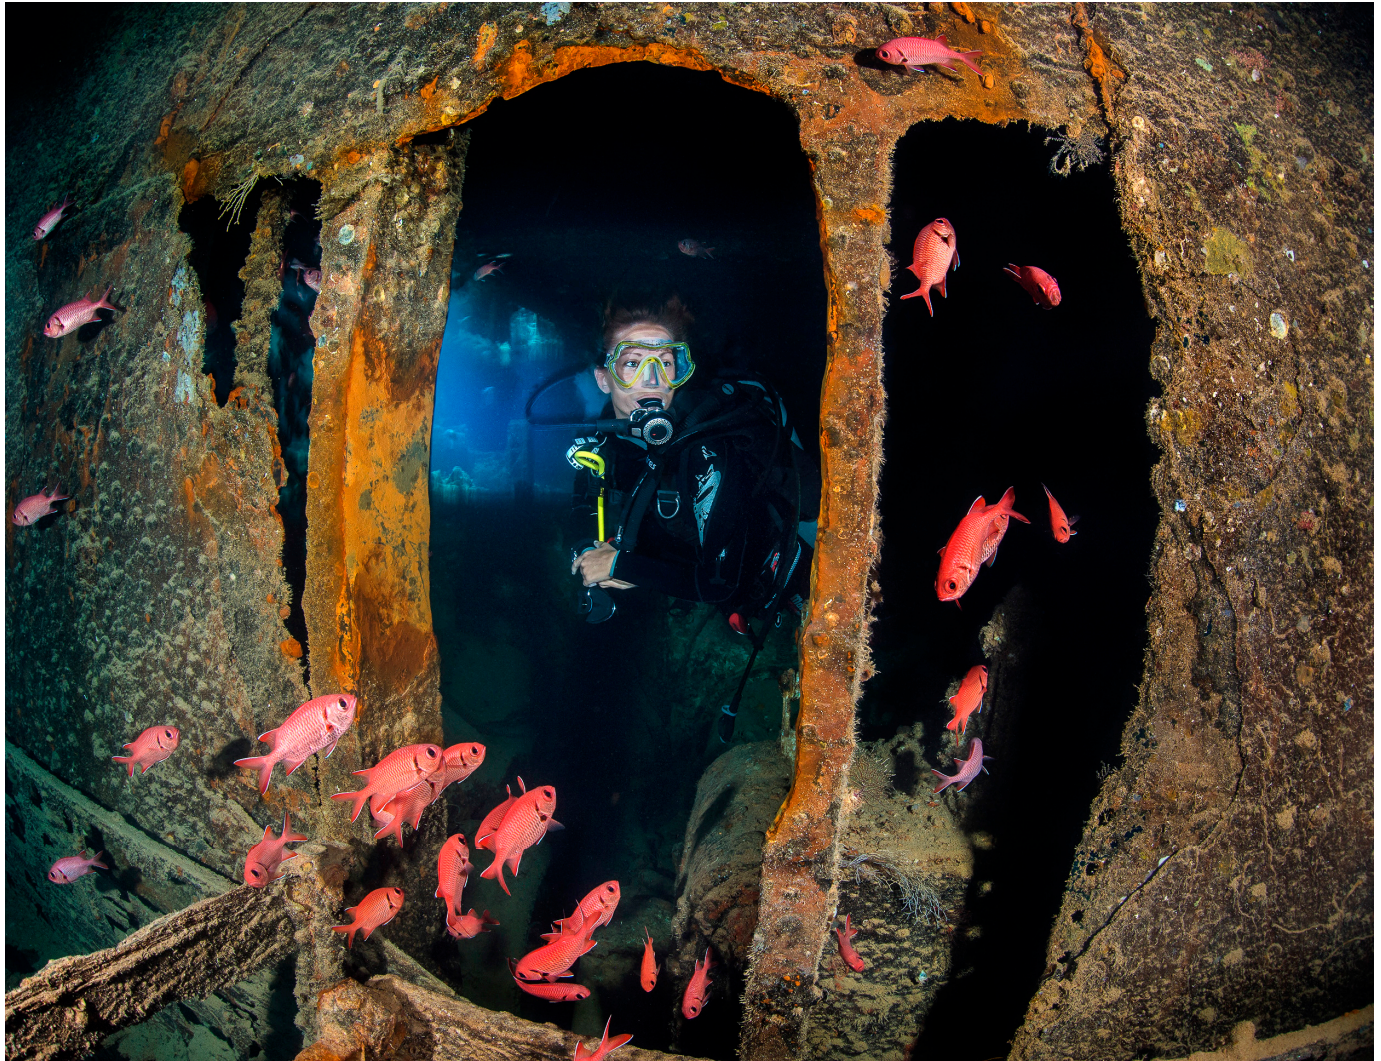
Watertight bulkheads originally designed to preserve the ship's integrity have also suffered extensive damage. Several were destroyed or damaged during the explosion that sank the ship, while others have been intentionally cut to facilitate diver passage and reducing decompression risks. This has led to significant structural weakening, with fresh oxidation visible on steel ribs indicating continued abrasion and erosion from diver contact (Figure 17).

Figure 17. Access hole through the watertight bulkhead between Hold Nos. 1 and 2. The red oxidisation of the vertical ribs indicates ongoing abrasion by divers (Photo: Alex Mustard).
