Documenting Change on the SS *Thistlegorm*, Red Sea, Egypt: Using Underwater Photogrammetry to Record Natural Deterioration and Human Impacts on a World War II Shipwreck

Simon Brown¹ and Jon C. Henderson^{2,*}

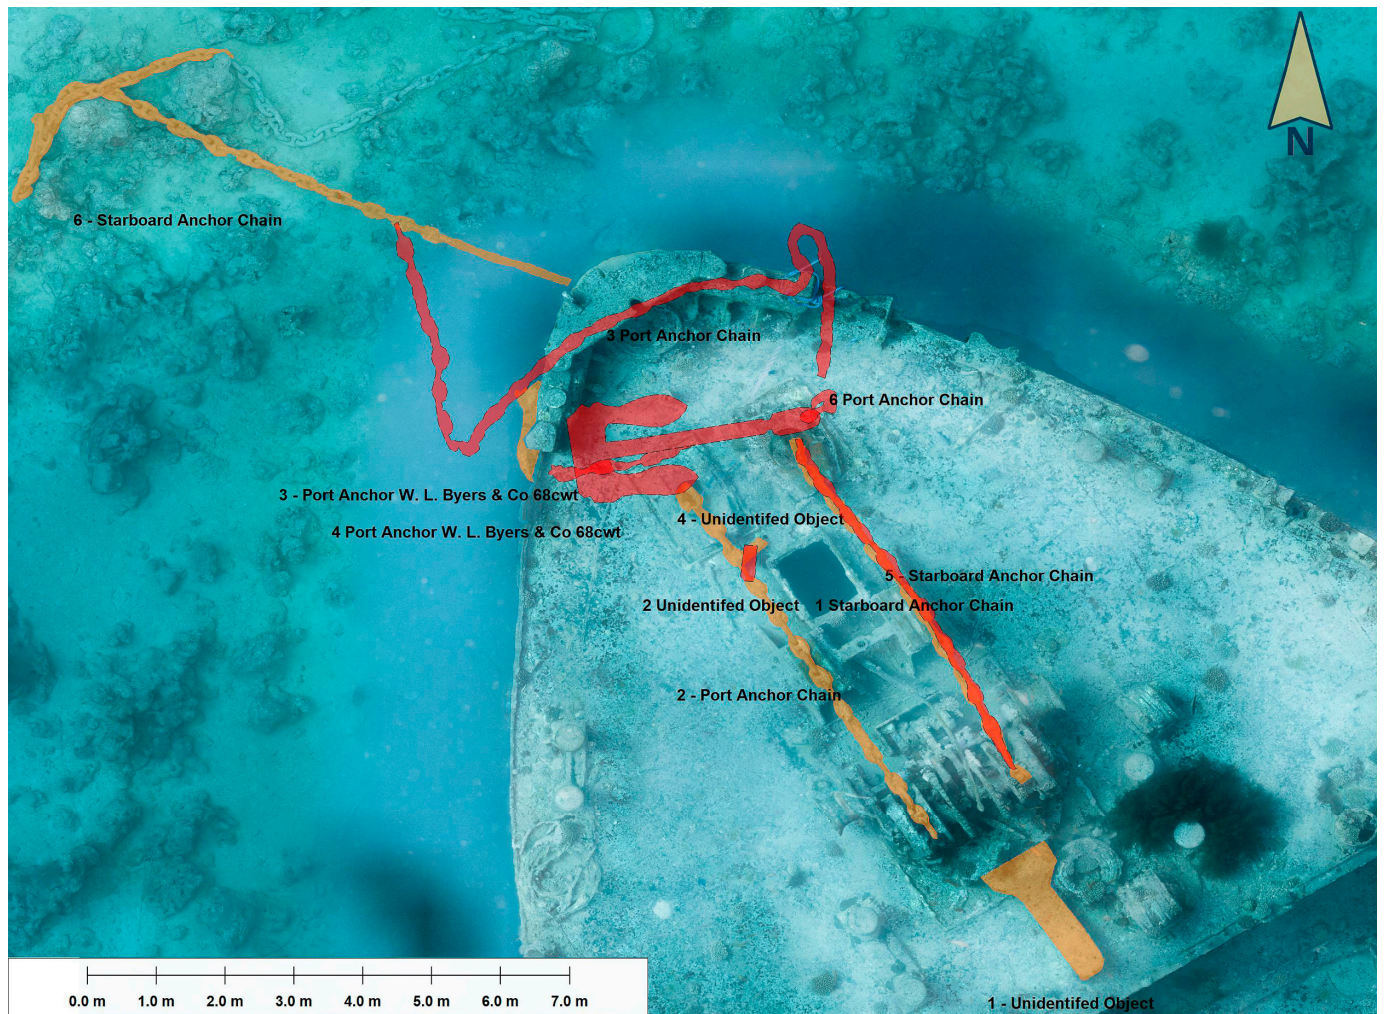
External areas of the wreck have also experienced significant degradation, particularly from mooring practices. The ship's anchor chains have historically been used to secure dive vessels, resulting in visible thinning and corrosion of the chains and the displacement of the starboard chain from its guides. The impact of this practice was evident from the 2017 survey with both anchor chains showing evidence of ongoing wear through thinning of the individual links and corrosion build up. It could also be seen that the starboard anchor chain had been pulled from its rubbing strip guides. In 2019, the port anchor chain failed entirely, dropping the 3.5-tonne anchor and chain to the seabed and further displacing the starboard chain (Figure 18).

Figure 18. Changes to port and starboard anchor chains and location of port anchor. Thus, 2017 recorded locations (Orange) are contrasted to the 2022 locations (Red) with the main change being the failure of the port anchor chain and the deflection present in the starboard chain.

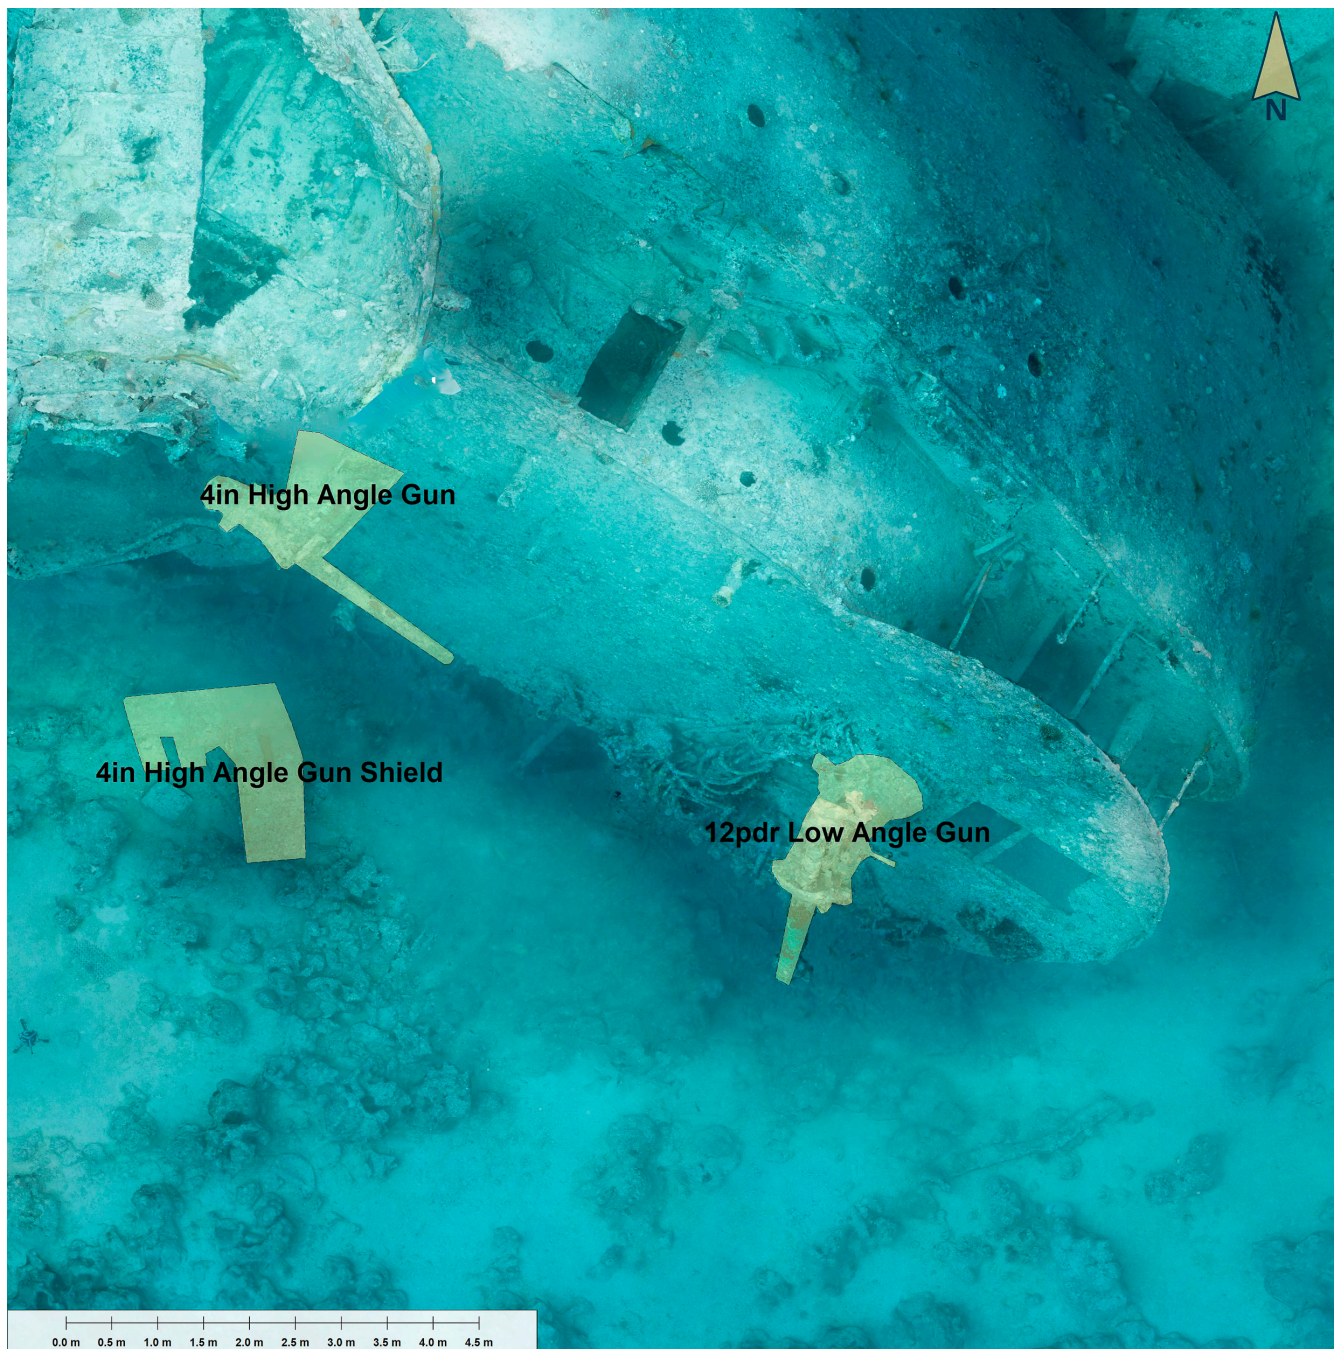
At the stern, the high-angle gun's protective steel shield, which was still in place in photos from 2011 and before, was found on the seabed beneath the gun during the 2017 survey, reflecting the ongoing deterioration and dislodgement of defensive fixtures on the wreck (Figure 19).

Figure 19. The 2017 survey records the stern high angle gun shield as detached and lying on the seabed directly under the gun.

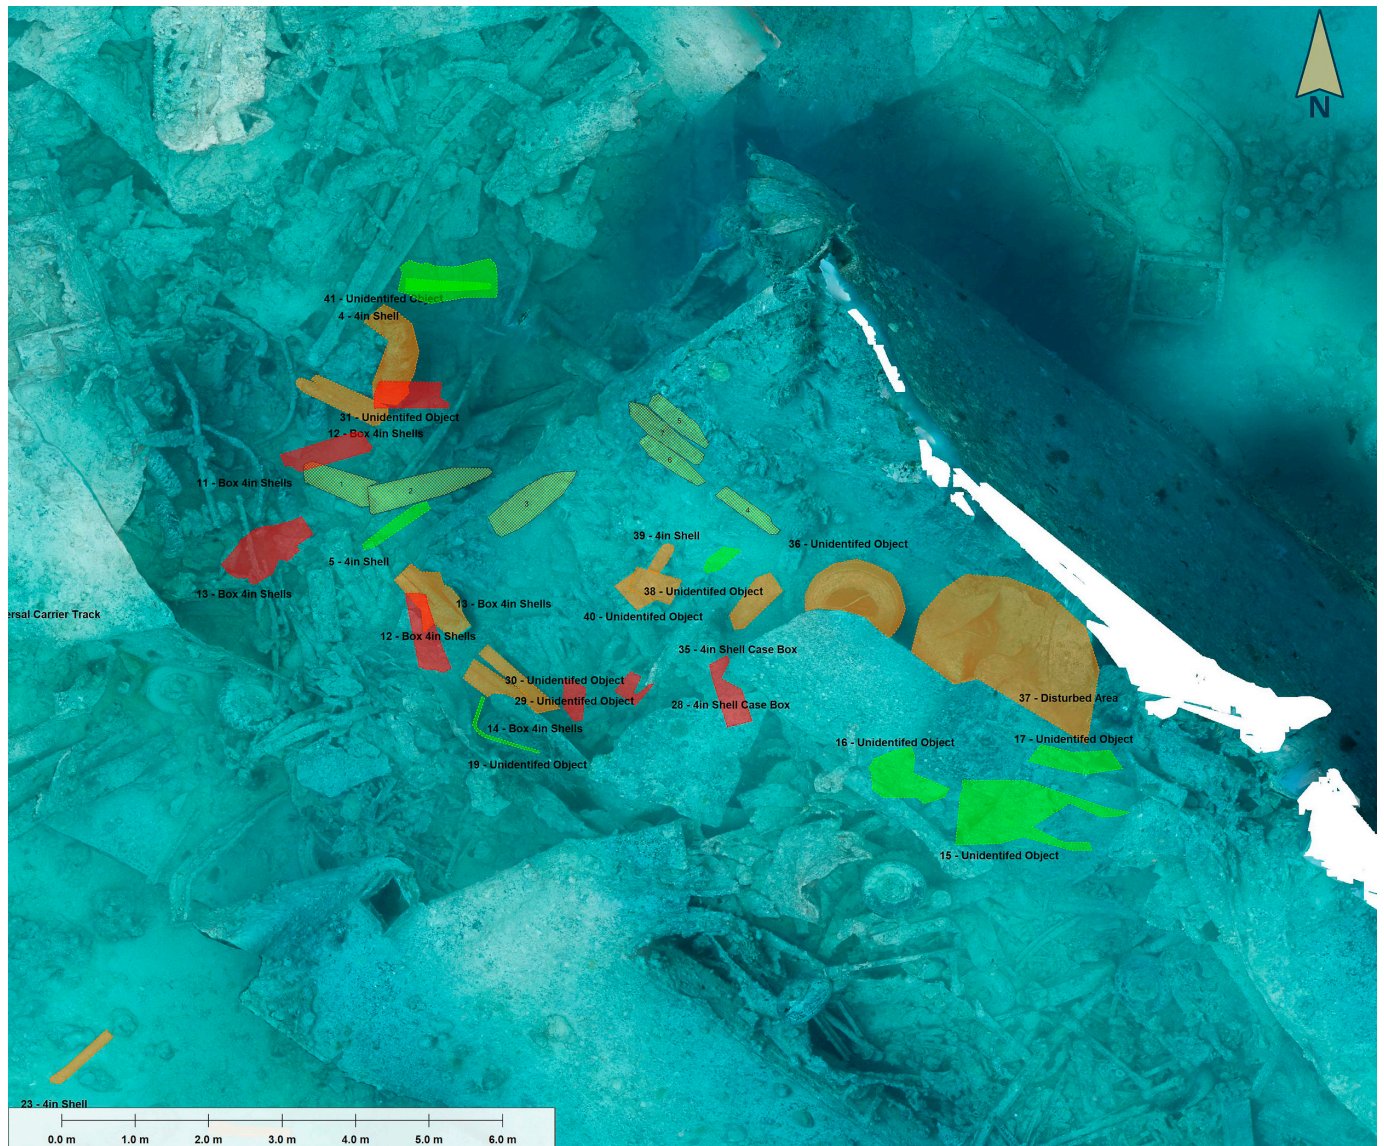
Although at first glance the debris field around Hold Nos. 4 and 5 appears stable, detailed analysis between the 2017 and 2022 of orthomosaics reveals significant changes, including the removal of artefacts, most notably non-ferrous items, and extensive evidence of the movement and redeposition of objects (Figure 20). While some of these losses appear to be small-scale disturbances, potentially by divers seeking souvenirs or engaging in opportunistic recovery for scrap, other removals indicate more organised efforts. Notably, by 2022, a large drum of copper cable or wire had been removed from Hold No. 5—a heavy artefact measuring $1.12\text{ m} \times 0.61\text{ m}$ —indicating a deliberate and planned salvage operation. The removal work disturbed the surrounding area with deck and hull plates being removed. Of particular concern is the movement of unexploded ordnance within the debris field, including Mk1 air-dropped depth charges containing around 113 kg of explosive material. These charges can become highly volatile, unstable and explode unexpectedly, having been responsible for the loss of at least one fishing vessel in UK waters [18], and underscore the severe safety and heritage risks posed by unauthorised artefact disturbance at the site.

Figure 20. Global Mapper layer documenting changes between 2017 and 2022 and the location of the 15'' shells. The area where the wire/rope object was located has been disturbed. Key: orange = 2017 location, red = 2022 location, green = 2022 new objects.

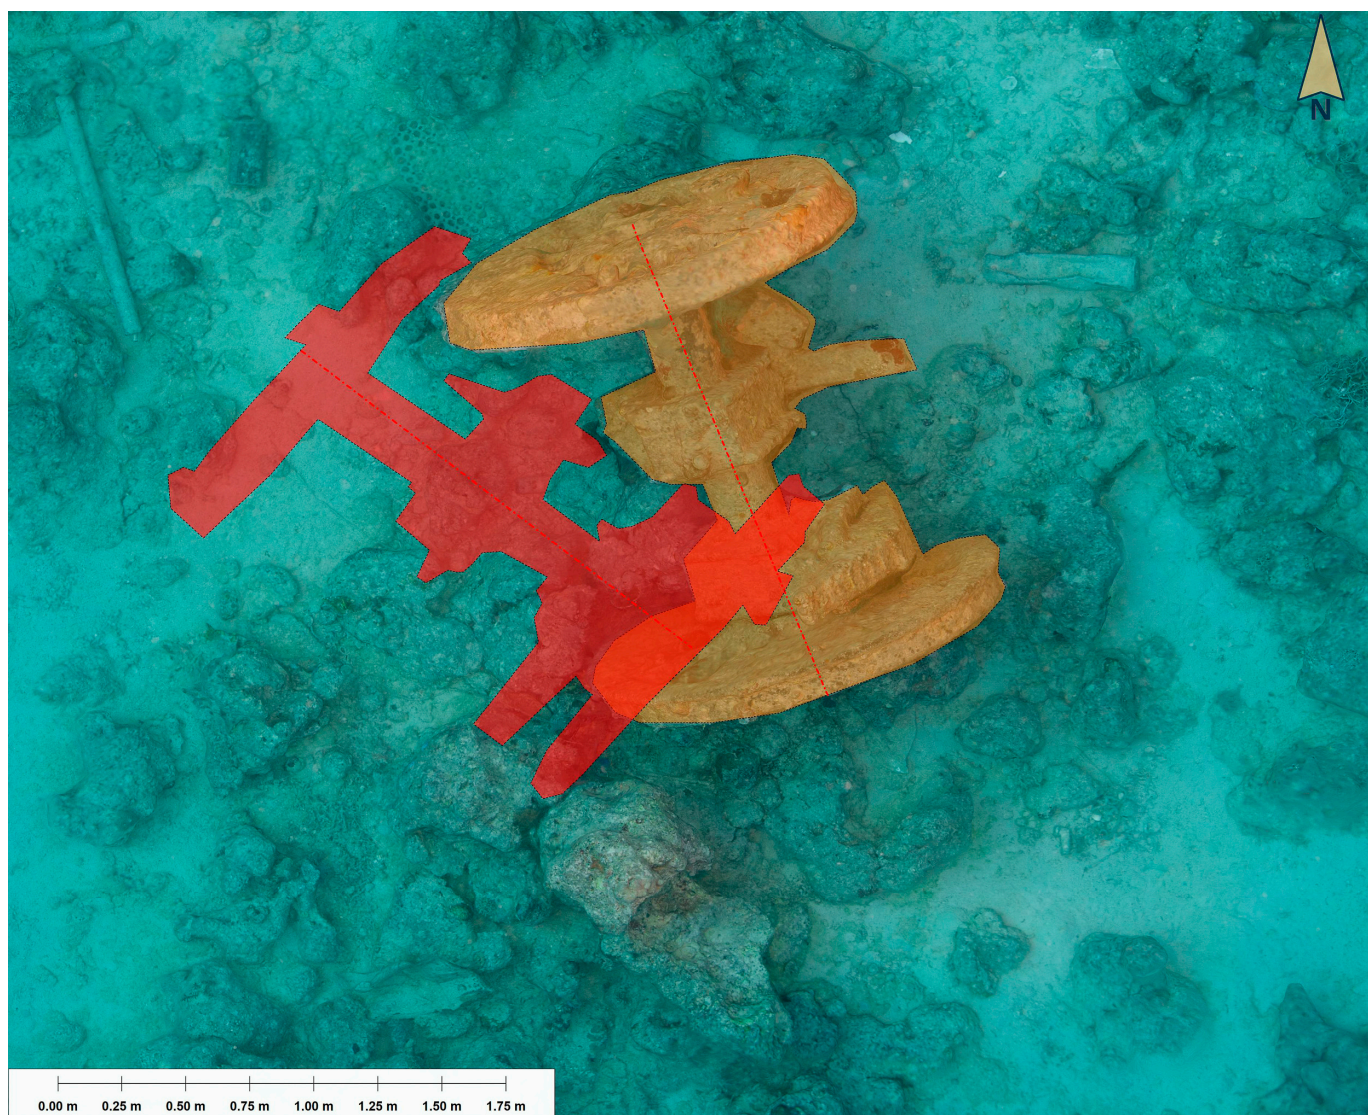
Nearby, a 2-tonne locomotive wheel and axle assembly located approximately 16 m from the main wreck was found to have rotated approximately 29 degrees between 2017 and 2022 (Figure 21). The most plausible explanation for this movement is entanglement with mooring lines from dive vessels, illustrating how even heavy artefacts can be vulnerable to unintentional displacement.

Figure 21. Starboard locomotive wheel assembly with recorded changes between 2017 (Orange) and 2022 (Red). At some point between July 2017 and May 2022 a substantial force was applied to the wheel assembly, rotating the wheels approx. 29° counter-clockwise from their as-recorded position.

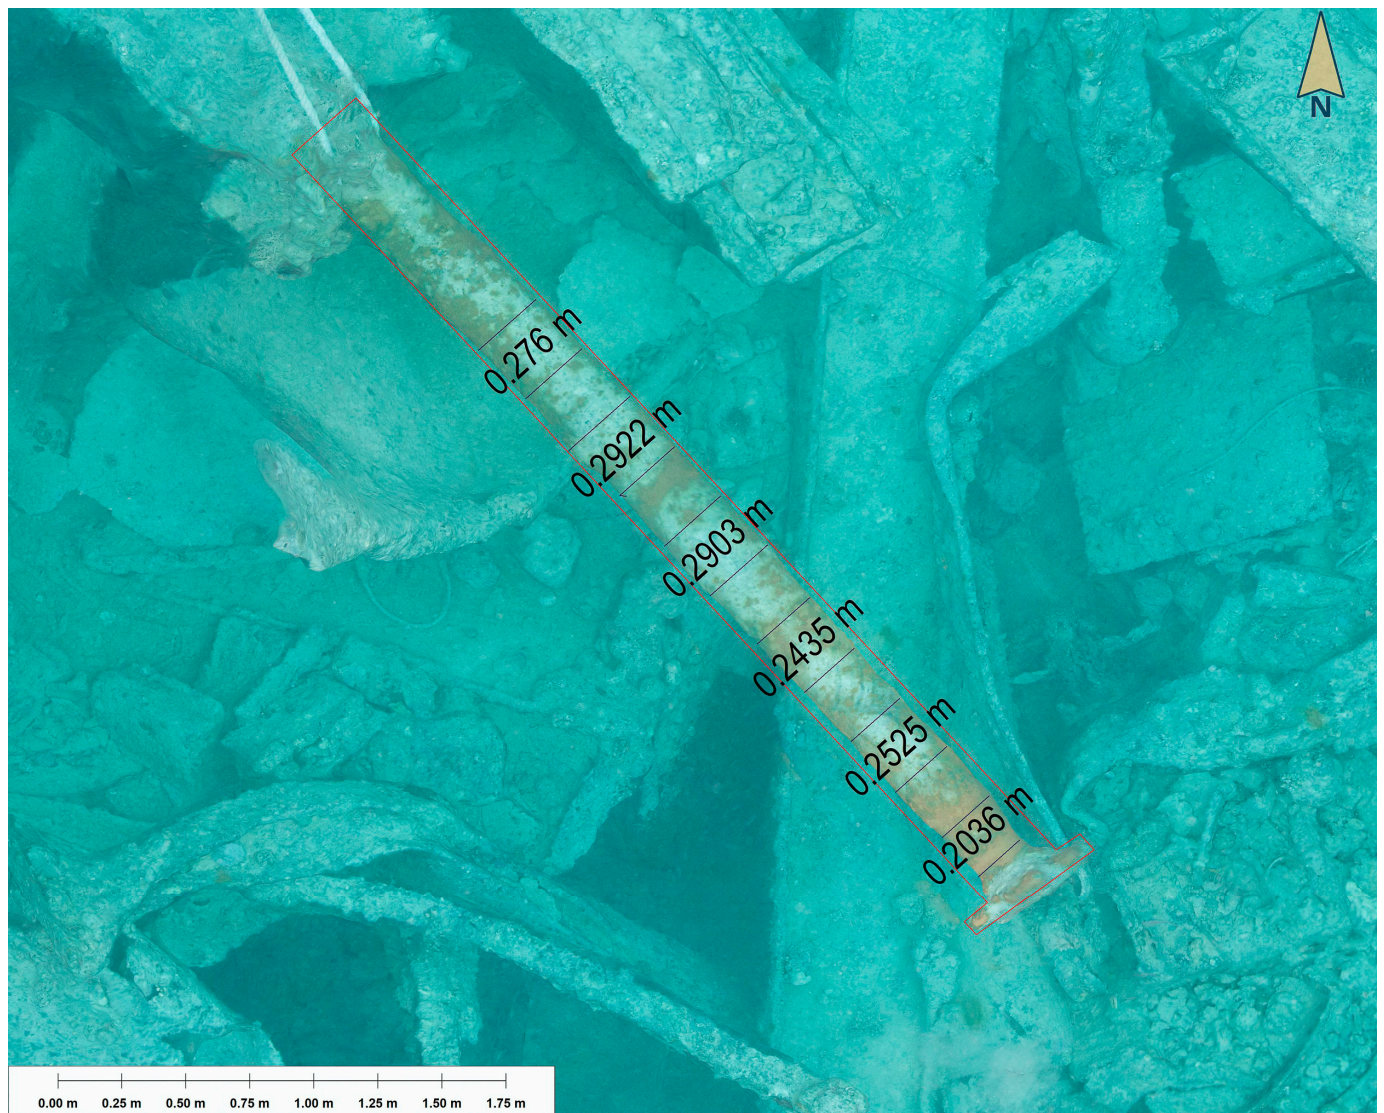
Finally, two flanged sections of the propeller shaft can be found within the shattered remains of Hold No. 4, one exiting the engine room area and one passing through the remains of the watertight bulkhead between Hold Nos. 4 and 5. With the absence of deck mooring bollards in this part of the wreck these features are frequently used by dive boats as a mooring point. Originally used to transfer the power from steam engine to propeller, the shaft is manufactured from steel and is of exceptionally robust construction. That said, it can be seen that mooring rope movement is eroding the steel, with the red oxidation covering indicating the process is ongoing. The original engineering drawings, to which the prop shaft would have been manufactured, are held by the Lloyds Register Foundation archive (Drawing No 10422) and record the diameter of the shaft, ranging from a minimum of 1' ½" (317 mm) to a maximum of 1' ¾" (323.85 mm). Photogrammetric survey of the shaft revealed that it now measures 203 mm at the narrowest point just behind the coupling flange (Figure 22). Without intervention, continued wear will lead to eventual failure of the shaft, risking vessel stability and diver safety during mooring operations. While the

Figure 22. The steel propeller shaft as recorded in 2017 with the outline of the original as-designed shaft taken from the engineering drawing overlaid (red outline). A series of sectional measurements across the diameter of the shaft reveals lower values compared to the original manufactured shaft diameter of $1' \frac{1}{2}''$ (317 mm), most likely caused by ongoing abrasion from mooring lines. Note also the evidence of red oxidation on the steel shaft (after Lloyds Register Foundation Archive Drawing No 10422).

installation of sacrificial sleeves could mitigate damage, the use of the propeller shaft for mooring is not recommended due to these escalating risks.

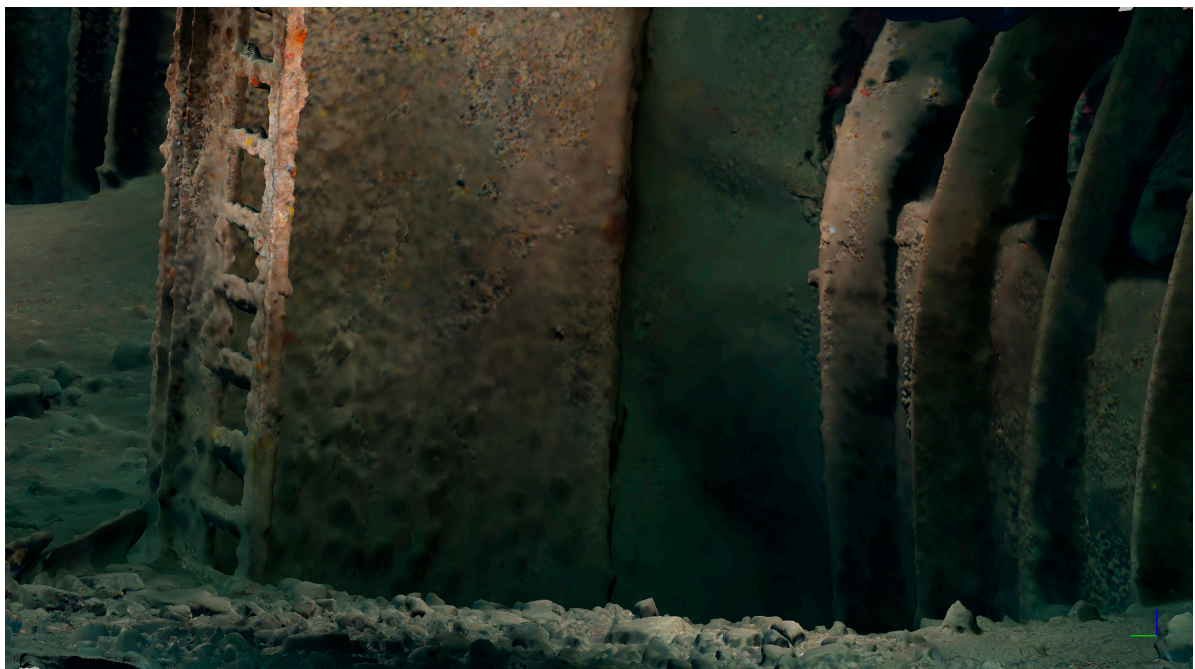
Initially overlooked in 2017 due to its apparent lack of cargo, Hold No. 3 was fully surveyed in 2022. The hold is loaded with coal to an estimated depth of 3 m and is devoid of the more exotic cargo such as Norton motorbikes found in Hold No. 2. Despite this, the survey revealed further evidence of the impact of the secondary explosion and subsequent sinking. Close inspection of the 3D photogrammetric model of Hold No. 3 revealed the aft watertight bulkhead at frame 86 was deformed, and that the deformation was not uniform. The model was compared in Global mapper to the as-designed bulkhead position extracted from the ship builders' plans. These plans, held by Tyne and Wear Archives and the Lloyds Register Foundation, clearly indicate the presence of a linear and uniform watertight bulkhead at frame 86. Analysis of 3D models and plans showed the bulkhead had shifted by up to 1.2 m from its original position, most likely due to the pressure wave from flooding during the sinking, rather than the secondary explosion itself (Figure 24). This deformation can also be seen by the curvature observed in the vertical stiffening ribs within the hold (Figure 25).

Figure 25. With the vertical ladder as a reference, the deformation of the watertight bulkhead ribs becomes apparent.

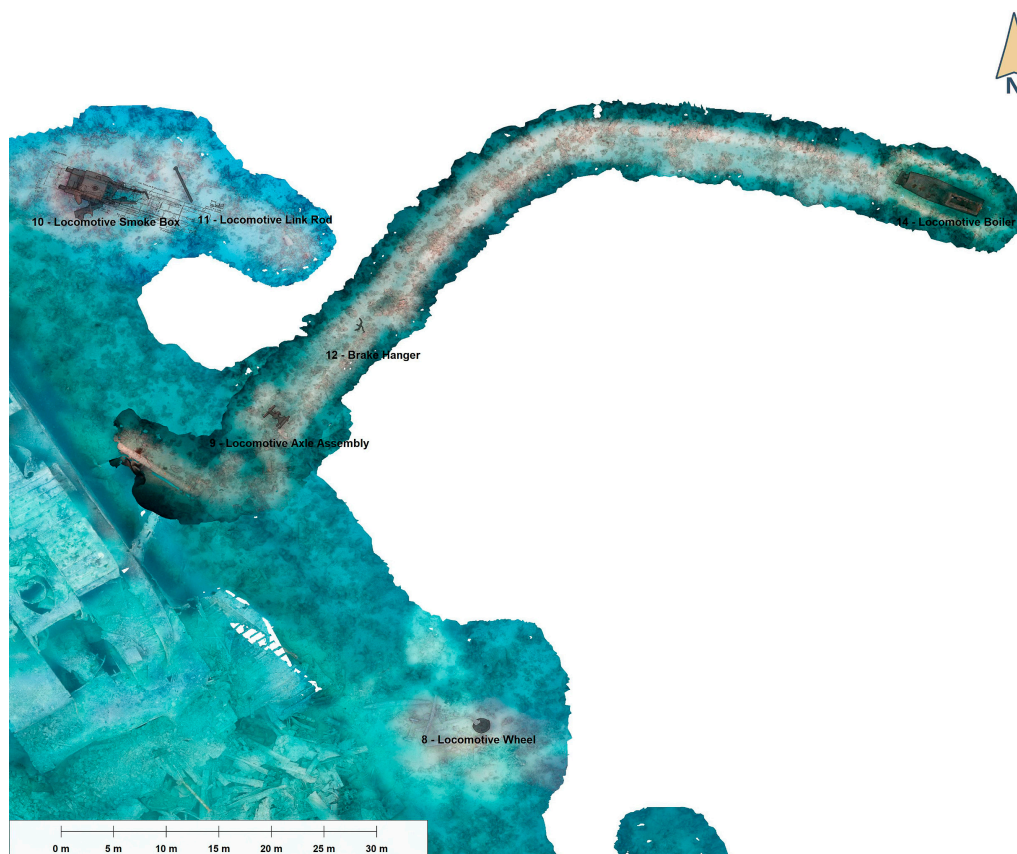
The presence of a locomotive boiler on the starboard side was also inferred from the existence of a smoke box, tender, driving and link rods, and associated wheels but the location of the locomotive itself was unknown. Using two reels of 50 m line starting from the starboard locomotive wheels, circular searches were conducted resulting in the discovery of the boiler 75~80 m from its stowed position, lying inverted and heavily deformed, with a distinctive concave damage pattern on the firebox wall (Figure 27). The estimated mass of this assembly is 22~24 tonnes.

Figure 27. Notably, a Stanier 8F brake hanger identified within the debris (Item 12) confirms the extent of dispersal and offers insight into the locomotive's disintegration during the blast.
