# Management Plan and Public Outreach for WWII Submerged Resources in Saipan

Jennifer F. McKinnon and Toni L. Carrell

2014

Grant Agreement No. GA-2255-11-018  
Final Report

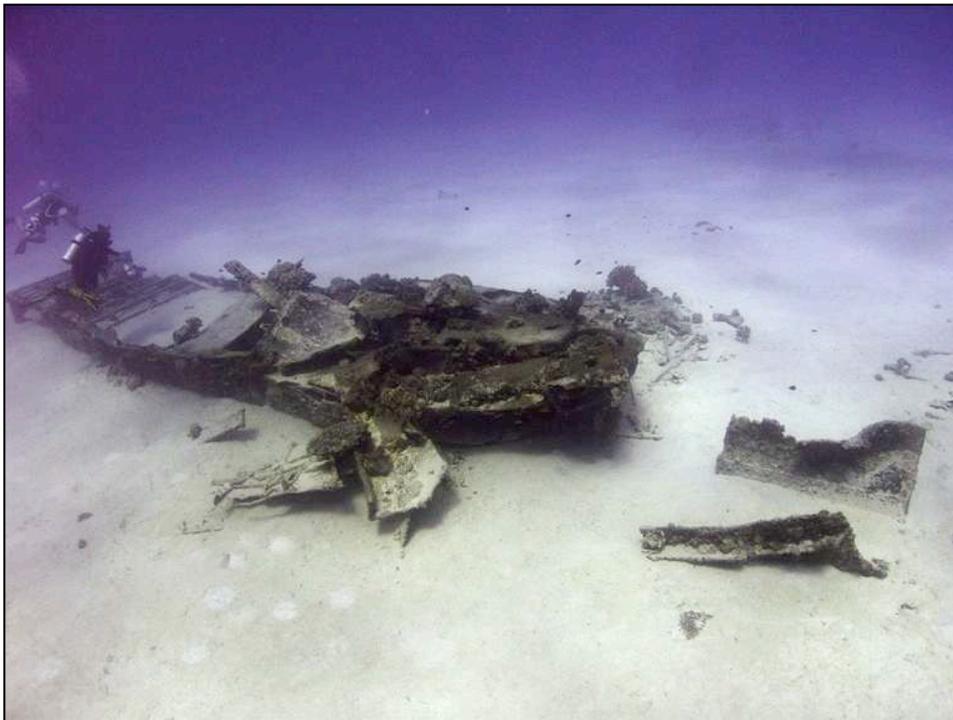
**Figure 4. Daihatsu Landing Craft 2 – port side view (Carpenter 2012).**

The vessel is upright on the seabed and is in poor structural condition. Daihatsu 2 is considerably more disarticulated than Daihatsu 1. Large sections lie separate and astern of the wreck and substantial remains have collapsed on the port side of the vessel. The engine is missing and presumed salvaged but the rudder and propeller shaft remain *in situ*. The maximum height of the main structure rises approximately 2-3m above the seabed. Limited burial has occurred with sand accumulation in the

loading zone and around the lower profile areas. There are some areas of active corrosion evident on the site, indicated by the presence of the typical red/brown “rust” spots on the surface of the vehicle.

The wreck is in a similar environment as Daihatsu 1, a flat, slightly undulating sandy seabed relatively devoid of marine biota. The wreck is covered in brown algal forms and some sporadic secondary colonization was evident (e.g. tunicates, soft and hard corals, seaweed, etc.). Isolated hard coralline growths have formed in some places. It appears that the wreck is not subjected to regular burial/exposure cycles. Sediment has partly covered the lower profile areas but the establishment of some hard corals indicates that significant accumulation of sediment does not readily occur. The site lies in the comparatively protected lagoon area but the site has the potential to be affected by storm conditions.

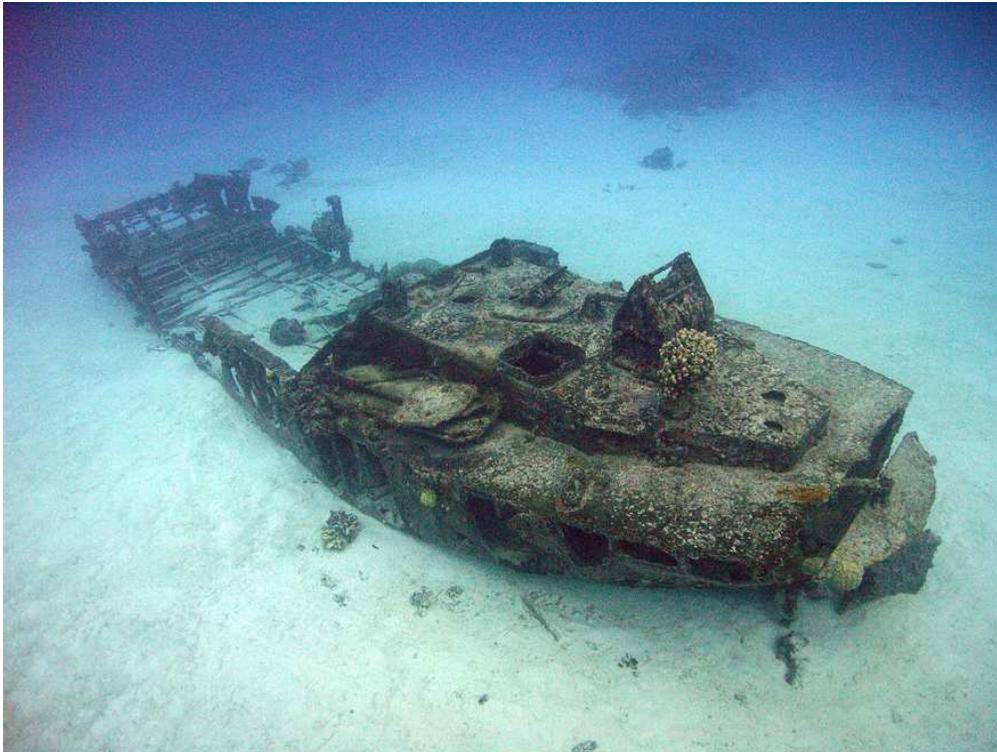
**Figure 5. Daihatsu Landing Craft 3 – port side view (Carpenter 2012).**

The vessel is upright on the seabed and is reasonably intact. The maximum height of the main structure rises approximately 2 m above the seabed. Some scouring has occurred around the stern and the rudder and propeller are exposed. Many hull plates are either missing or considerably corroded with significant areas of loss. Most of the port and starboard side hull structure in the amidships area has collapsed. The engine room of this vehicle is visible through perforated hull plates. The engine remains *in situ* and is complete with the exhaust system and other associated features and ancillary equipment. For example, a funnel is located in the starboard forward corner of the engine room.

There are some areas of active corrosion evident, especially in the shallower, more exposed areas (i.e. upper surfaces of the stern section) indicated by the presence of the typical red/brown “rust” spots on the surface of the vehicle. The fact that the engine, other associated machinery and some artifacts (e.g. funnel) are still present *in situ* supports the fact that this site is not visited frequently and human interference has been minimal to date.

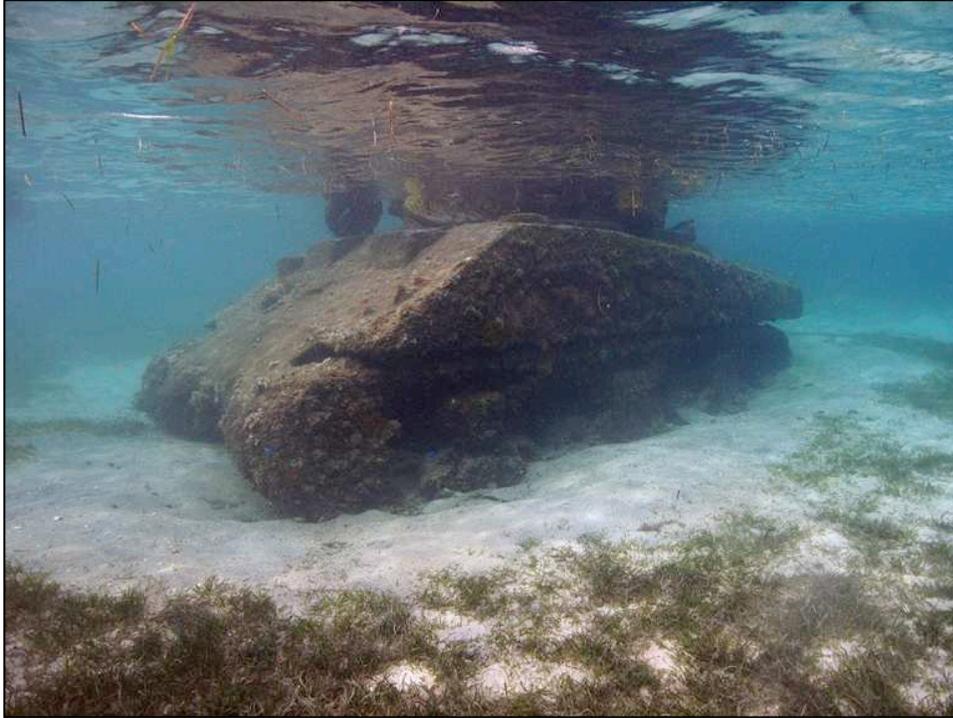
**Figure 6. M4 Sherman Tank 1 – port side view (Carpenter 2012).**

The tank was identified as a M4A2 Dry model, constructed principally of rolled and cast homogenous steel, is 5.84m in length, 2.62m wide and 2.74m in height (Grove 1976:130-131). The hull of Tank 1 is oriented with its bow toward the shore on a bearing of 133°. The main 75mm gun is fixed on a bearing of 197°. The main body of the vehicle is mostly intact but other smaller components are missing. This loss may be due to corrosion and/or cultural impacts, such as salvage. There are many areas of active corrosion evident on the site, indicated by the presence of the typical red/brown “rust” spots on the surfaces of the tank. There are also signs of accelerated corrosion on the upper sections of the tank (flaking, surface spalling and cracking of the metal surfaces and gun barrel) that are cyclically exposed to the atmosphere. Children were observed playing on the tank, walking along the main gun barrel and jumping or diving into the water. In time, this practice may become a health and safety issue due to the extensive corrosion exhibited by these exposed sections and the ever increasing probability that these areas may collapse or fragment.

When combined, Saipan’s environment and the tanks’ bulk react, taking a toll on these tanks in the form of holes, cracks, and corrosion. Certain components of the tanks have disappeared altogether, while others are in danger of being lost. Natural processes such as corrosion and cultural impacts like salvage are the primary explanations for many missing components. This is particularly true of long, thin parts of the vehicles like the main gun barrel as well as movable parts such as brackets and hatches.

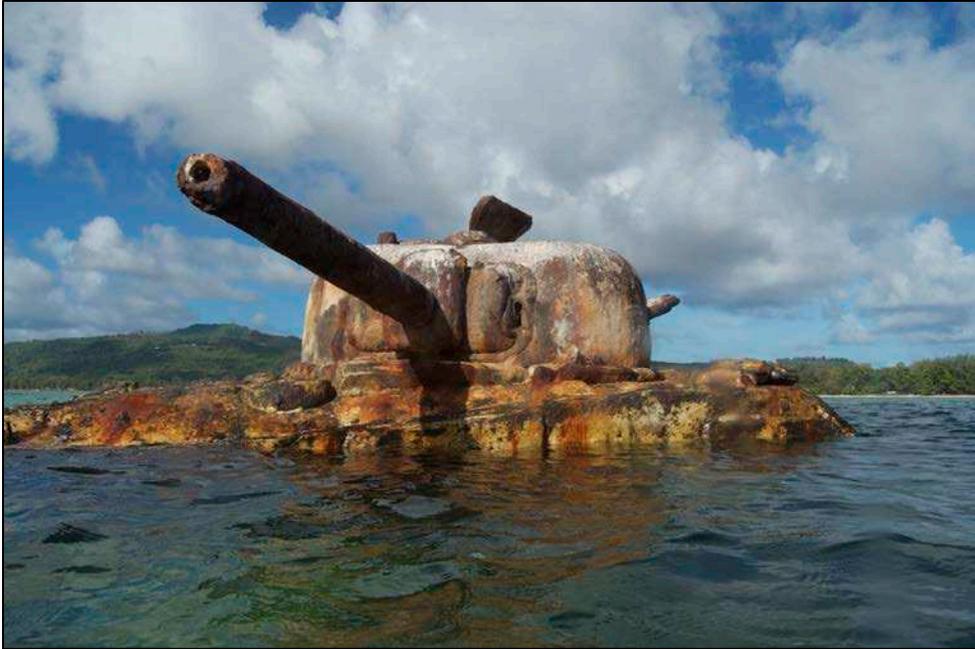
The tracks, roller assembly, and suspension bogies of Tank 2 are exposed. Because of its shallow location, the tank is semi-submerged and at low tide all components above the upper hull including the turret and gun are exposed to the atmosphere (Figure 7). Many of the removable components have been detached and long, thin parts have become brittle and cracked. Components at risk of being lost include the 75mm main gun barrel, hatches, and tow hooks. The tank exhibits the signs of many years of corrosion and environmental pressure, but less evidence of human disturbance. This may be due to the fact that this tank is further offshore making it less accessible to shore-based traffic. Unlike the sandy environment around Tank 1, seagrass is present right up to the tracks and stretches approximately 20 m from the center of the turret in all directions (Figure 8).

**Figure 7. The tank shows evidence of rust, surface spalling, and loss of structural integrity (Carpenter 2012).**

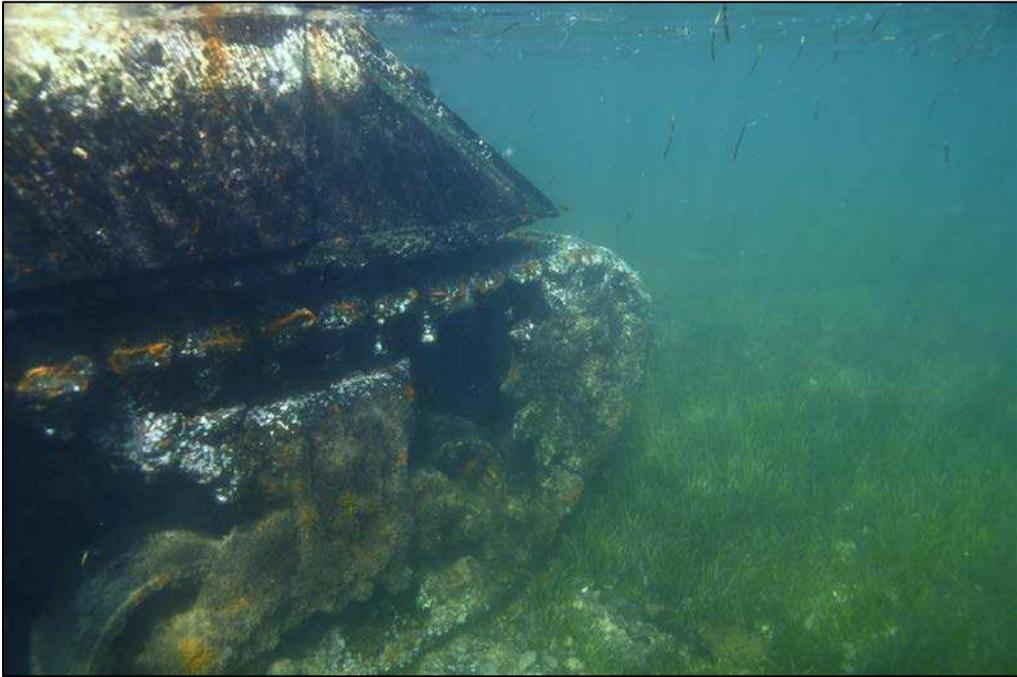
**Figure 8. The tank sits on a bed of seagrass that extends in all directions (Carpenter 2012).**

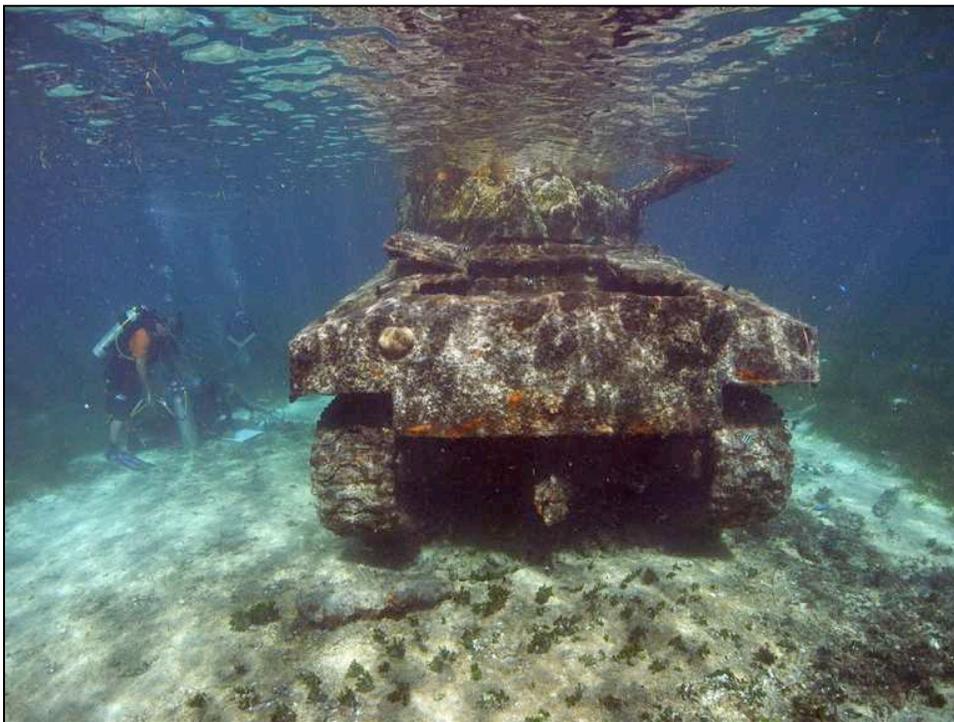
**Figure 9. M4 Sherman Tank 3 – stern view (Carpenter 2012).**

The tank, identified as a M4A3 Wet model, constructed principally of rolled and cast homogenous steel, is 5.91m in length, 2.62m wide and 2.74m in height (Grove 1976:130-131). Tank 3 is orientated with its bow pointing seaward on a bearing of 295° and the 75mm gun fixed on a bearing of 60° (McKinnon and Carrell 2011:109-110). The main body of the vehicle is mostly intact but other smaller components are missing. Most obvious is the loss of the engine cover and cowling and the gun barrel is broken. These remains are lying on the seabed in close proximity to the tank. This loss may be due to corrosion and/or physical damage by natural and/or human impacts. There are many areas of active corrosion evident on the site, indicated by the presence of the typical red/brown “rust” spots on the surfaces of the tank. There are also signs of accelerated corrosion on the upper sections of the tank (flaking, spalling and cracking of the metal surfaces and the broken gun barrel) that are cyclically exposed to the atmosphere.

No human activity was observed on the site at the time of the survey but on a previous survey in 2011, tour boats and ‘banana’ boats frequently passed near the site, tourists used jet skis on a race course just north of the site and there was significantly more rubbish around the tank than observed on the Tank 1

The corrosion rates noted on Tank 3 were very inconsistent in comparison to those measured on Tank 1. No statistically valid relationships between depth of immersion and corrosion could be observed for this tank. The areas that are constantly immersed (water depth greater than 1m) will tend to provide more consistent corrosion results. However, similar to Tank 1, there were very few secondary colonizing organisms on the concretion with the exception of algal forms and some seaweed species sporadically located on the upper surfaces of the tank. This suggests that there is a significant amount of water movement on this shallow site and possible sediment effect during periods of rough sea conditions, which would significantly reduce colonization rates and increase corrosion rates.

The natural and cultural impacts of the local environment on Tank 3 are more aggressive than those experienced by Tank 1. More importantly, because there is more tourist activity associated with Tank 3 it is likely that this increase in human interference is causing the accelerated deterioration. Although Tank 2 was not tested, because it is farther off shore and visited less by casual swimmers and snorkelers, the rate of corrosion may be more similar to Tank 1, simply due to less human impact. Testing of Tank 2 is recommended. All three tanks are fragile and some efforts to educate visitors about both the dangers and the fragile nature of the sites are warranted.

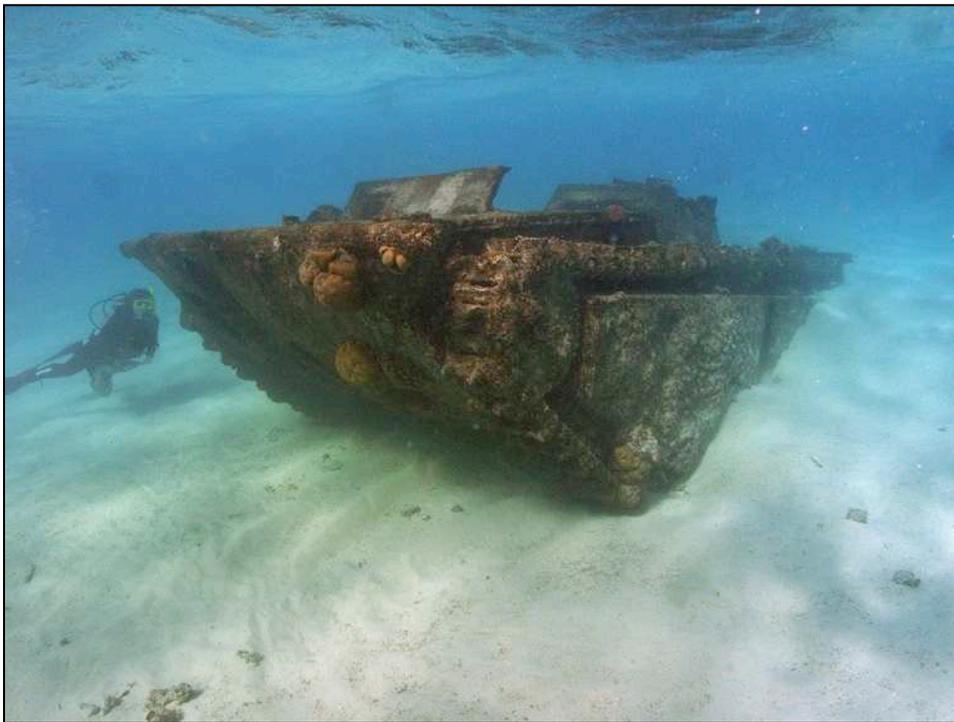
**Figure 10. Landing Vehicle Tracked 1 – port side view (Carpenter 2012).**

The remains of a landing vehicle (Figure 10 ) are located approximately 1,100 m (3,600 ft.) from the seaplane base at Tanapag (UTM [REDACTED]) (SEARCH, Inc. 2008a:84). The landing craft is a LVT (A)-4, constructed principally of rolled homogenous steel. Its dimensions are 7.95m in length, 3.25m wide and 3.11m in height, and it is resting at a slight angle in 2-10 ft. (.7 - 3 m).

The LVT(A)-4 is mostly intact with major structural features and a number of field expedient modifications still evident, but many other components are missing, such as armor plating across the deck, tracks and engine room, the guns and many of the controls. The turret has collapsed into the deck space of the wreck. These losses may have been caused by corrosion but it is more likely that they were salvaged, possibly during the disarming and disposal process outlined by the U.S. military (McKinnon and Carrell 2011:123-124). There are some areas of active corrosion evident on the site, indicated by the presence of the typical red/brown “rust” spots on the surface of the vehicle but these are minimal when compared to the tanks.

The wreck lies on a flat, slightly undulating sandy seabed, comprising of calcareous sediment. There are small and larger patches of reef surrounding the wreck but none are in direct contact with the wreck. The stern of LVT(A)-4, which faces shoreward, is partially buried in the seabed and there appears to have been significant scouring around the bow (seaward side) of the vessel. The rear and lower track are entirely buried and the upper surfaces are fully exposed to the marine environment. Stormy sea conditions could result in sand movement that is likely to affect the extent of burial/exposure, however it is not anticipated that the entire vehicle would ever become totally buried. The wreck was covered in brown algal forms and some sporadic secondary colonization was evident (e.g. tunicates, soft and hard corals, seaweed, etc.).

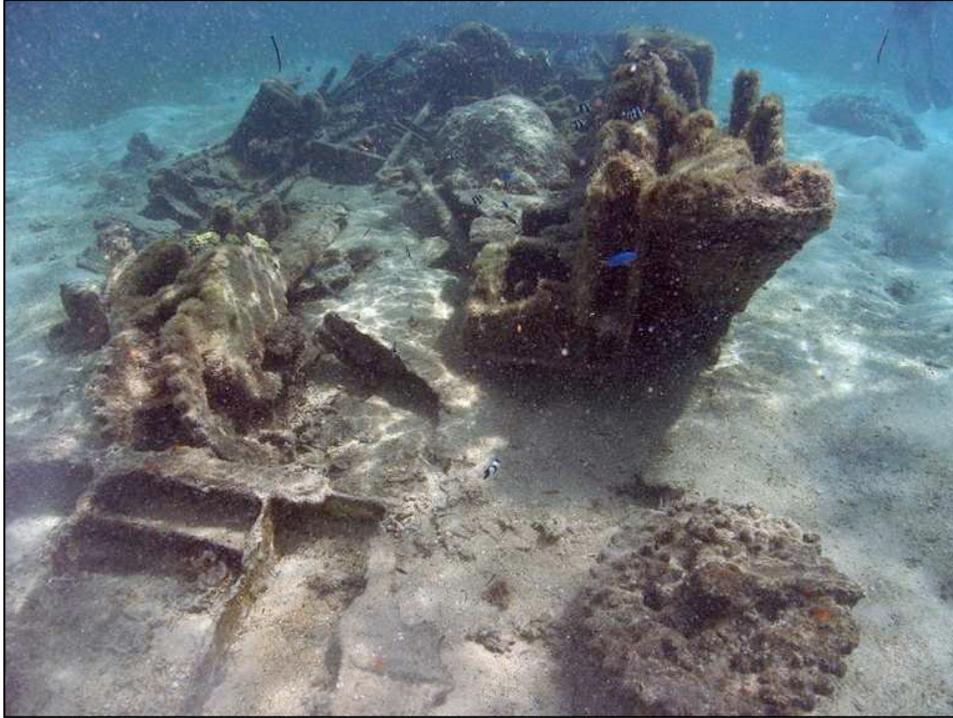
**Figure 11. Landing Vehicle Tracked 2 – front view (Carpenter 2012).**

The vehicle has almost totally collapsed and a track sprocket is detached and lies on the port side close to its previously installed position (Figure 11). The tracks themselves are also detached and lie, exposed, in close proximity to the major vessel remains. The vehicle is incomplete with the main components, such as the engine and superstructure missing. The remains are partially buried (lower track wheel bogies were not visible) with the starboard side of the vehicle possessing more sediment coverage. The starboard side of the vessel is extremely damaged and the loss of structure is quite extensive with the bow region almost absent, which facilitates sediment ingress into the interior of the vessel. Stormy sea conditions could result in sand movement that is likely to affect the extent of burial/exposure, however it is not anticipated that the entire vehicle would ever become totally buried. There are many areas of active corrosion evident on the site, indicated by the presence of the typical red/brown “rust” spots on the metal surfaces and at the sediment interface.

The surrounding seabed consists primarily of calcareous sediment with dead coral interspersed around the site and is relatively flat with short period undulating sand ripples caused by winnowing. Occasional living coral can be observed on the surrounding seabed but there is very limited coralline growth on the vehicle structure itself. The wreck was densely covered in brown algal forms. High nutrient levels in the lagoon may be contributing to this extensive algal growth (Denton et al. 2001).

The poor condition and collapsed state of the LVT2 could be due to a number of human factors including WWII but storm damage through increased wave action, in such shallow water, has very likely contributed to its gradual destruction. Recent impact damage was noted on the higher profile part of the structure and is probably due to a small boat collision. It is not included on the maritime trail, so visitation to the site by divers and snorkelers is expected to be less than to those wrecks that are listed.

Based on the results of Richards and Carpenter (2012) both LVT sites exhibit less corrosion of hull at the level of the seabed than the shallower, more exposed positions. These lower sections of the vessel near the sediment/seawater interface are subjected to periodic burial cycles, which would reduce the total amount of dissolved oxygen impacting the concretion surface, consequently reducing the overall corrosion rate. It is difficult to say whether LVT- 2 is corroding at a faster rate than LVT-1. Considering the extent of deterioration of LVT-2 in comparison to LVT-1, particularly when one considers its shallower depth, it is not surprising that the natural and cultural impacts on LVT2 are greater than those experienced by LVT1. Visitation at LVT-2 should be limited because of its greater deterioration.

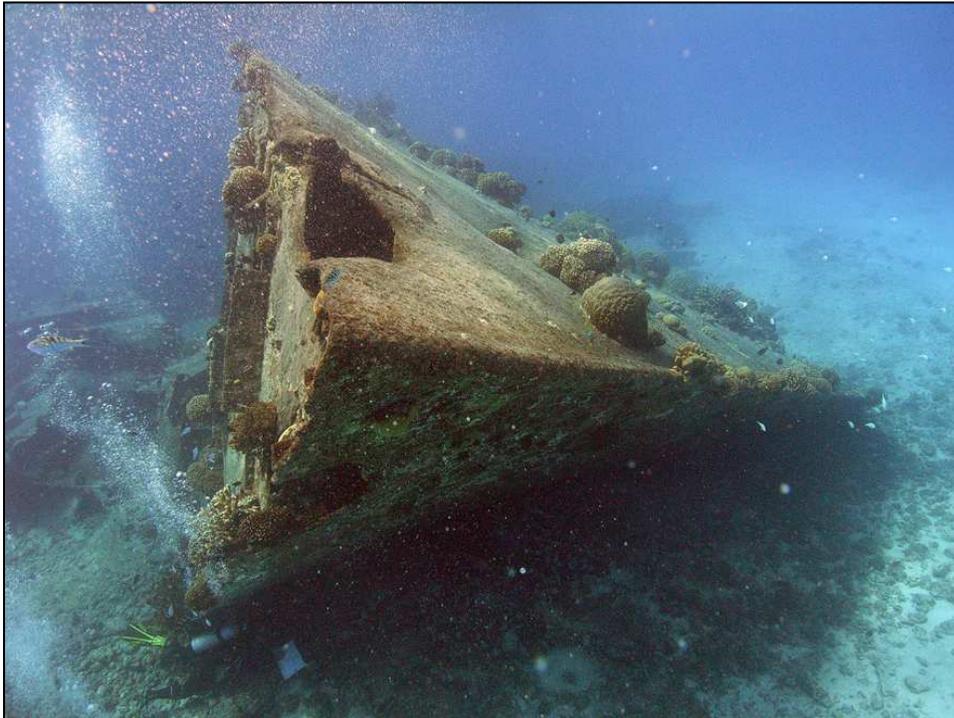
**Figure 12. Japanese merchant Ship (bow view) (Carpenter 2012).**

If this is *Shoan Maru*, it was torpedoed in 1943 but did not sink and was towed to Saipan for repairs or salvage. In 1944, it was attacked again by aircraft and damaged beyond repair. During the post-war cleanup of Tanapag Harbor the ship was heavily salvaged and cut-down to the waterline because it was considered a navigational hazard. There are also reports that it was used for explosives training during

this time (McKinnon and Carrell 2011:38-40). The remains lie in 35 ft (10.66 m) of water and the overall length of the site is approximately 274 m (900 ft) (UTM [REDACTED]) (Figure 12). A complete site plan for the shipwreck has not been produced due to its sheer size. The vessel lies on its starboard side and although most of the wreck is disarticulated and has collapsed in many areas, major elements such as the engines, boilers, steering mechanism and superstructure are generally located in close proximity to their original position. No apparent cargo was observed.

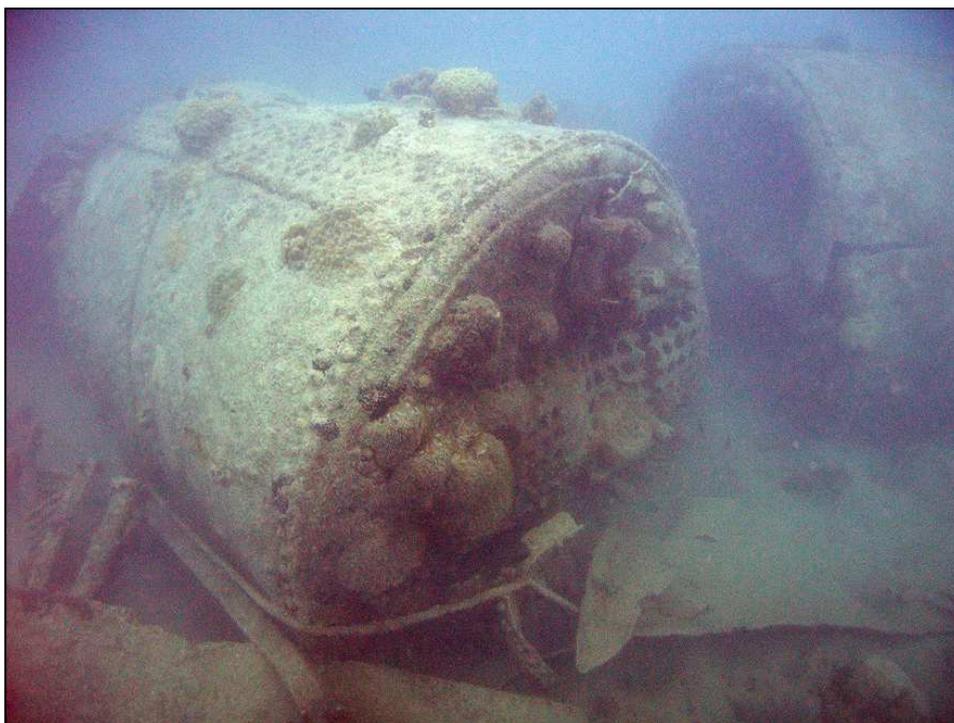
**Figure 14. Unidentified steamship – boilers (Carpenter 2012).**

It appears that the unidentified steamship is not subject to regular burial and exposure cycles, at least to any great extent. Sediment has partially covered the lower profile areas, such as collapsed hull/deck plates, and the mast/king post structures lying on the seabed were approximately one third buried in sediment. Maximum exposure height of the main structure was approximately 4m. However, due to the high profile of the remains and the establishment of hard corals in some areas it is likely that significant accumulation of sediment does not readily occur on this site.

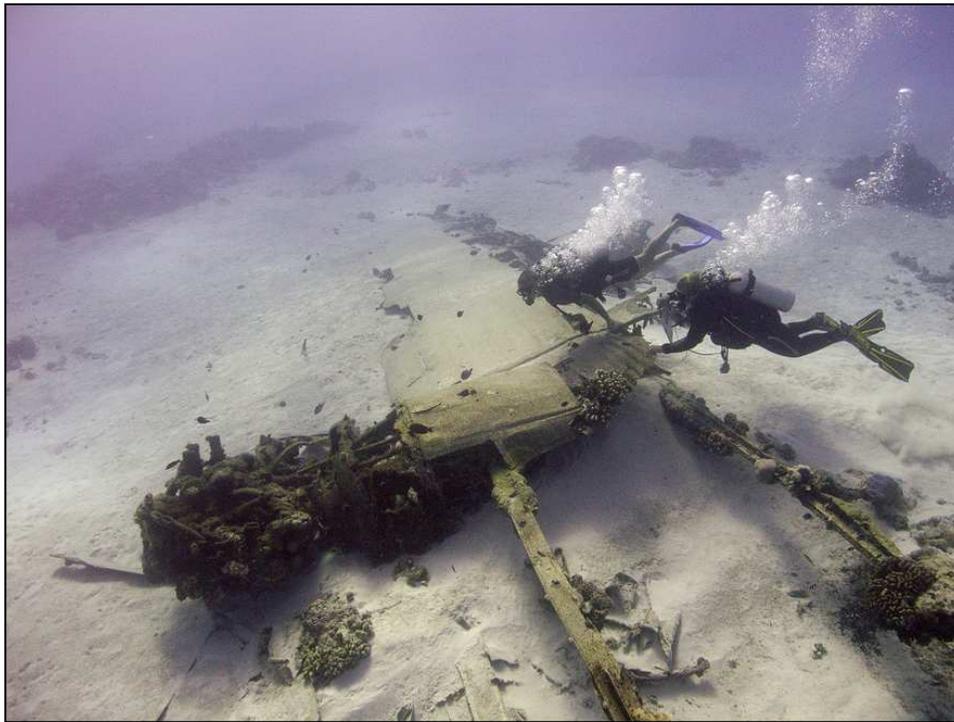
**Figure 16. Kawanishi H8K (EMILY) (Carpenter 2012).**

The remains are located on a relatively flat, undulating seabed with sporadic coral outcrops in the vicinity. Some lower profile sections, such as the wings are covered in a thin layer of fine sediment. There appears to be evidence of localized, seasonal exposure/reburial cycles on the site, but most of the remains are exposed and total burial seems unlikely to occur. The maximum height of the main structure is approximately 1.5 m above the seabed. A thin mucilaginous layer and algal forms cover the aluminum surfaces and coral growth is evident on various parts of the aircraft, especially near areas where the presence of ferrous components encourages more secondary colonization. A steady and generally light current affecting the site did not visibly move sediment. The plane is in relatively shallow water (9m) and may be affected by turbulent seas generated by storms and cyclones.

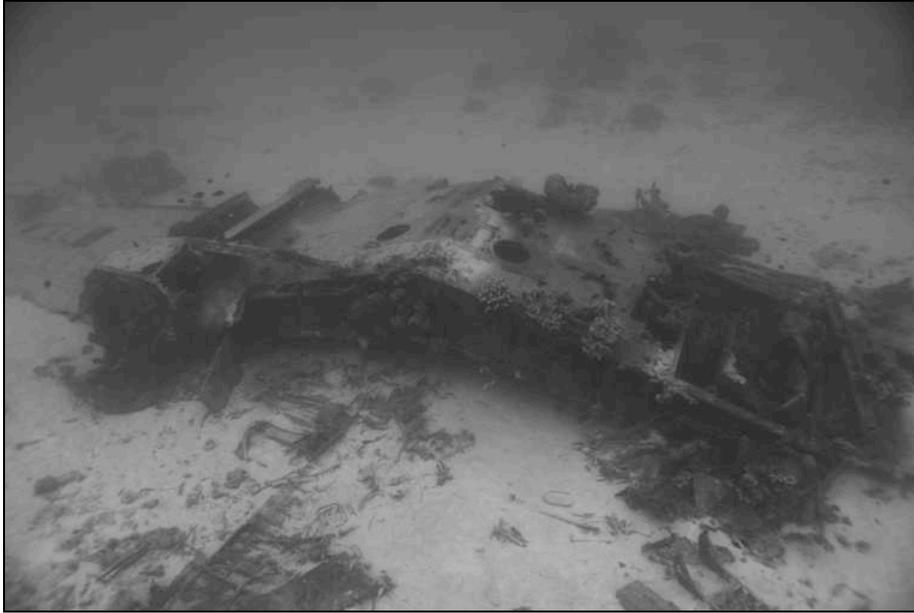
**Figure 17. Overview shot of central portions of Martin PBM Mariner site; note dihedral wing (D. McHenry, June 2010).**

The remains are located on a relatively flat, undulating seabed with sporadic large coral outcrops. Some lower profile sections, such as the wings, were covered in a thin layer of fine sediment. There appears to be evidence of localized, seasonal exposure/reburial cycles, however, most of the remains are exposed and total burial seems unlikely to occur. The maximum exposure height of the main structure is approximately 1.5 m above the seabed. A thin mucilaginous layer and algal forms cover the aluminum surfaces, and coral growth is evident on various parts of the aircraft especially near areas where the presence of ferrous components encourages more secondary colonization. A steady and generally light current affecting the site did not visibly move sediment. Because the site is relatively shallow (7 m) it may be affected by turbulent seas generated by storms and cyclones.

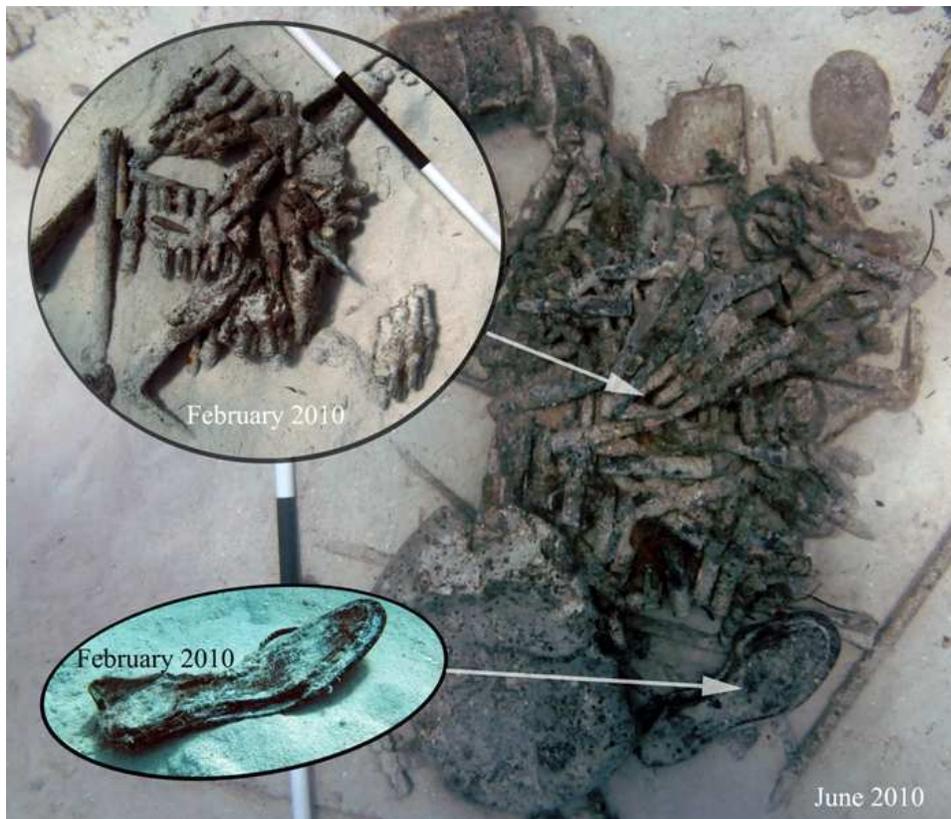
**Figure 27. Artifact pile created by divers and altered over time (Bell 2010).**

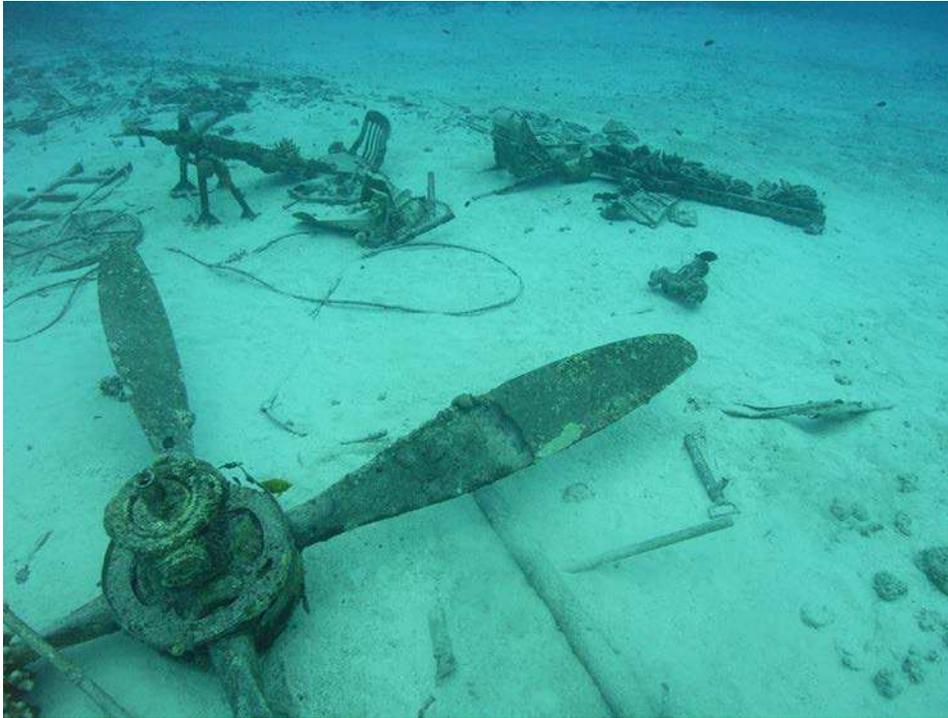
**Figure 28. Faux airplane wreck created for a submarine tour with artifacts gathered from sites in the vicinity. Note four-blade propeller (foreground) and gun in background (Carpenter 2012).**

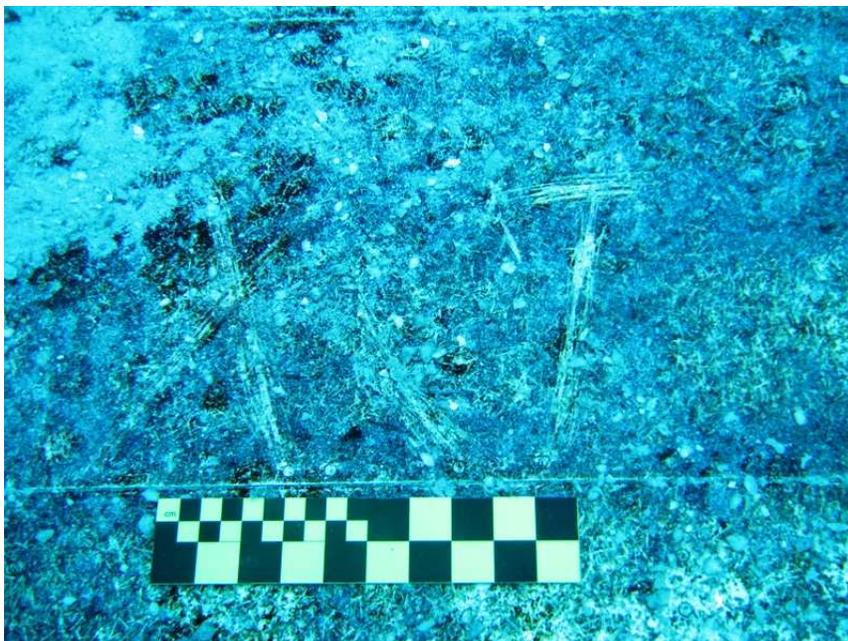
**Figure 29. Graffiti etched into the Kawanishi H8K (Bell 2010)**
