The Public Inquiry into the Piper Alpha Disaster

The Hon Lord Cullen

VOLUME ONE

Presented to Parliament
by the Secretary of State for Energy
by Command of Her Majesty
November 1990

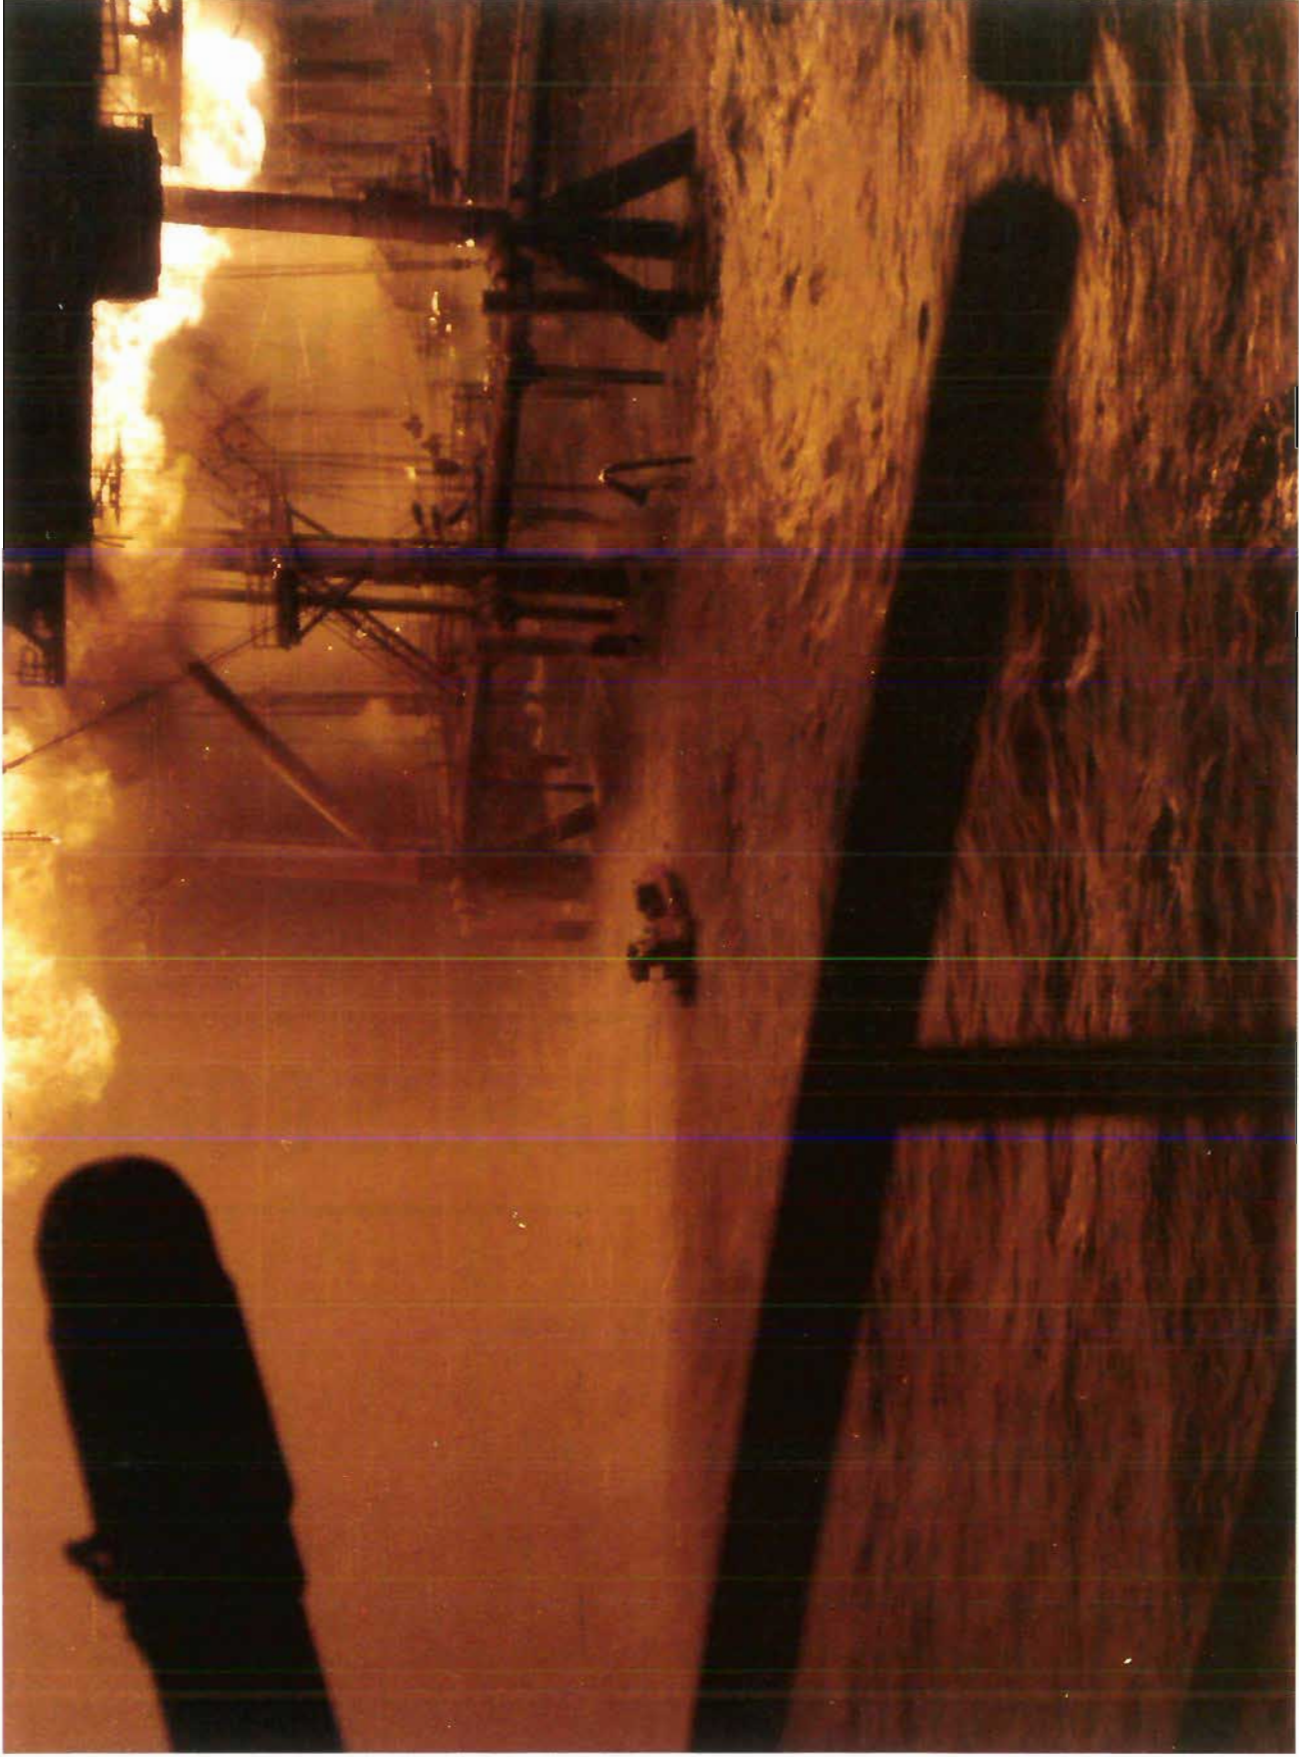
Frontispiece

A fast rescue craft near the 20ft level some time after the first riser rupture: photograph taken by Mr Miller from the *Tharos*.

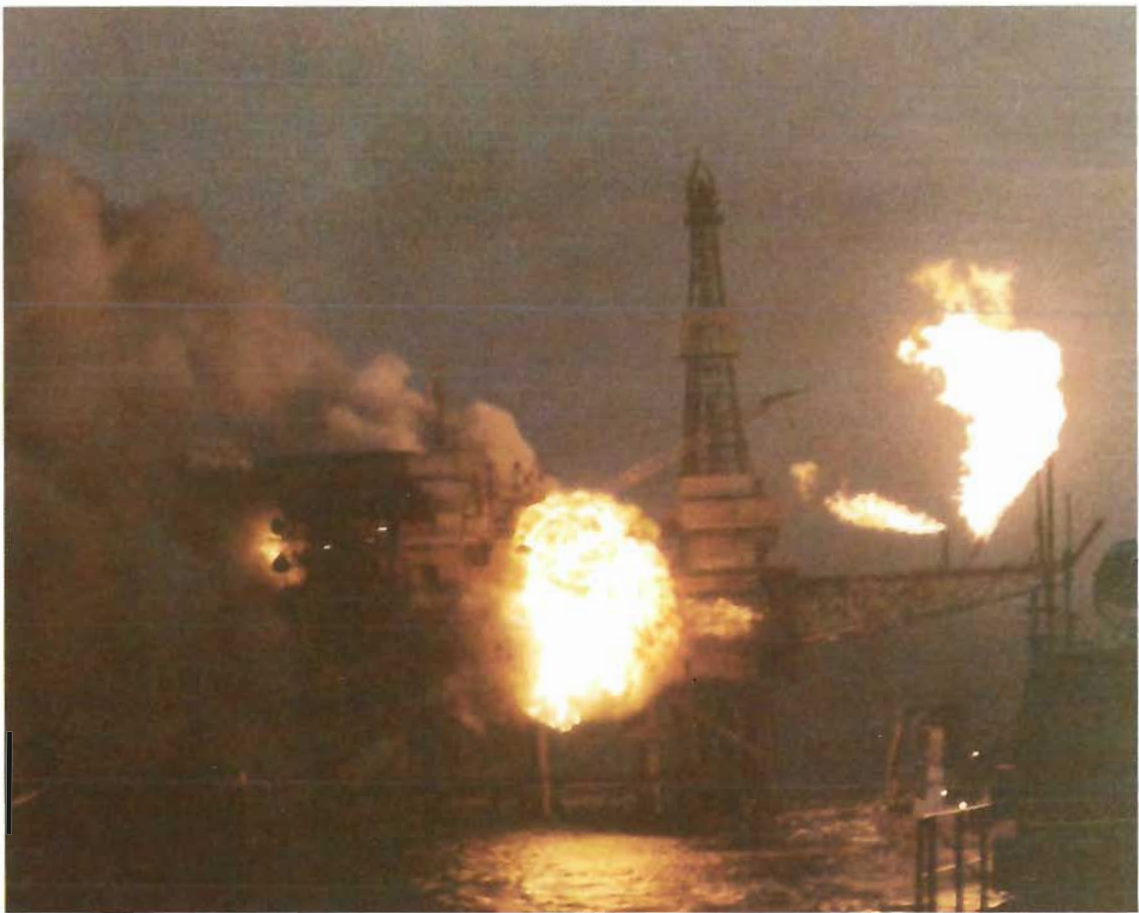
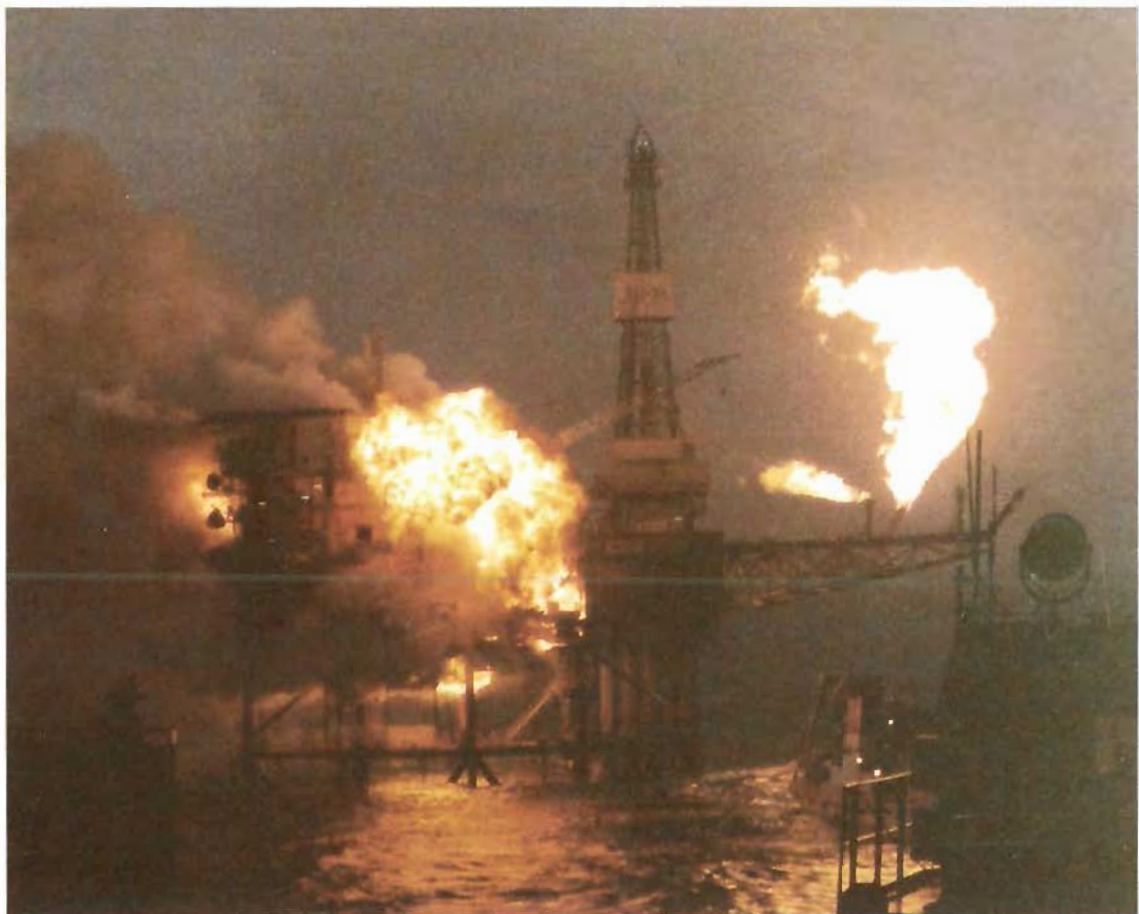
Plate 14(a)

The early fire in B Module: (a) Mr Miller's first photograph; and (b) his second photograph. The first photograph was taken from the *Tharos* some 15 seconds after the initial explosion. The next five photographs were taken in quick succession at intervals estimated as 2-3 seconds.

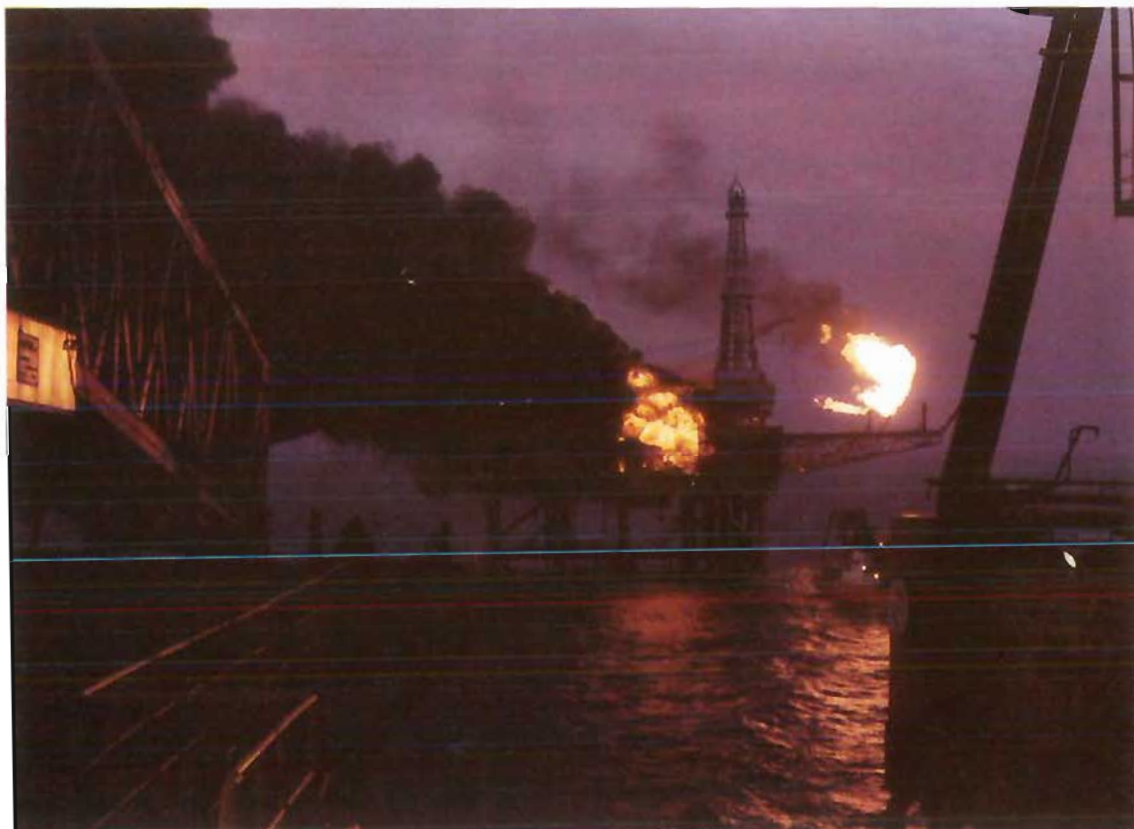
Plate 17(b) The fires on Piper before riser rupture: Mr Miller's thirteenth photograph.

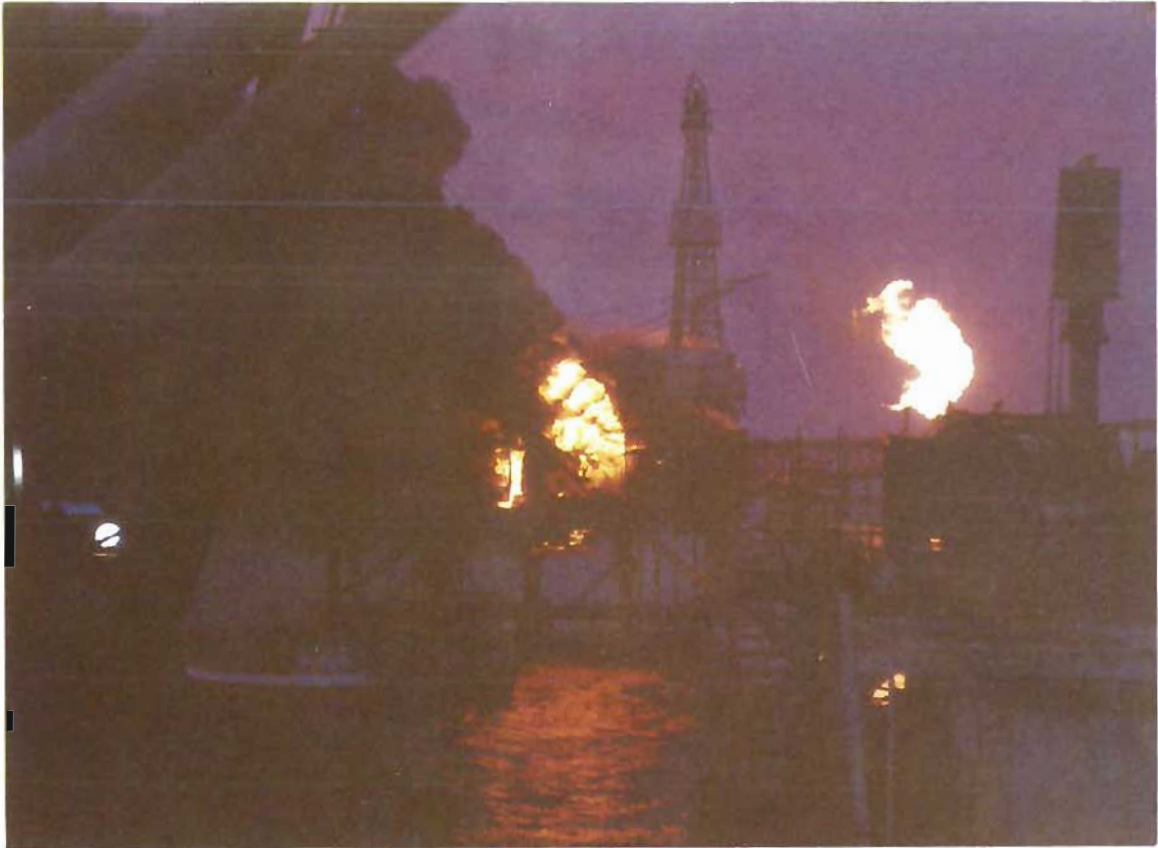
Plate 18(a) The fires on Piper before riser rupture: Mr Miller's nineteenth photograph.

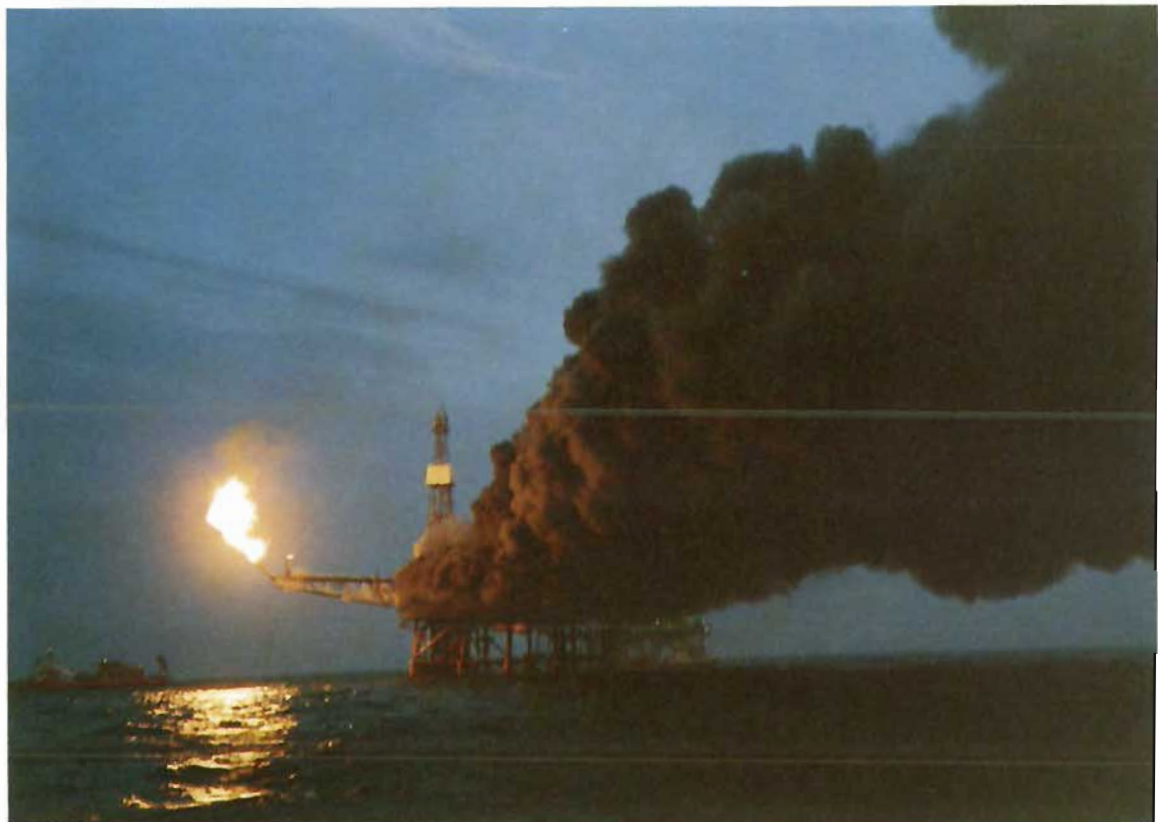
Plate 18(b) The fires on Piper before riser rupture: photograph taken from the *Maersk Cutter*.

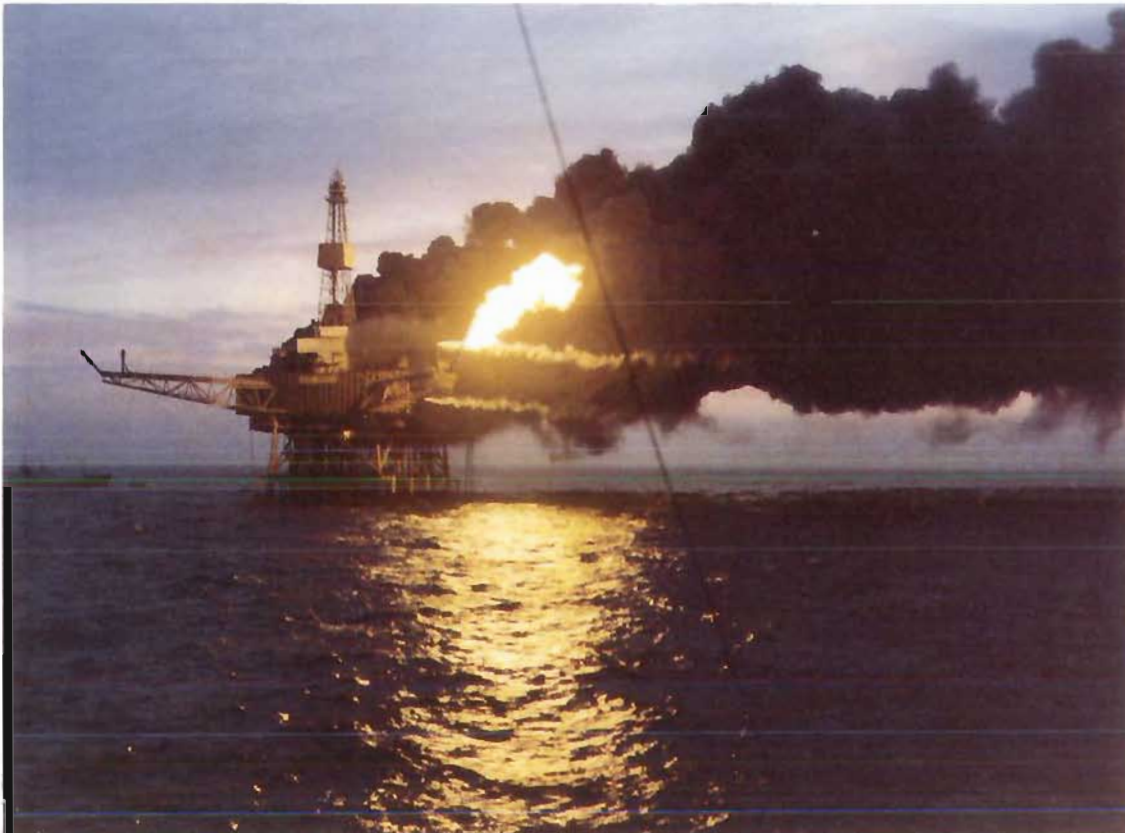
Plate 19(a) The fires on Piper before riser rupture: photograph taken by Mr Ritchie from the *Lowland Cavalier*

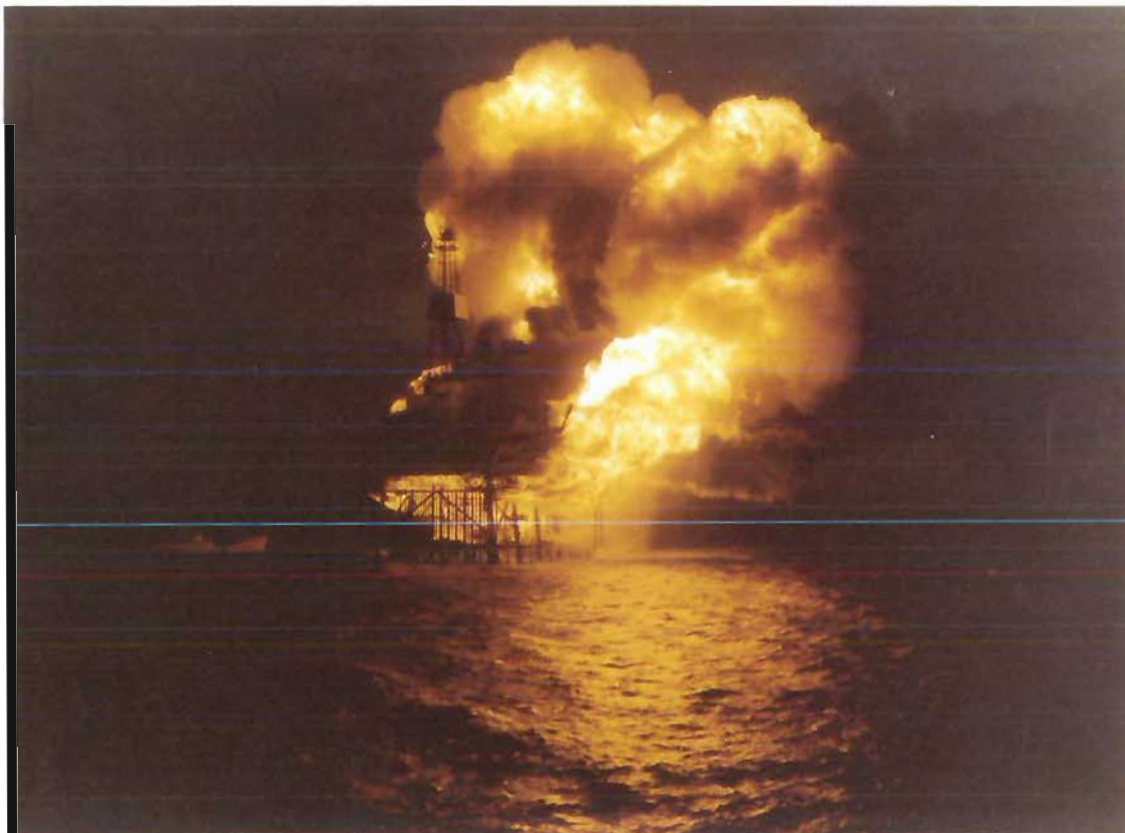
Plate 19(b) The fires on Piper just after rupture of the Tartan riser: photograph taken by Mr Gibson from the *Lowland Cavalier* at a time estimated as 22.20–22.22 hours.

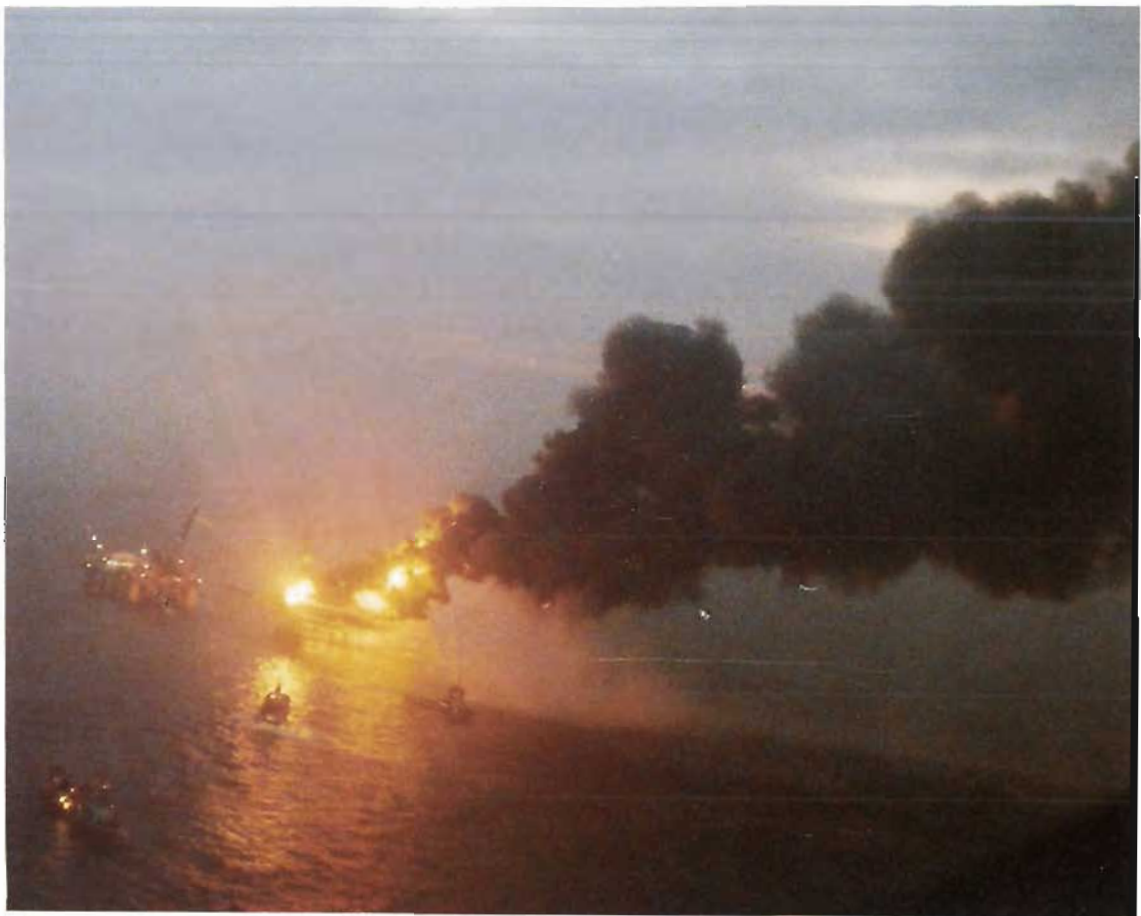
Plate 20(a) The fires on Piper some time after riser rupture: photograph taken from the *Tharos* helicopter.

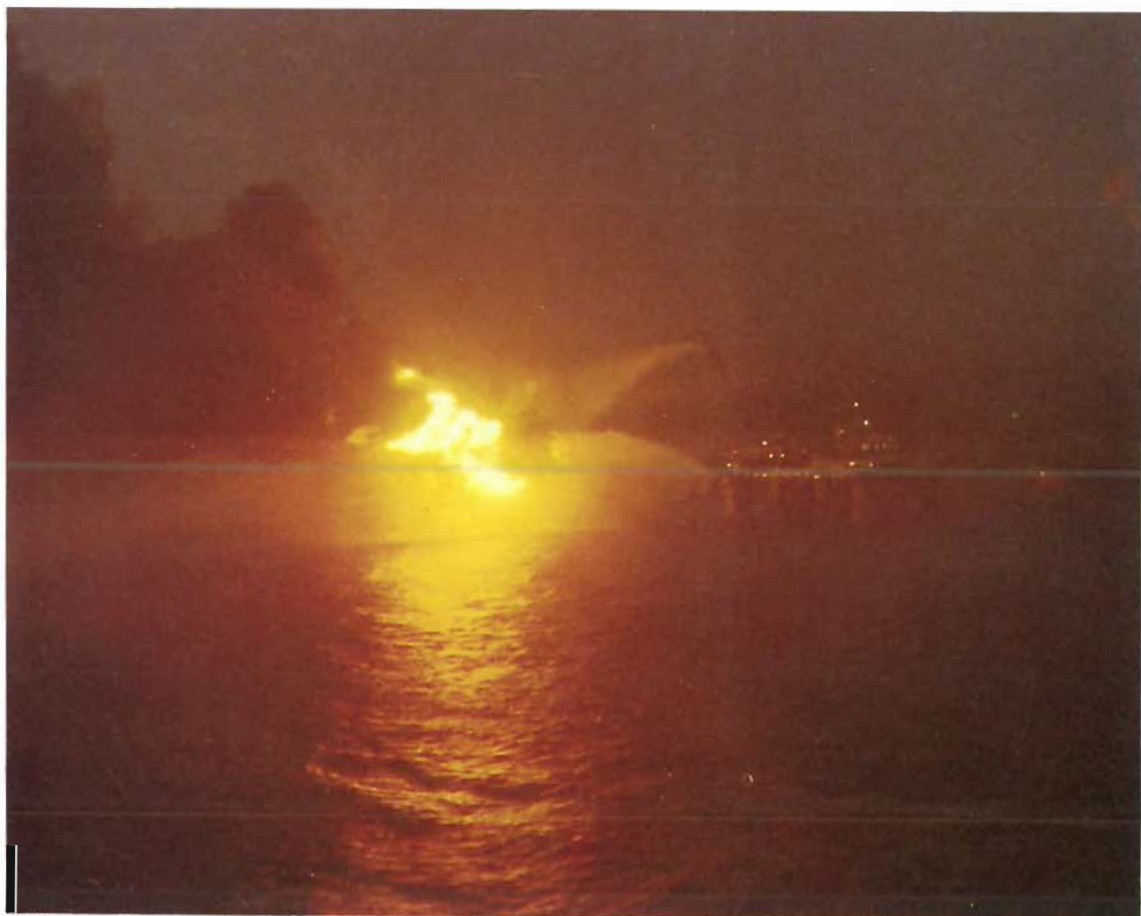
Plate 20(b) The fires on Piper some time after riser rupture: further photograph taken from the *Tharos* helicopter.

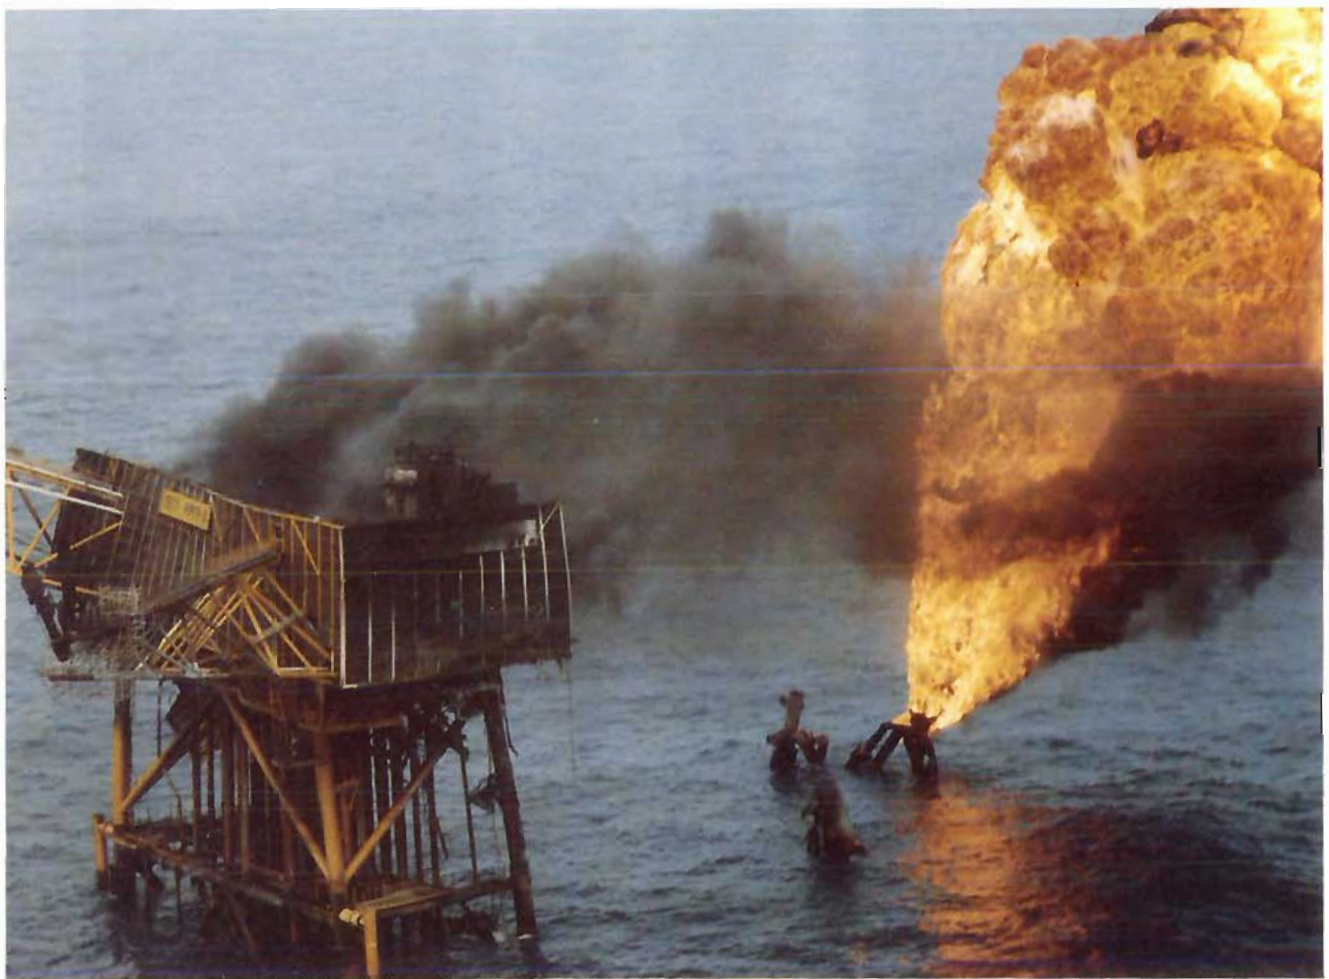
Plate 21 The remains of A Module on the morning of 7 July.

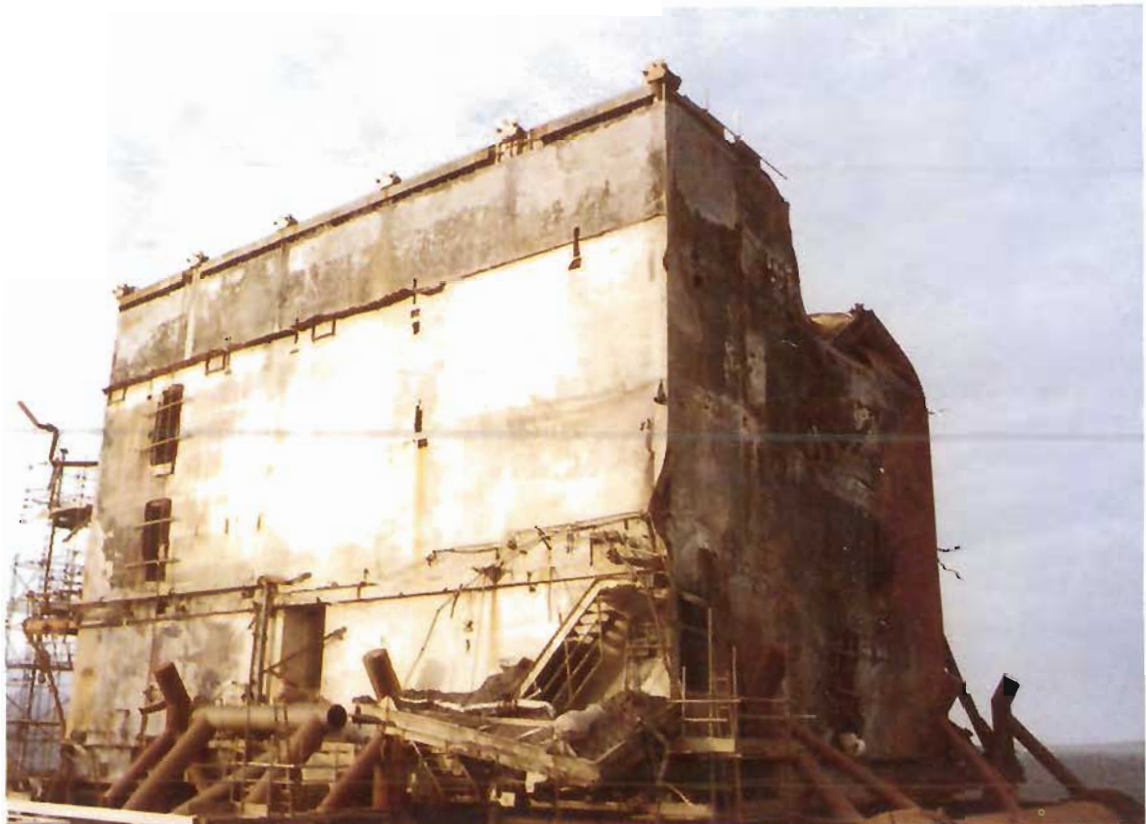
Plate 22(b)

Accommodation modules at Flotta after recovery from the seabed — 1: (a) the East Replacement Quarters (ERQ); and (b) the south face of the ERQ.

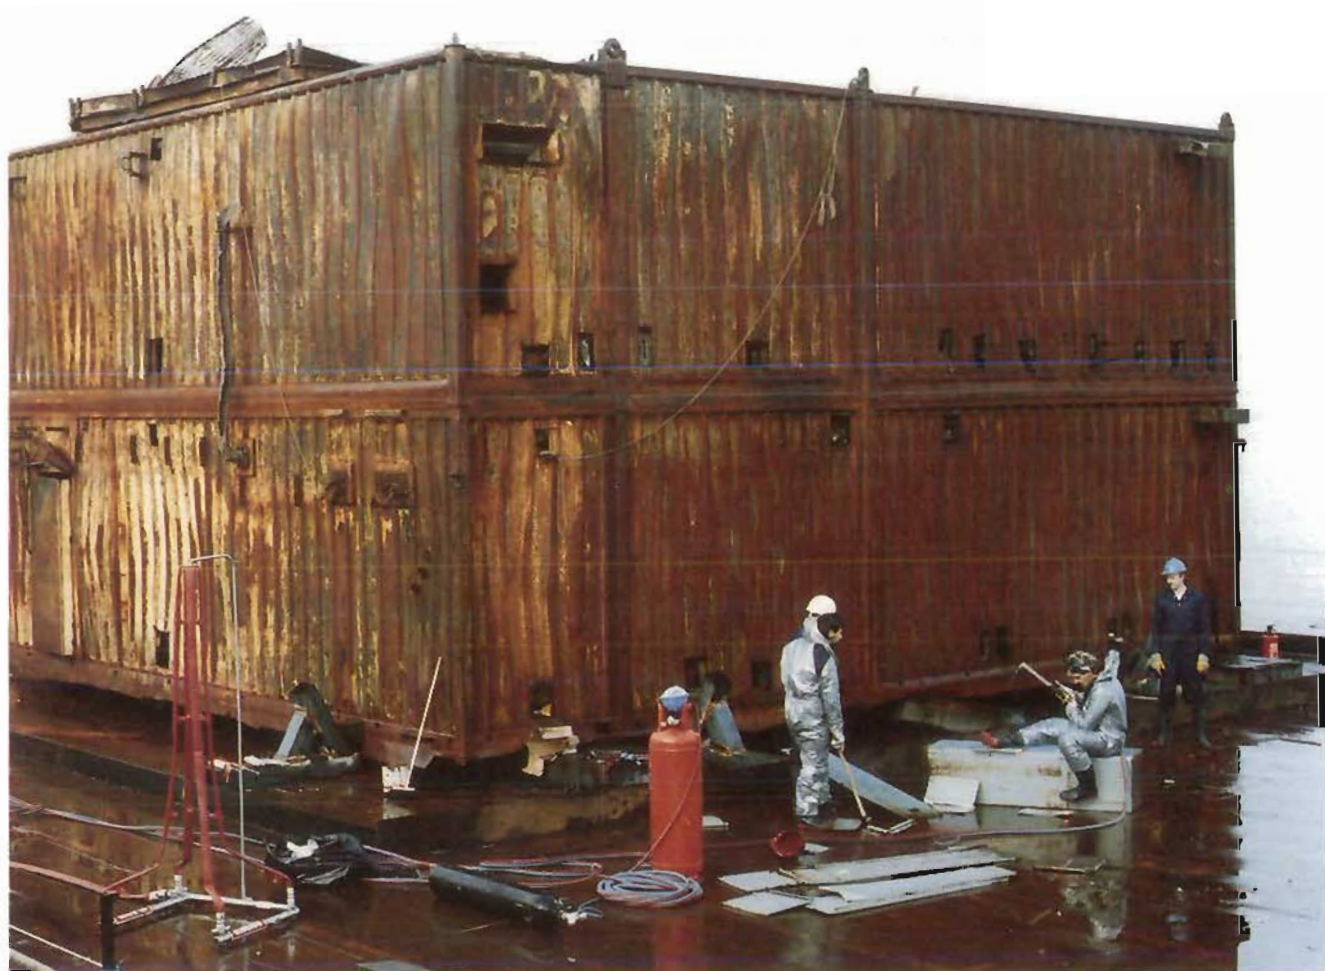
Plate 23 Accommodation modules at Flotta after recovery from the seabed — 2: the Additional Accommodation West (AAW).
