# Underwater Inspection of Submerged Elements in Masonry Bridges and Other Old Civil Structures Using Drones

[Rubén Rodríguez Elizalde](#) \*

Posted Date: 7 August 2024

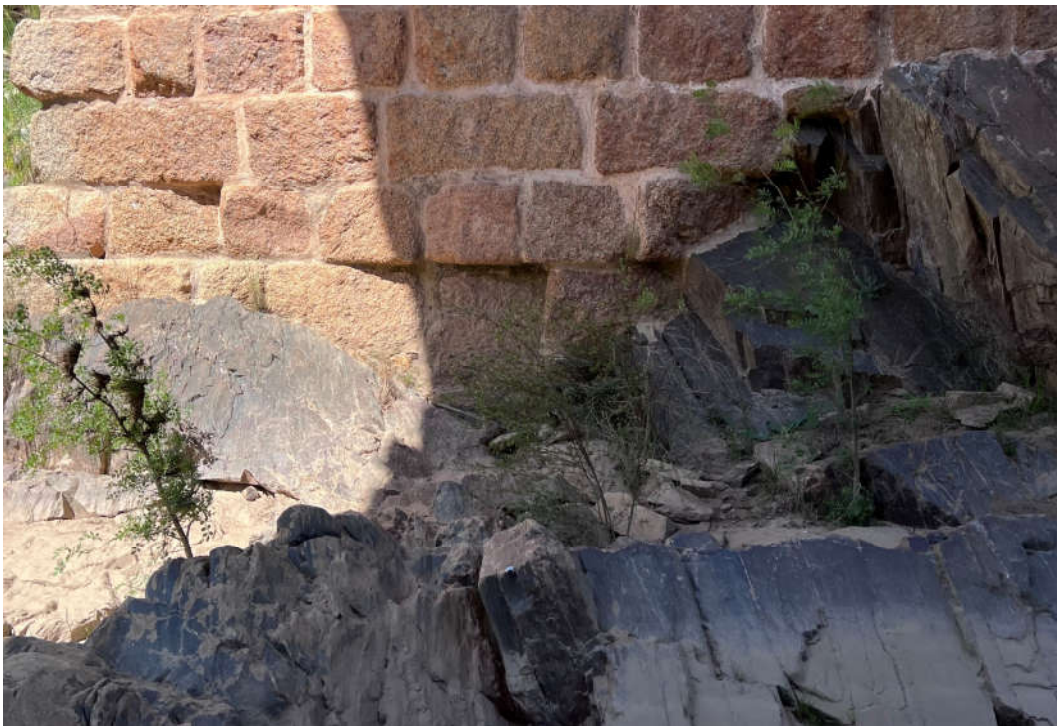
The bridge was built directly on the schistose rock that characterises this section of the Erjas River channel. The first rows of ashlar were placed on it to form the bridge's piers and abutments (Figures 3 and 4).

**Figure 3.** Close-up of the abutment on the Portuguese side, showing the arrangement of its first rows on the rocky material (photo by the author).

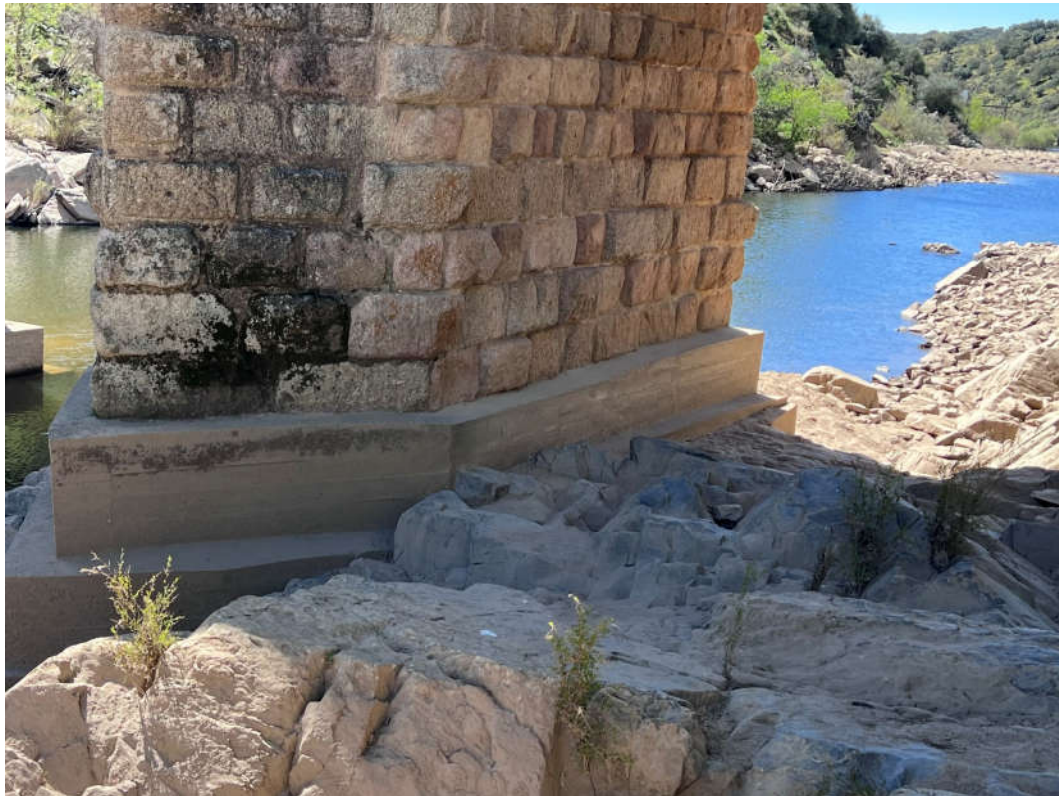
**Figure 4.** First pile, starting from the Portuguese side, where the casing and supporting rock can be seen (photo by the author).

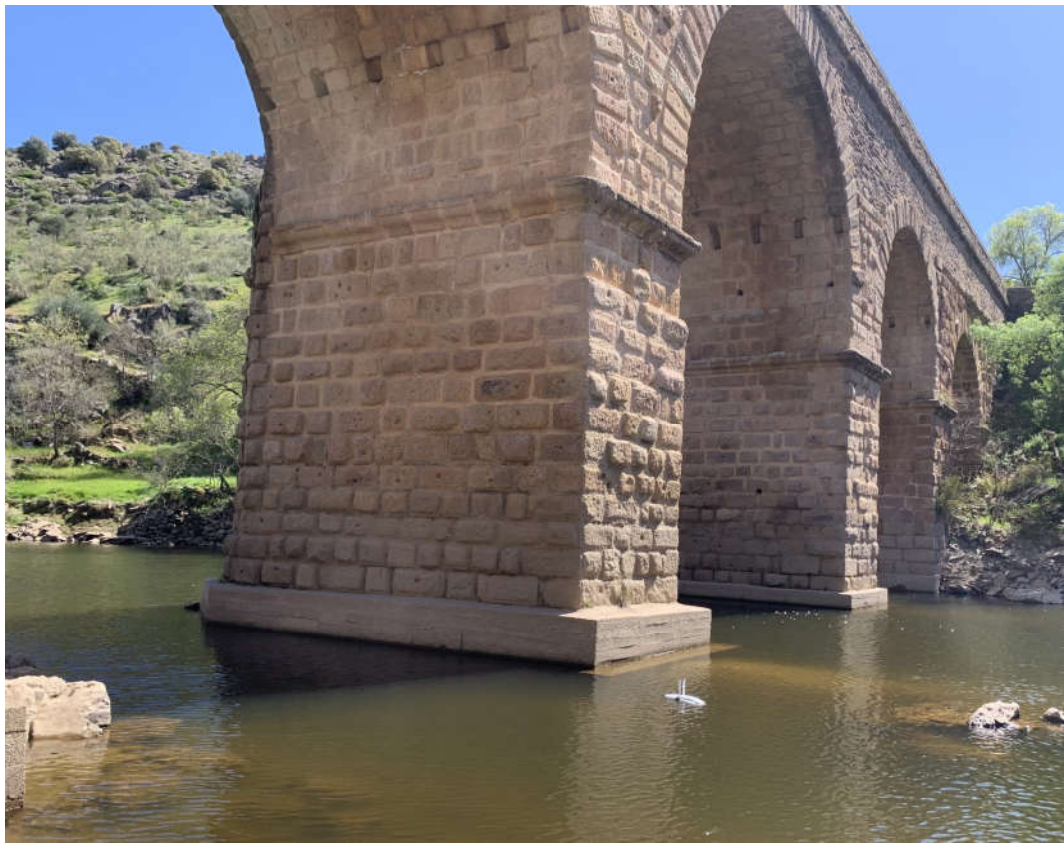
Based on this premise, the underwater drone used for the inspection was launched from a point with access to the river, downstream of the bridge, and approached the Roman structure against the current to inspect the submerged elements (Figure 5).

**Figure 5.** Underwater drone approaching one of the central piers of the Segura Bridge from downstream / the south (photo by the author).

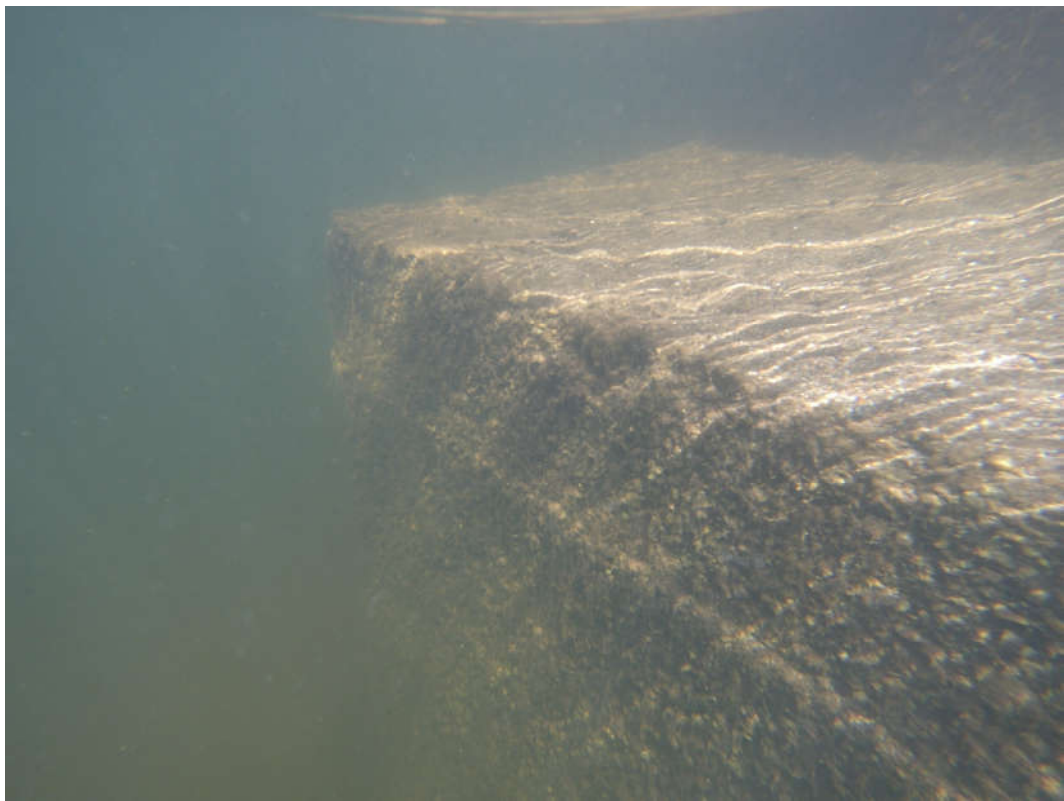
This made it possible to check that there was no deterioration damage to the bridge. The element inspected was the concrete casing mentioned above, which had recently been installed to protect the lower ashlars at the expense of hiding them. The texture of the concrete showed no loss of material due to the direct action of the water (Figure 6) and was relatively healthy despite being submerged and exposed to flowing water. The drone was able to verify that there were no cracks in the concrete, no exposed steel reinforcement and no disaggregation.

The drone also analysed the soil-foundation complex to check for signs of possible future undermining. The visual inspection of the elevation had indicated that there were no previous settlement or pile rotation problems. However, it is believed that the effect of water flow on the foundation and pile bases is the most common cause of failure in the soil-foundation complex for this type of structure, leading to very serious instability situations as a result of cavity formation and decompression of the soil around the pile bases.

**Figure 6.** Underwater drone image showing the condition of the foundation inspected in Figure 5 (photo by the author).

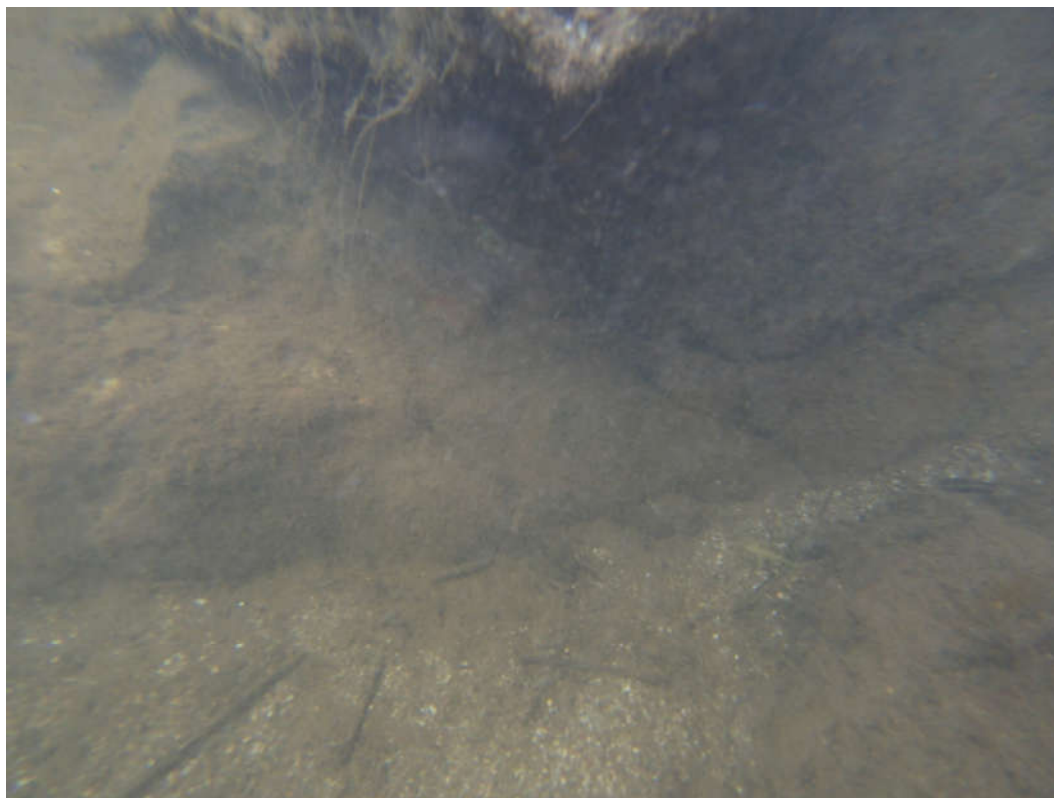
The lack of evidence of destabilisation and mobilisation of significant thicknesses in the riverbed, together with the good condition of the concrete protection, indicates that there has been no increase in the erosive power of the water, at least in recent times. Analysis of the area around the base of the submerged breakwaters showed that no bed material had been torn from the edge by the vertical component of the flow and lifted and carried by the current. When one of the piles was removed (the first, counting from the abutment on the Portuguese side), no evidence of conical depressions in the bed was found. A small depression was found at the edge of the breakwater of this first pile, but its size and depth were minimal and therefore not of concern (Figure 7).

All this led to the conclusion that the submerged elements of the bridge were in a suitable state of preservation and able to fulfil their function in the short and medium term, thus guaranteeing the absence of undesirable phenomena related to the foundation.

**Figure 7.** Underwater drone image of the junction between the foundation and the riverbed (photo by the author).

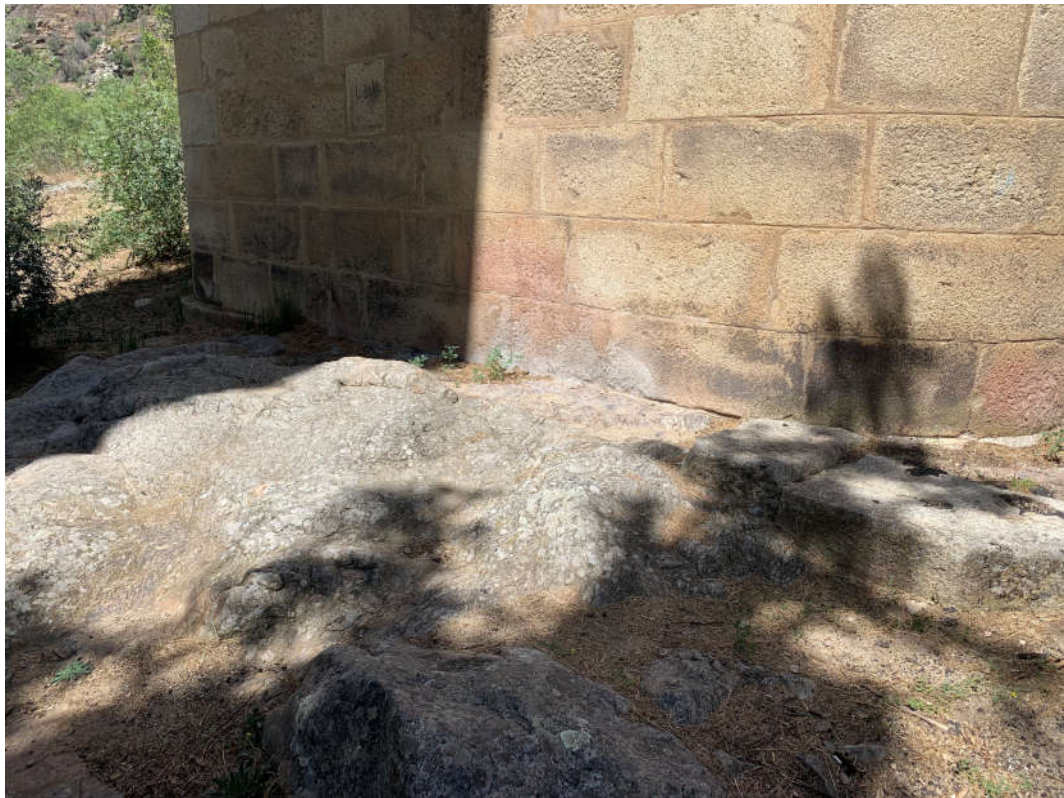
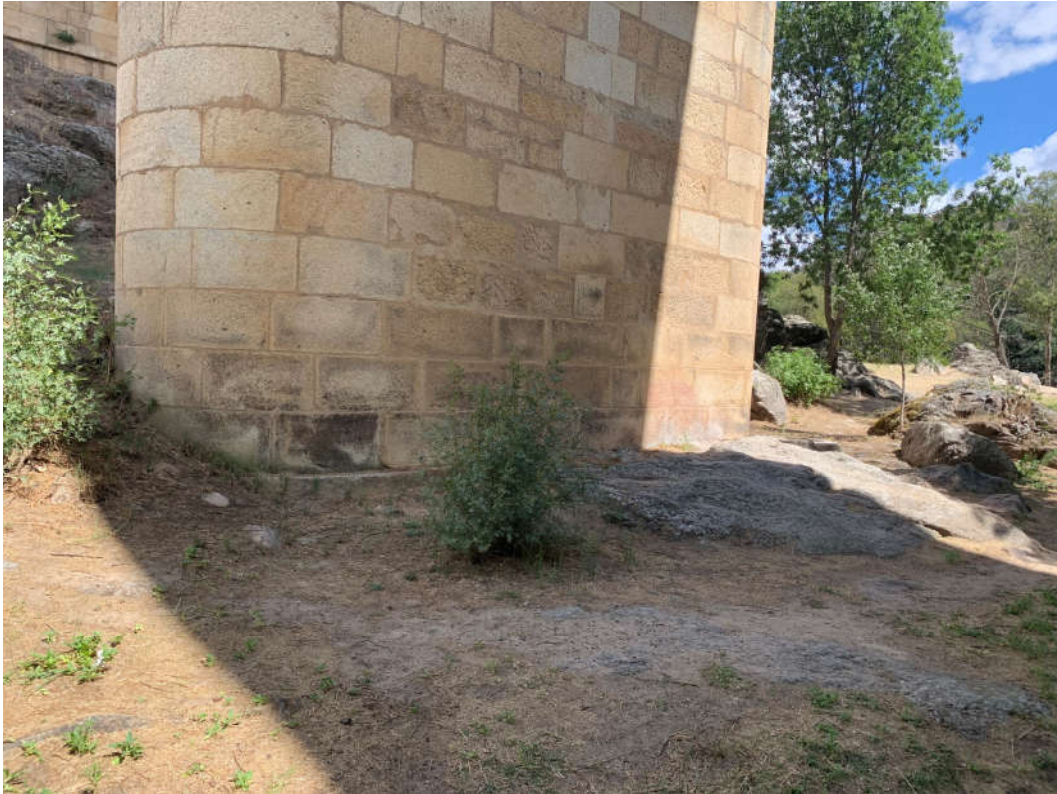
Unlike the Segura Bridge, the piers here have no additional concrete elements. The underwater drone confirmed the observation made on the non-submerged elements (Figures 10 and 11): the piers rest directly on the ground and the first ashlar rise out of the sand of the riverbed (Figures 12 and 13). As in the previous case, detailed observation allowed us to verify that there were no symptoms of the type that may appear in the superstructure as a result of the main foundation defects: twisting, absolute settlement or differential settlement. A quadcopter drone was used for this purpose.

**Figure 10.** View of the first pier of the bridge, counting from the northern abutment (Zamora side), showing its support (photo by the author).

**Figure 11.** Another view of the pile shown in Figure 10, with the northern abutment in the background (photo by the author).

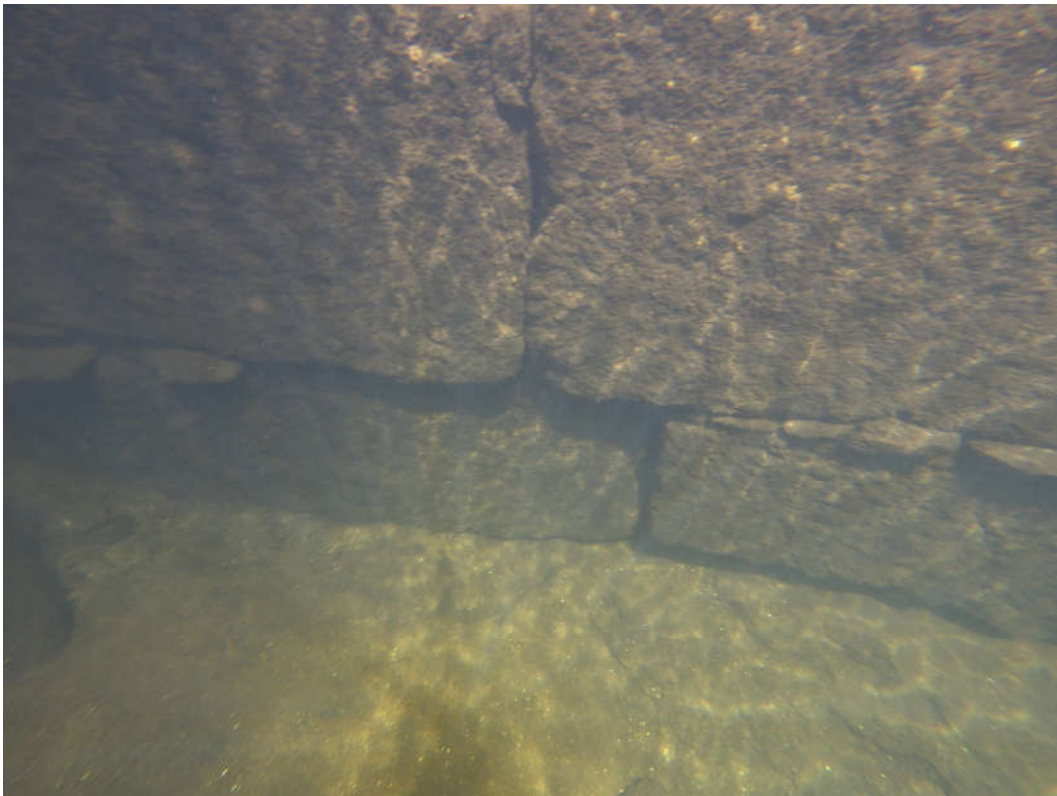
The underwater drone inspection of the submerged parts confirmed the correct state of the elements underwater: there were no missing granite ashlars and the granite forming the submerged ashlar was in an adequate state of preservation. The presence of stone slabs in various joints between the ashlars and their appropriate location (Figure 12) appeared to help maintain the position of the ashlars by mutual friction against the erosive action of the river. This would have prevented the need to use grouting mortar, which inevitably tends to dissolve or be lost over time due to the washing action of the flowing water.

It was also possible to verify that the lower part of all the submerged piles was in complete contact with the riverbed. This, together with the absence of deformations in the position of the ashlars, allowed us to confirm the absence of undermining under these piles.

**Figure 12.** Underwater drone image showing the status of a fragment of the lower part of the pile inspected in the position of Figure 9 (photo by the author).

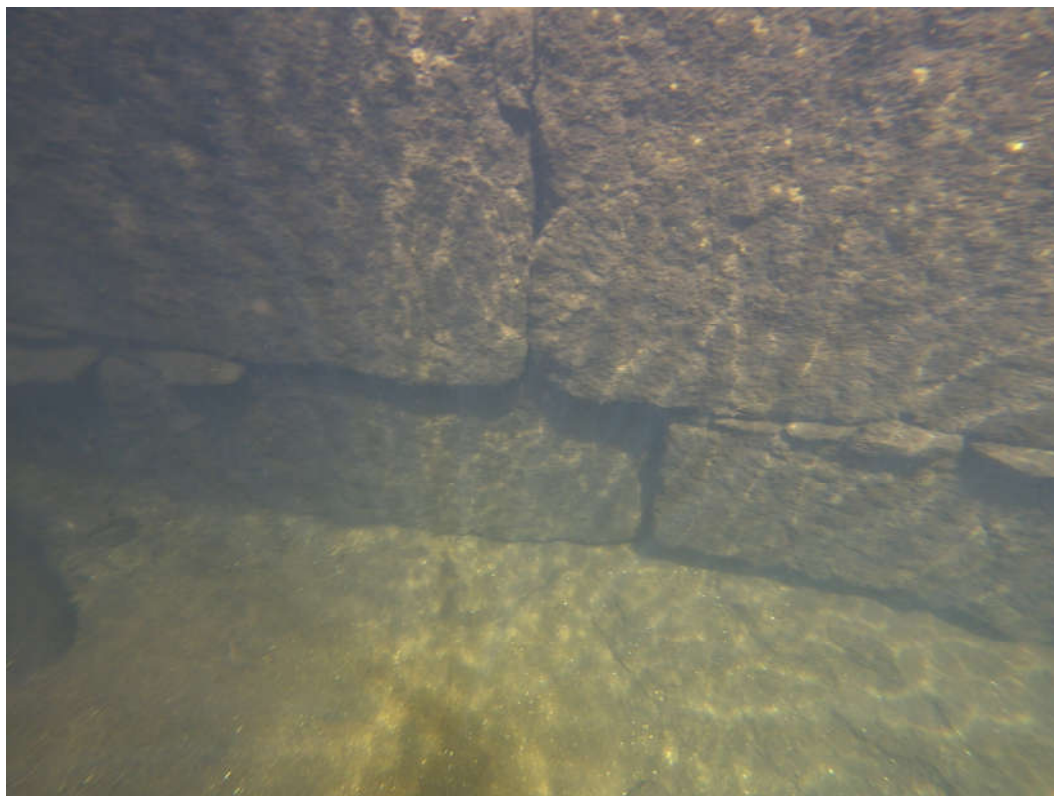
**Figure 13.** Condition of another fragment of the lower part of one of the inspected piles, in an image captured by the underwater drone (photo by the author).

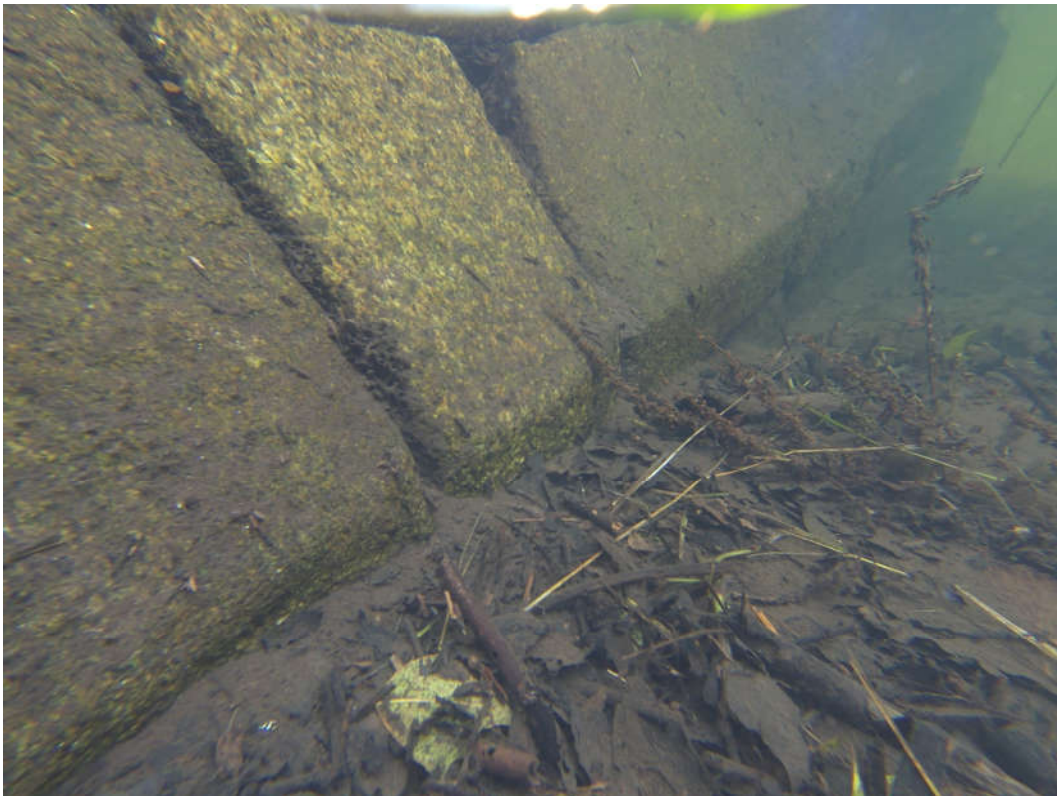
The drone inspection showed that the materials forming the base of the submerged piles were in adequate condition: the granite showed no signs of deterioration or erosion from the action of the water, nor were there any missing elements, particularly ashlar.

Thanks to the drone, it was possible to rule out the existence of any degradation phenomena in the material making up the submerged elements, as well as the presence of any signs of poor performance of the soil-pile assembly due to the actions to which this assembly is exposed. It was therefore concluded that the foundation was in good working order.

**Figure 16.** Underwater drone image of a fragment of the base of one of the central piers of the Brandomil Bridge (photo by the author).
