Yang R, Kong Q, Ren M, Ji F and Li D
(2023), Statistical and numerical analysis
on characteristics and influence factors
of construction cracks of large-diameter
underwater shield tunnel: a case study.
Front. Earth Sci. 11:1235674.
doi: 10.3389/feart.2023.1235674

Statistical and numerical analysis on characteristics and influence factors of construction cracks of large-diameter underwater shield tunnel: a case study

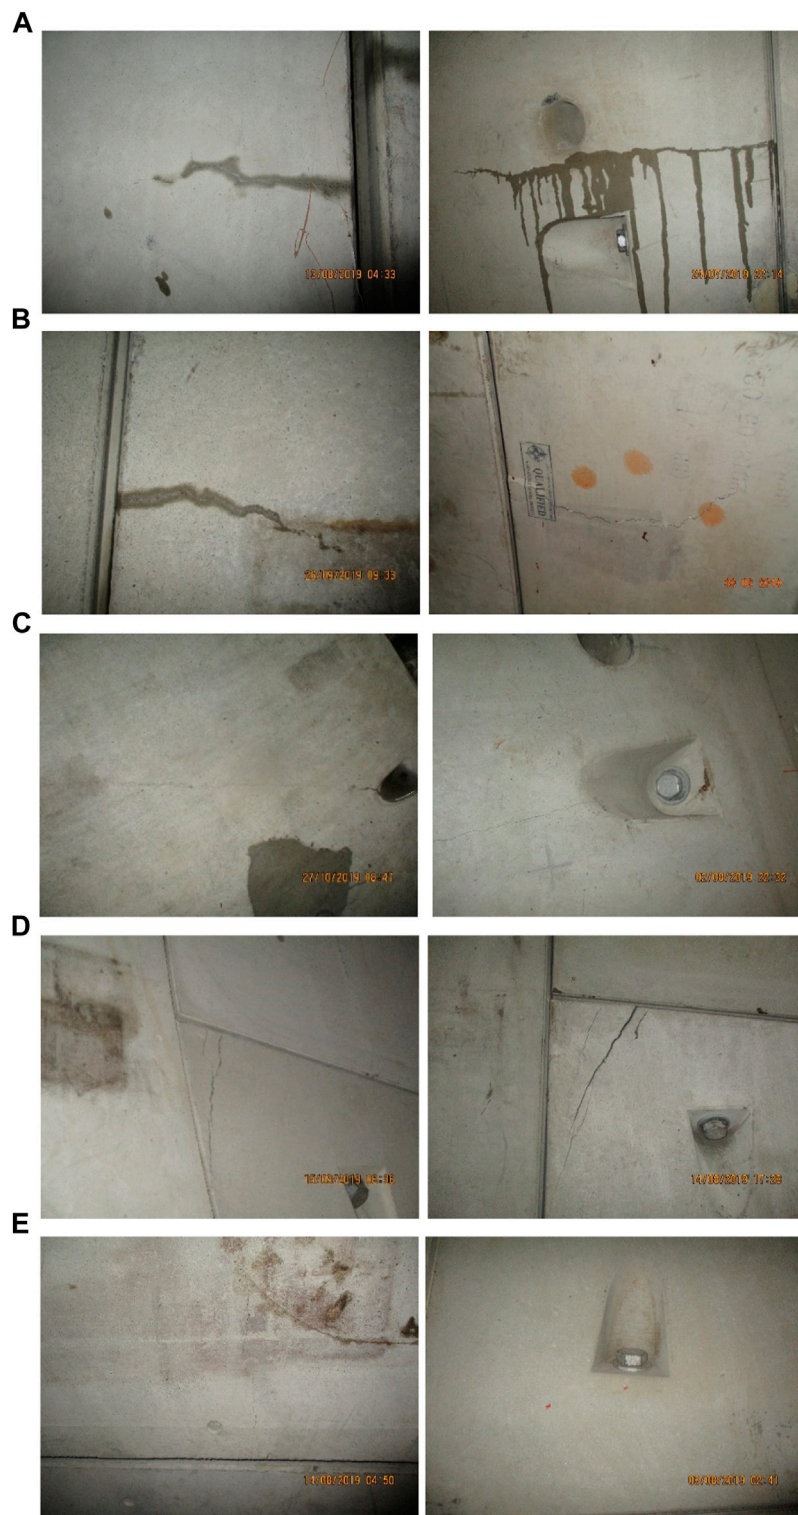
A total of 927 cracks were identified in the left tunnel, and the segment rings with cracks accounted for 47.7% of the total number of segment rings. The cracks could be divided into five types: positive, backward, handhole, corner and circumferential cracks. The handhole cracks started from the end of the bolts and developed obliquely (Figure 4).

FIGURE 4
 Typical cracks: (A) positive crack, (B) backward crack, (C) bolt crack, (D) corner crack, and (E) circumferential crack.

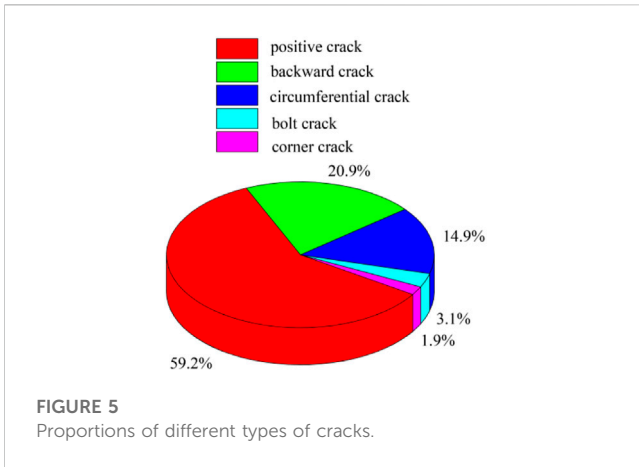
The proportion of each crack type is illustrated in Figure 5. Positive cracks accounted for the largest proportion, followed by the backward and circumferential cracks. These three types of cracks accounted for 95% of the total cracks. The focus of the work was therefore on the causes of the longitudinal and circumferential cracks.

FIGURE 5 Proportions of different types of cracks.

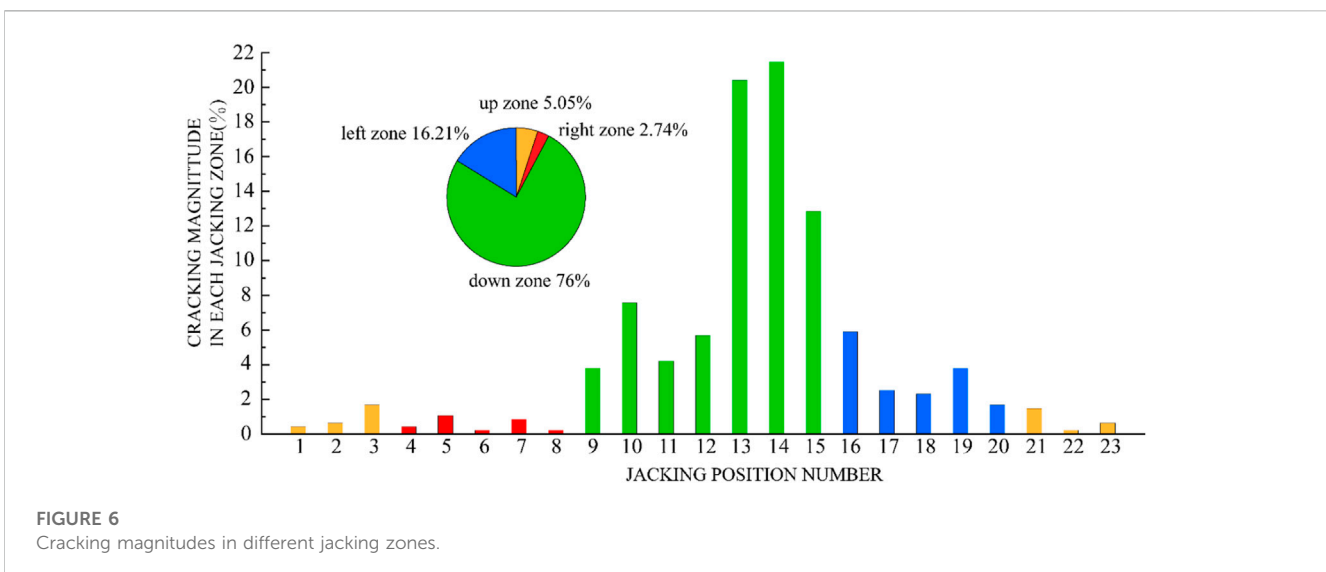
Considering that the dominant loads acting on segments were the thrust of the jacks before the segments were pushed out from the shield tail, the number of longitudinal cracks at locations of the 23 jacks was counted (Figure 6). The longitudinal cracks occurred mainly in the down zone of the jacks, followed by the left zone. Cracks in the lower and left zones accounted for 76% and 16.21% of the total cracks, respectively. Of the 23 jacks, the largest proportion of longitudinal cracks was found at jacks 13 and 14, which were mainly in the down zone closest to the left zone of the jack.

FIGURE 6 Cracking magnitudes in different jacking zones.

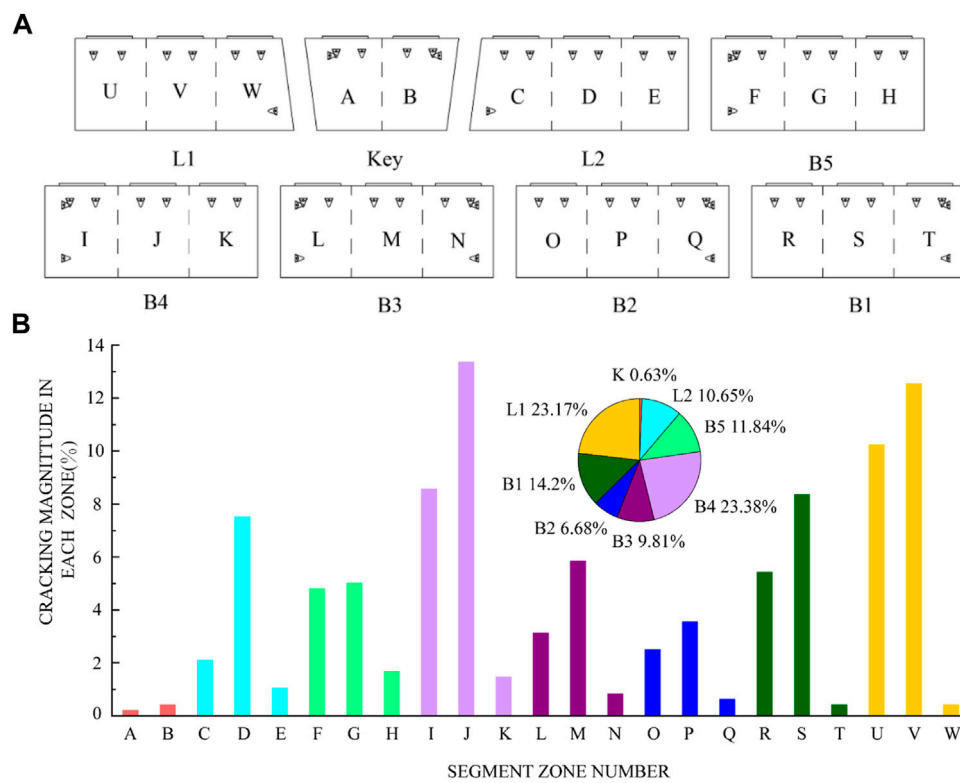
To investigate the relationship between the cracks and segment type, eight segments were divided into 23 zones (labelled as A–W), with the boundary of the adjacent zones being the bisector between the two force transfer platforms (Figure 7A).

Figure 7B lists the numbers of longitudinal cracks in each zone of the different segments. The largest proportion of longitudinal cracks was in zone J, followed by zone V. The segment with the most longitudinal cracks was B5, followed by L1, and the K segment had the least longitudinal cracks. For each segment, the zone with the largest proportion of cracks was the force transfer platform in the middle part, followed by the force transfer platform on the left.

FIGURE 7 (A) Zoning of the segmental linings for statistical examination (B) Cracking magnitude in different segment zones.

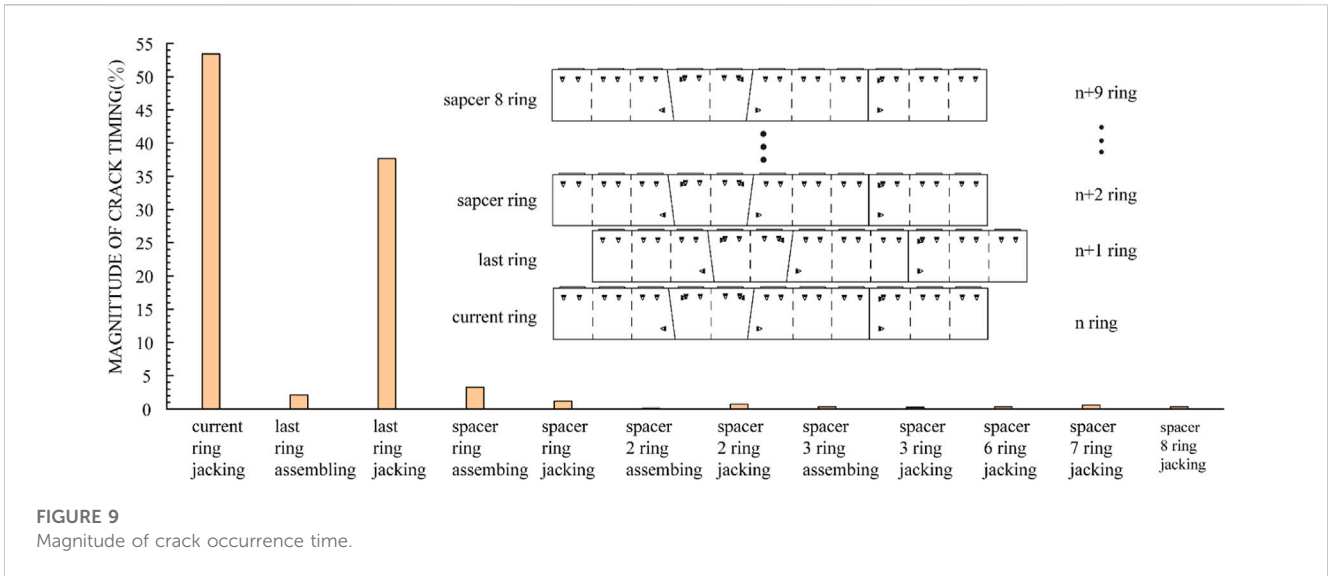
Figure 9 displays the distribution of the occurrence time of the longitudinal cracks. The current ring jacking indicates that the cracks were produced in the *n*-th segment when the *n*-th segment was jacked. The last ring jacking represents that the cracks were generated in the *n*-th segment when the (*n*+1)-th segment was jacked. The third ring jacking denote that the

Figure 9, demonstrates that more than half of the cracks were formed during the current ring jacking stage. However, unlike different

from previous studies, 38% of the cracks were formed during the last ring jacking stage. Considering that 93% of the cracks were formed in the current and last ring jacking stages, this study only concentrated on the cracks developed in these two jacking stages.

FIGURE 9 Magnitude of crack occurrence time.

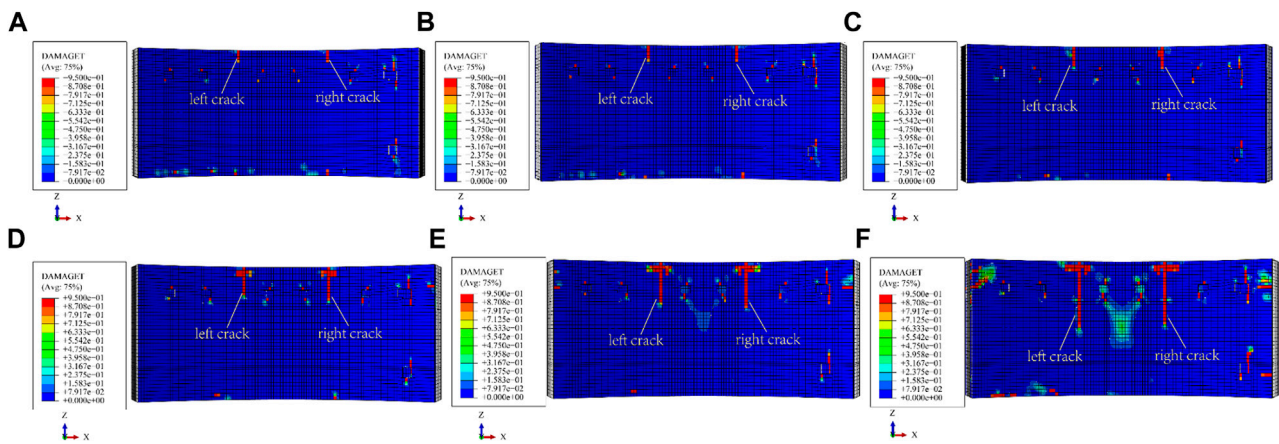
As segmental cracks could only be observed inside the tunnel, the analysis in this section concentrated on the cracks occurred on the segment inner surface. Figure 16 illustrates the damage results of the B4n segment in the first phase under various shield attitude adjustment

conditions. The DAMAGET threshold for crack occurrence was defined as 0.95. Two major tensile cracks occurred in all the studied scenarios regardless of the deflection angle, while the crack lengths

FIGURE 16 Damage of B4n, jack pressure of 23 MPa, 8 mm between guide bar and segment, deflection angle: (A) 0° (B) 1° (C) 2° (D) 3° (E) 4° (F) 5°.

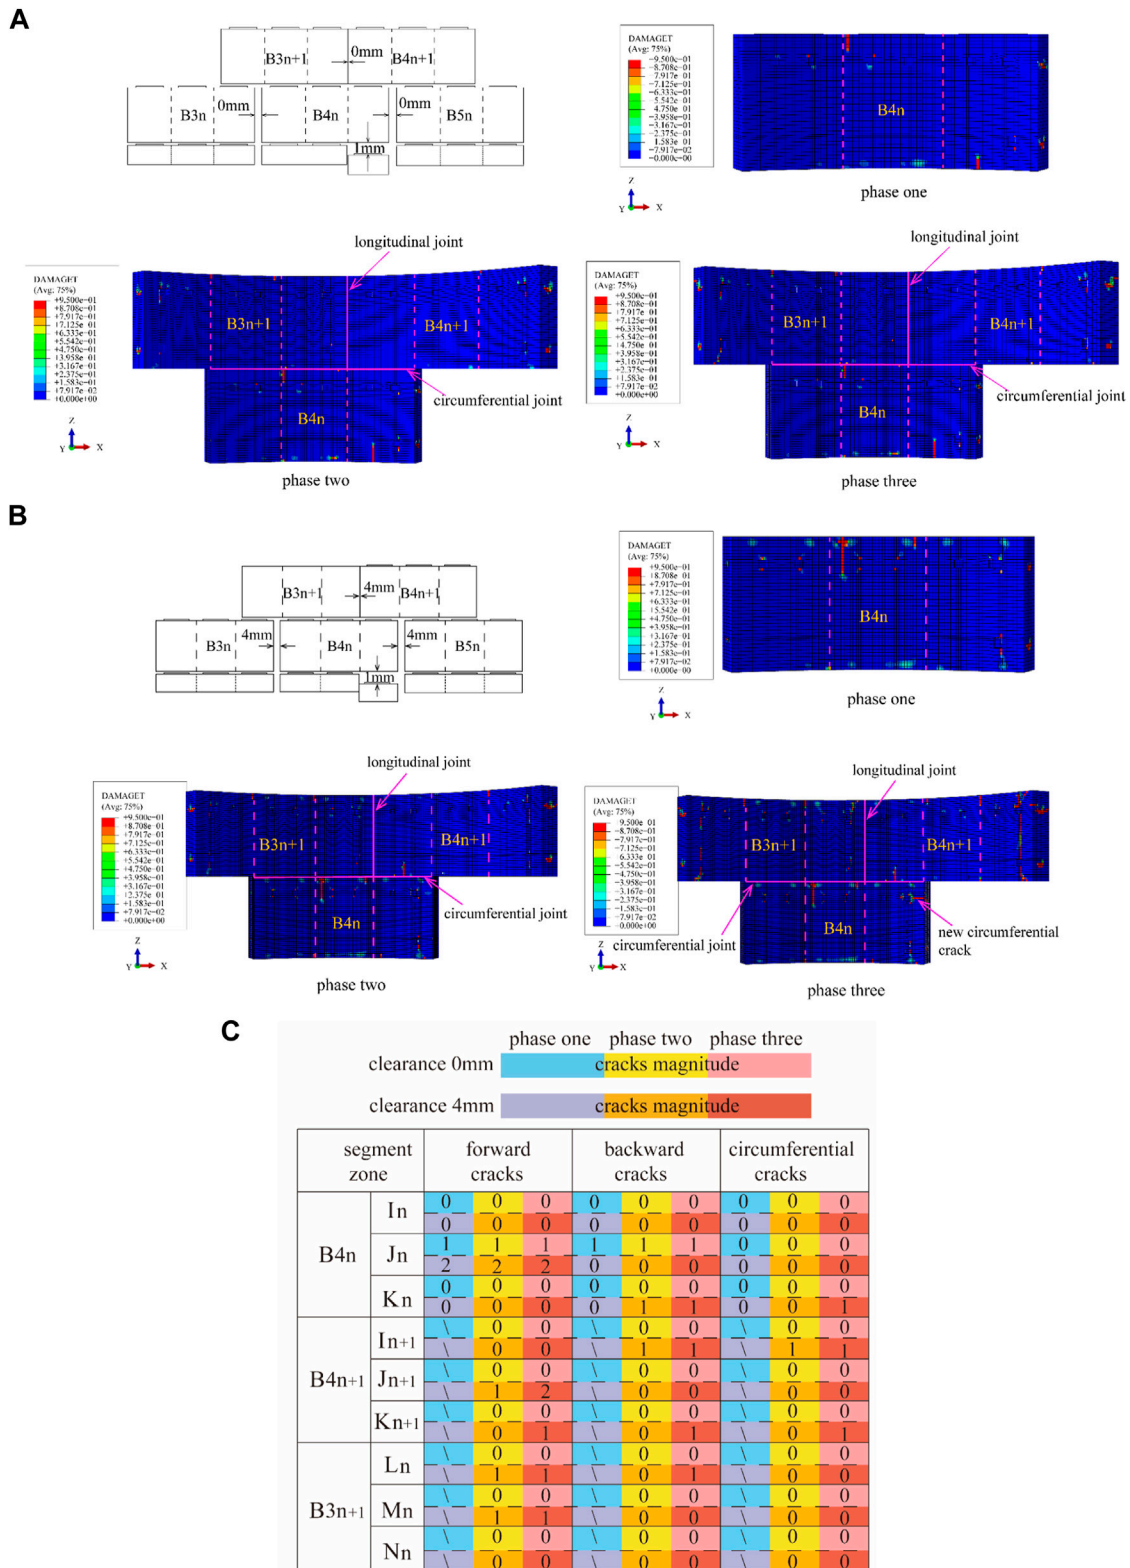
Figure 20 presents the simulation results of a single-ring segment with the presence of uneven longitudinal support. When the assembly clearance was 0 mm, the right end of the B_{4n} segment was deformed in the negative Z-axis direction during the jacking of the n -th segment, causing the tension on the end face and the formation of positive tensile cracks. Moreover, due to friction of the right-side segment and the constraint of the bolts, there was shear at the rear end of the uneven support, which resulted in backward shear cracks. During the jacking of the $(n+1)$ -th segment, the positive cracks did not propagate, the length of the backward crack increased by 150 mm, and there were no cracks in the B_{3n+1} and B_{4n+1} segments. All cracks were formed in the current jacking stage, and the total number of cracks was 2. When the assembly clearance was 4 mm, the maximum length of the positive cracks was 600mm, which was an increase of 350 mm compared to the case of the tense assembly model. Meanwhile, during the last ring jacking stage, two positive tensile cracks developed on B_{4n+1} , one backward shear crack developed on all B_{4n} , B_{3n+1} , and B_{4n+1} and one circumferential tensile crack developed on both B_{4n} and B_{4n+1} the total number of cracks increased to 14.

FIGURE 20 Formation of cracks due to longitudinal dislocation: **(A)** S pedestal dislocation with a longitudinal assembly clearance of 0 mm and **(B)** S pedestal dislocation with a longitudinal assembly clearance of 4 mm **(C)** cracks magnitude of longitudinal dislocation.

- 3) Assembly defects led to positive, backward and circumferential cracks, and most cracks propagated during the subsequent construction process. A proportional of cracks were formed in the last ring jacking stage rather than the current ring jacking. The inverted V-shape longitudinal joint with an was the most severe assembly defect, which caused dense backward cracks in the middle part of B4 segment. The V-shape or inverted V-shape longitudinal joint should be avoided during construction.

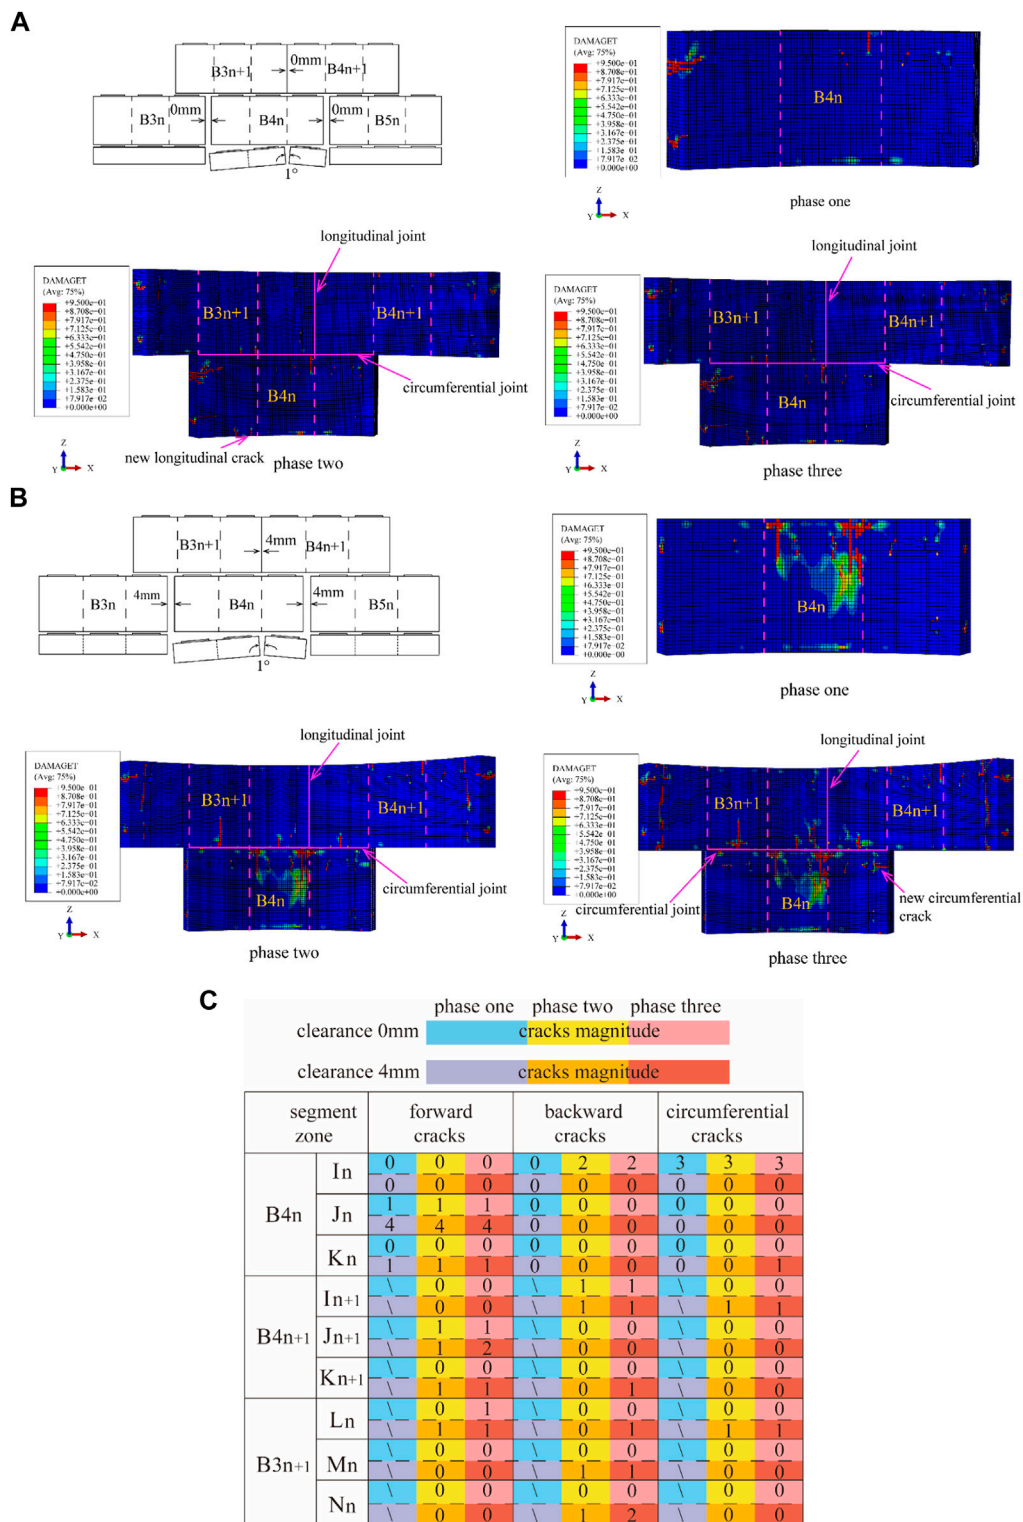
Figure 21 shows the results of a single-ring segment with a V-shaped opening in the longitudinal joint. When the assembly clearance was 0 mm, the front end of B_{4n} was under tension during the jacking of the n -th segment. Consequently, a positive tensile crack formed in the middle segment. The left end of B_{4n} was subjected to the friction from the adjacent segment and the constraint from the bolts during deformation, which resulted in a circumferential tensile crack. During the jacking of the $(n+1)$ -th segment, there was a clearance between B_{4n} and pedestal H, and the left end of B_{4n} continued to deform in the negative Z-axis direction. Due to frictional constraint at the left end, the length of the circumferential crack increased by 300 mm, and a new backward shear crack generated at the rear of B_{4n} . The total number of cracks was 9. When the assembly clearance was 4 mm, the both ends of B_{4n} were only constrained by the bolts, and the deformed in the negative Z-axis direction and were in contact with pedestals S and H. The maximum length of the positive cracks was 850mm, whereas in the tense assembly model the length was only 300 mm. Meanwhile, during the last ring jacking stage one positive tensile crack developed on B_{4n+1} , one backward shear crack developed on B_{4n+1} , two backward shear crack developed on B_{3n+1} , and one circumferential tensile crack developed on B_{4n} , the total number of cracks increased to 18.

FIGURE 21 Formation of cracks due to V-shaped longitudinal joint: (A) S and H pedestals with inverted V-shapes and a longitudinal assembly clearance of 0 mm and (B) S and H pedestals with inverted V-shapes and a longitudinal assembly clearance of 4 mm (C) cracks magnitude of longitudinal joint V-shaped.

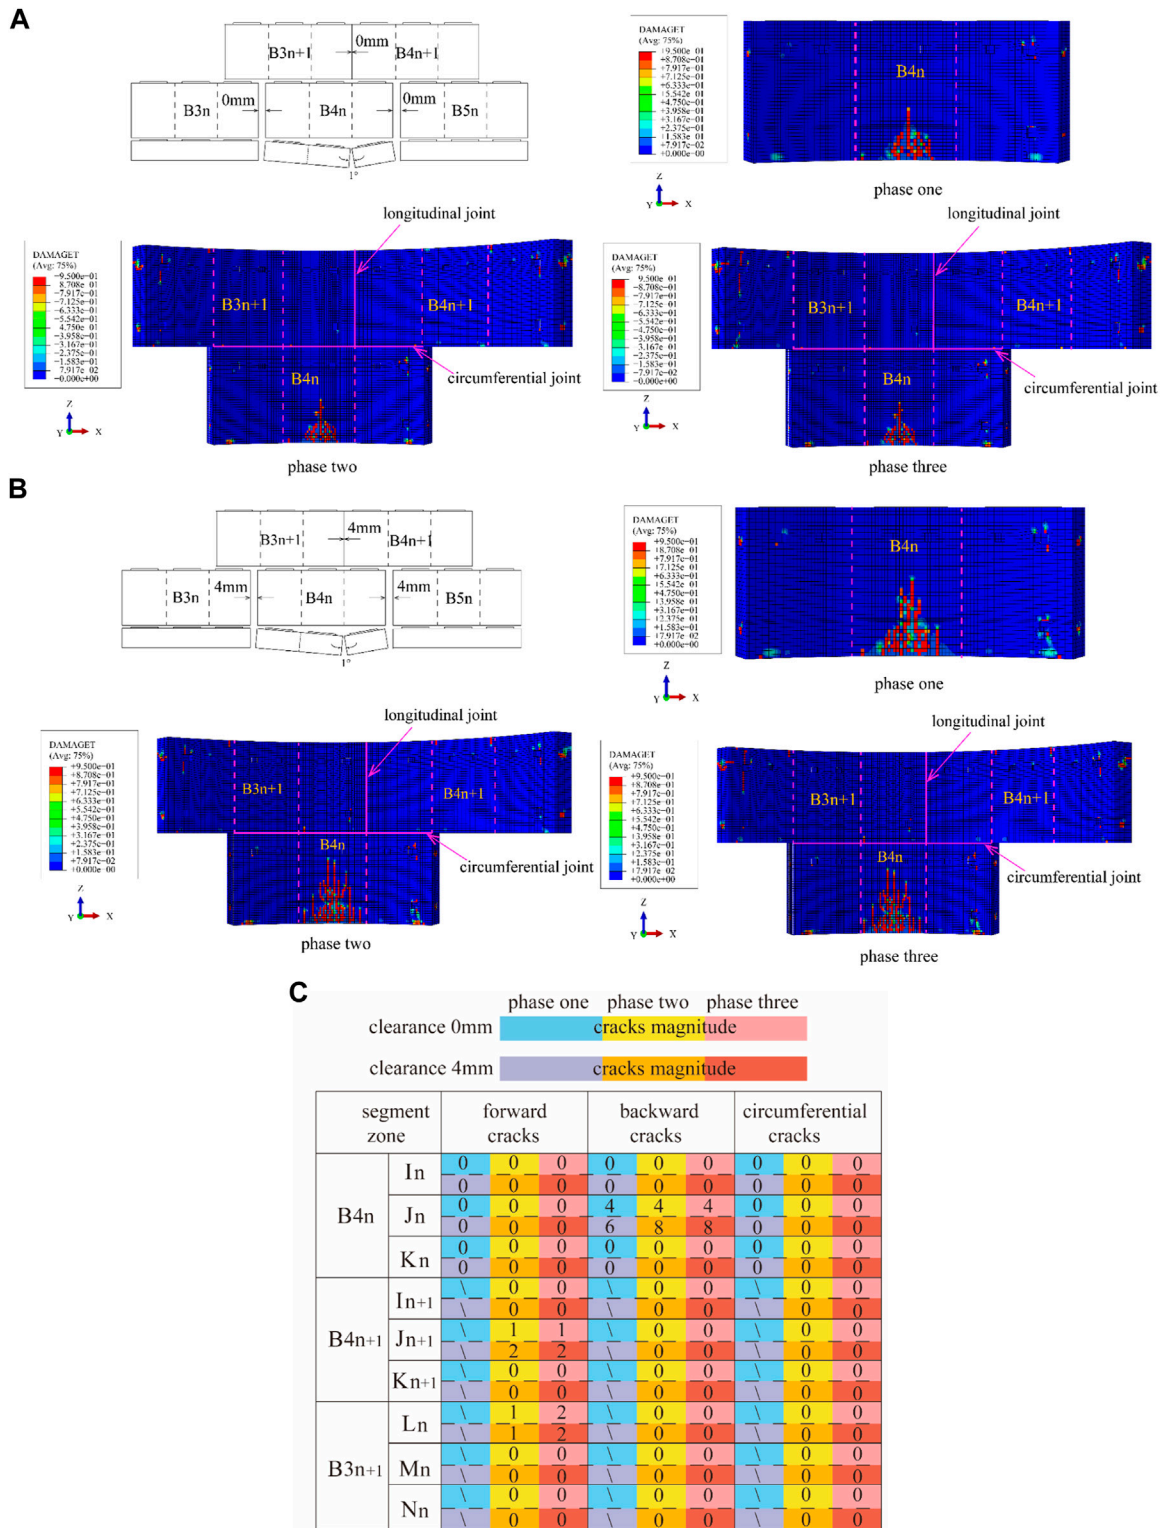
Figure 22 presents the results of a single-ring segment with an inverted V-shaped opening in the longitudinal joint. When the assembly clearance was 0 mm, B_{4n} was a simply supported beam that was restrained at both ends during the jacking of the n th segment. The rear end was under tension, so that multiple longitudinal shear and tensile cracks formed in the middle part of the segment. During the jacking of the $(n+1)$ -th segment, the backward crack did not propagate and there were no cracks developed on the B_{3n+1} and B_{4n+1} segments due to the friction constraints on both ends of B_{4n} . One positive tensile crack on B_{3n+1} occurred in the last ring jacking stage, and the total number of cracks was 7. When the assembly clearance was 4 mm, the length of the backward crack during jacking of the n -th segment was 250 mm longer than that when the assembly clearance was 0 mm due to the lack of friction constraints. The maximum length of the backward tensile crack was 1300 mm, while in the tense assembly model the length was 700 mm. Meanwhile, one positive tensile crack on B_{3n+1} and two backward shear cracks on B_{4n} formed in the last ring jacking stage, the total number of cracks increased to 12.

FIGURE 22 Formation of cracks due to longitudinal joint with inverted V-shape: **(A)** S and H pedestals with inverted V-shapes and a longitudinal assembly clearance of 0 mm and **(B)** S and H pedestals with inverted V-shapes and a longitudinal assembly clearance of 4 mm **(C)** cracks magnitude of longitudinal joint with inverted V-shape.

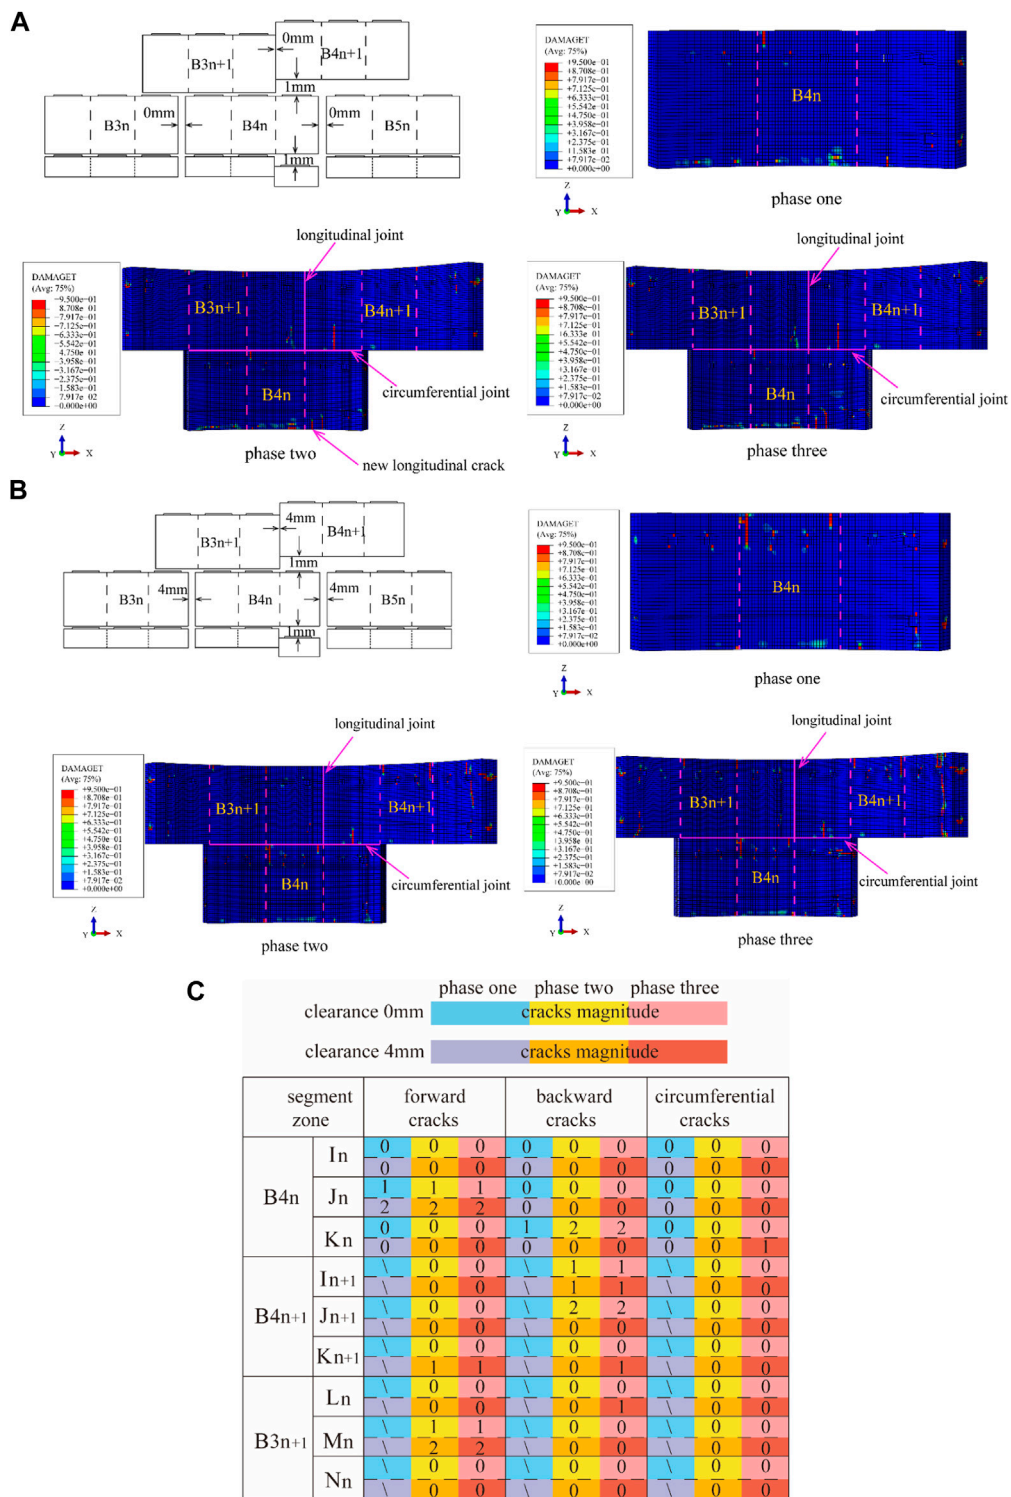
Figure 23 shows the segment cracks formed due to the continuous uneven support. Compared with Figure 20, when the assembly clearance was 0 mm, the front and rear rings on the right end of B_{4n} were not sufficiently restrained during the jacking of the $(n+1)$ -th segment. The pressure on the segment led to the shear on the uneven platform and a new backward shear crack was formed. The left end of B_{4n+1} was deformed in the negative Z-axis direction, and one backward shear crack was generated due to the friction of the B_{3n+1} segment and the constraint of the bolts. One backward shear crack on B_{3n+1} occurred in the last ring jacking stage and the total number of cracks was 7. When the assembly clearance was 4 mm, the maximum length of the positive tensile crack was 500 mm, while in the tense assembly model the length was 200 mm. Meanwhile, one positive tensile crack developed both on B_{3n+1} and B_{4n+1} , and one circumferential tensile crack developed on B_{4n} in the last ring jacking stage, the total number of cracks increased to 12.

FIGURE 23 Formation of cracks due to serial longitudinal dislocation: **(A)** S pedestal and B4n+1 dislocation with a longitudinal assembly clearance of 0 mm and **(B)** S pedestal and B4n+1 dislocation with a longitudinal assembly clearance of 4 mm **(C)** cracks magnitude of serial longitudinal dislocation.
