# Failure analysis on cracking and leakage of 304 stainless steel flange in petrochemical butyl device

**Abstract:** During the pressure test process in a petrochemical butyl device in China, it was found that the 304 stainless steel flange of the ethylene pipeline appeared to be cracking and leakage. This article analyzed the reasons for failure using macroscopic inspection, chemical composition analysis, metallographic structure analysis, scanning electron microscope, energy dispersive spectroscopy, mechanical properties test, and intergranular corrosion test. The results show that the carbon content of the flange base material exceeds the standard, many carbides precipitate at the grain boundary, the material itself is seriously sensitized, and the intergranular corrosion resistance is reduced. At the same time, under corrosive media such as sulfur and chlorine and high stress, the flange displays stress corrosion cracking, which leads to cracking and leakage failure. This article reports the reasons for the failure of the flange, and some reasonable suggestions are put forward to avoid similar leakage accidents.

There is an actual instance of cracking and leakage failure of 3

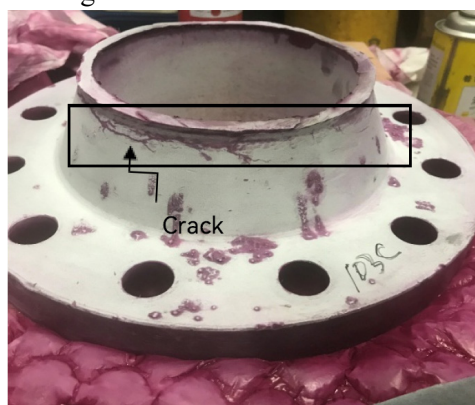
Firstly, the failure flange was observed macroscopically, and the macroscopic failure characteristics of the failure flange were mastered, which laid a good foundation for the subsequent experimental analysis. Figure 1 and Figure 2 are the macroscopic of flange crack morphology. Macro-inspection indicates no obvious corrosion on the inner and outer surfaces. The cracks are distributed along the circumference of the flange neck in a zigzag and intermittent way, almost parallel to the weld. The cracks on the outer surface of the flange neck are extended in a full circle along the circumferential direction, and some of them have penetrated. Besides, it is displayed that the crack gap on the outer surface is larger than on the inner surface. Considering that the crack position is not only a structural discontinuity but also a weld heat-affected zone with high-stress characteristics, it can be judged from the foregoing phenomena that the cracks originate from the outer surface and extend to the inner surface.

**Figure 1.** External crack morphology of flange.

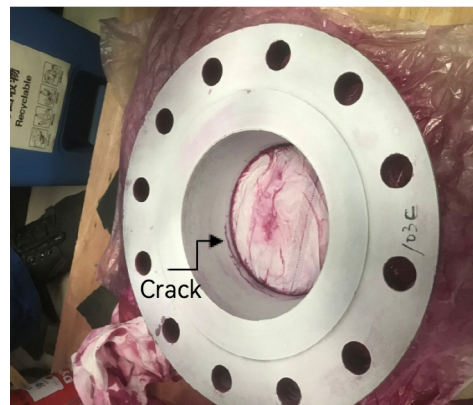
**Figure 2.** Morphology of internal cracks in flange.

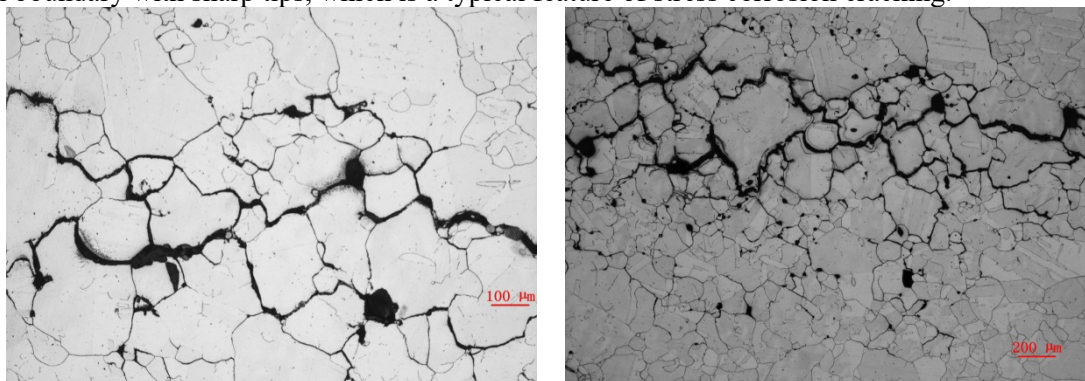
Metallographic analysis was carried out to observe the microstructure characteristics of the crack. Figure 3 displays the microscopic metallographic morphology of flange cracks. It can be seen the microstructure is austenite, and there are twins and granular carbides distributed in the grain, which leads to a significant electrochemical property difference between the grain and the grain boundary. Besides, the cracks display dendritic morphology with obvious trunk and branches and spread along the grain boundary with sharp tips, which is a typical feature of stress corrosion cracking.

**Figure 3.** Microscopic morphology of cracks.

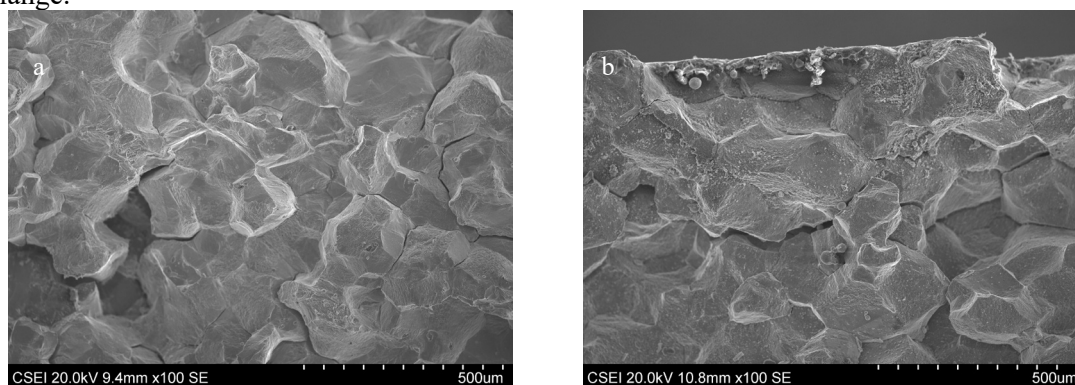
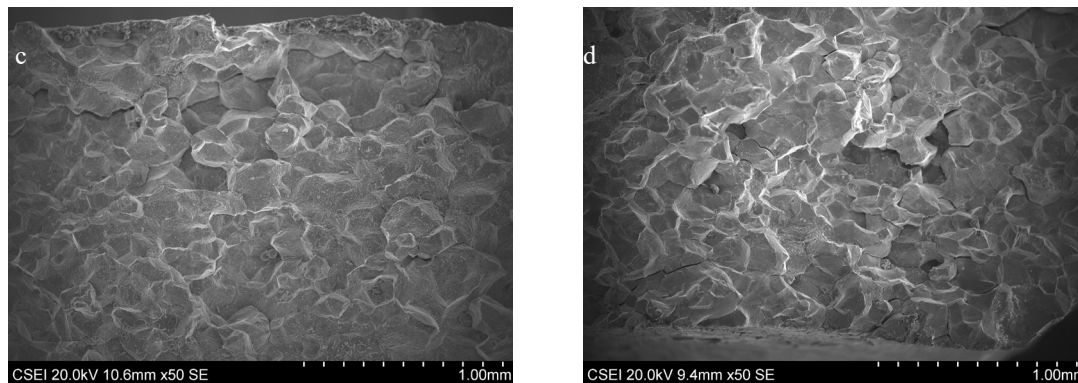
SEM and EDS were used to analyze the crack position of the flange, and the micro-morphology characteristics of the crack position were observed. The corresponding corrosion element information was found. As shown in Figure 4, the fracture surface of the flange was further observed with SEM. The results illustrate that the fracture surfaces have a polyhedral feature and crystalline grains are angular and smooth to show a typical rock sugar shape. The results reveal that the flange cracking is an obvious intergranular fracture. Table 2 exhibits the energy spectrum analysis results of the corrosion products on the fracture surface. Compared with the chemical composition result in Table 1, the contents of chlorine and sulfur increase significantly, respectively, at 3.02% and 0.49%. This may be attributed to the fact that there are many corrosive elements in the industrial environment, and the increase in sulfur and chlorine content is related to the exposed contact between the flange and the atmospheric environment. The increase of chloride and sulfur contents will destroy the passive film formed on the grain boundary, resulting in intergranular corrosion or pitting corrosion and easily causing stress corrosion cracking of the flange.

**Figure 4.** Fracture morphology of flange.

Energy spectrum analysis shows that the corrosion products on the fracture surface contain corrosive elements such as chlorine, sulfur, oxygen and matrix elements such as iron and chromium. The appearance of corrosive elements is related to the direct contact between the flange and the atmospheric environment, the erosion of rain, and the existence of this element in the atmospheric environment of the factory.

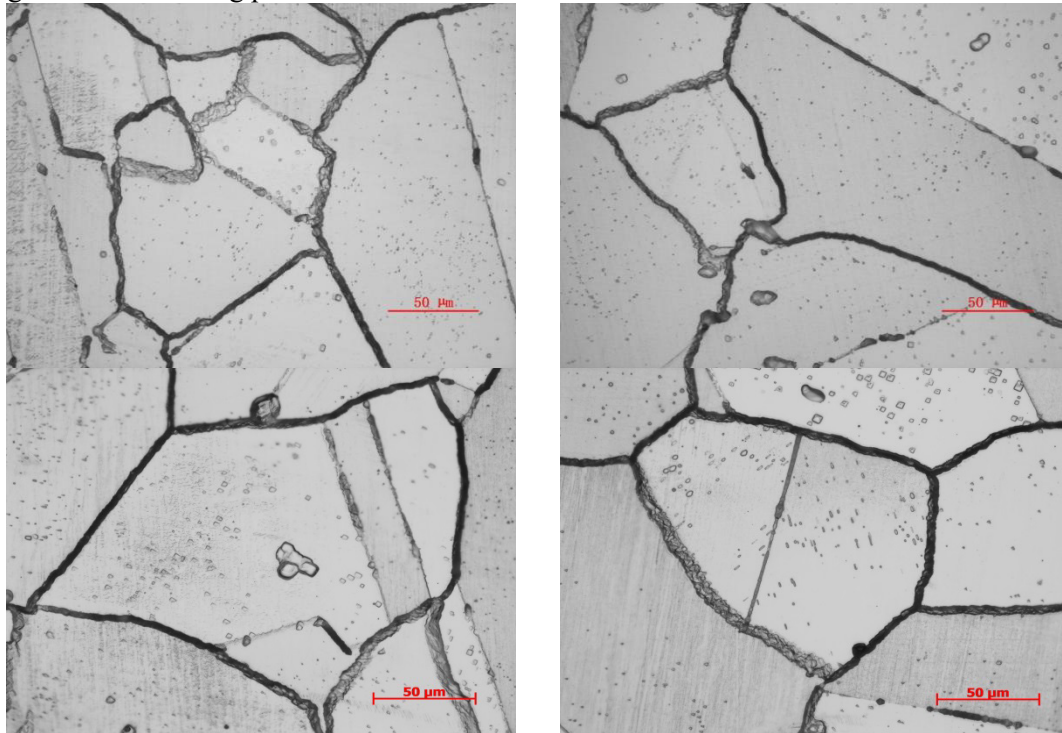
Samples were taken at the crack and the base of the flange, and intergranular corrosion tests were carried out to determine whether the stainless steel material of the flange was sensitized. As indicated in Figure 5, it can be seen that there are a lot of carbides precipitated at the grain boundary accompanied by pitting corrosion, and corrosion grooves surround some grains. According to GB/T 4334-2020, it can be judged as three types of groove structure, and the material itself is seriously sensitized. The possible

reasons for sensitization may be that the flange has not been treated by a solid solution process before leaving the manufacturing plant.

**Figure 5.** Morphology of intergranular corrosion.

The above process is further validated by the results of the intergranular corrosion test, which shows that the flange material itself has been seriously sensitized. The occurrence of sensitization leads to a significant difference in electrochemical performance between the chromium-poor region and the crystal grain itself, which further forms an activated-passive battery with great potential difference between the chromium-poor region (anode) and the substrate (cathode). The chromium-poor area at the grain boundary is rapidly corroded with corrosive media such as sulfur and chlorine combined in the atmospheric environment. Consequently, the intergranular bonding force is significantly weakened, and the grain boundary's mechanical strength and intergranular corrosion resistance are significantly reduced [12-14].

Based on the above analysis, preventive measures and effective suggestions are provided to avoid recurrence failure for other flanges. Firstly, newly purchased 304 stainless steel flanges should be treated by solution treatment after forging; thus, the carbides dissolve in austenite after heating to 1100-1150°C, and then they are rapidly cooled to obtain a single-phase austenite structure. The ultra-low carbon 304L covered electrode is used for welding, such as A002, etc, which can avoid the precipitation of weld carbide during welding. Secondly, the quality of materials can be controlled by

strengthening the supervision of incoming flange materials through related tests, such as chemical composition analysis, metallographic examination, and intergranular corrosion test. Thirdly, the interlayer temperature of weldments should be kept low, preferably not exceeding 150°C. During field welding, the residence time at 450-850°C can be reduced by shortening the heating time, reducing the weld cross-section, reducing the linear energy, and cooling rapidly to avoid the material sensitization caused by welding.
