# T9630-AB-MMD-010

REVISION 3

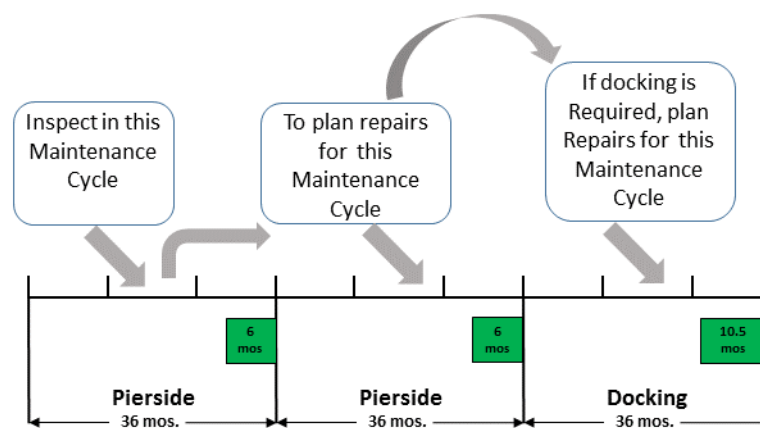
Figure 1-1 Notional Inspection and Repair Planning Cycle

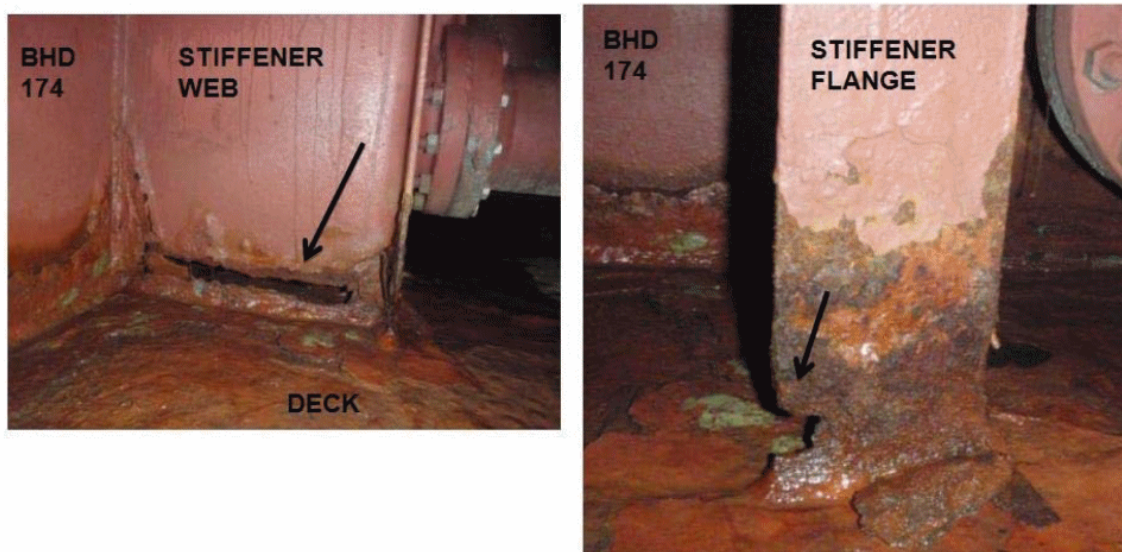
Figure 1-2 Coating Failure and Structural Damage in a Machinery Compartment Bilge Area

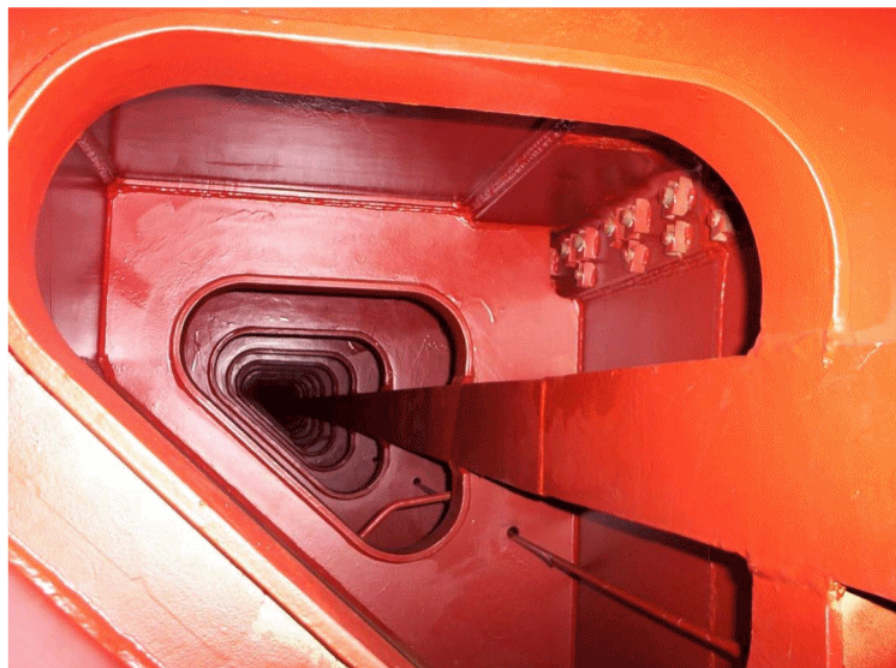
Figure 1-3 Aircraft Carrier Catapult Wing Void

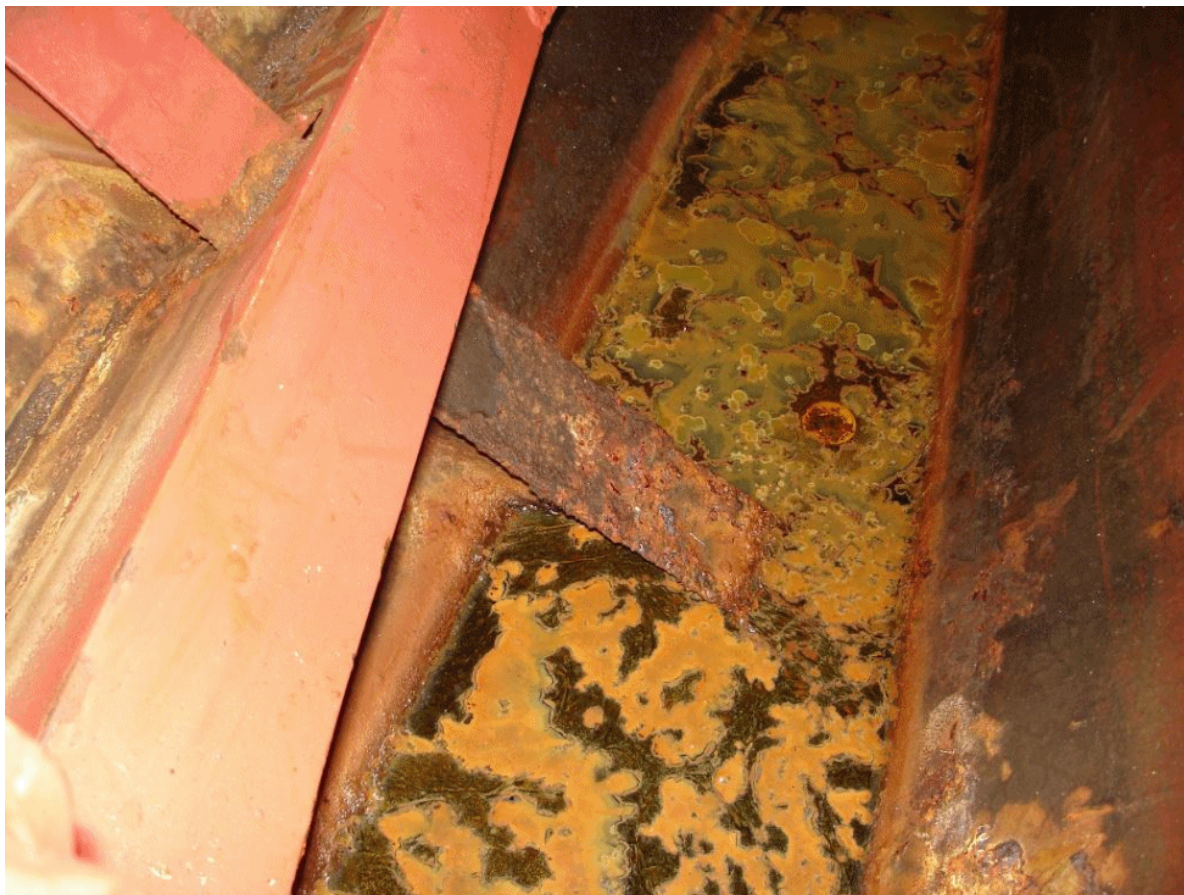
Figure 1-4 Bilge Pocket Obscured by Oily Water and Sludge

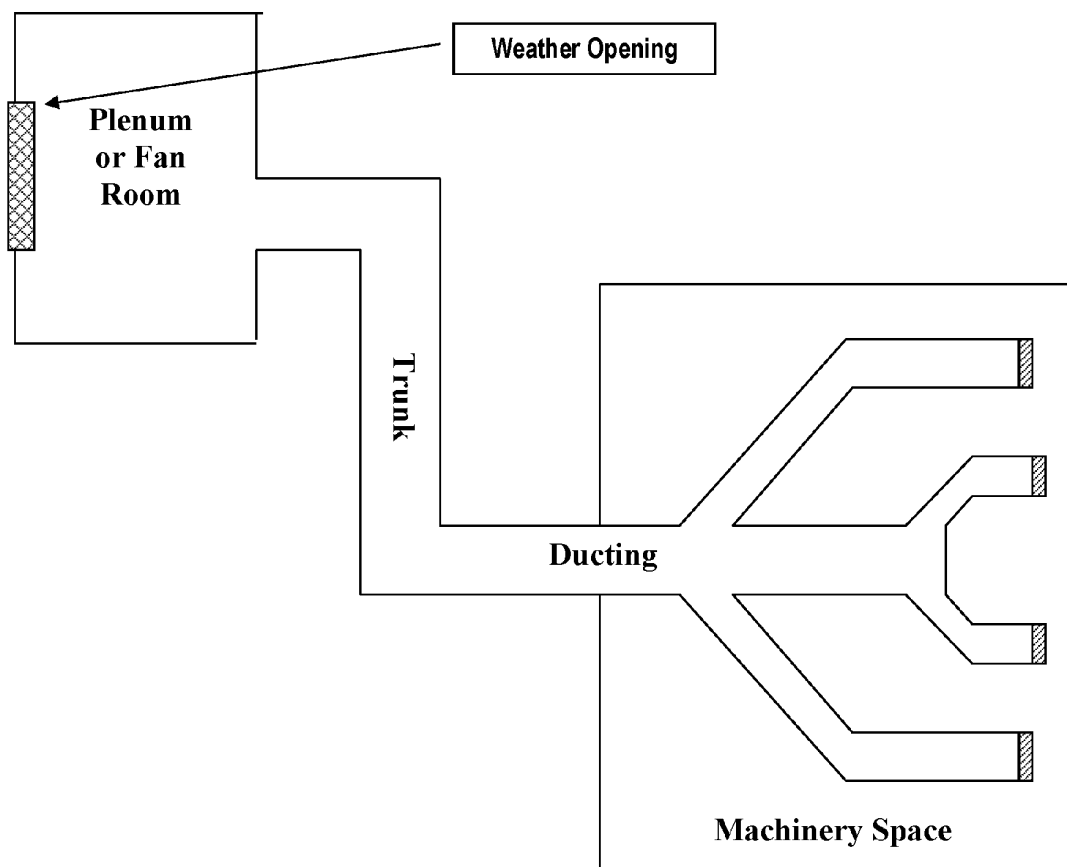
Figure 1-5 Illustration of Typical HVAC System Terminology

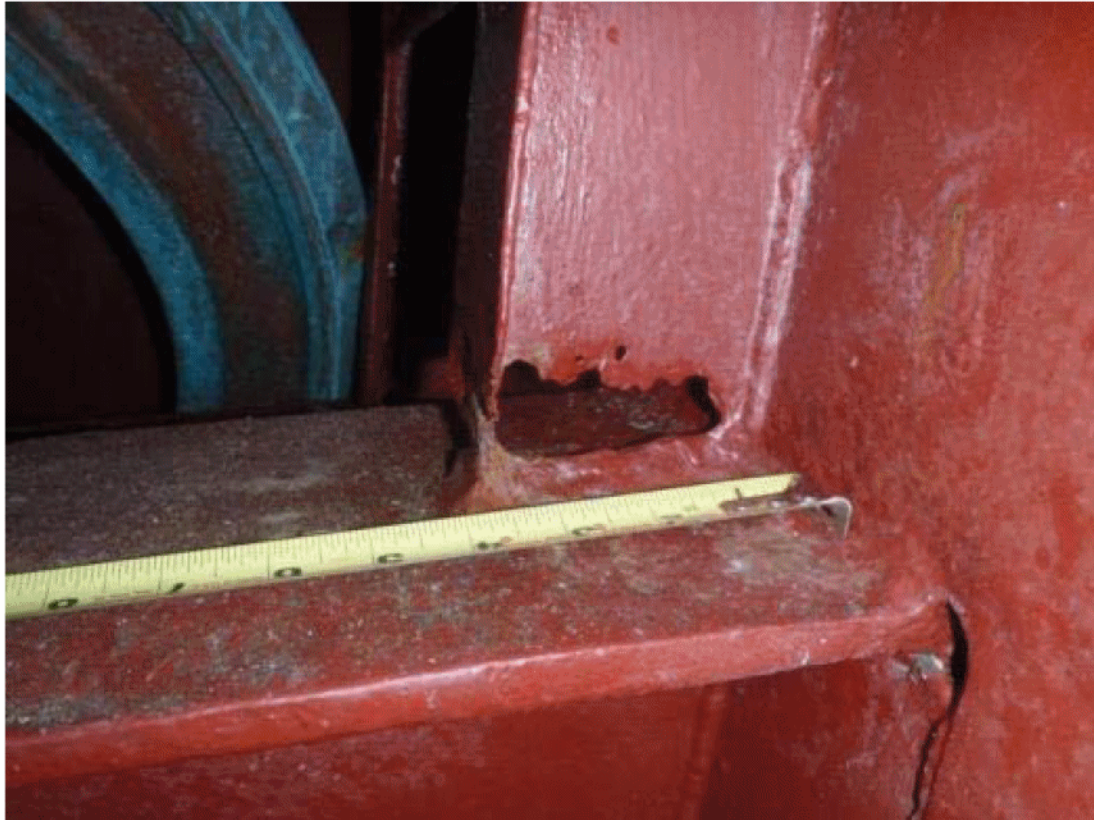
Holed and Painted Vertical Stiffener

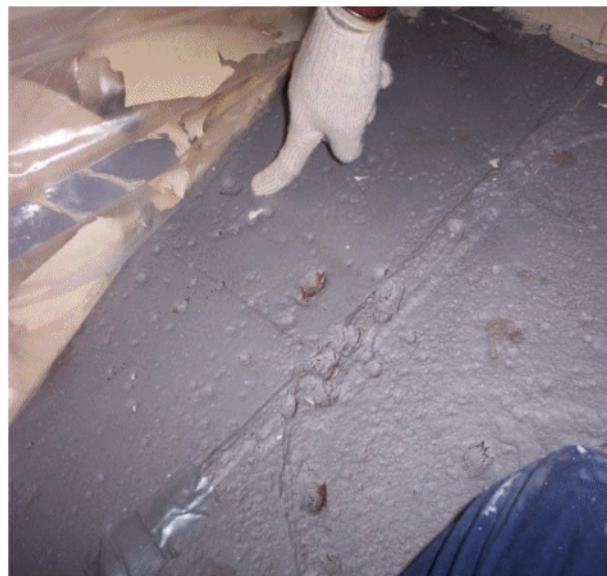
Deeply pitted tank bottom shell plate

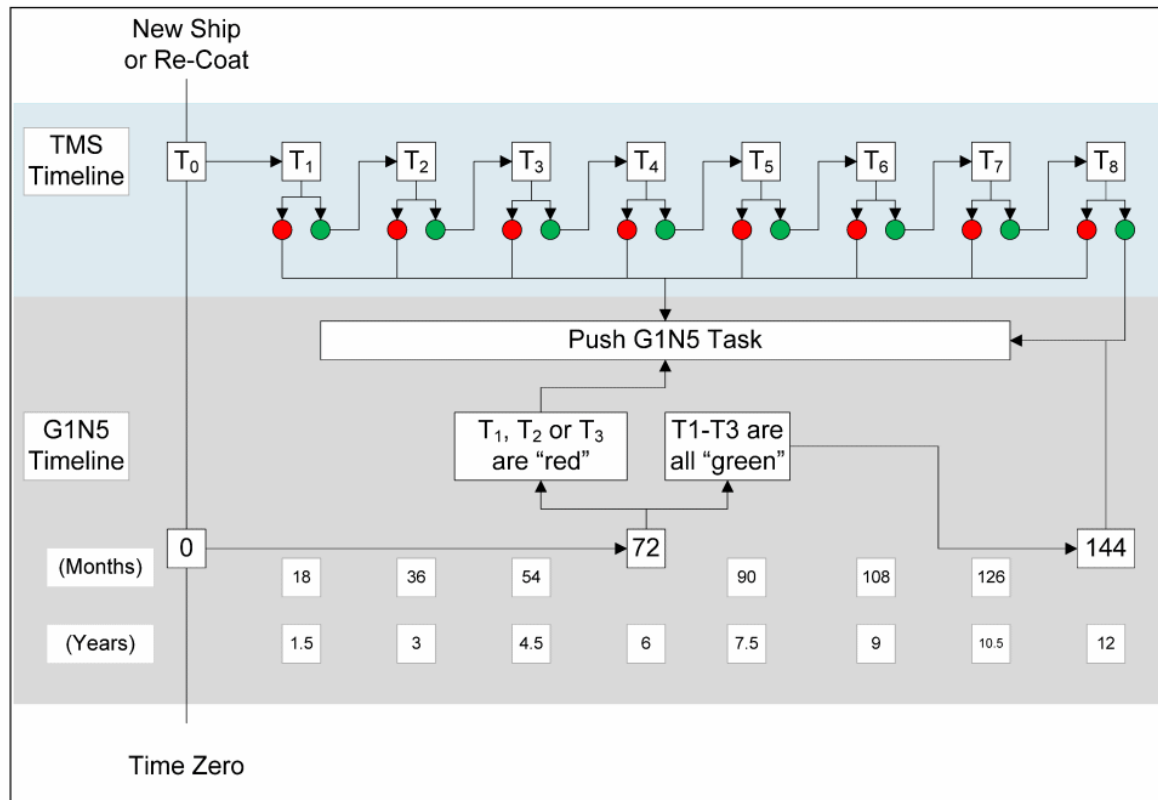
Figure 3-3 TMS Relationship to MRC G1N5 Surveys

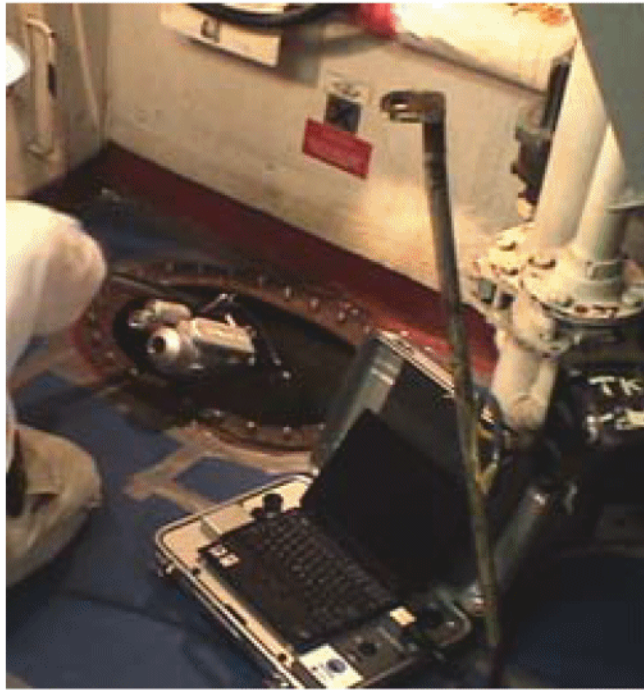
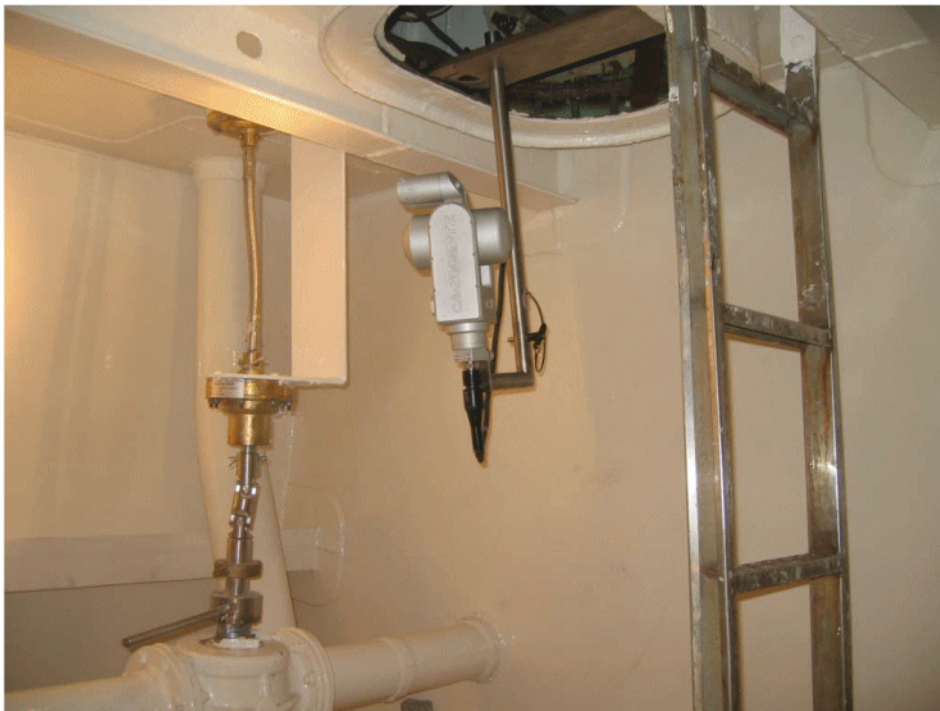
Figure 3-4 Example of ISIS Tank Assessment Without Human Entry

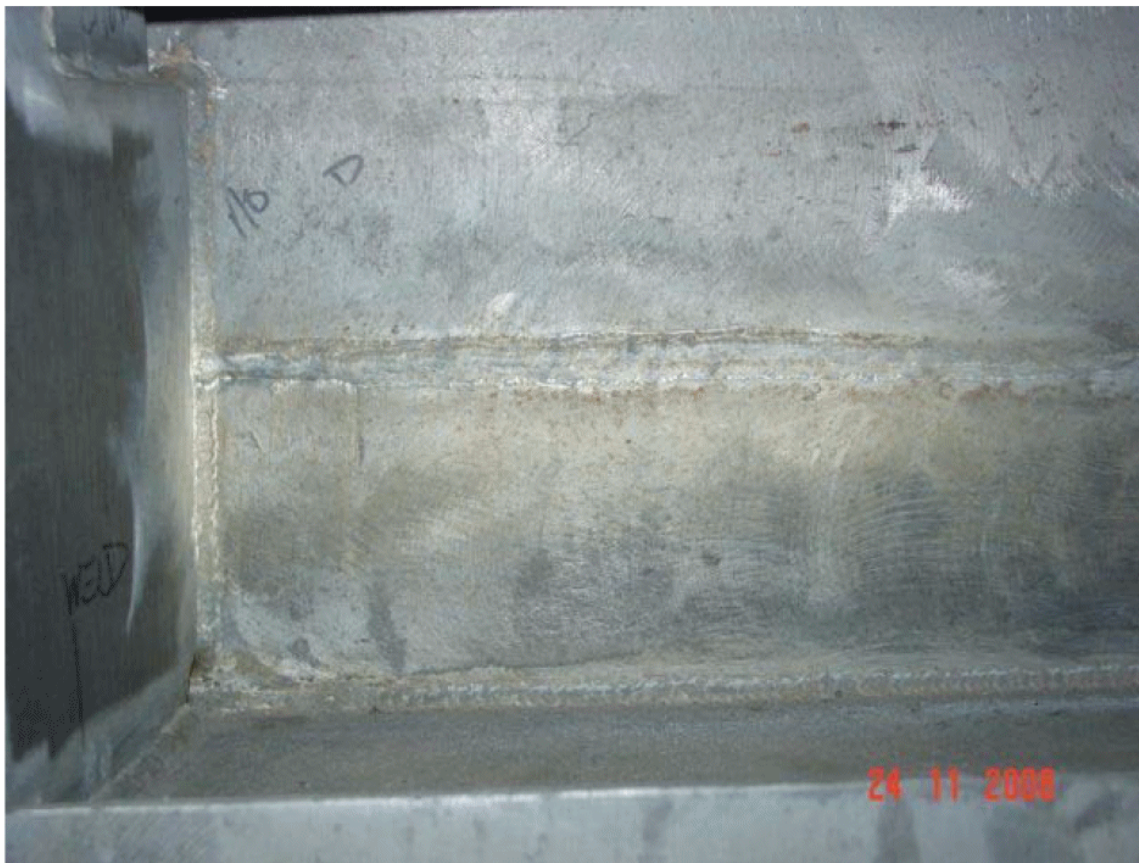
Figure 4-1 Bare Aluminum Water Tank With Acceptable Oxidation

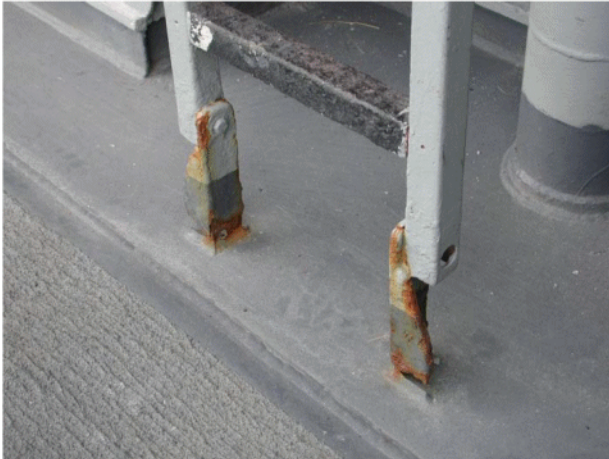
GRP Ladder and Steel Supports

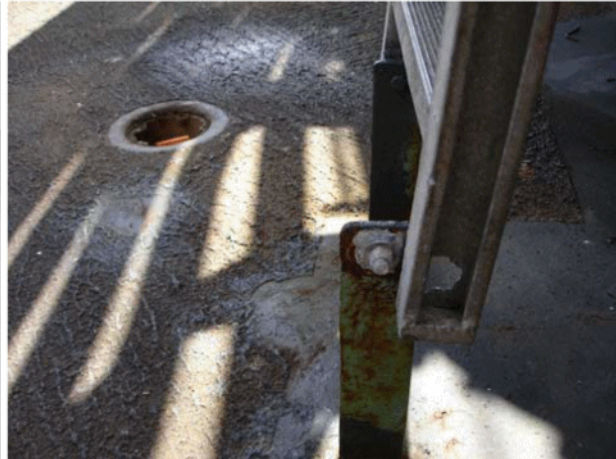
Aluminum Ladder and Steel Supports

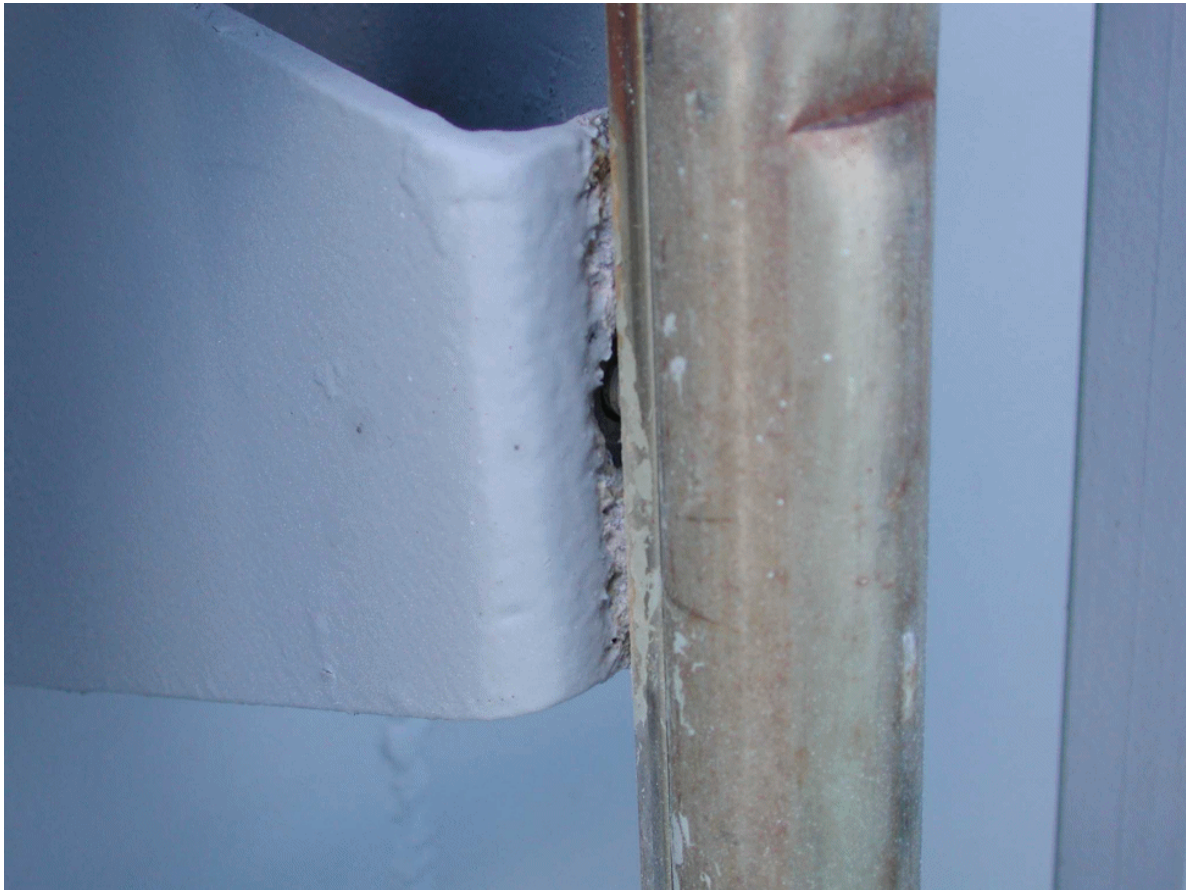
Figure 4-4 Corrosion of Aluminum Support for Stainless Steel Climber Safety Rail

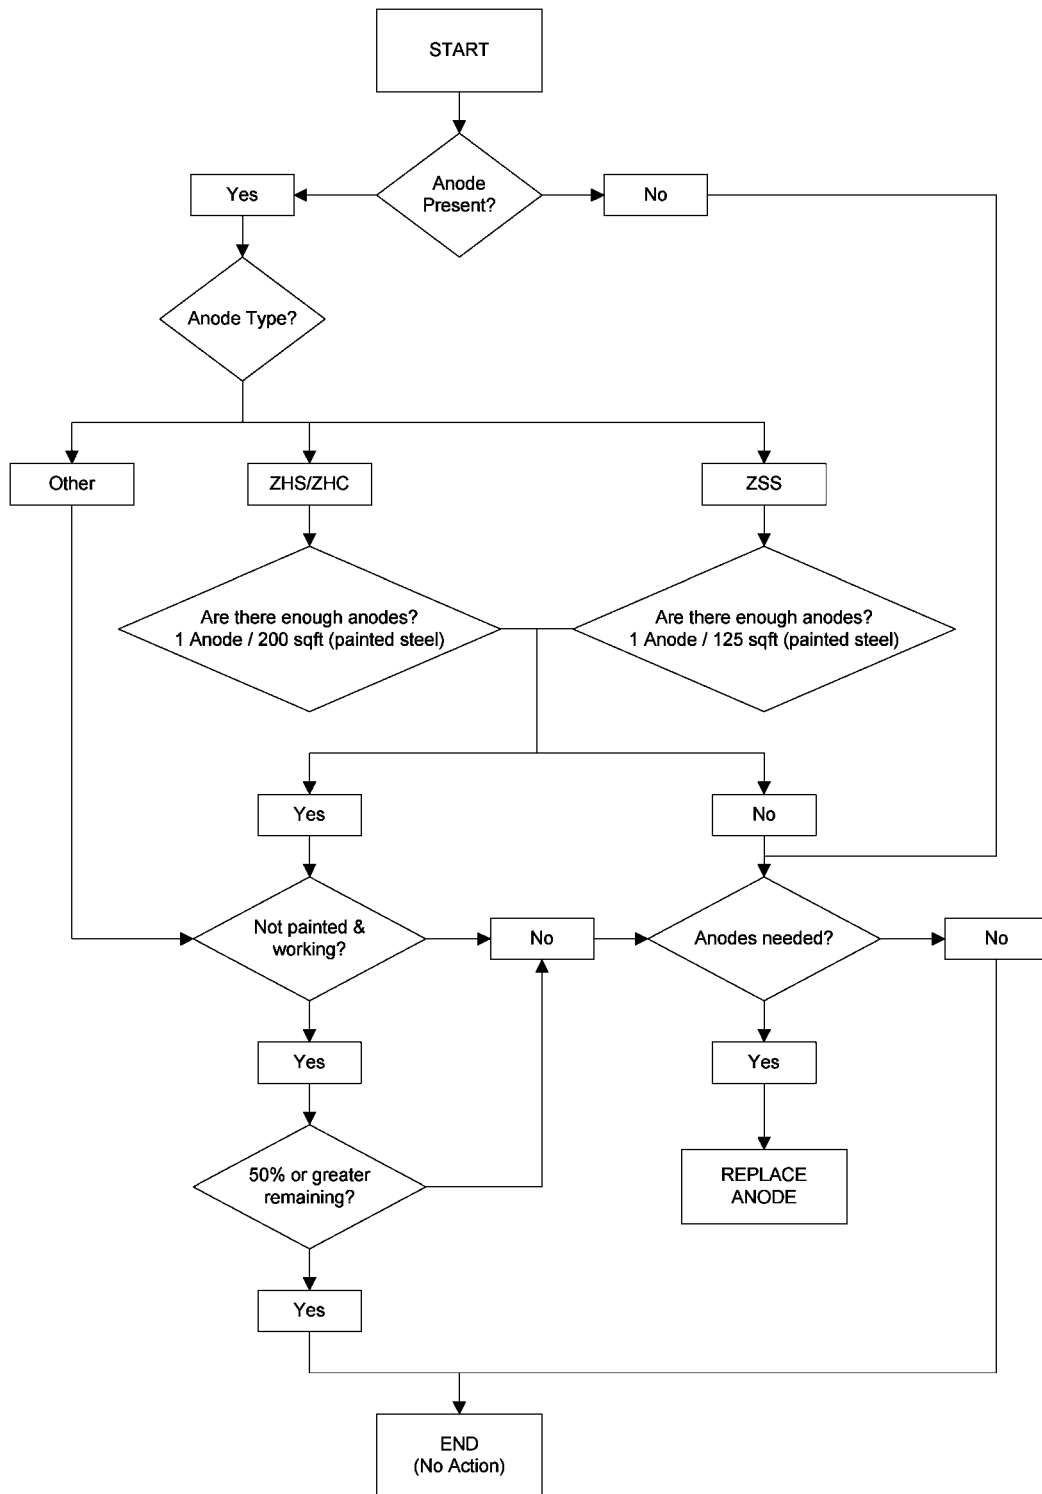
Figure 4-5 Anode Assessment Flow Chart

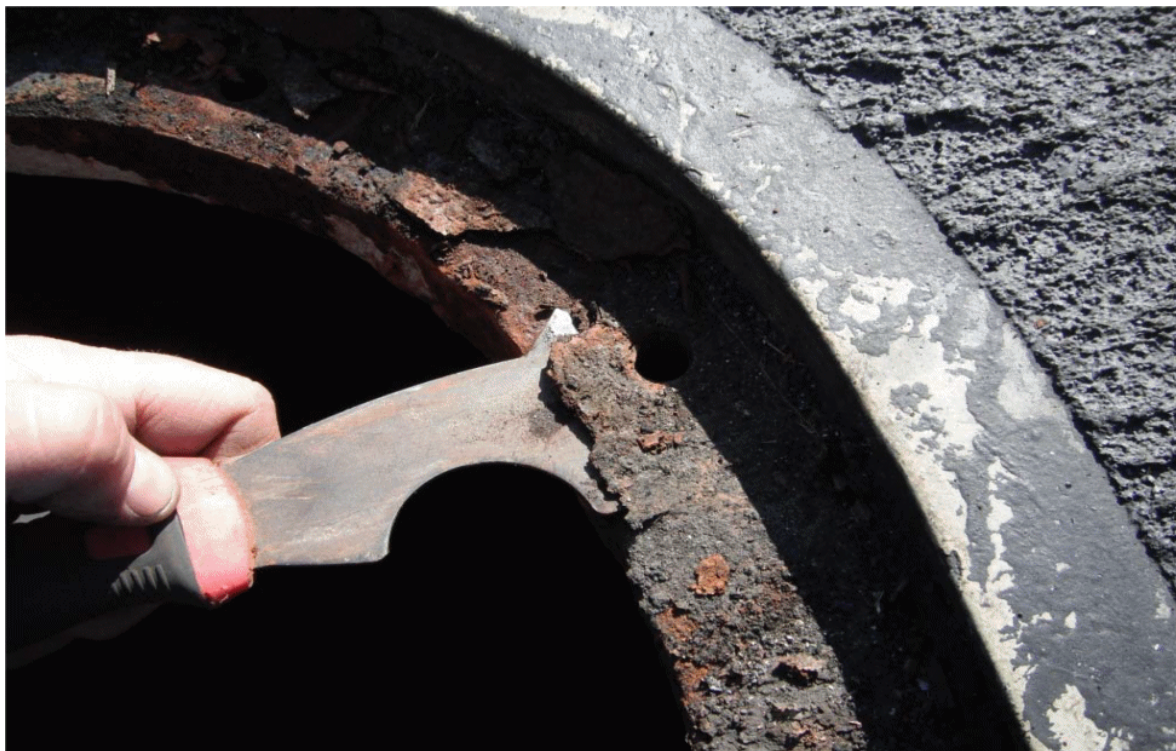
Figure 4-6 Heavy Rust Scale Of Steel Deck Manhole Cover Seating Surface

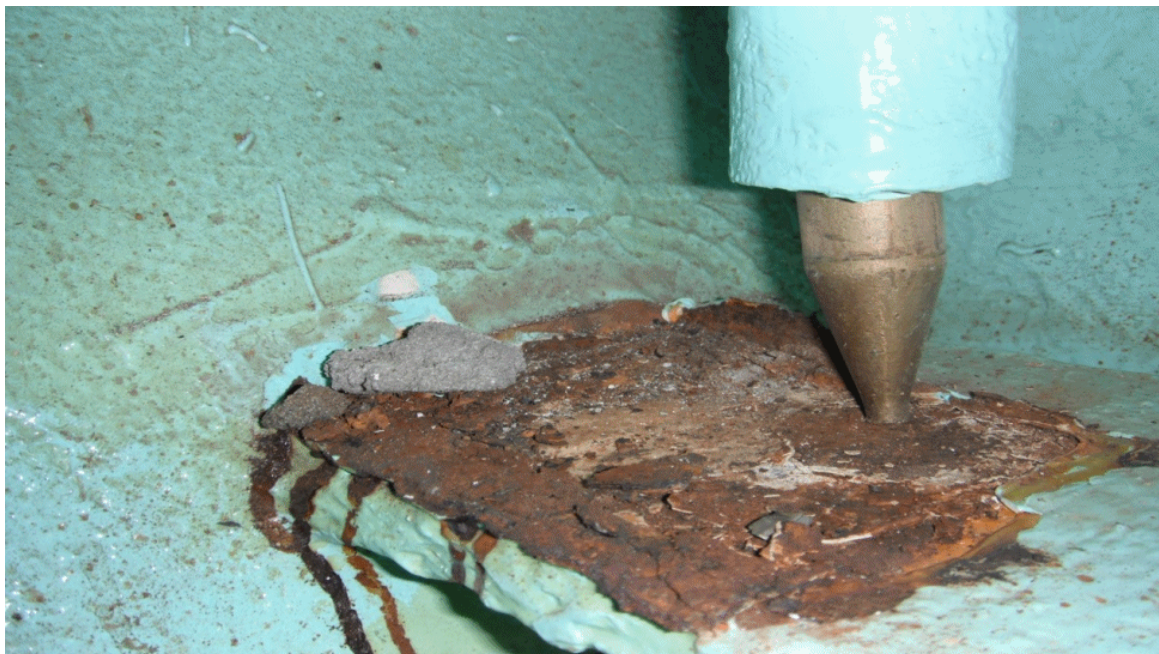
Figure 4-7 Coating Damage and Corrosion of Sounding Tube Bob Striker Plate

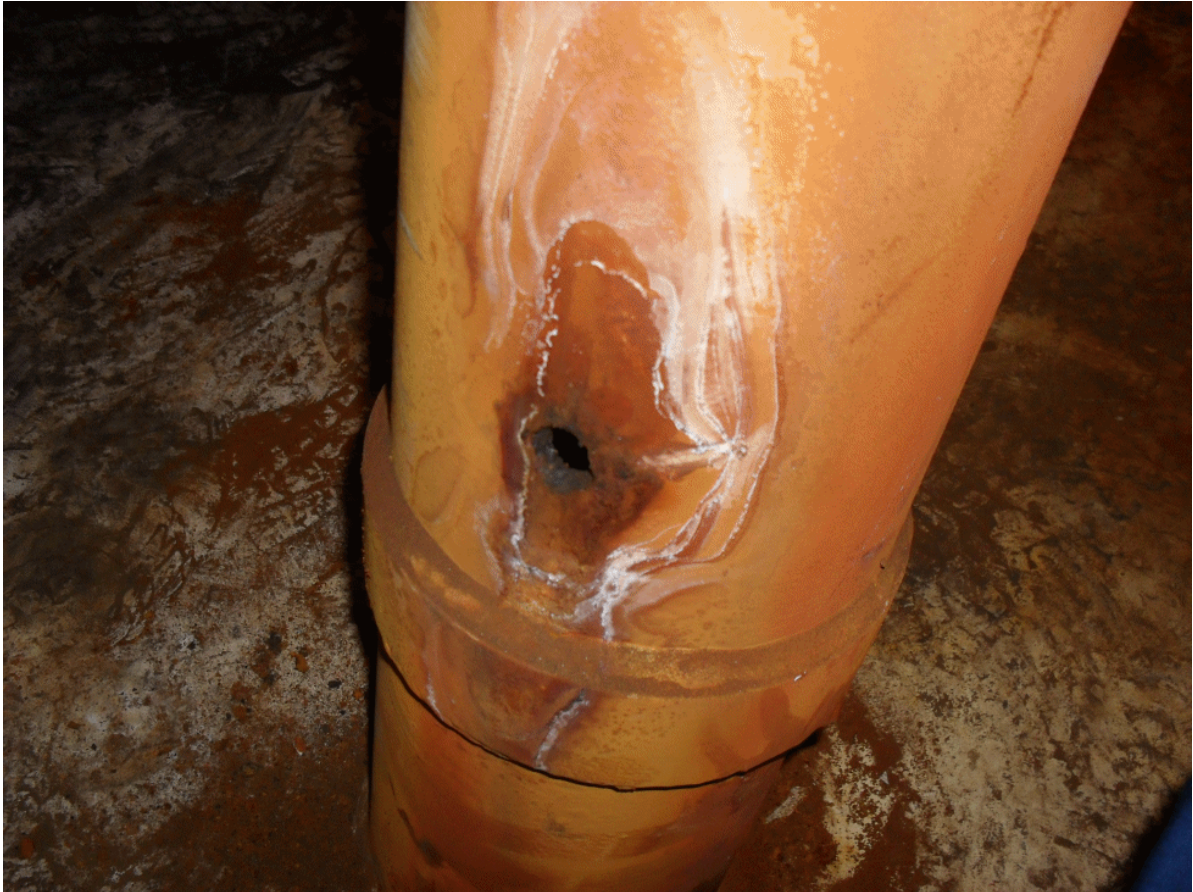
Figure 4-8 Corroded And Holed Degaussing System Conduit In A Tank

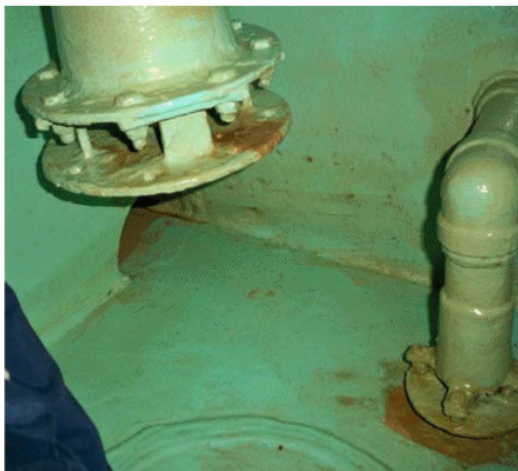
A. Waster Installed On Pipe

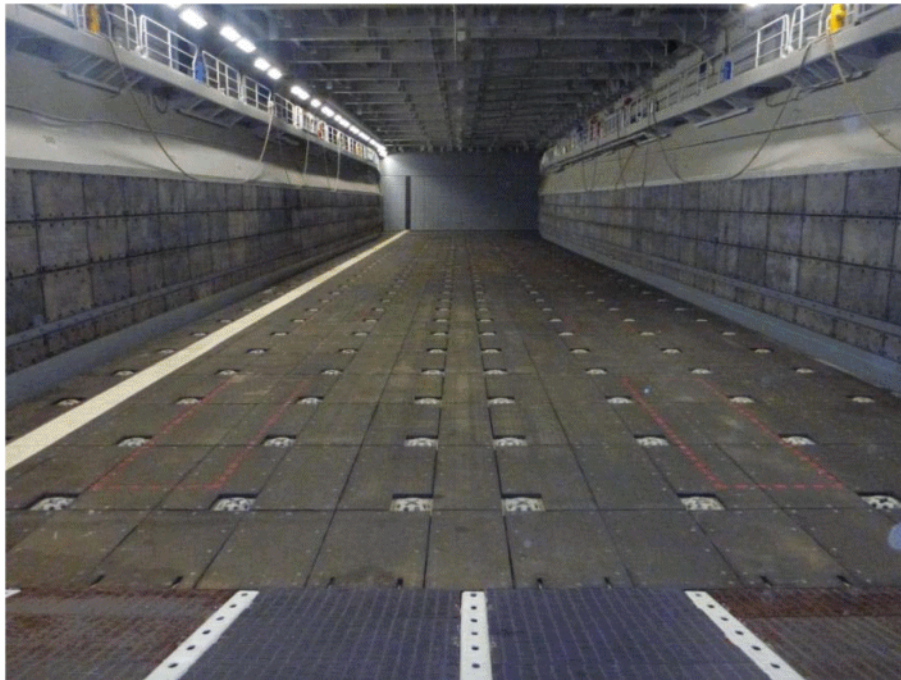
A. Composite Material Beach Boards and Batter Boards in Well Deck

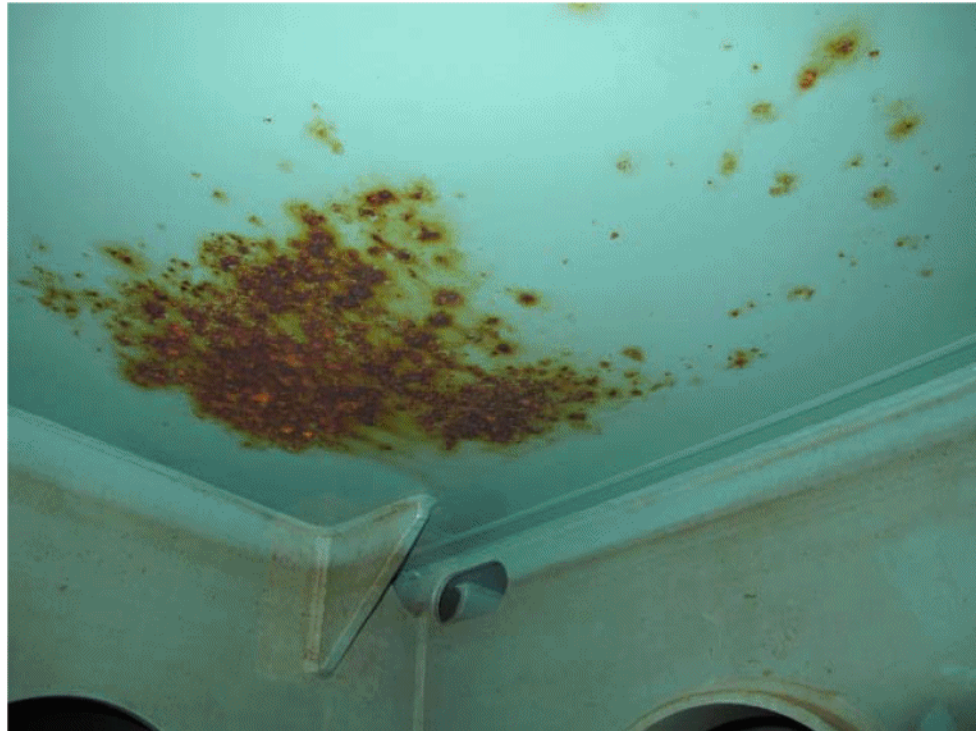
A. Corrosion in ballast tank overhead (tank top) above the waterline

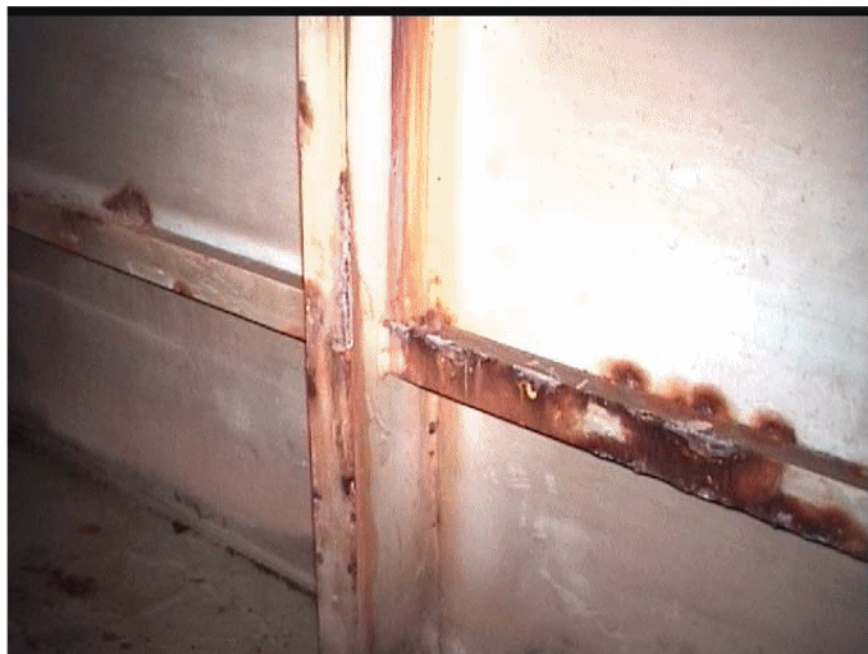
B. Coating failure initiated at stiffener edges and welds

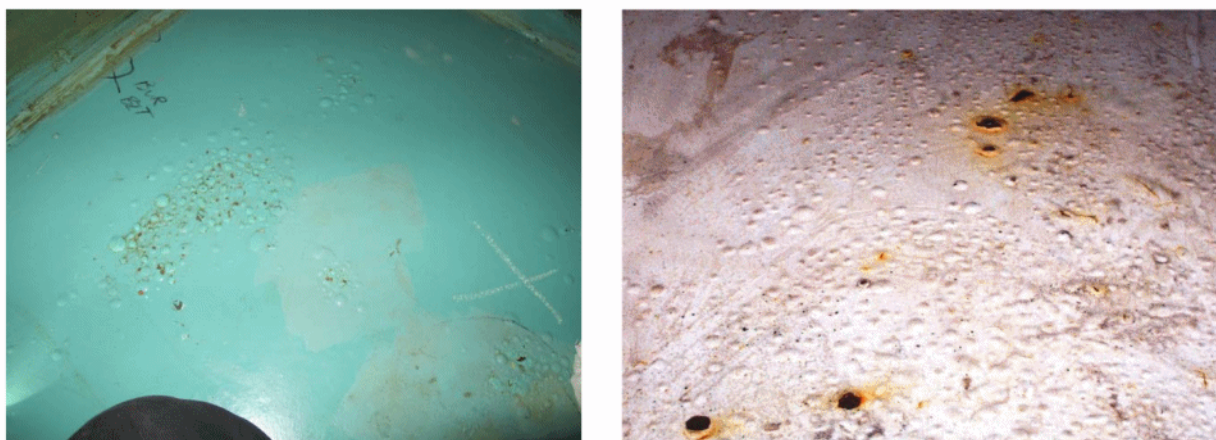
Figure 4-13 Examples of Osmotic Blistering Found in In-Service Tanks

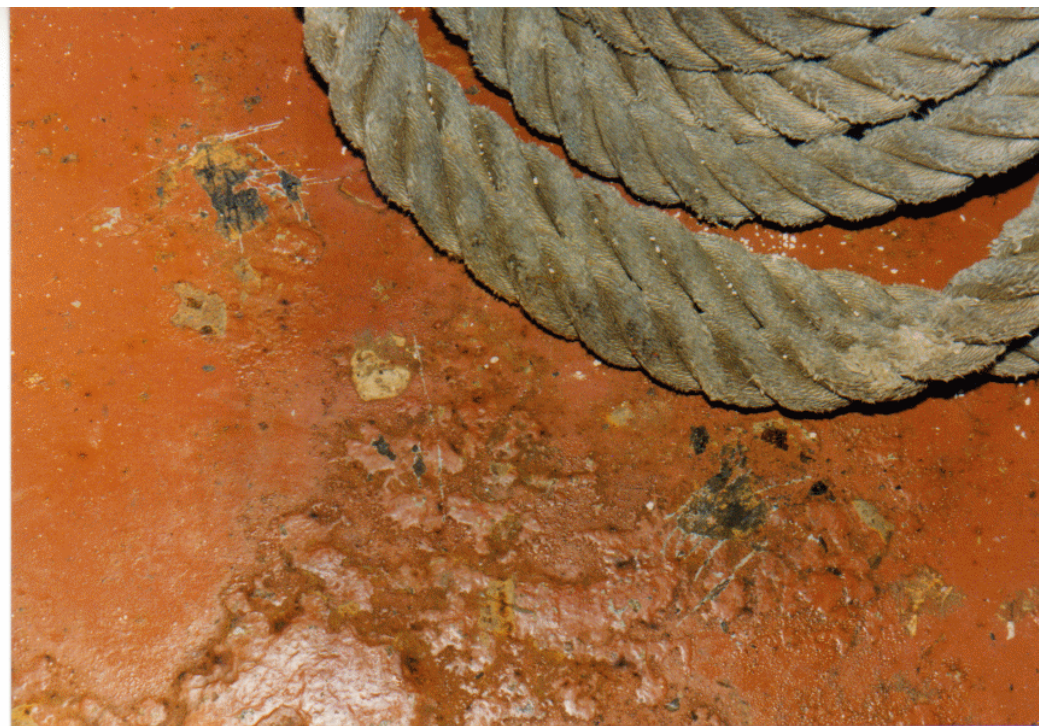
Figure 4-14 Blister-Like Coating Failure Over Rust

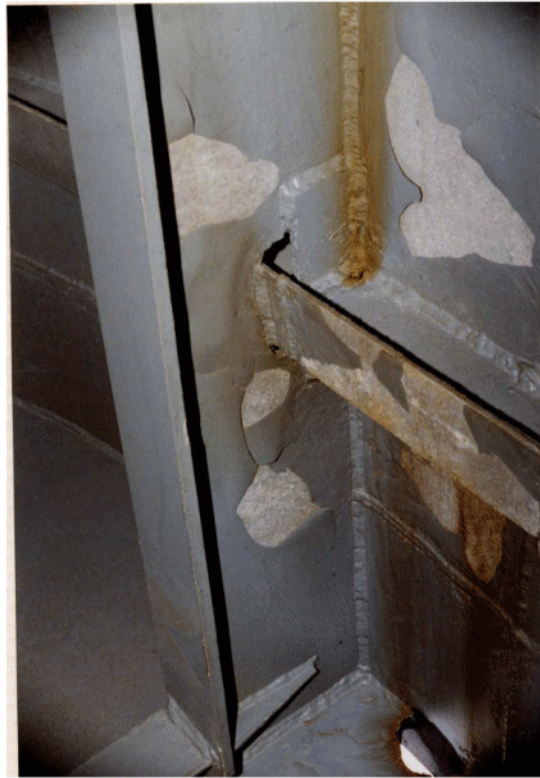
Disbonded Coating on Aluminum Structure

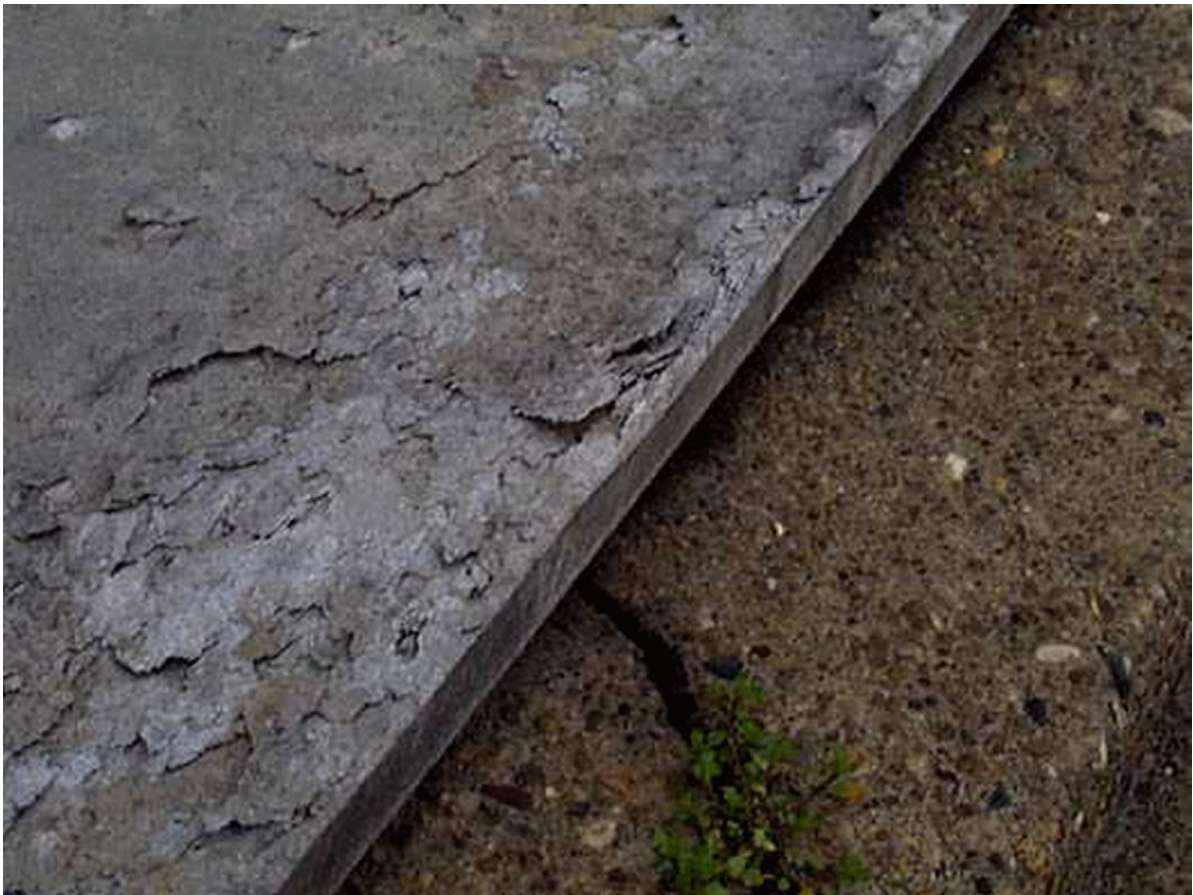
Figure 4-16 Exfoliation Of The Surface Of An Aluminum Plate

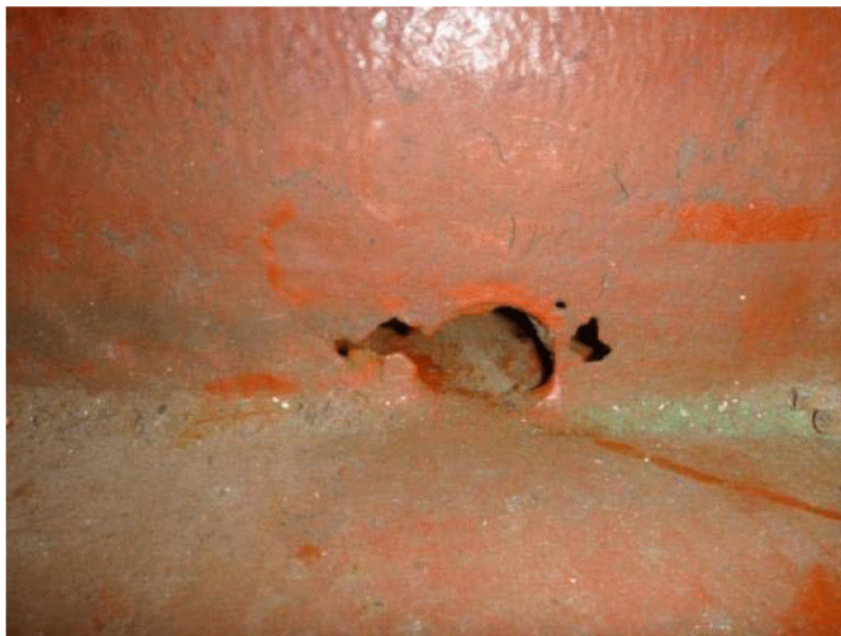
Figure 4-17 Drain Hole in Stiffener Enlarged by Corrosion

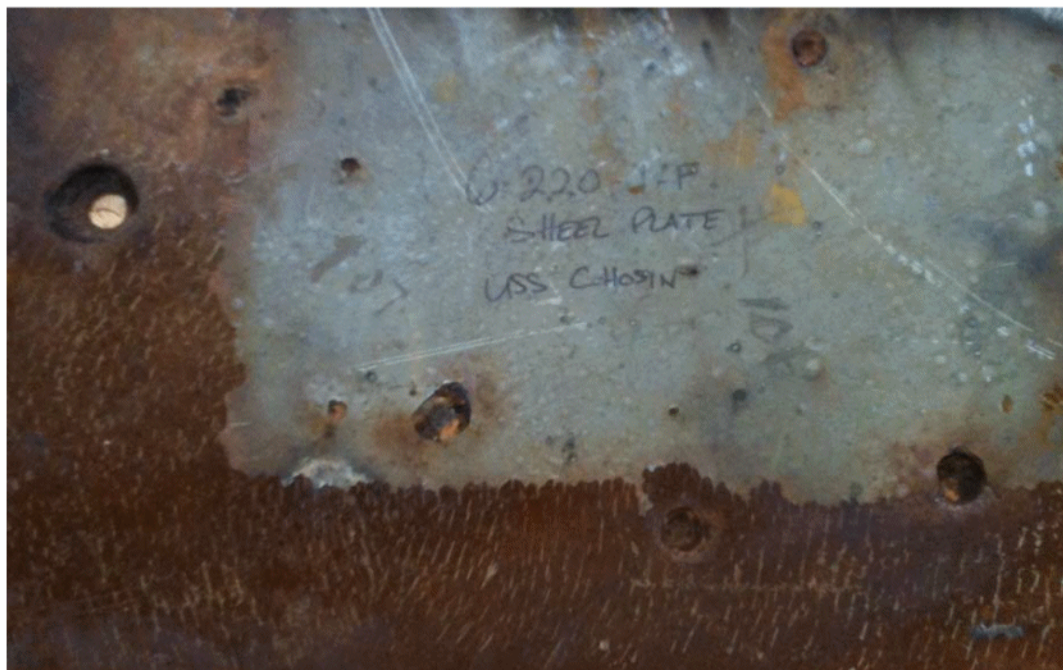
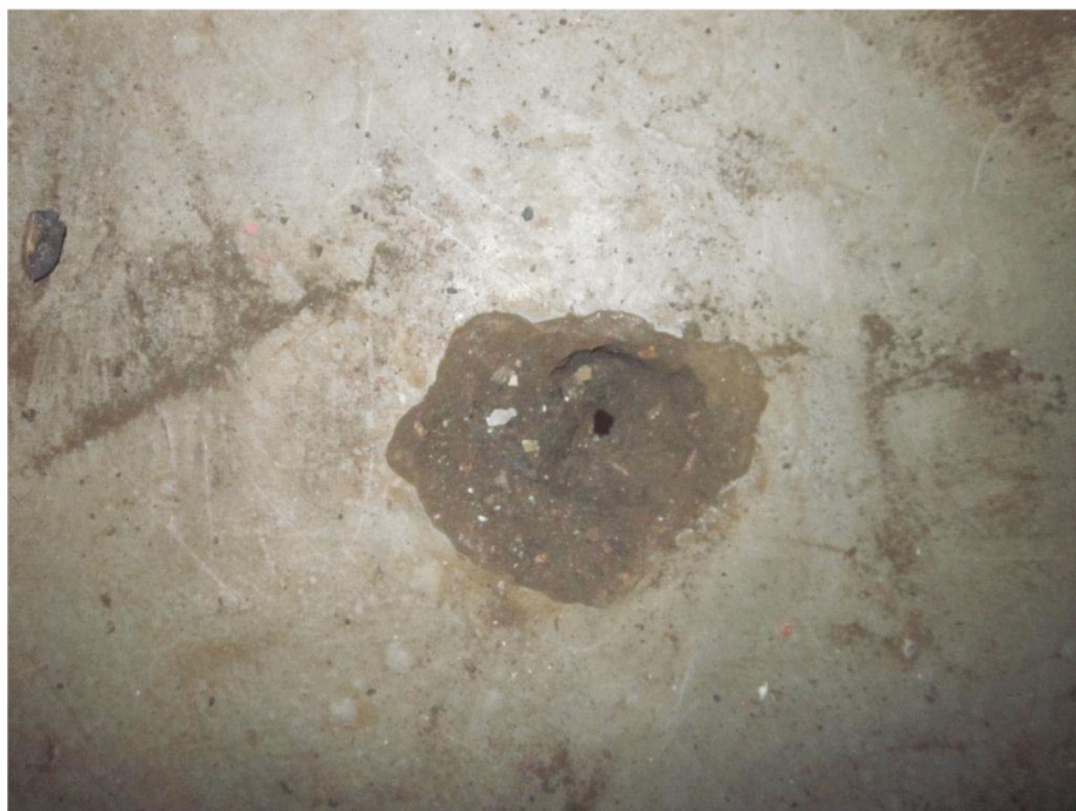
Figure 4-18 Examples of MIC-Produced Isolated Pitting in a Waste Oil Tank

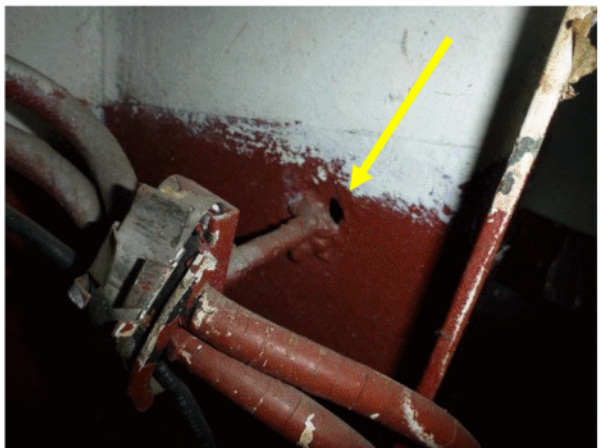
Undercut Base Metal At Weld Toe

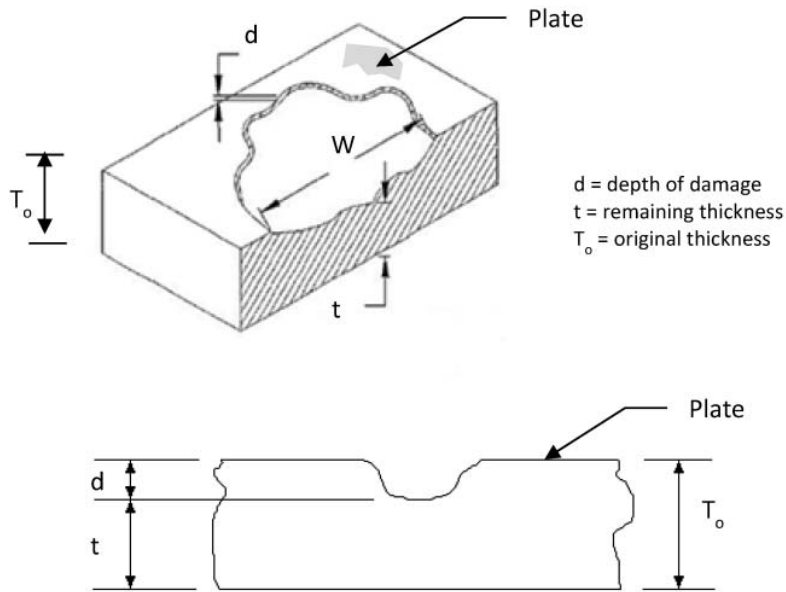
Figure 4-20 Determination of the Percent Reduction in Plate Thickness

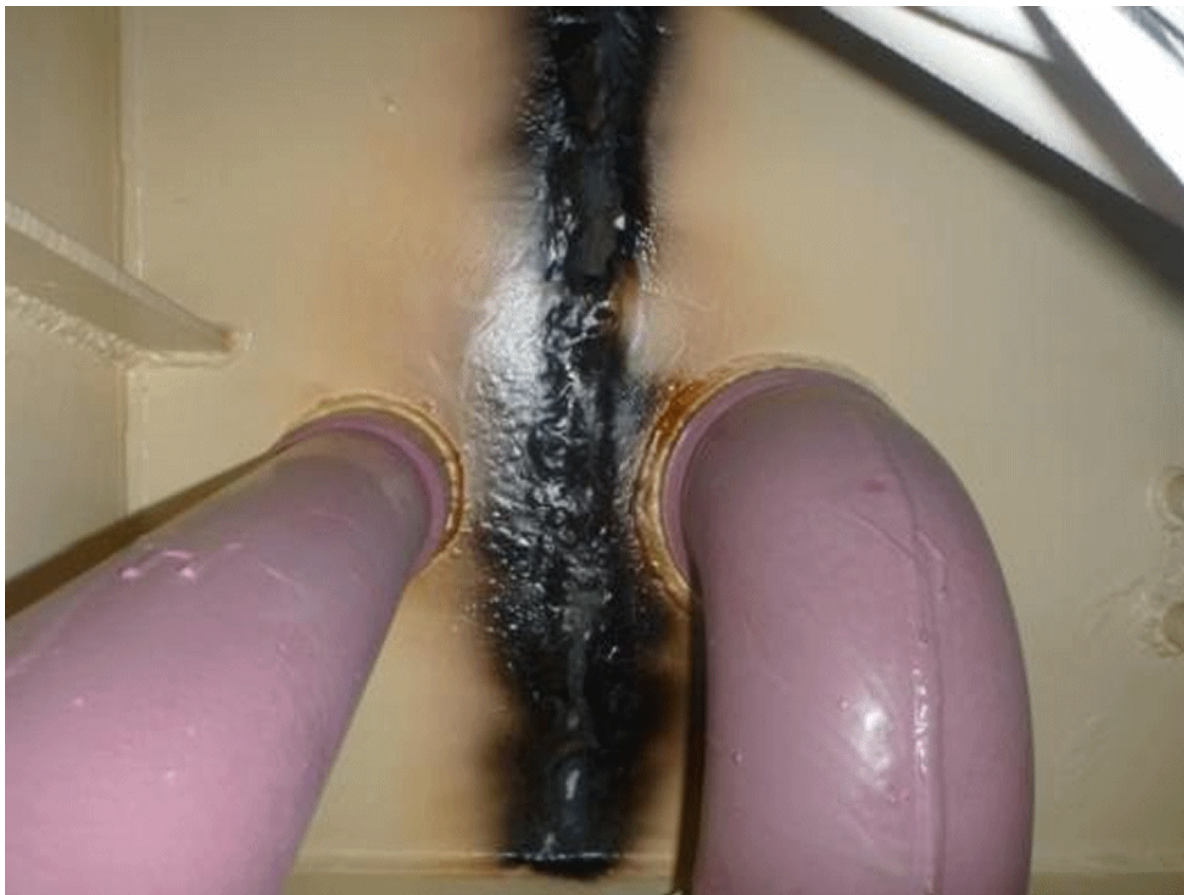
Figure 6-1 Burned Coating From Welding on Opposite Side of Plate
