# Monitoring Aquatic Debris in a Water Environment Using a Remotely Operated Vehicle (ROV): A Comparative Study with Implications of Algal Detection in Lake Como (Northern Italy)

**Keywords:** debris; ROV; lake; algal blooms

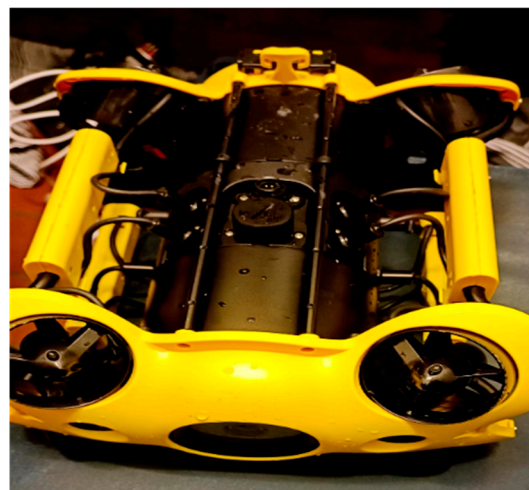
**Figure 2.** Remotely operated vehicle (ROV).

A remotely operated vehicle (ROV) was used to record debris objects. Given its reasonable price, it is a feasible device for underwater videography, as represented in Figure 2.

The system called Trident, developed by Open Rov snc, is based on a Raspberry Pi shield programmed to record video from a CCD sensor and manage input from a controller. It is cabled to the surface with a 100 m tether and is equipped with LED lights (with a brightness of 200 lumens), a thermometer, a depth sensor, and an internal digital compass for navigation support. An ABS 3D-printed shell maintains water pressure resistance up

to 100 m below the surface, and a LiPo battery provides an actual autonomy of 3 h. A smartphone (iPhone) was attached to a device as the main device, which was used to record observations and control the application. Data such as depth, temperature, direction, and battery life were displayed in real-time on the application via onscreen display (OSD). The device was assembled with three motors capable of propelling the Trident at speeds of up to two meters per second, a reliable speed for its size. The navigation system is similar to that of a radio-controlled airplane, using a single vertical motor for pitch adjustment, enabling vertical navigation while maintaining high speed. This system was secured with a sturdy rope cable.

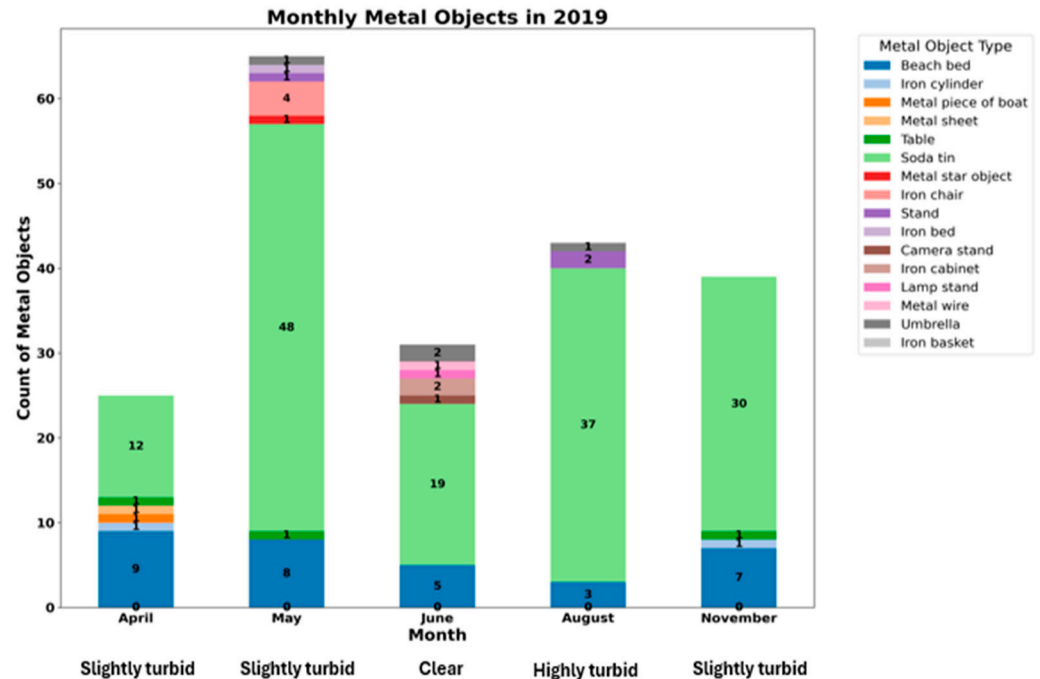
Figure 3. Stack representation of monthly metal objects in year 2019.

Figure 3 presents a stacked graph showing the monthly counts of various metal object categories observed in Lake Como in 2019 highlighting the consistent predominance of soda tins, particularly in May, August, and November, while the presence of other metal objects varied throughout the year. During April 2019 a total of 25 metal objects were recorded, with beach beds (9) and soda tins (12) being the most frequently observed. Other categories included iron cylinder (1), metal piece of boat (1), metal sheet (1), and table (1). Whereas, in May 2019, the total count was 65 metal objects, with a notable presence of soda tins (48) and iron chairs (4). Additional counts included beach beds (8), metal star objects (1), stand (1), iron bed (1), and camera stand (1). Upon further analysis of the ROV video footage, it was observed that heavier objects, such as beach beds, tend to become partially or fully buried in bottom sediments over time. This likely explains the discrepancy in counts, as one of the beach beds may have been obscured by sediment accumulation during the May survey and was therefore not visible. Sediment burial of heavy debris is a well-documented phenomenon in aquatic environments, particularly in areas with active sediment deposition. In June 2019, the recorded total was 31 metal objects, with soda tins (19) being the predominant category. Other objects included beach beds (5), metal wire (2), iron bed (2), and camera stand (1). In August 2019, a total of 43 metal objects were counted, including soda tins (37) and iron beds (2). Other categories included

beach beds (3) and stands (2). Similarly, in August, the turbidity levels were high due to sediment disturbance, which further obscured visibility and hindered debris identification. In November 2019, the total count was 39 metal objects, with soda tins (30) being the most frequently observed. Additional objects included beach beds (7) and iron cylinders (1). In general, smaller objects were particularly challenging to detect during these months due to increased water turbidity and camera movement.

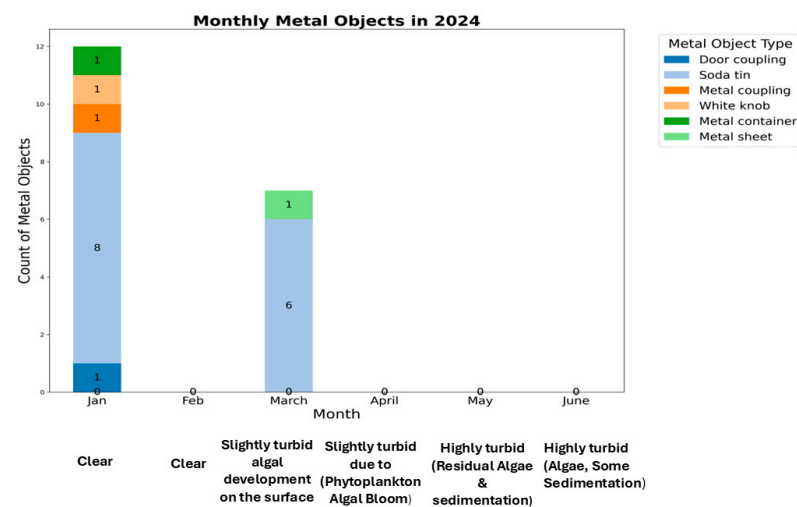
Figure 4. Stack representation of monthly metal objects in year 2024.

The stacked graph (Figure 4) visually summarizes the distribution of metal debris, highlighting that soda tins were primarily observed in January and March, while other metal objects were either rarely detected or absent in subsequent months.

In January 2024, the most frequently observed items were soda tins (8) followed by white knobs (1), door couplings (1), metal couplings (1), and metal containers (1). No metal sheets were recorded. In February 2024, no metal objects were detected across any category,

with all counts recorded as 0. In March 2024, the count was dominated by soda tins (6), with a single metal sheet (1) observed. No other metal objects were recorded. In April 2024, there were no metal objects observed, with all categories showing 0 counts. In May 2024, all categories showed 0 counts, indicating no detected metal debris. Similarly, in June 2024, no metal objects were detected, with counts remaining at 0 for all categories. The observed disappearance of certain metal objects in February and April–June 2024 may be attributed to several factors. It is possible that some debris was buried due to sedimentation or moved due to water currents, which could account for their nonvisibility in subsequent surveys. Based on video observations, it was noted that in some months, turbidity and sediment disturbance led to the partial or complete burial of objects, particularly larger debris like metal pieces. Additionally, in March 2024, dense algal blooms and higher turbidity obscured the objects’ visibility, making it difficult to identify debris, which might have led to an undercount. Furthermore, it is not confirmed whether any cleaning of the lakebed occurred between the surveys, as this was outside the scope of the study. However, the lack of visible debris in specific months may reflect natural processes, such as the movement of debris due to currents or sedimentation, rather than any active removal or cleaning efforts. No organized efforts to collect or remove underwater debris were documented in the study area during the survey period. The variation in observed debris counts between surveys may result from natural factors such as sedimentation burying objects, changes in visibility conditions, and debris movement influenced by lake currents and turbulence. These natural processes could obscure the detection of certain items over time, contributing to variability in debris counts across months.

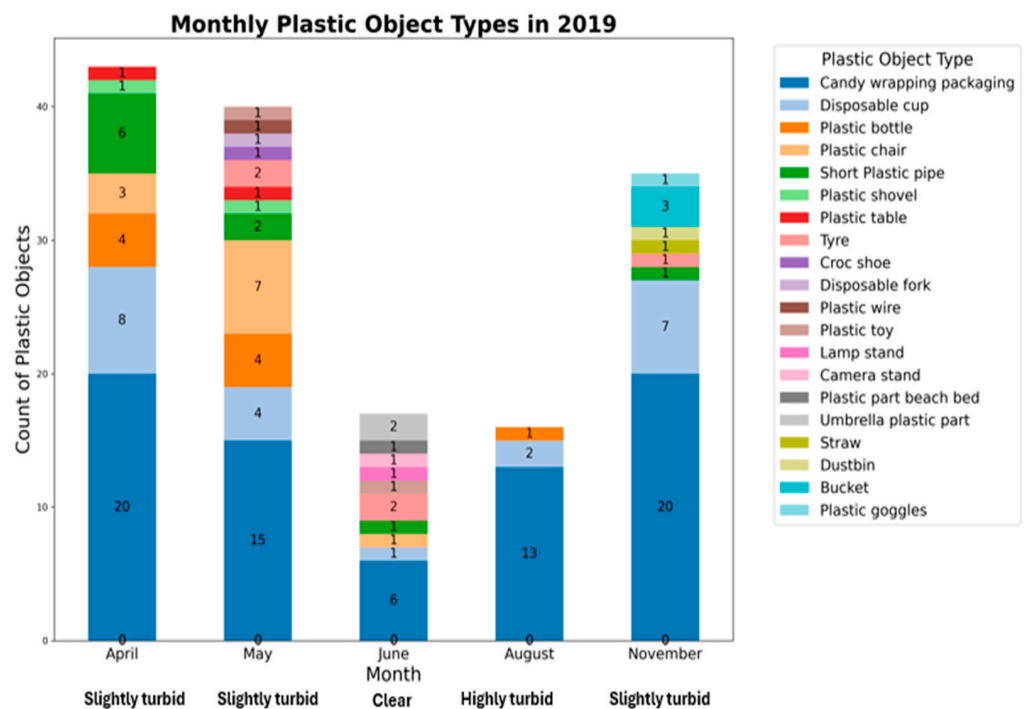
Figure 5. Stack representation of monthly plastic objects in year 2019.

The stacked graph (Figure 5) visually summarizes these distributions, emphasizing the prevalence of candy wrapping throughout the year, particularly in April and November, while other plastic items showed variable counts across months.

The categories of plastic debris included candy wrapping packaging, disposable cups, plastic bottles, plastic chairs, short plastic pipes, plastic shovels, plastic tables, tires, croc

shoes, disposable forks, plastic wires, plastic toys, lamp stands, camera stands, plastic parts of beach beds, umbrella plastic parts, straws, dustbins, buckets, and plastic goggles. During April 2019, the total count was 43 plastic items, with significant contributions from candy wrapping packaging (20), disposable cups (8), and plastic bottles (4). Other items included plastic chairs (3) and short plastic pipes (6). In May 2019, a total of 40 plastic items were recorded, including candy wrapping packaging (15), disposable cups (4), and plastic bottles (4). Additional items included plastic chairs (7) and tires (2). Whereas, in June 2019, the total count was 17 plastic items, with notable observations of candy wrapping packaging (6) and plastic shovels (1). Other items recorded were plastic tables (2) and plastic toys (1). In August 2019, a total of 16 plastic items were observed, predominantly candy wrapping packaging (13). In November 2019, the count was 35 plastic items, with notable counts of candy wrapping packaging (20) and disposable cups (7). Additional items included plastic chairs (1) and plastic goggles (3).

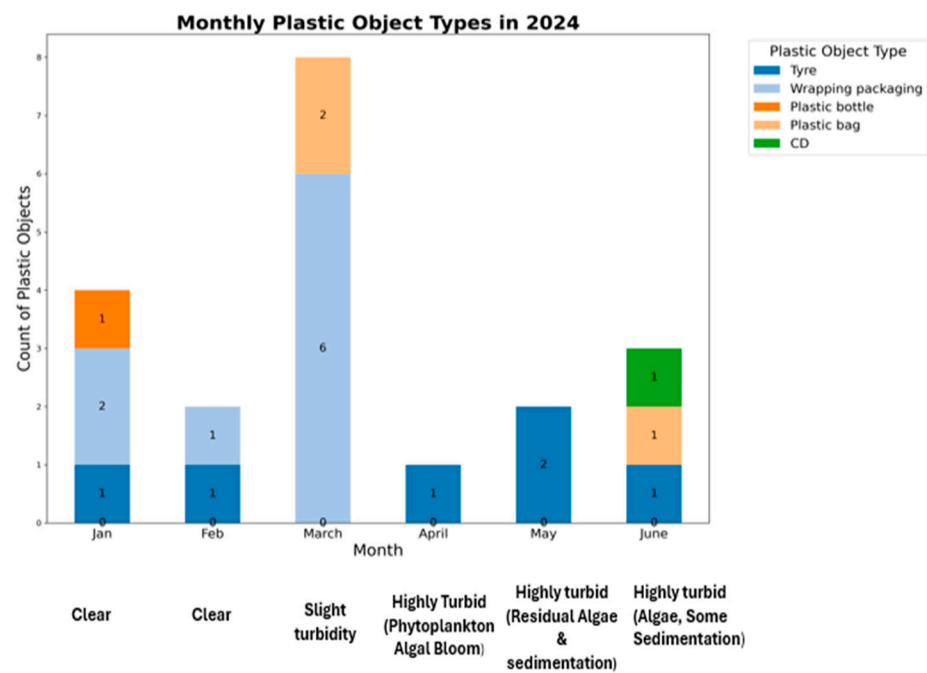
Figure 6. Stack representation of monthly plastic objects in year 2024.

Figure 6 effectively visualizes the monthly distribution of plastic debris types throughout 2024. The data highlight variations in the presence of different plastic objects, with wrapping packaging being most frequently observed in March, while other categories such as tires and plastic bags appeared in different months.

During January 2024, a total of 4 plastic objects were recorded, including 1 tire, 2 wrapping packaging, and 1 plastic bottle. No plastic bags or CDs were observed. In February 2024, the total count was 2 plastic objects, comprising 1 tire and 1 wrapping packaging. No other categories were detected. In March 2024, a total of 8 plastic objects were observed, with 6 wrapping packaging and 2 plastic bags. No tires, plastic bottles, or CDs were recorded. In April 2024, the count was 1 plastic object, specifically a tire, with no other categories detected. In May 2024, a total of 2 plastic objects were recorded, both of which were tires. No wrapping packaging, plastic bottles, plastic bags, or CDs were observed. Whereas, in June 2024, the total count was 3 plastic objects, including 1 tire, 1 plastic bag, and 1 CD. No wrapping packaging or plastic bottles were detected.

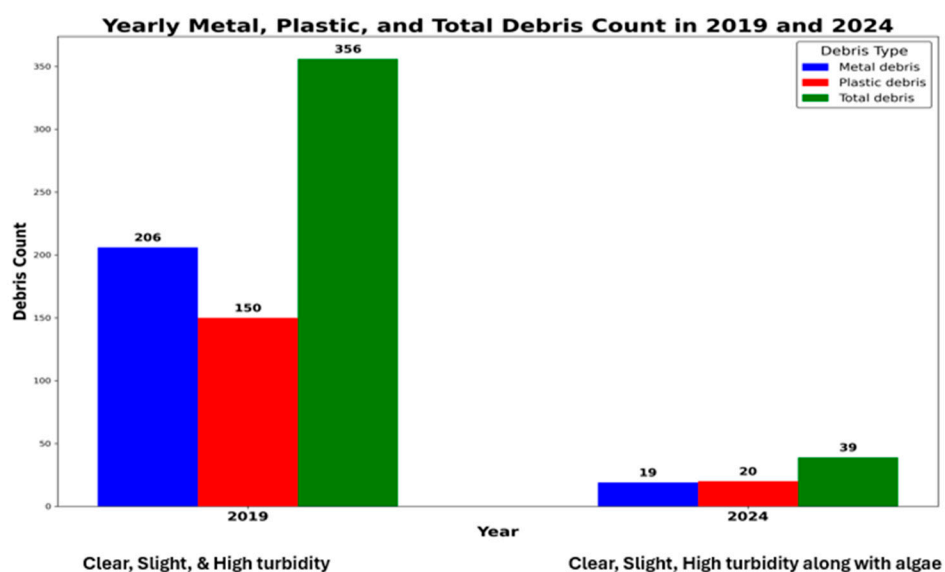
Figure 7. Bar graph representation of yearly breakdown of plastic and metal count in 2019 and 2024.

Figure 7 illustrates the yearly aggregation of the monthly variations, showing an overall decrease in debris across all months monitored in 2024. A paired *t*-test comparing total debris counts for 2019 and 2024 yielded a *p*-value of 0.061, indicating that although there was a clear reduction in debris, it was not statistically significant at the 0.05 level. This trend suggests potential improvements in environmental conditions or waste management practices over the five-year period. Although a clear visual reduction in debris was observed between 2019 and 2024, statistical testing using a paired *t*-test did not indicate a significant difference ( $p = 0.061$ ) at the 0.05 significance level. This result is due to the fact that the total number of debris items in both years (2019 and 2024) was relatively low in certain months, particularly in 2024. A few months in 2024, such as April, May, and June, recorded an extremely low number of debris items (1, 2, and 3 items, respectively), which may have caused a higher variance and reduced statistical power in detecting a significant difference. Despite this, the visual trend of a decrease in debris is apparent and aligns with broader environmental or waste management changes that could have occurred over the years, such as improvements in waste collection efforts or natural factors such as sedimentation.

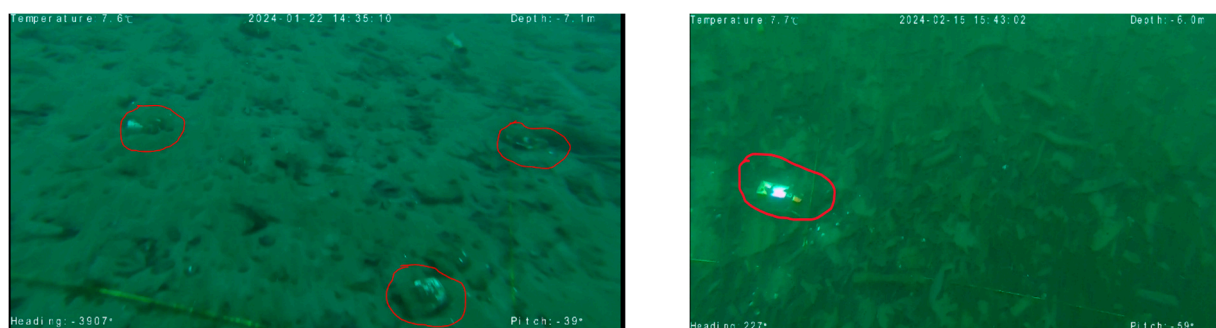
(a) Image 22 January 2024 represents clear water

(b) Image 15 February 2024 represents clear water

This section presents a visual analysis of water turbidity and algal presence in Lake Como during the survey periods of 2019 and 2024. Screenshots captured from ROV video recordings highlight the differences in water clarity and algal development across various months, providing a clearer understanding of the environmental conditions that impacted debris detection efforts. These visual comparisons aim to support the findings on the influence of algal blooms on underwater visibility. Figure 8 visually represents the clear underwater visibility observed in January and February 2024, where objects were easily identifiable and countable. Both months exhibit similar conditions for object detection, as indicated by the red markers highlighting the debris presence.

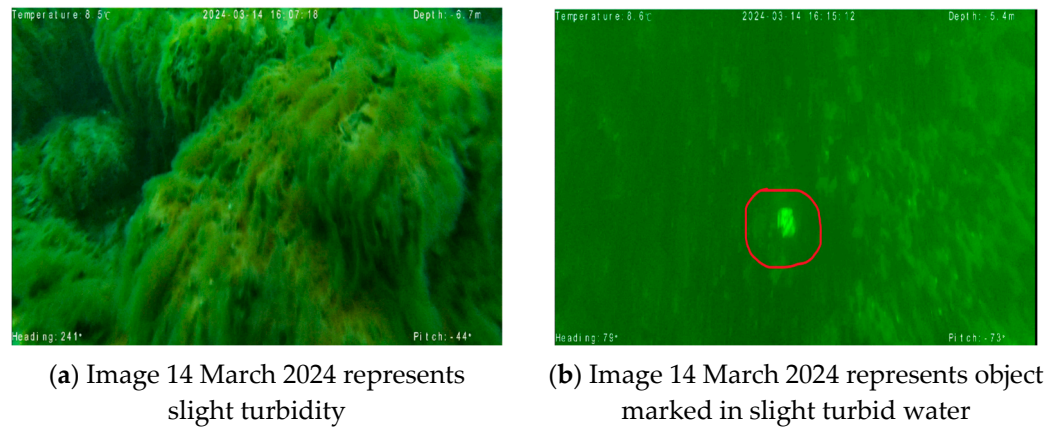
**Figure 9.** (a) Dense algal development. (b) The encircled object is present in algal development conditions.

Figure 9 illustrates the dense algal development observed in March 2024. The algal growth caused slight turbidity and altered the watercolor, significantly reducing visibility. This hindered the ability to detect and count objects on the lakebed, as much of the bottom was largely covered with dense algae. As a result, only a few objects could be identified and counted.

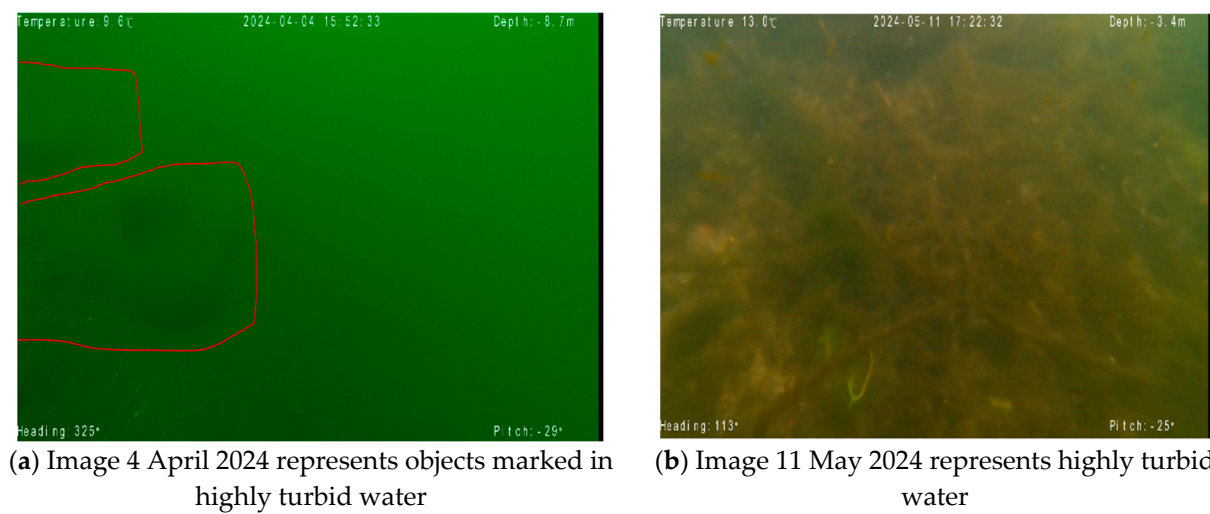
**Figure 10.** (a) Encircled objects in highly turbid water (April). (b) Highly turbid water in May.

Figure 10 shows that the water in April 2024 was highly turbid due to a phytoplankton algal bloom, which caused cloudiness in the water. Despite the absence of sedimentation, the algal growth and change in watercolor made it difficult to detect objects. Similarly, in May 2024, both algae and sedimentation contributed to high turbidity, further obscuring the visibility of objects on the lakebed.

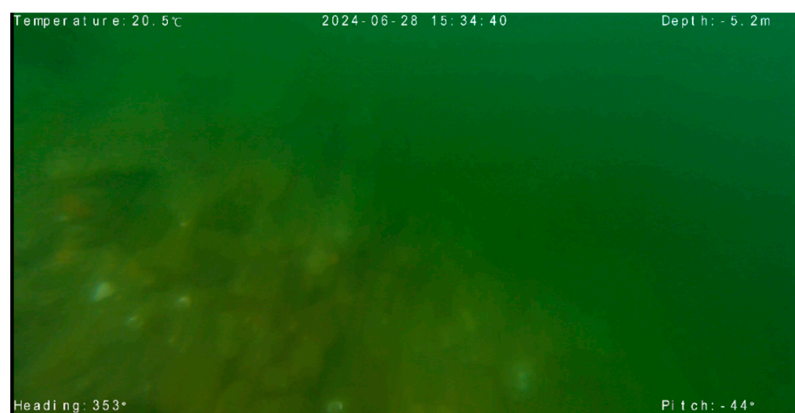
**Figure 11.** Image 28 June 2024 represents highly turbidity.

Figure 11 shows that while the watercolor in June 2024 was less green compared to previous months, significant sedimentation caused cloudiness, making it difficult to locate objects. The reduced visibility due to sedimentation hindered the identification of debris on the lakebed.

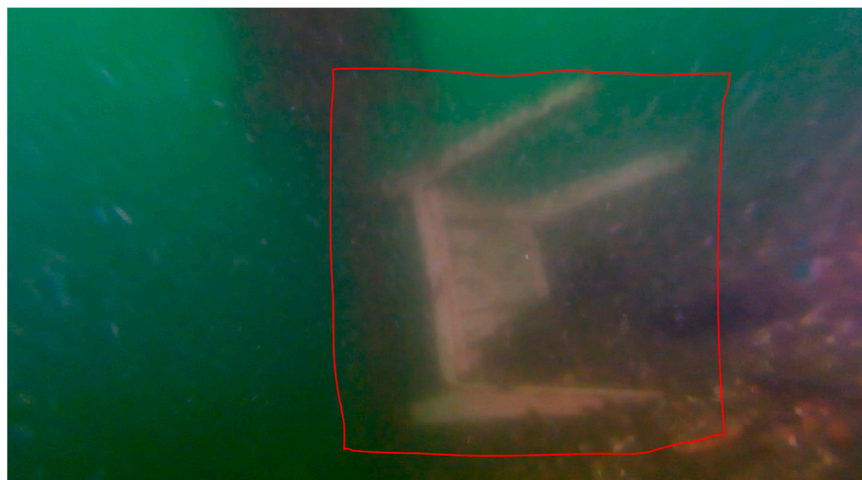
**Figure 12.** Image 2 April 2019 represents slight turbidity due to sedimentation.

Figure 12 shows that in April 2019, the objects were clearly visible with minimal interference from algal development. While sedimentation caused mild turbulence, it did

not significantly affect the visibility of the objects. Water turbidity was relatively low during this period.
