# A 14th-century wreck discovered at Lootsi Street 8 in Tallinn

In spring and early summer of 2022, an exceptional shipwreck was brought to light during the construction of an office building at Lootsi St. 8 in Tallinn: it measures 24.5 metres in length and 9 metres in width. In terms of its dimensions, this discovery ranks among the largest medieval shipwrecks found in Northern Europe. Identified as a cargo ship, it is believed to have been in use around the mid-14th century, and its scientific value was enriched by the numerous arte- and ecofacts recovered from it. Since the beginning of July 2022, the Lootsi Wreck, as archaeologists named it, has been located at the Estonian Maritime Museum's Seaplane Harbour area where the conservation works are taking place and micro-scale excavation work inside the hull continues as well.

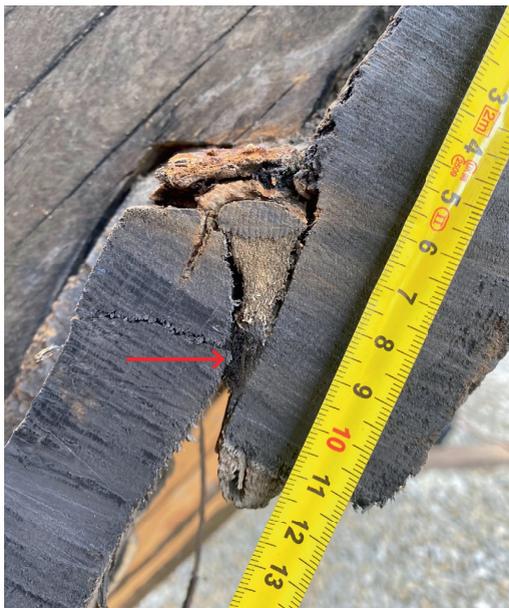
**Fig. 4.** Caulking between two planks. Animal hair marked with the red arrow.

The internal planks on the bottom of the ship are approximately 45 cm wide and 8 cm thick, the upper planks are somewhat narrower and thinner. The planks were laid with about 15–20 cm gap between them, which was filled with loose smaller trees and branches, probably for creating a floor for the cargo. The internal planks were fastened to the frames with trenails, in some locations, iron nails have been used.

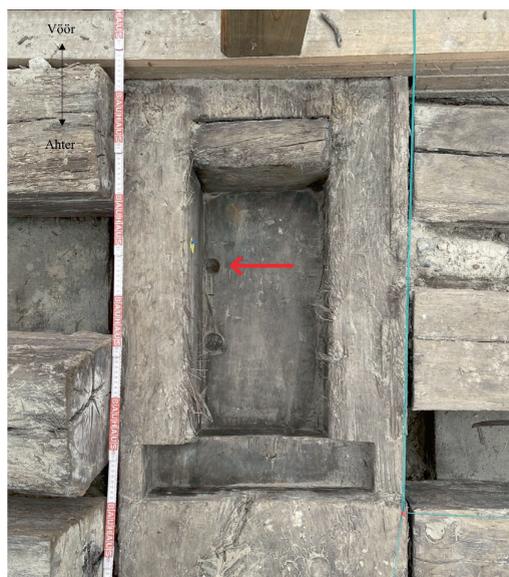
Fig. 5. Maststep with a drainage hole (marked with the red arrow).

the keelson between the frames are beveled upwards, thus leaving more room between the keelson and the keel. On the bottom of the maststep, a water drainage hole has been drilled (Fig. 5).

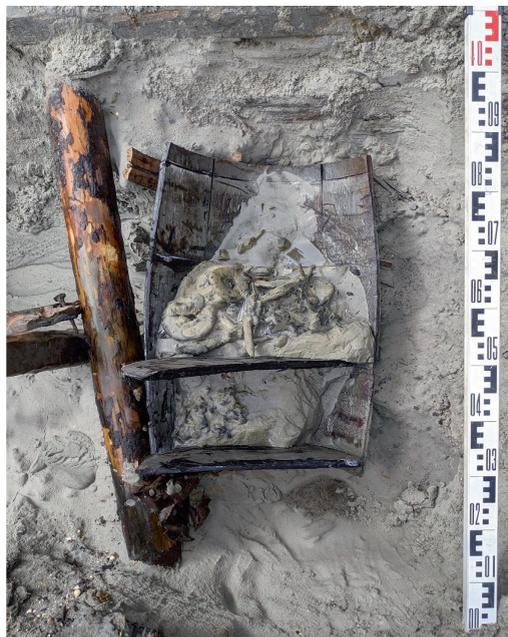
Fig. 8. A barrel chest for keeping iron tools, fastenings and nails.

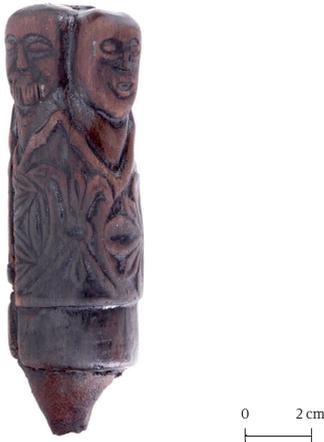
**Fig. 10.** A handle of a carpenter's caliper depicting four-headed Slavic god Sventovit. The handle is made of apple (*Malus sp.*) or pear (*Pyrus communis*).

Kui paljudele leitud asjadele on arvukalt vasteid ka mujalt, siis vähemalt kaks eset paistavad oma erandlikkusega rohkem silma. Neist esimene on ehituspusepa vararaud (jn 10), mille teeb eriliseks tema käepide. Sinna on sisse lõigatud neli eri suundadesse vaatavat mehenägu, mis võivad kuuluda slaavlaste

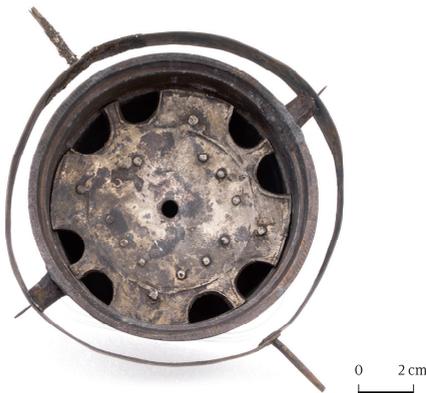
**Fig. 11.** A 14th-century marine compass found from the Lootsi Wreck.

Another artefact that beyond doubt deserves extra handling in the future is the compass, found in two parts (a compass kettle and a compass rose) in the stern section of the wreck (Fig. 11). To our knowledge

this is the oldest compass found in Northern Europe, about 150–175 years older than the archaeological compass find from Mary Rose, sank in 1545 (Stimson 2005, 268). However, this find seems to fit very well into the temporal context, as maritime compasses were not uncommon in ships sailing along Baltic coasts based on written sources from the late 14th century. Thus, for example, in 1394, a compass maker in Kampen received money for outfitting a cog. In 1398, skipper and compass maker Gise Korling was mentioned in Stralsund, which led to a dispute between the city and Kampen (Ellmers 2018, 233). Hence, in both Hanseatic cities, compasses were crafted for local sailors. The discovered object from the Lootsi Wreck offers additional food for thought on late medieval maritime navigation.

jumalusele Sventovitile. Eriti haruldane on vraki ahtriosast leitud kompassi kauss ja -roos (jn 11), millele nii varaseid paralleele pole teada. Küll aga võib kirjalike allikate põhjal oletada, et sarnased kompassid olid 14. sajandi lõpus üsna tavalised.
