Wreck Sites as Systems Disrupted by Trawling

Jan Majcher, Rory Quinn, Gert Normann Andersen, and David Gregory

C. Jarvis (ed.), *Threats to Our Ocean Heritage: Bottom Trawling*,

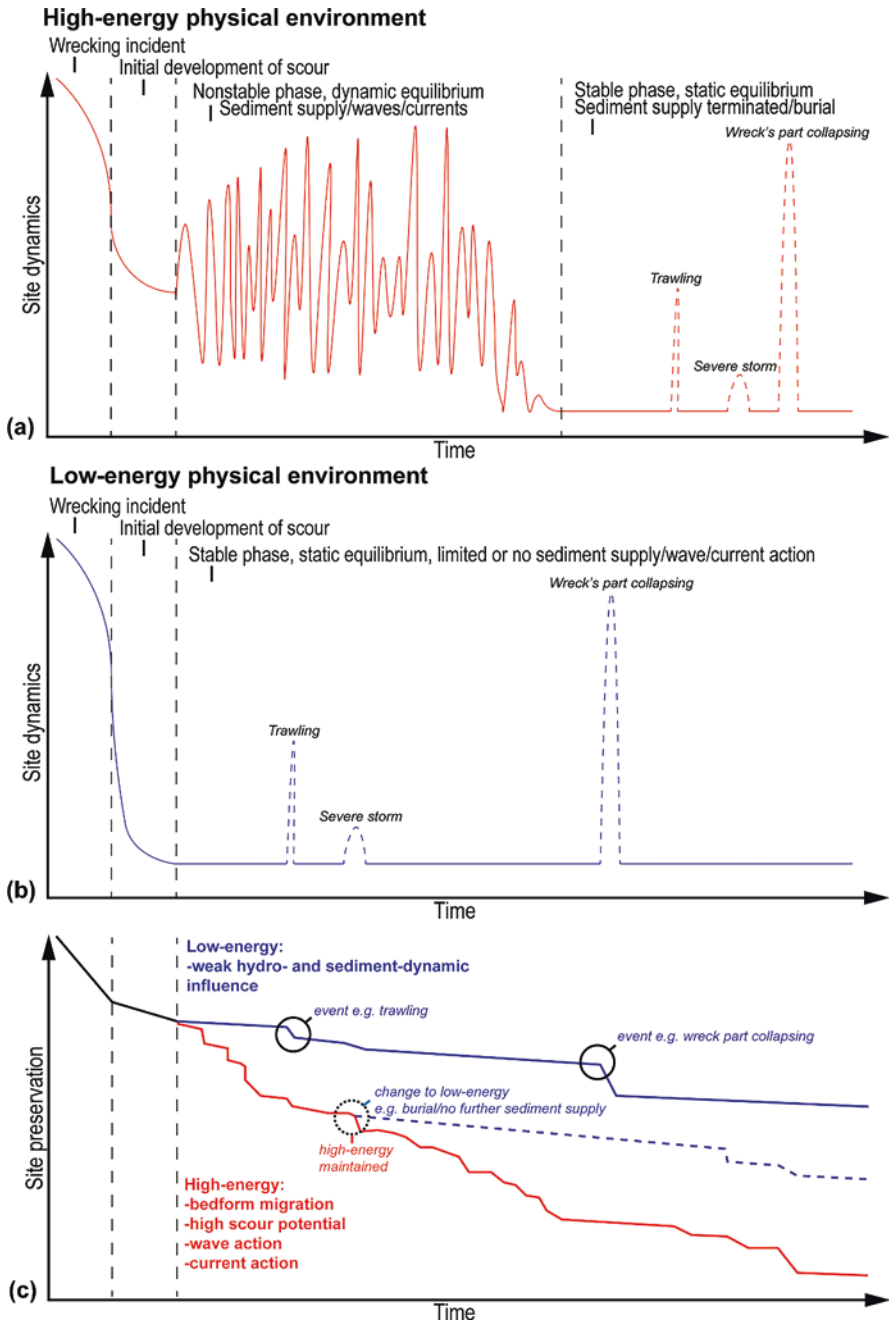
Fig. 5.1 Conceptual diagram for wreck site dynamics for (a) high-energy and (b) low energy environments, along with (c) corresponding estimates for site preservation in the two categories. Rapid changes in site dynamics due to either continuous sediment supply or singular events, result in accelerated degradation and lower site preservation. In contrast, periods of stability favour preservation. However, preservation is always steadily declining due to corrosion and biological action. (Adapted from Majcher et al., 2021)

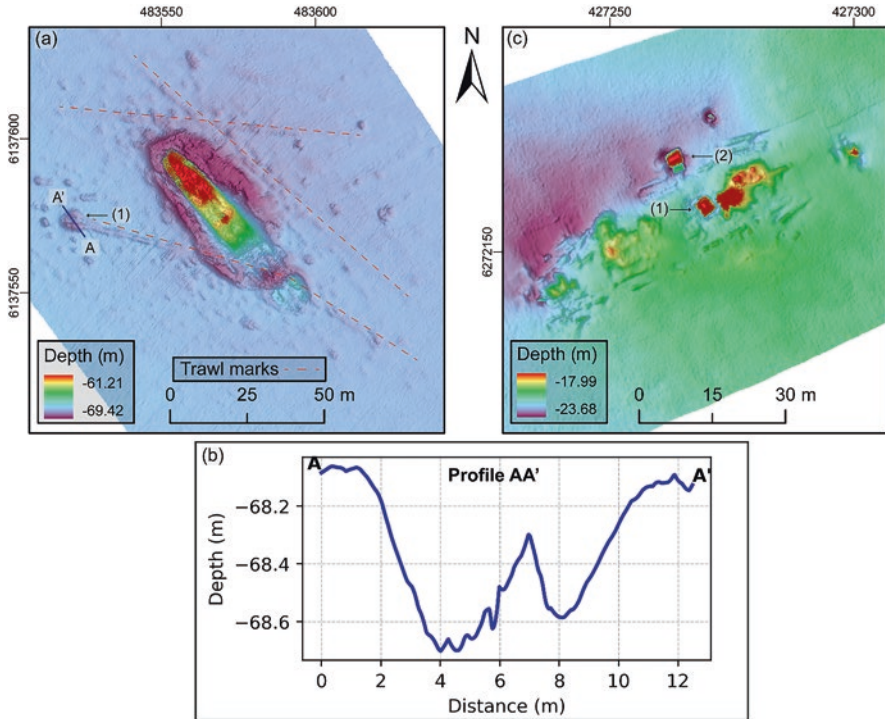
Fig. 5.2 Multibeam echosounder data-derived, hillshaded digital elevation models of (a) a steamship wreck, possibly *SS Edgar* in the Baltic Sea with (b) a bathymetric profile denoted as AA'. (c) hillshaded digital elevation model of an unknown wreck in the Danish North Sea. Numbers shown in on the figures correspond to structural elements discussed in the text. (Data courtesy of JD-Contractor A/S)

Convincing evidence of direct trawl damage to the wreck of a steamship (likely *SS Edgar*, lost in 1894) in the Baltic Sea is shown in Fig. 5.2a. The site is intersected by multiple interpreted trawl marks, and numerous displaced sonar contacts are scattered around the wreck. One particularly prominent example, marked as (1) in Fig. 5.2a, displays a structural element that measures roughly $4 \times 1.5 \times 0.3$ m in terms of length, width, and height, respectively. The object is located 32 m from the wreck's hull and lies at the end of a linear trawl mark which intersects the stern section of the vessel. It is probable that this object was dislodged from the wreck and represents one of its original structural components. A scour pit measuring 10 m across and 0.5 m deep is developed around the object (Fig. 5.2b). Although, in this instance, the scour pit does not directly threaten the integrity of the hull, it shows how the site's system adapted to the redistributed wreck components on the seabed.

Another example of a site most likely impacted by trawling (Fig. 5.2b) is represented by a significantly deteriorated, unidentified wreck in the North Sea at a depth of 20 m. While a large portion of the wreck's hull has decayed, several heavily-engineered structural elements remain on the seabed, likely remnants of the ship's

steam engine and machinery. Two boilers are imaged, one rests within the deteriorated hull ((1) in Fig. 5.2b) and the other is located externally, offset to the north of the vessel ((2) in Fig. 5.2b).

Multiple explanations for the second boiler's position outside of the main wreck structure are conceivable. One possibility is a salvage operation that resulted in the boiler's relocation. Another scenario is that the boiler slid out during the wrecking event. A third possibility is displacement due to trawling. While the first scenario remains plausible, the second appears less likely. This is because the ship's hull maintains a coherent shape, suggesting it did not break up or undergo a violent wrecking event to displace the boiler from its original position. Even though no prominent trawl marks are evident in the multibeam data, the third possibility is credible, depending on the specifications of the trawl gear (Brennan, 2016). Open-source Vessel Monitoring System (VMS) data from EMODnet (2023) demonstrate that beam trawls, bottom otter trawls, and bottom seines are operational in the area. Given that a significant portion of the ship's structure has decayed, the boilers, now largely exposed in the water column, pose clear obstructions to fishing gear.

As evidenced in many surveys (e.g., Fig. 5.2b) boilers are among the most resilient structural elements on shipwreck sites. This may be attributed to the fact that they were built to withstand high operating pressures and temperatures, with thick and strong iron or steel structures. Additionally, due to their location within a vessel, boilers are also sheltered from the physical forces affecting the wreck's hull externally, hence being protected by its structure until it gradually deteriorates or collapses. These factors possibly contribute to their long-term durability in the marine environment compared to the other parts of the ship.

Nevertheless, the displacement of the boiler recorded in the multibeam data (Fig. 5.2b) could have implications for its further preservation. Just as the structural element pulled out of the shipwreck in Fig. 5.2a, the displacement and exposure of the boiler to bottom currents led to the formation of a small scour pit around it. The boiler that remained within the hull is not affected by seabed scour, possibly because it is shielded by the hull remains. Therefore, the displaced boiler is more exposed to the physical environment, after losing the protective function of the wreck's structure. While both boilers appear to be in good condition presently, this example underscores the destructive potential that trawling or other human activities capable of causing displacement might have, especially when juxtaposed with natural forces. The future preservation potential of the boiler removed from the wreck's hull may be compromised due to that displacement event.

Given the examples mentioned here, it can be inferred that the detrimental impacts of bottom-contact fishing are not confined to ancient sites (Brennan et al., 2016). They also extend to larger, relatively more coherent modern wrecks, like the steamship shown in Fig 5.2a. In essence, a trawling event acts as a 'scrambling device' (Muckelroy, 1976), initially triggering reorganisation of a wreck site. This site may then undergo further changes, depending on its capacity to absorb the disruption. Potential outcomes might involve seabed erosion leading to heightened exposure of relocated structural components to external forces, and result in the acceleration of corrosion process.

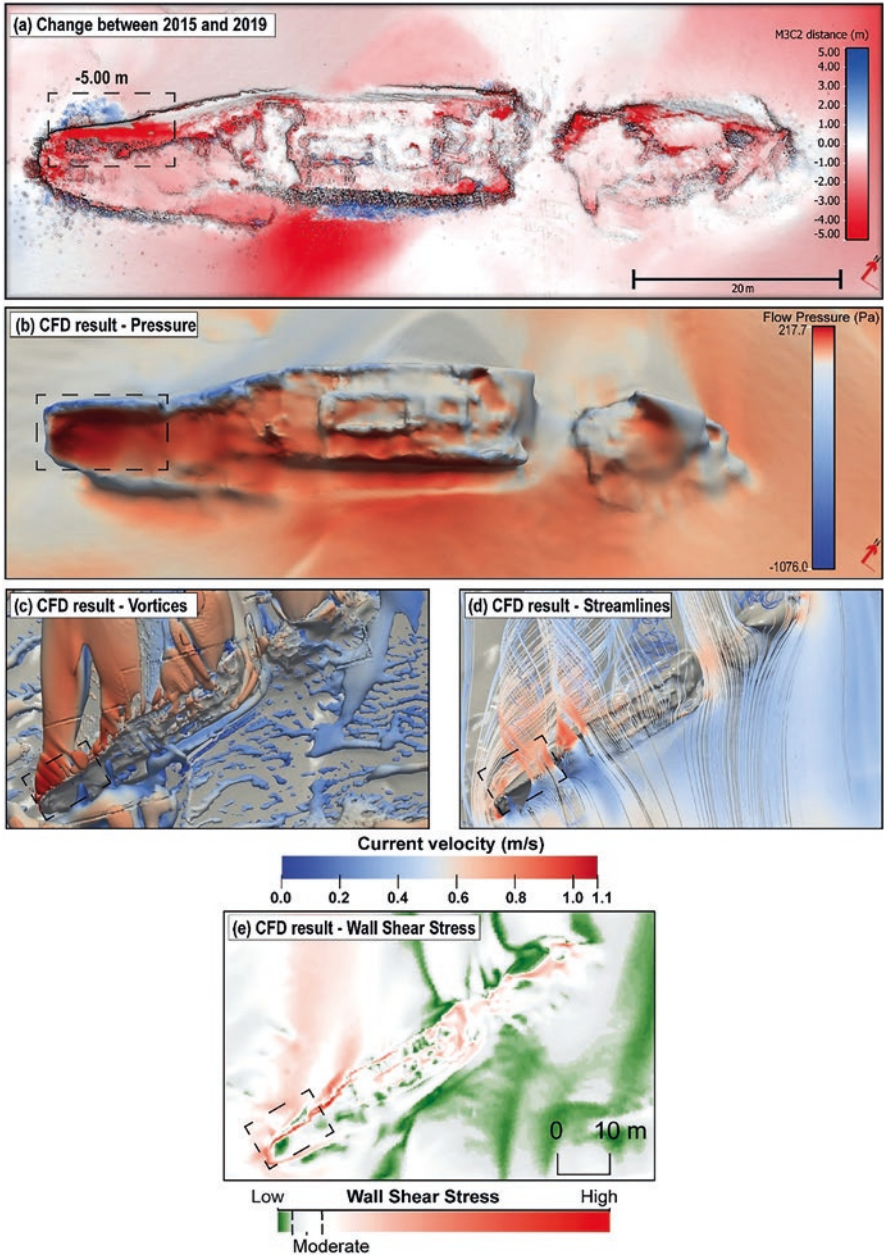
Fig. 5.3 (a) Differences between multibeam echosounder point clouds obtained for the SS *WM Barkley* site in 2015 and 2019. (b) CFD-simulated NNW-oriented tidal current flow pressure exerted on the modelled seabed at the same site, (c) vortical patterns delineated by the simulations, (d) NNW-oriented current flow streamlines, and (e) wall shear stress. Dashed boxes show the stern and portside gunwale of the ship discussed in the text. A detailed data and methodology description is provided in the original publication of Majcher et al., 2022

In addition to investigating geomorphic adjustment at these sites, an attempt was made to detect structural changes at these wrecks through point-cloud comparisons of high density multibeam data. Although the subjective nature of the manual point cloud cleaning process meant that detecting minor centimetric changes was challenging due to the noise associated with wreck data, the method was sensitive enough to identify substantial structural displacements. For example, between 2015 and 2019, the SS *WM Barkley* wreck suffered the detachment of a considerable part of its portside gunwale near the stern (Fig. 5.3a).

The environmental dynamics and the nature of the SS *WM Barkley* shipwreck’s degradation present a compelling argument for the involvement of anthropogenic external forces, such as trawling, as catalysts for the observed changes. The wreck is tilted towards its starboard side, and if the gunwale had collapsed due to corrosion only, it would be expected to have moved gravitationally towards the deck. However, it moved in the opposite direction, towards the seabed. The possibility of an external force, like an anchor or trawl door pull, causing this movement becomes more likely given the direction of detachment.

Therefore, to understand possible causes of the gunwale displacement, CFD-modelled variables (Fig. 5.3b–e) were compared against structural changes (Majcher et al., 2022). A few observations were made: (1) the stern section is generally subject to relatively high flow -exerted pressure under the NNW, flow, tidal current (Fig. 5.3b); (2) vortices are created over the gunwale (Fig. 5.3c) with streamline contraction and increase in the flow speed (Fig. 5.3d), and (Fig. 5.3) the collapsed gunwale was subject to high shear-stress exerted under the NNW flow conditions (Fig. 5.3e). On the other hand, the modelled tidal current flowing in the opposite, ebb, SSE direction (tidal currents are bi-directional in the area) exerted lower shear stress on the same gunwale. Although these observations support the idea that the deterioration of the gunwale could be due to natural causes, specifically the NNW tidal current-induced push towards the wreck's portside, the influence of fishing cannot be ruled out. It remains probable that the tidal flows caused gradual wear which enabled a passing trawl door or net to eventually detach the gunwale.

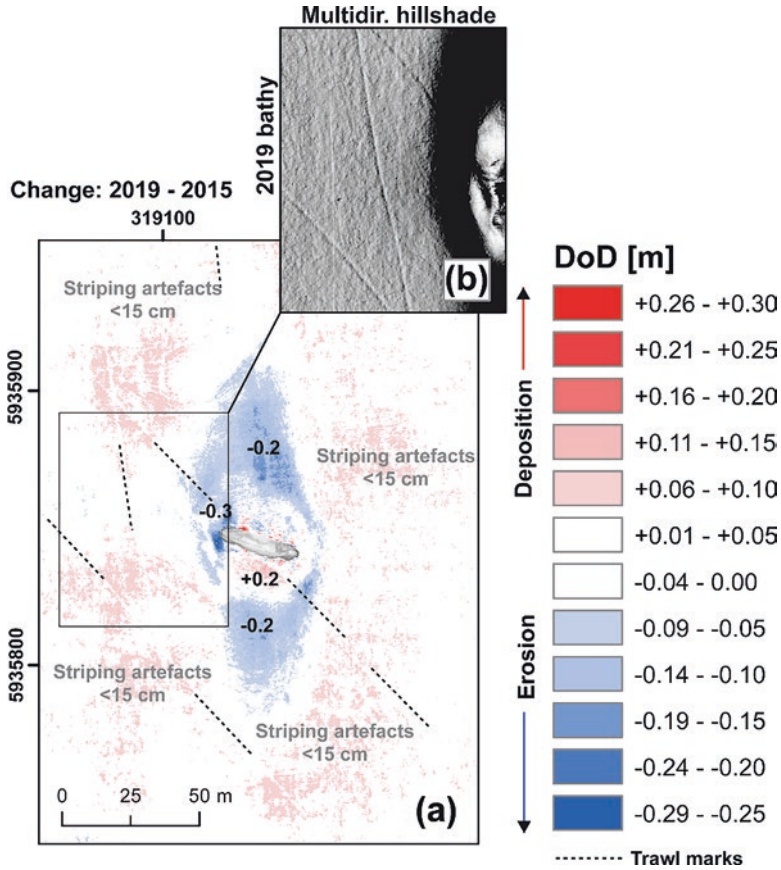
Fig. 5.4 (a) Digital Elevation Model of Differences (DoD) for the FV *St. Michan* site, showing bathymetric changes between years 2015 and 2019, and (b) inset map showing a hillshaded elevation model created using the data collected in 2019. New trawl marks were recorded in the 2019 data. (Adapted from Majcher et al., 2021)

A contrasting Irish Sea example, where bottom trawling is assumed to directly impact a site (similar to the Baltic site of SS *Edgar* discussed above), is the FV *St. Michan* (Majcher et al., 2021). *St. Michan*, a motor fishing trawler, was lost in 1918 at a depth of 70 m, close to the Western Irish Sea Mudbelt, an area heavily trawled for Dublin Bay prawn (*Nephrops Norvegicus*) (Coughlan et al., 2015). The site was surveyed with high-resolution multibeam echosounder data in 2015 and 2019, and recent trawl marks directly intersecting the wreck were detected in the 2019 data (Fig. 5.4). Although no substantial damage was observed to the wreck's structure in the multibeam data, it cannot be ruled out, as the vessel is relatively small (30 m long) and lying exposed in a scour pit.
