# Exploration of Alaska's World War II Submerged Heritage: The *Kotahira Maru* and SS *Dellwood* Wreck Sites off Attu Island

In June 1942, imperial Japan captured the Aleutian Islands of Attu and Kiska, marking the first and only time since the War of 1812 that United States territory in North America was occupied by a foreign power. The following year saw the imprisonment of Attu's indigenous Siskinaï population, the United States' effort to expel the invading forces, and the eventual recapture of the two islands. Over eight decades later, however, the story of Attu, and by extension the entire North Pacific theatre of World War II, remains an oft-forgotten chapter of history. In an effort to rectify this situation, the first systematic survey of Attu's underwater cultural heritage was conducted using a combination of synthetic aperture sonar and underwater video. Among the most significant findings were the discovery of two wartime shipwreck sites, the Japanese army transport *Kotahira Maru* and the American cable-layer SS *Dellwood*. The documentation of these sunken vessels not only sheds light on their final moments, but it can also be used to bring renewed awareness of Alask

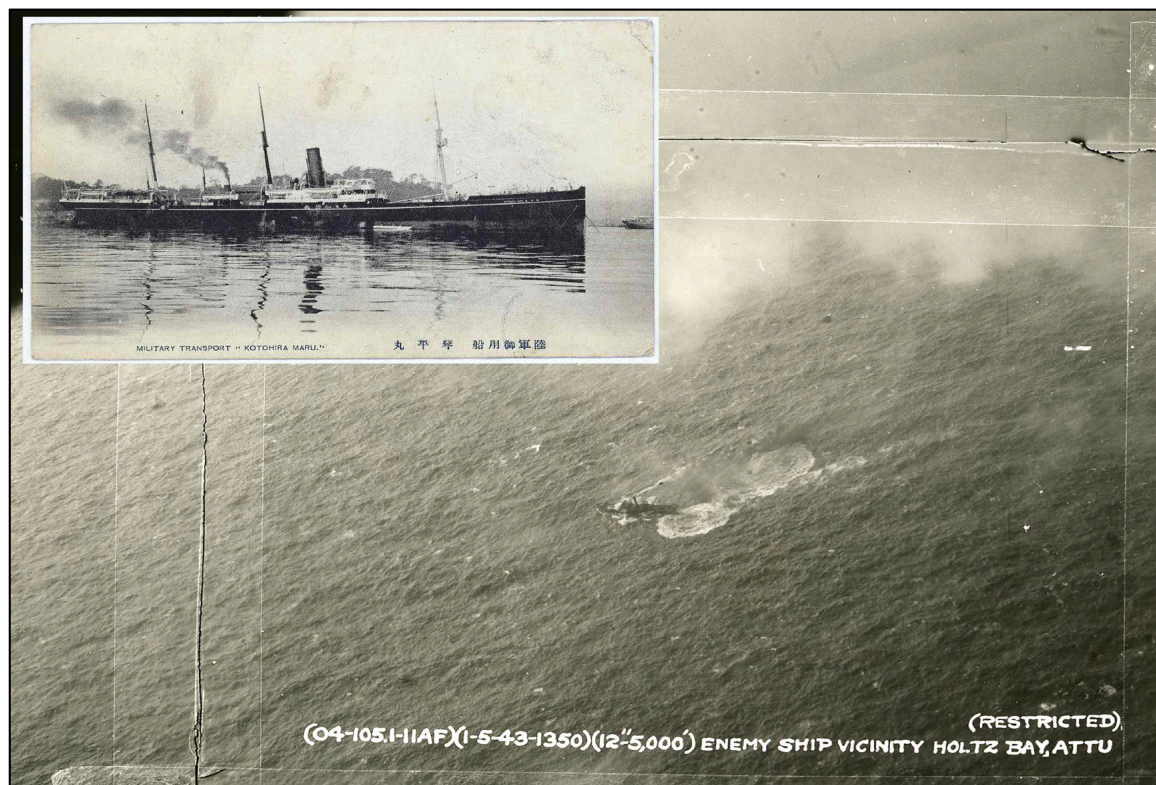
**Figure 3.** Historical photo of *Kotohira Maru* (Yamamoto Museum) and photo taken during the aerial bombing of the ship on 5 January 1943 (National Archives, Record Group 80-S).

The airmen observed a ship weighing at least 5000 tons and measuring 120 m long attempting to enter Holtz Bay (Figure 3). The vessel's construction was described as including a single tall stack amidship, two stick masts, a counter stern, and two heavily loaded well decks [45]. The weather plane dropped a dozen 500-pound bombs equipped with one tenth of a second delay noses and 45 s delay tail fuses from 1500 m. The B-24 scored two direct hits on the vessel's side and bow, with aerial photos taken during the attack showing that the ship was left burning and down by the bow, nearly 8 km from the shoreline. The following day, a second B-24 weather plane confirmed the freighter's sinking, as indicated by the flotsam at the sea surface near the entrance to Holtz Bay [45]. Evidently, news of *Kotohira Maru*'s demise was relayed back to Tokyo, with both wartime records and postwar interrogations confirming that it was in fact the only Japanese ship sunk off Attu on 5 January 1943 [28].

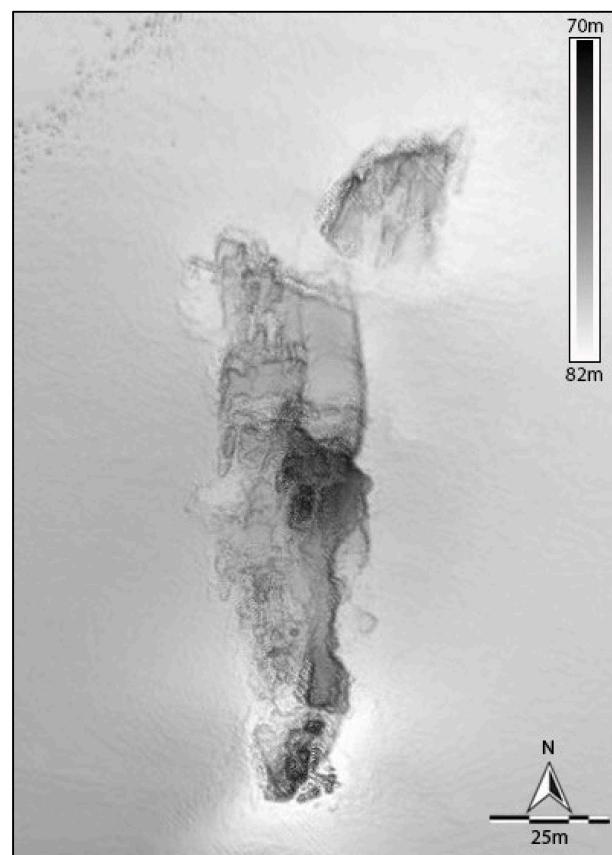
**Figure 6.** MBES imagery of *Kotohira Maru*.

The SAS imagery for the midship section of the wreck (between Hatches 4 and 3) is difficult to interpret. According to the MBES data, this section represents the highest portion of the wreck and likely corresponds to the ship's propulsion machinery (Figure 6). Specifically, the large, highly reflective object seen immediately forward of Hatch 4 appears to be the triple-expansion steam engine. Its position on the wreck accords with the location expected for the engine based on the vessel's construction plans.

Less speculative, is the cylindrical component forward of the suspected engine. This is almost assuredly one of the ship's three scotch boilers. Both the shape and dimensions, 4 m in diameter and 3.5 m in length, match those provided in the machinery report for *Kotohira Maru* [40]. Adding further credence to this interpretation, is the presence of a small

rectangular feature near the boiler. Reminiscent of a hatch coaming, this object is likely one of the vessel's coal hatches, which were situated between the boiler room and Hatch 3 in the same orientation as observed in SAS imagery. Given the elevated nature of the machinery relative to the rest of the wreck, it appears that the vessel's hull has largely collapsed. It is unclear if the deck elements observed represent remnants of the bridge deck, upper deck, or the main deck. Key vertical structures amidship, such as the vessel's smokestack and superstructure appear to be missing or destroyed.

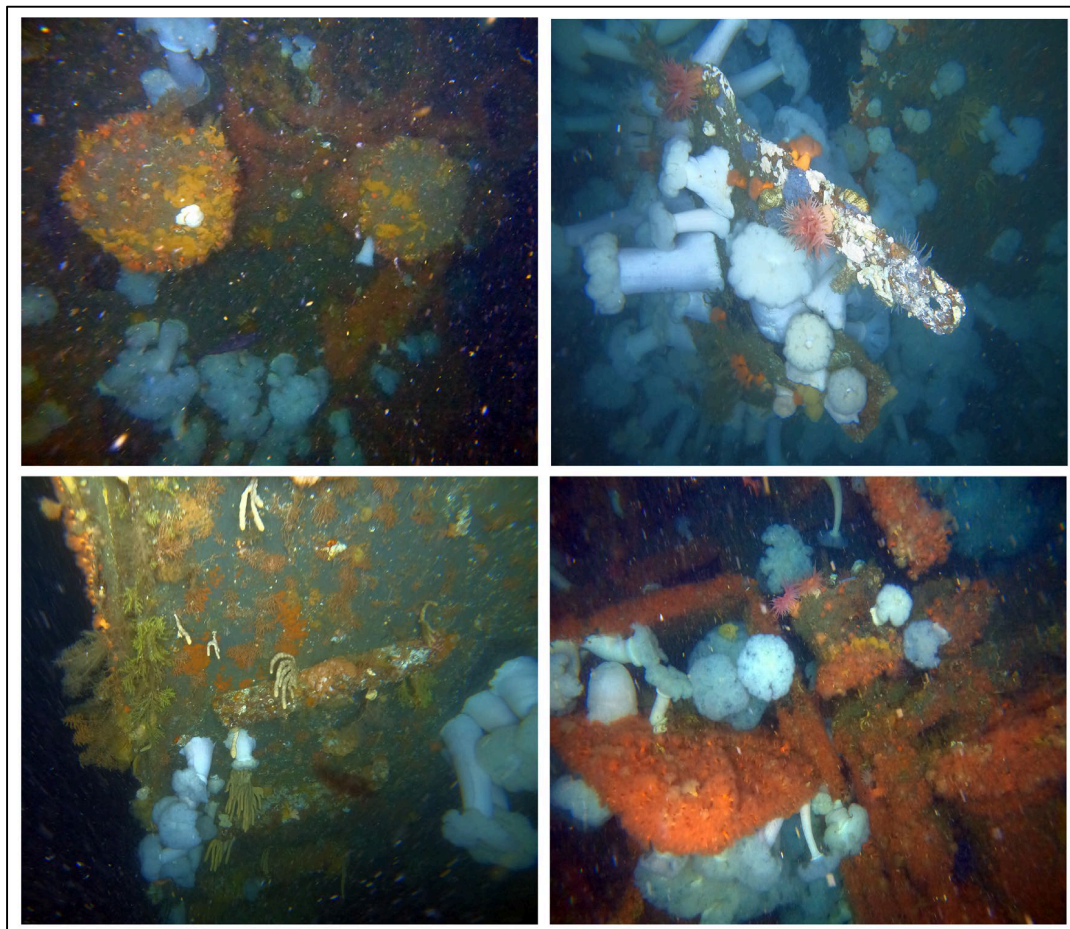
The ROV was deployed four times on *Kotohira Maru*, though as mentioned previously, efforts to photographically document the site were hindered by subsurface currents that proved challenging for it. As a result, the ROV was only able to locate the wreck during two of the deployments. Both times, the investigation focused on the bow quarter, starting with a large metal pole on the starboard side that can be seen in the SAS imagery. The disarticulated nature of this section rendered it difficult to discern specific wreck features beyond the broken deck beams and hull plating (Figure 7).

**Figure 7.** ROV imagery of *Kotohira Maru*. (**Top Left**): Deck bollards; (**Top Right**): Broken deck plating with significant anemone growth; (**Bottom Left**): Hull plating with cargo batten; (**Bottom Right**): Piping with increased corrosion and benthic growth.

Wreck surfaces demonstrated little in the way of corrosion, as the original steel was readily visible. Corrosion tended to be higher on piping and other internal components that could be seen amongst the wreckage. Benthic colonization in the surveyed area was dominated by anemones, namely white-plumed anemones (*Metridium farcimen*), who appear to outcompete sponges and cold-water corals at this depth. It is recommended that a robust ROV system with more powerful thrusters and a dedicated transponder tracking system be employed to properly record the full extent of the wreck. Doing so could capture data useful for interpretation, for better understanding the benthic environment and ecological characterization, and for the creation of public outreach materials.

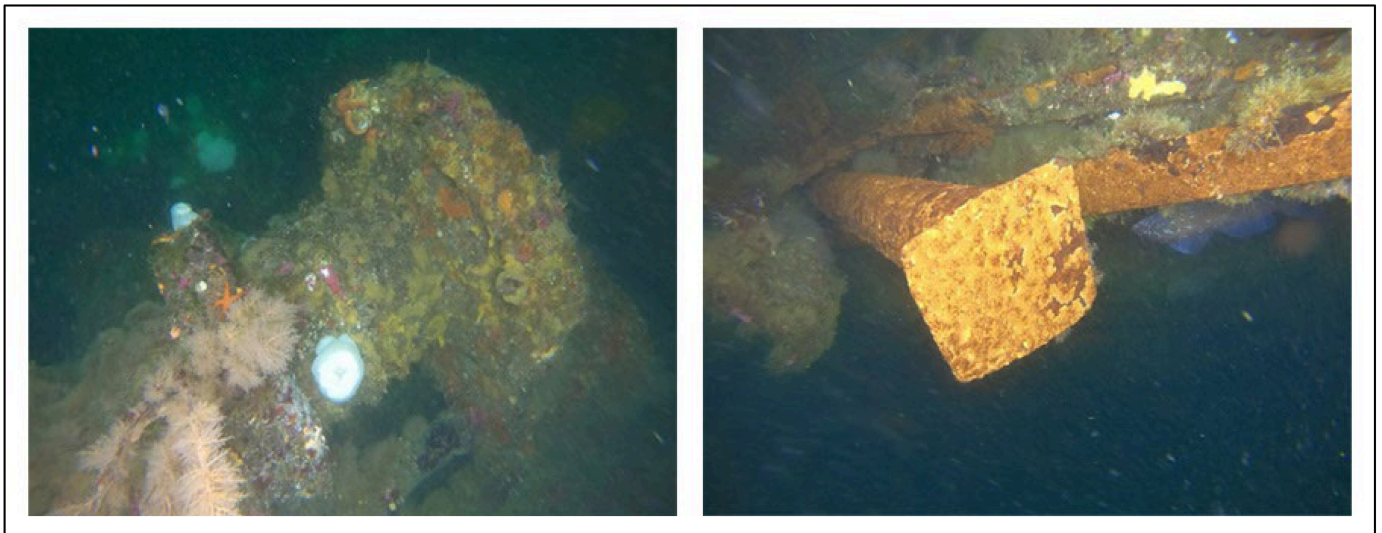
**Figure 10.** ROV imagery of SS *Dellwood*. (Left): Winch from the mast bed displaying significant calcareous concretion; (Right): Corroded deck beams.

macrobiofouling (e.g., anemones) less prevalent. Unfortunately, maintaining position over the site was extremely challenging due to very strong surface currents at the mouth of the bay. As a result, the ROV was only able to capture the opposite end of the wreck. Despite this limitation, a partial photogrammetric model was constructed of the area surveyed. This optical imagery yielded valuable insights into interpreting both the elevated feature and the wreck site as a whole (Figure 11).
