Corrosion Studies on the USS Arizona with Application to a Japanese Midget Submarine

The assessment of corrosion on the USS Arizona included the pioneering development of a minimum-impact cost-effective technique to determine the corrosion rate of steel-hulled shipwrecks in seawater. The technique, with potential application worldwide, is illustrated in this paper with the application to a World War II Japanese midget submarine submerged in deep waters off the Oahu, Hawaii, coast.

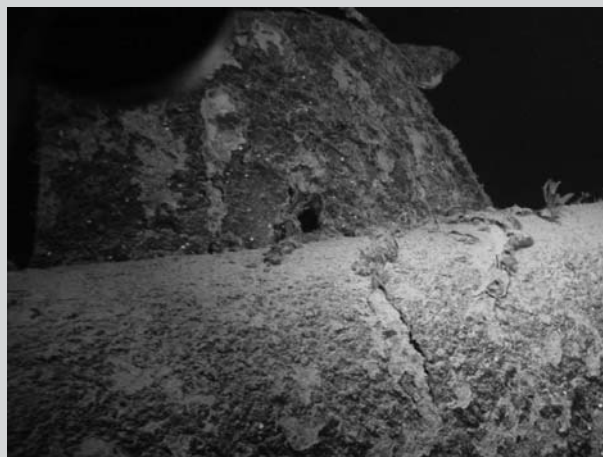
Figure 1. A shell hole at the starboard base of the conning tower on the Japanese midget submarine. Photo courtesy of the National Oceanic and Atmospheric Administration/Hawaiian Undersea Research Laboratory.

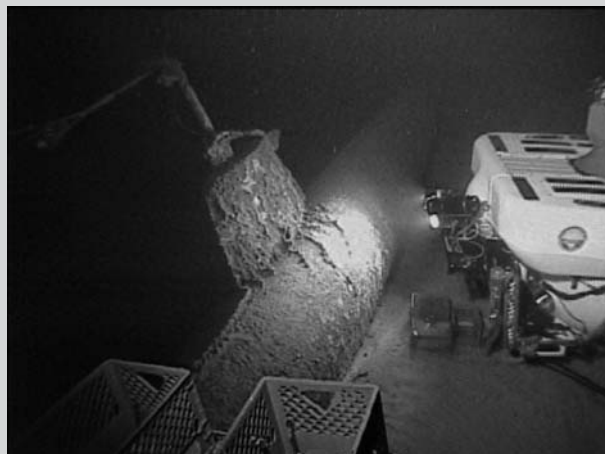
Figure 3. The aft end of the Japanese midget submarine during collection of concretion samples. Photo courtesy of the National Oceanic and Atmospheric Administration/Hawaiian Undersea Research Laboratory.

water. In a later submersible descent, several small segments of marine concretion were recovered from the aft end of the midget sub by the robotic arm of HURL's *Pisces* submersible (Figure 3). These samples were analyzed in metallurgical and chemistry laboratories at the University of Nebraska–Lincoln, and x-ray diffraction measurements were conducted at the Air Force Research Laboratory, Eglin Air Force Base, Florida. The purpose of this paper is to review Corrosion Equivalent Corrosion Rate (CECR) methodology,² a minimum impact technique pioneered on *Arizona*, and its application to estimate the average corrosion rate of the external hull of the midget submarine. A second purpose is to present the results of x-ray diffraction studies on the concretion samples and to relate these results to physical and chemical properties of the submarine's concretion.

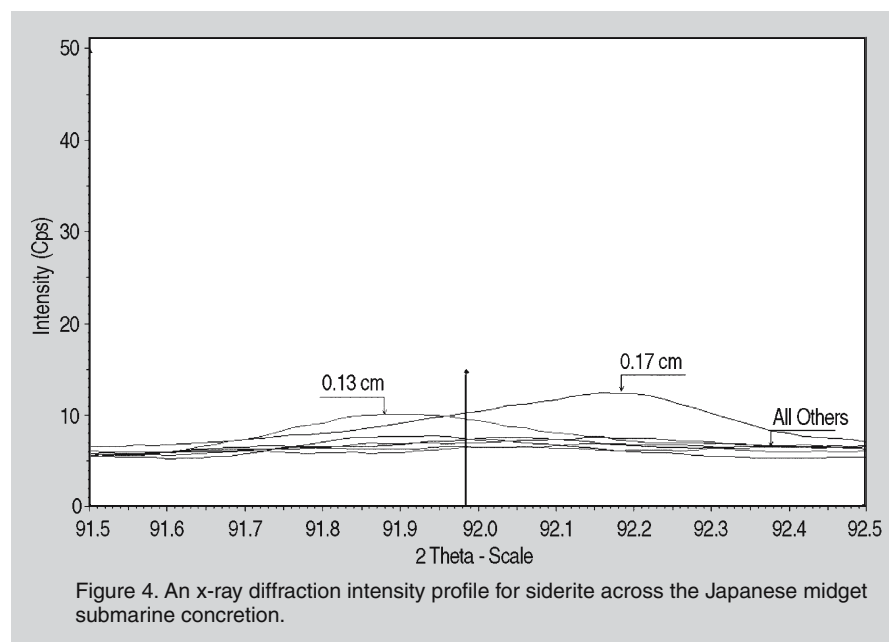
Figure 4. An x-ray diffraction intensity profile for siderite across the Japanese midget submarine concretion.

Maximum siderite toward seaside (Figure 4) suggests that iron diffusion through the concretion is fast relative to siderite formation kinetics. The exact mechanism by which siderite forms is unknown, but it is probably related to iron exchange with calcium in calcium carbonate.¹² North reported that the original aragonite skeletal material was converted into various iron compounds with siderite being the most common. Maximum goethite and magnetite toward

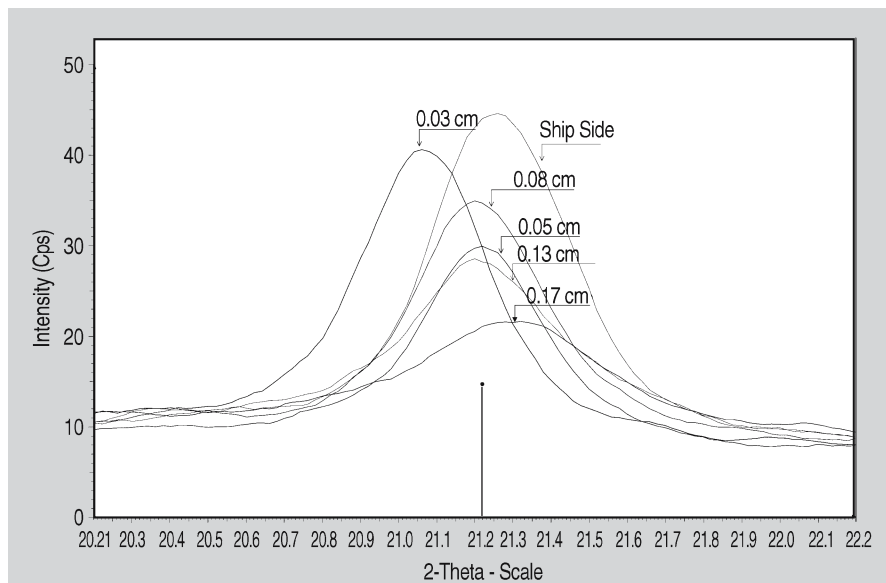
Figure 5. X-ray diffraction intensity profiles for goethite across the Japanese midget submarine concretion.

shipside (Figures 5 and 6, respectively) suggests that oxygen diffusion is fast relative to iron oxide formation kinetics. The presence of goethite in the concretion rather than at the metal/concretion interface, as in the case of *Arizona*, may explain the higher iron content in the midget submarine concretion than in *Arizona* concretion. Although a chloride-containing oxide, akaganeite, appears in *Arizona* scale, no chloride containing oxides appear in the midget submarine concretion. Other research indicates that akaganeite forms after the concretion is exposed to air,¹³ which may explain the presence of this mineral in *Arizona* concretion, but it does not explain its absence in the midget submarine concretion.
