AUSTRALIAN HISTORIC SHIPWRECK PRESERVATION PROJECT

THE IN-SITU PRESERVATION & REBURIAL
OF THE COLONIAL TRADER CLARENCE (1850)

Excavation & Monitoring Programme Report *2012–2015*

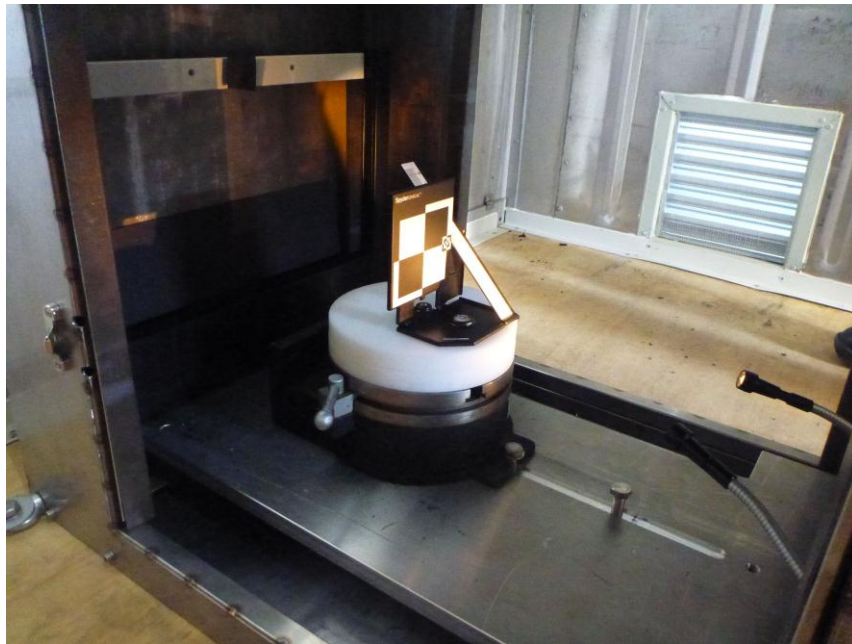
Figure 12. Object placed on rotary stage. Photo by D. Creagh.

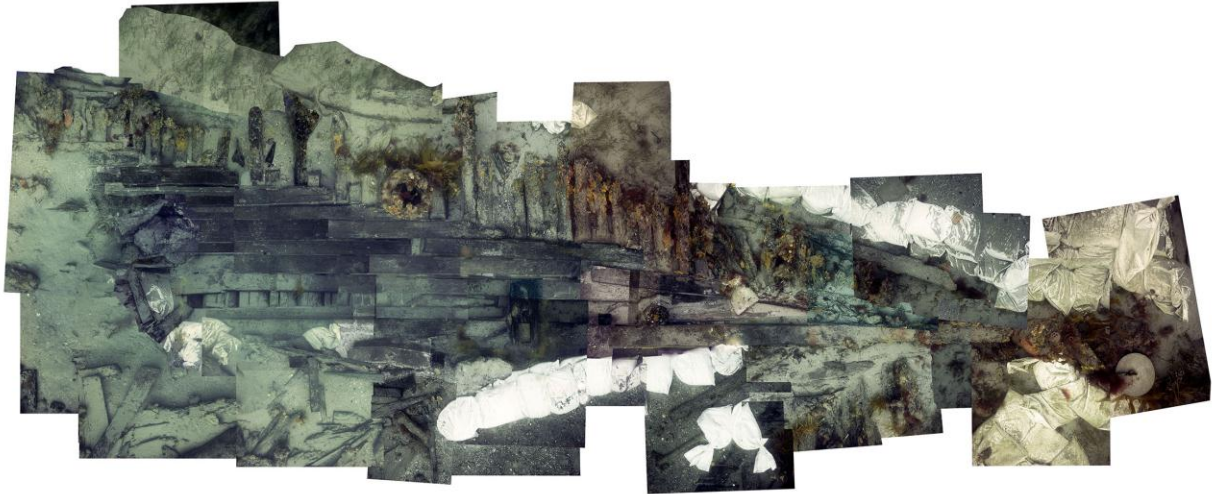
Figure 21. Photomosaic of *Clarence* post-excavation. Image created by D. Shefi.

Stills and video were taken of all excavation squares, and exposed features; multiple linear transits were made of the site and excavation area; and, complete mosaics were made at different flying heights over the site. Sufficient saturation and wrap-around runs were made to complete Surface from Motion 3D reconstructions and also photomoaiscs. Availability of AgiSoft Photoscan by the end of the project allowed more detailed 3D photogrammetry (Fig. 22) and heightfield data models (Fig. 23) to be completed by Kevin Edwards. Profiles across the hull can be reconstructed from these hightfield data.

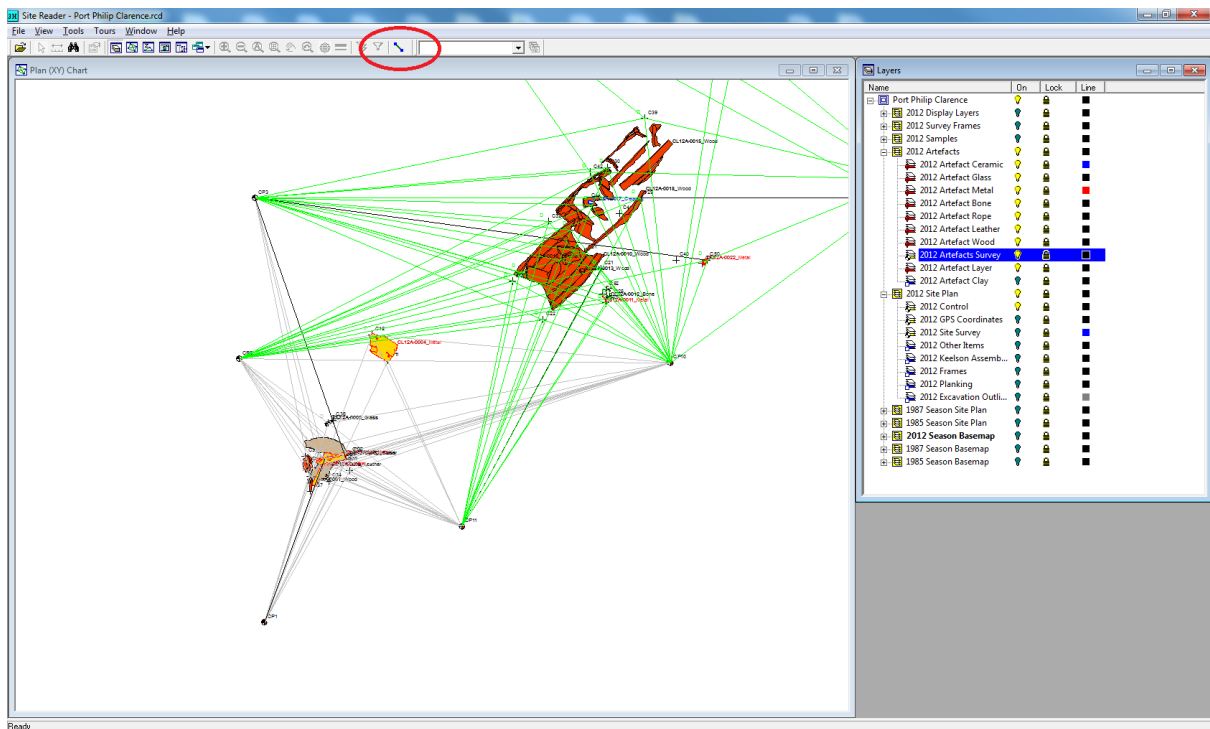
Figure 25. Site Recorder 4 screen shot showing measurements taken to points on artefacts *in situ*. Image by A. Khan.

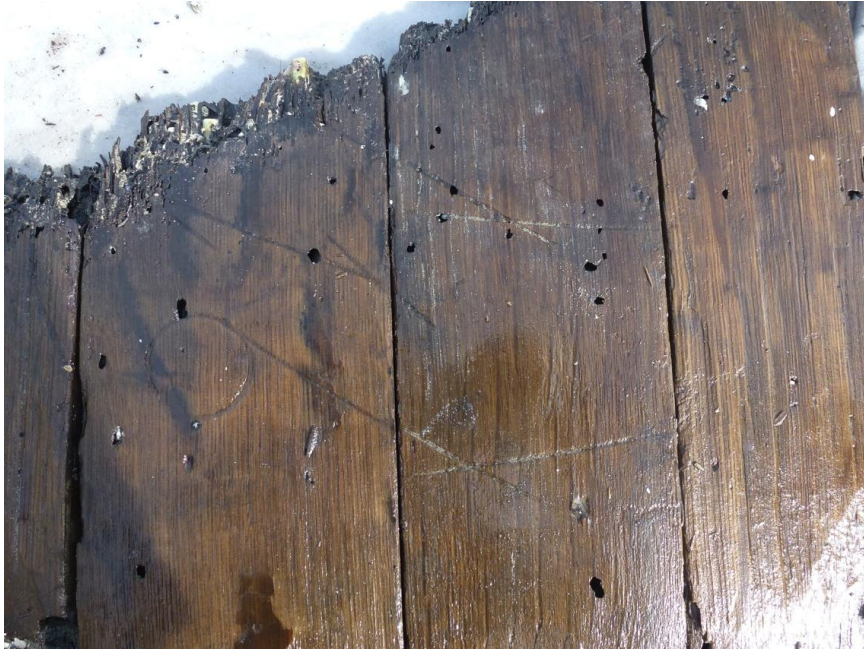
Figure 28. Assembly marks inscribed on a cask head (127.00099). Photo by J. Rodrigues.

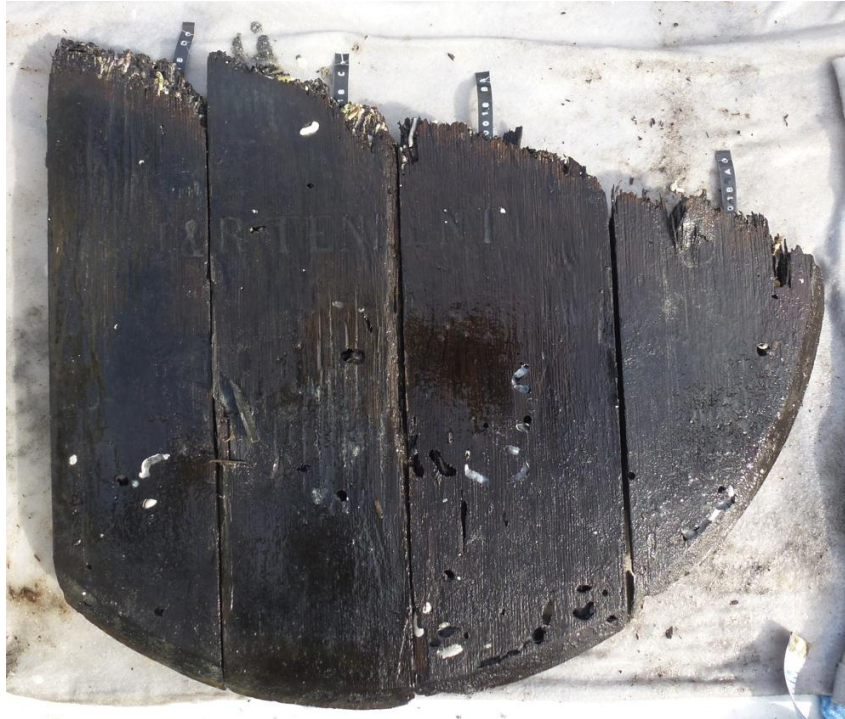
Figure 29. Headpiece (127.00102) branded with 'J & R TENNENT'. Photo by J. Rodrigues.

The *Clarence* cask headpieces were branded with names that suggest these casks may have contained ale; however, it should be noted that coopers often re-used cask components for economic reasons. Some sets of headpieces, consisting of the cant and middle pieces, were branded with one of three names: 'J & R TENNENT' (Figs 29 & 30), as well as 'SAMUEL' and 'BURTON' (Fig. 31), which while branded separately, were on the same headpieces. These names, either partial or complete, were located on the topside. To date, at least one identity of J & R Tennent has been traced to Wellpark Brewery in Glasgow, Scotland, which was in operation in the 1840s. If some of the casks originated from an overseas brewery, it is possible that the casks and similar contents were continuing to be transported elsewhere along a trade route or the casks or some components were being re-used. The latter option was not an uncommon practice by coopers.

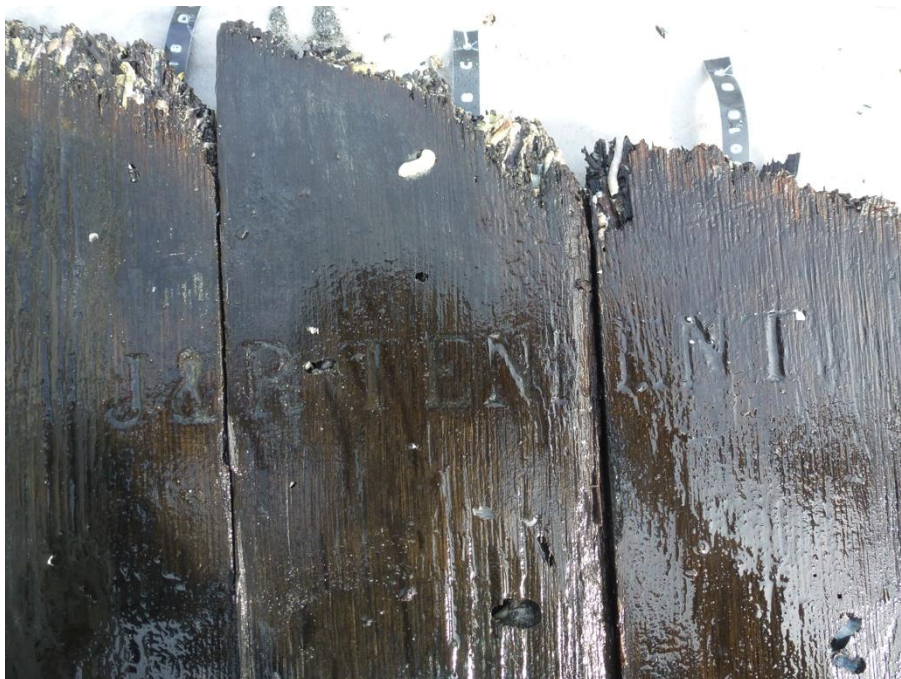
Figure 30. Detail of headpiece (127.00102) branded with 'J & R TENNENT'. Photo by J. Rodrigues.

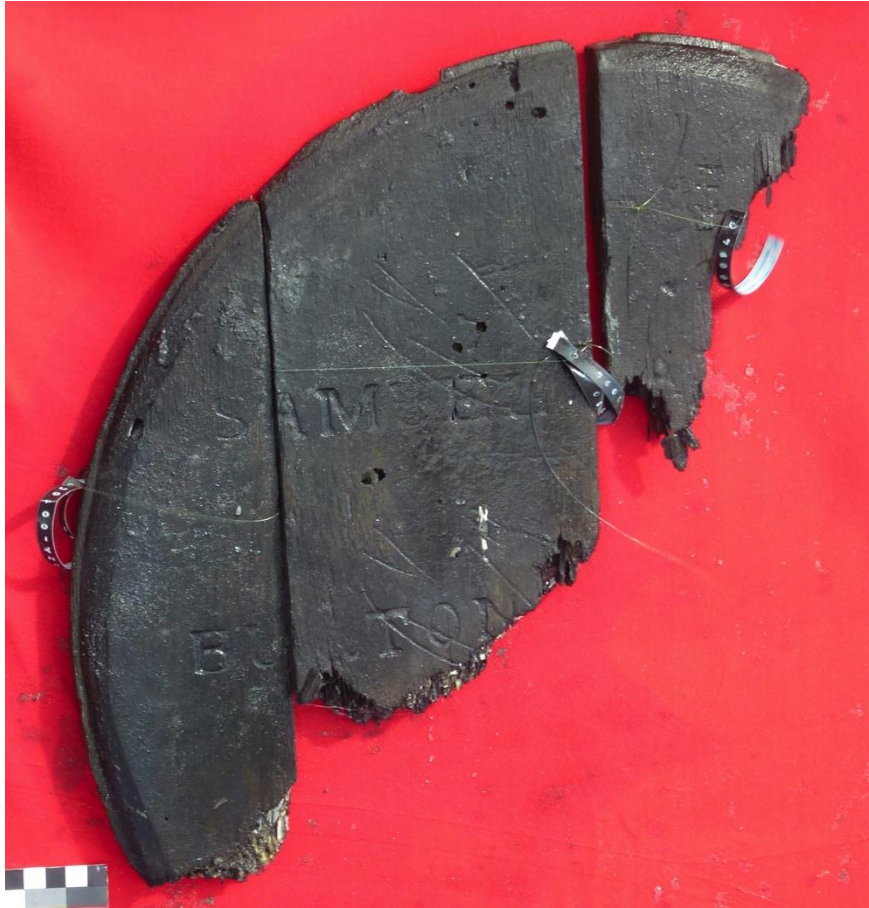
Figure 31. Headpiece (127.00094) branded with 'SAMUEL' and 'BURTON'. Photo by J. Rodrigues.

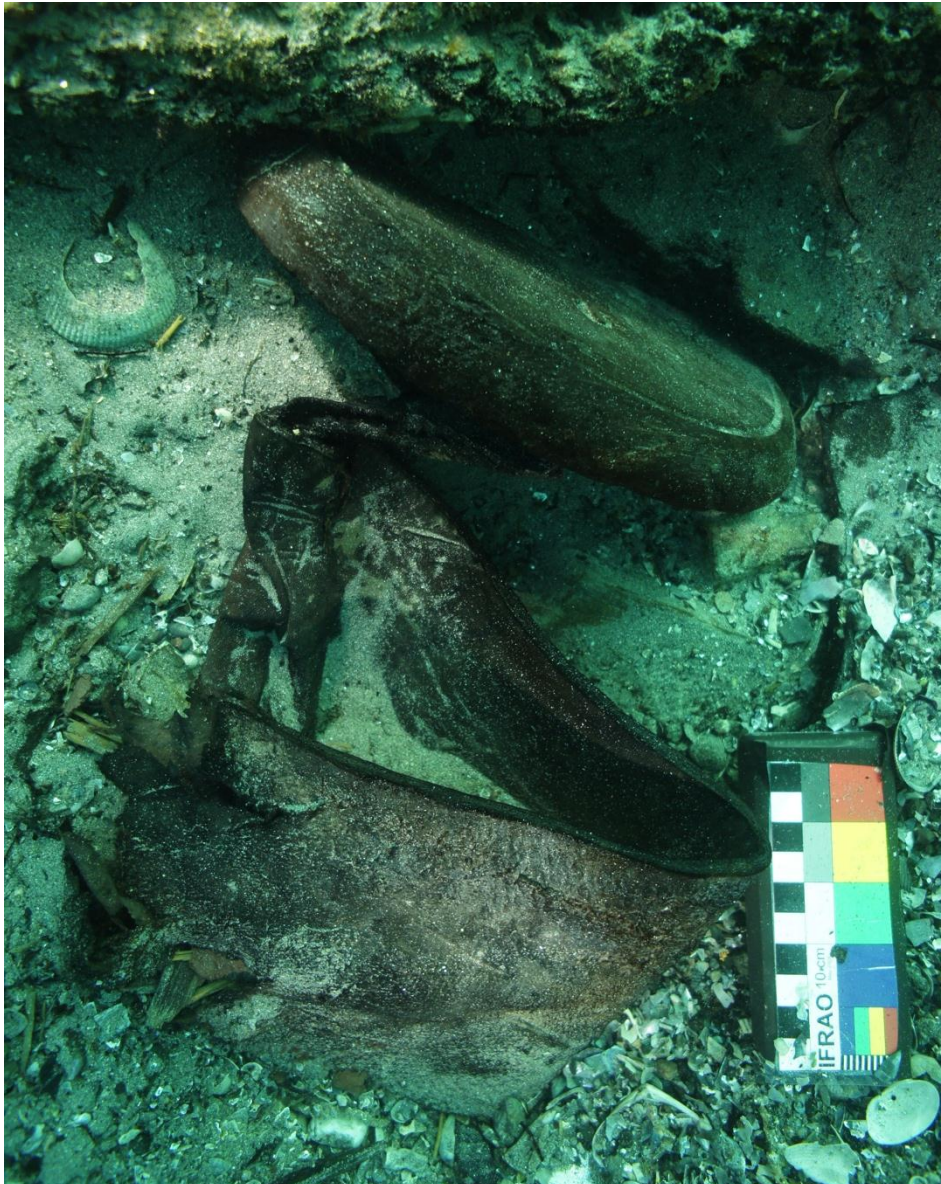
Figure 32. Leather bag or satchel *in situ*. Timber base (127.00091) visible at top of image. Photo by D. Shefi.

examined the artefact assemblage *in situ*, this is thought to be a bosun's bag (Fig. 32). The size and thickness of the leather satchel suggests it may have been used to carry tools (i.e. for repairing masts or rigging), as it appears to have a strap to sling over the shoulder. Interestingly, Kilby's (1971: 164) text on coopers and their craft illustrates a 19th century travelling cooper carrying an over-the-shoulder leather bag or basket containing tools.

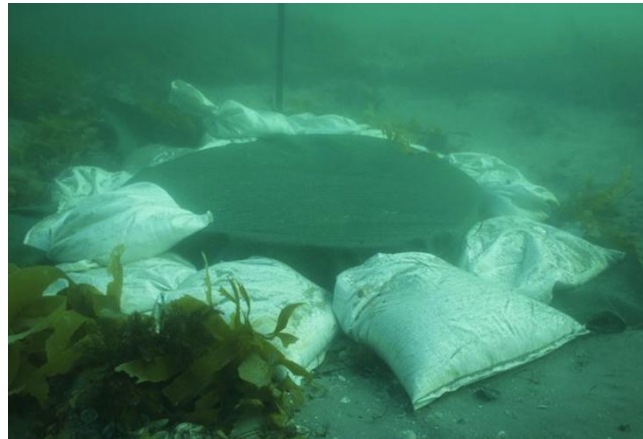
Figure 33. Off-site storage depot at the end of the May 2012 fieldwork period. Photo by J. Parkinson.

A proprietary 2000 L high density polyethylene water tank (1.8 m height; 1.2 m diameter) was purchased, the ends cut off and the tank sawn in half. This cylinder (1.0 m height) was then dredged into the seabed 10 m south of the site, just off the starboard stern. The sand was dredged from within the confines of the cylinder and the least degraded organic artefacts (i.e. two wooden barrels and leather artefacts) placed at the bottom of the depot, covered with 10 cm of surrounding sand then the more fragile organics (i.e. rope, dunnage and the most degraded barrel) were placed on top of this layer. The depot was then backfilled with surrounding sediment, covered with shadecloth and anchored with polypropylene sandbags (Fig. 33).

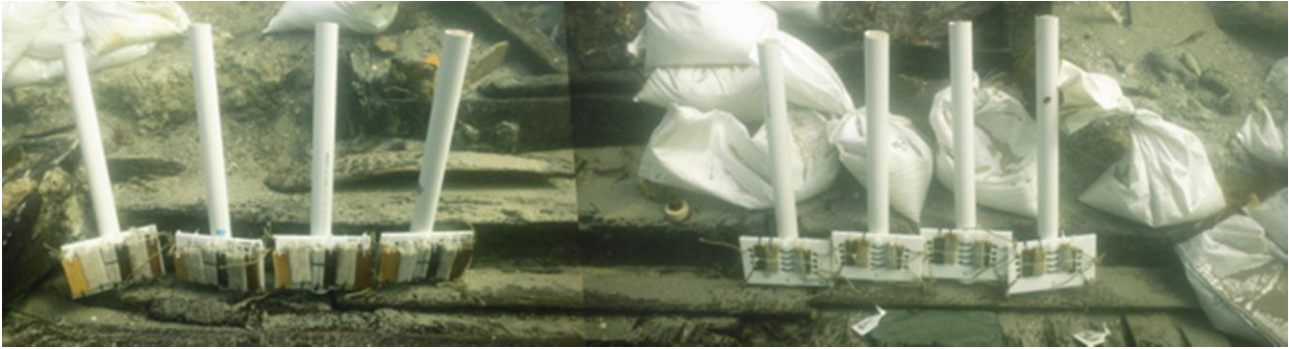
Figure 34. Sacrificial iron and wood samples and wrapped metal artefacts on site prior to reburial. Image by K. Kasi after J. Parkinson.

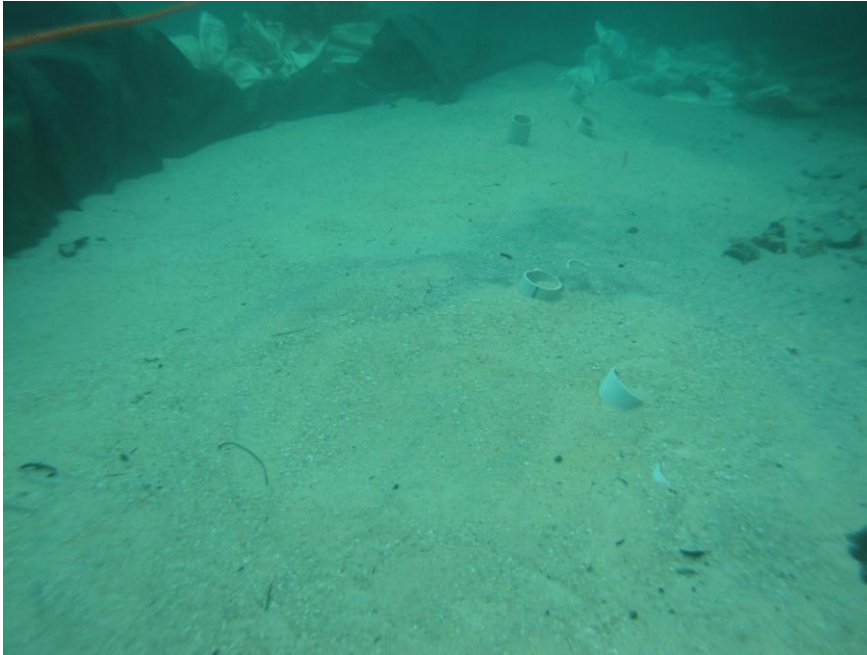
Figure 35. Sacrificial samples covered with 1 m of sand. Photo by AHSP.

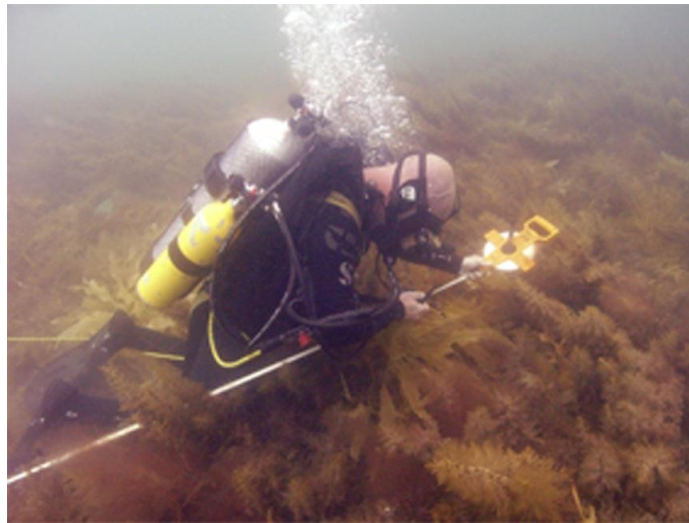
Figure 36. *Clarence* in December 2014, two years after covering the site with PVC tarpaulins. Photograph by J. Carpenter.

Over twelve months from November 2012, visual inspections of the site indicated that the *in-situ* preservation strategy had been successful. All sandbags were in place and the PVC tarpaulins were mostly intact despite evidence of angler visitation. There was some entrapped sediment over the site and extensive colonisation by marine organisms (Fig. 36). The sediment under the shadecloth was grey in colour indicating a low oxygen environment.

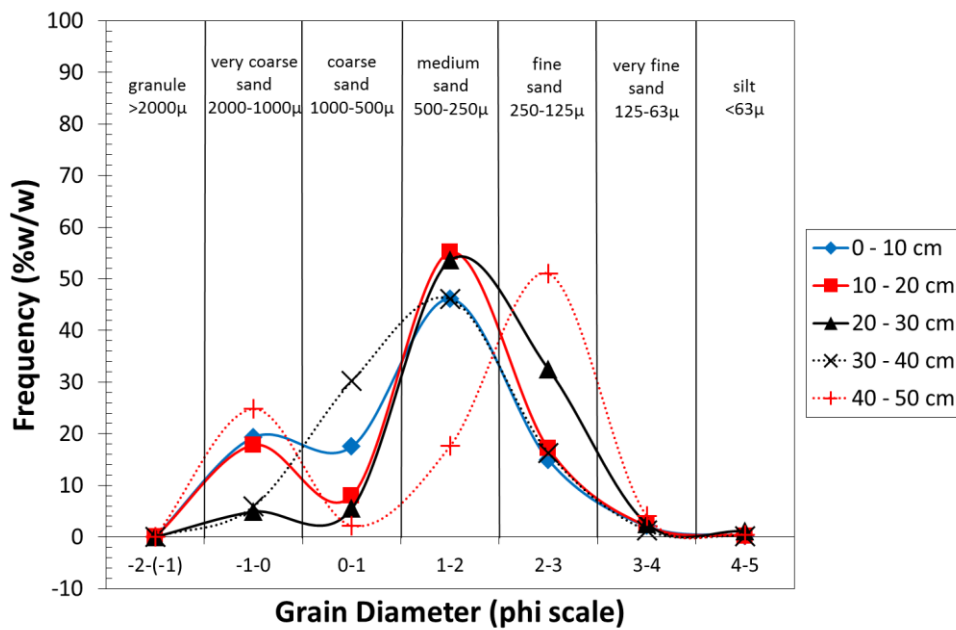
Figure 37. Grain size distribution of the baseline sediment on *Clarence* prior to excavation in April 2012.

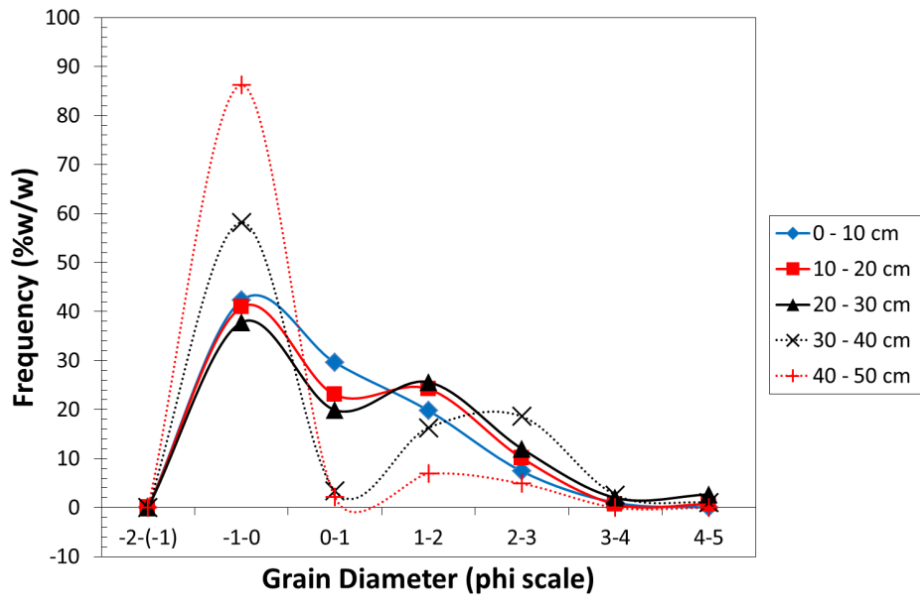
Figure 38. Grain size distribution of the reburial trench sediment in December 2014 (30 months after reburial; 25 months after covering).

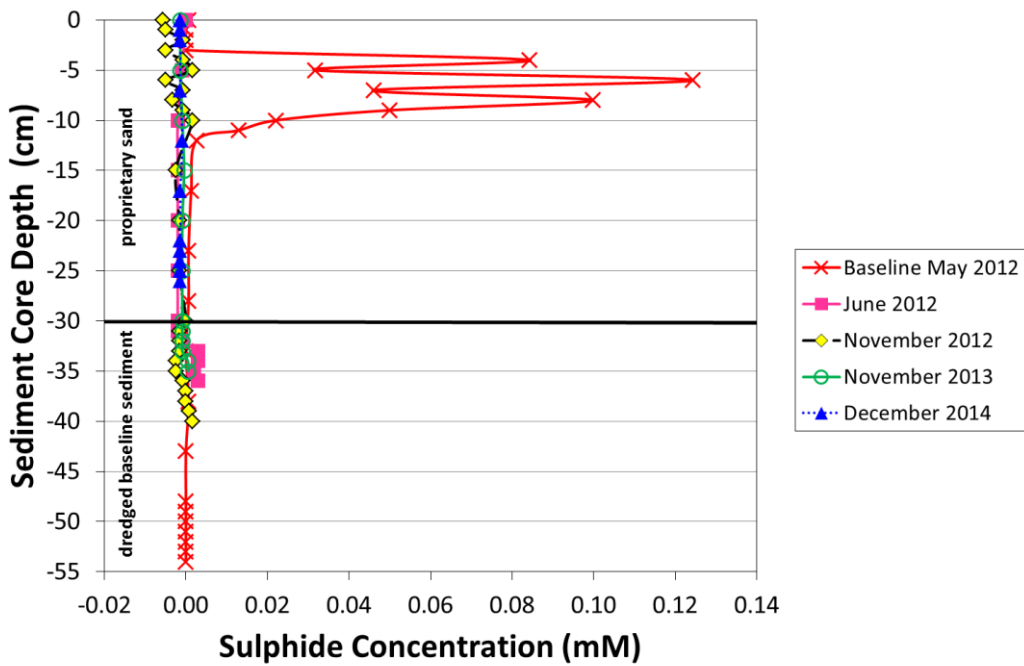
Figure 42. Sulphide contents in the baseline and reburial trench sediments.

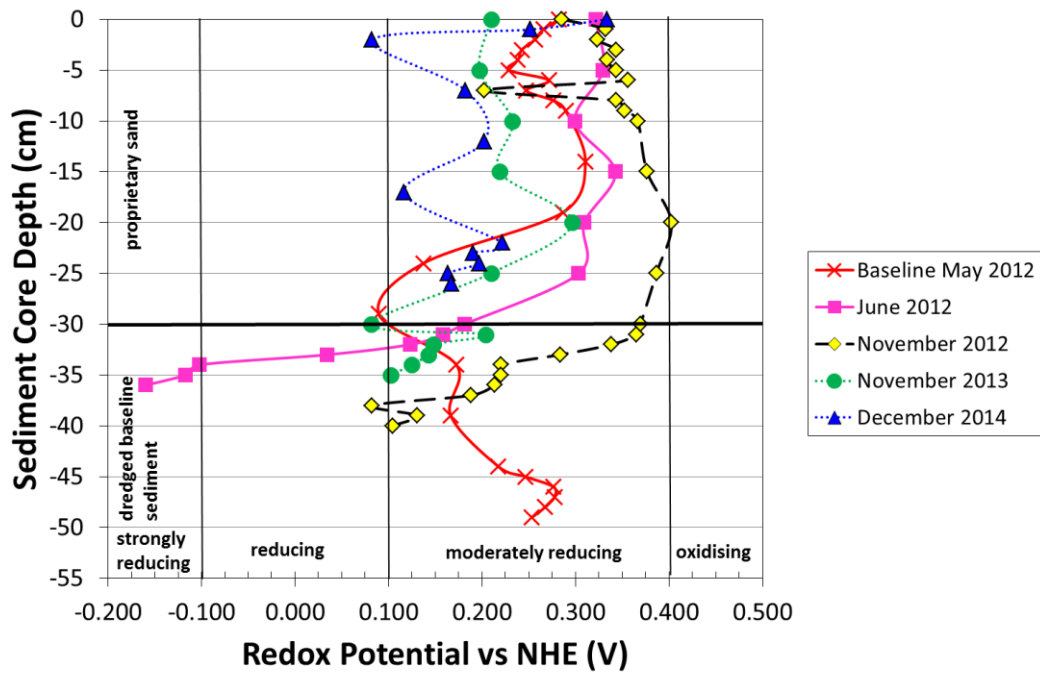
Figure 43. Redox potential profiles of the baseline and reburial trench sediments.

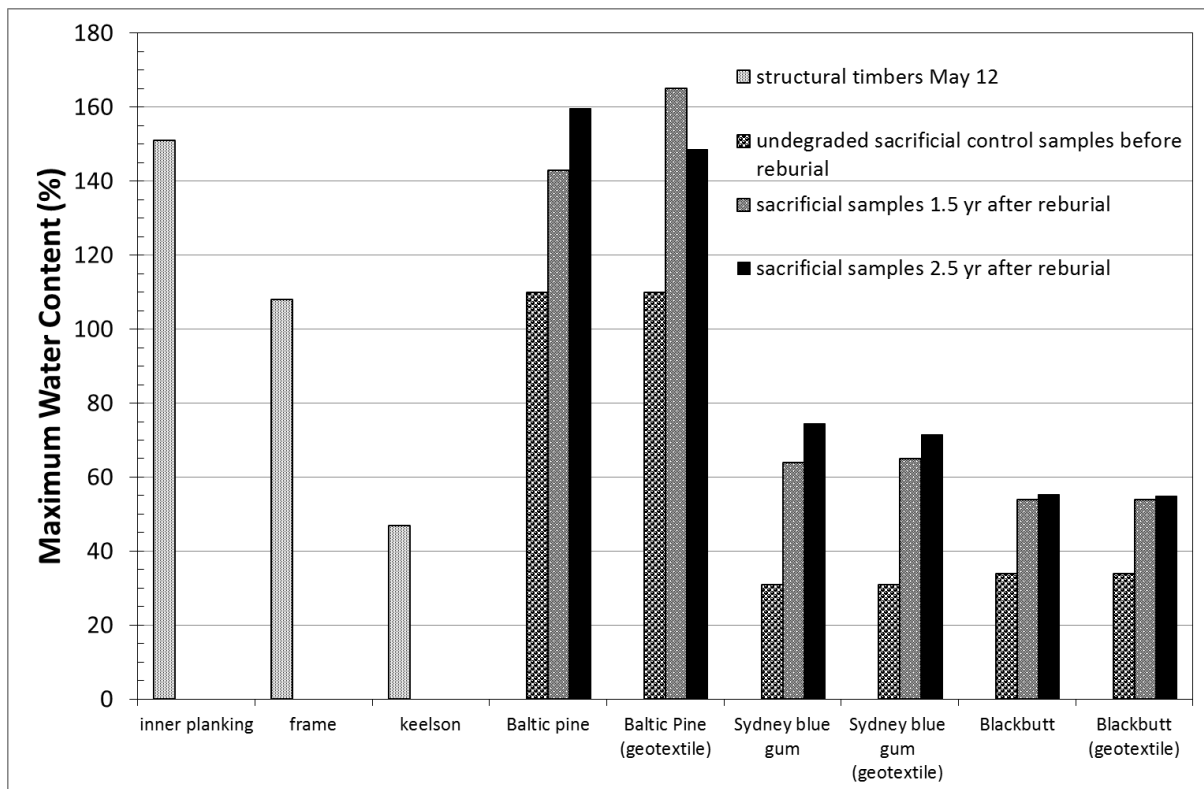
Figure 45. Maximum water contents of the structural timbers and modern undegraded and degraded sacrificial samples.

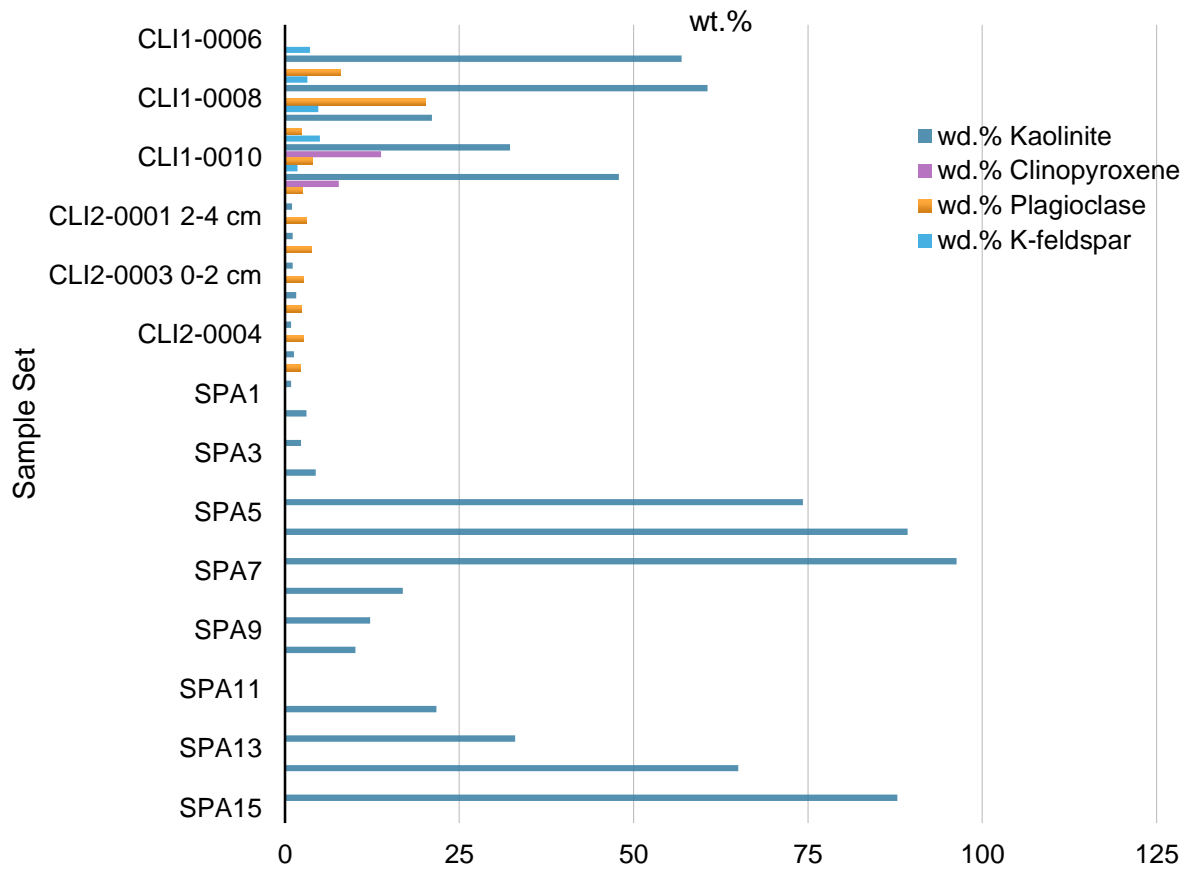
Figure 48. Mineralogical percentages of kaolinite, clinopyroxene, plagioclase and K-feldspar in Sets A, B and C.

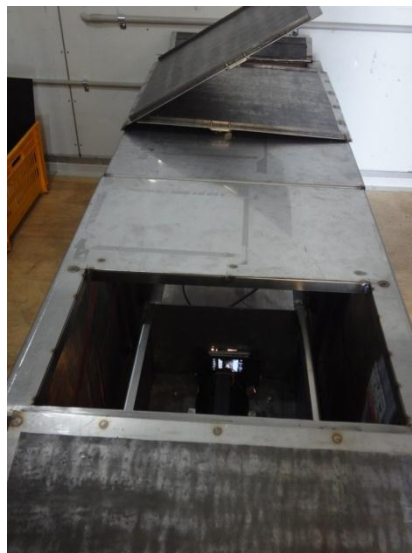
Figure 1. X-ray enclosure showing the access doors for the X-ray source, the specimen stage, and the imaging plates. The X-ray source has been removed, and the camera inserted. The photographic image, presented on the viewing screen of the camera can be seen.

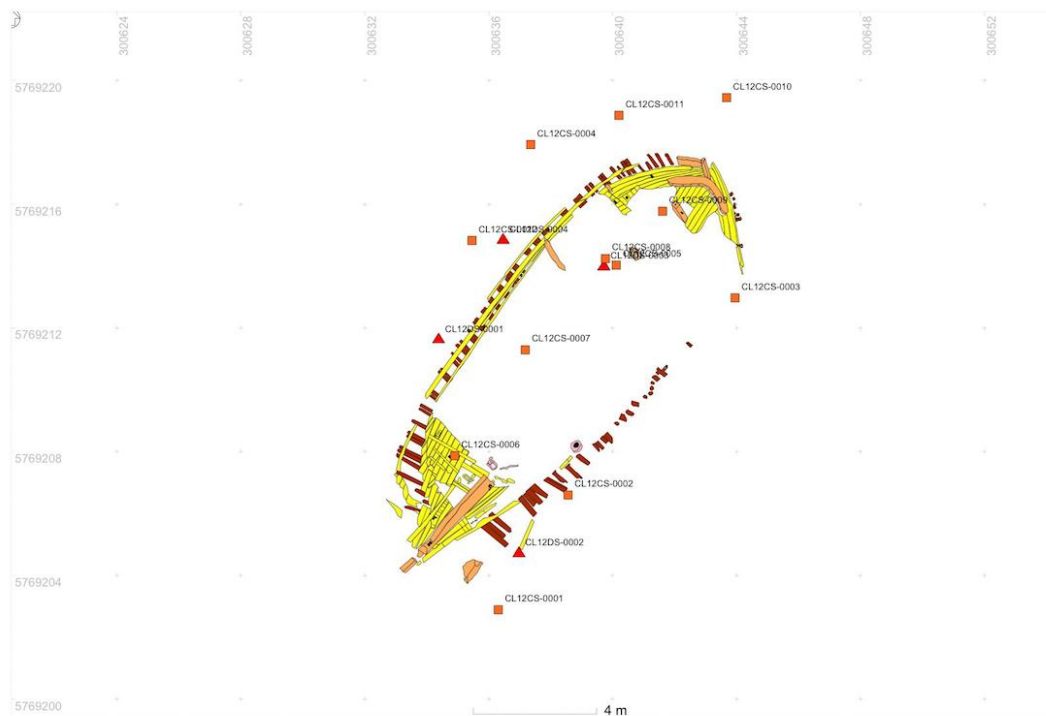
Figure 1. Short core and grab sample locations in the wreck of the *Clarence* (A. Khan).

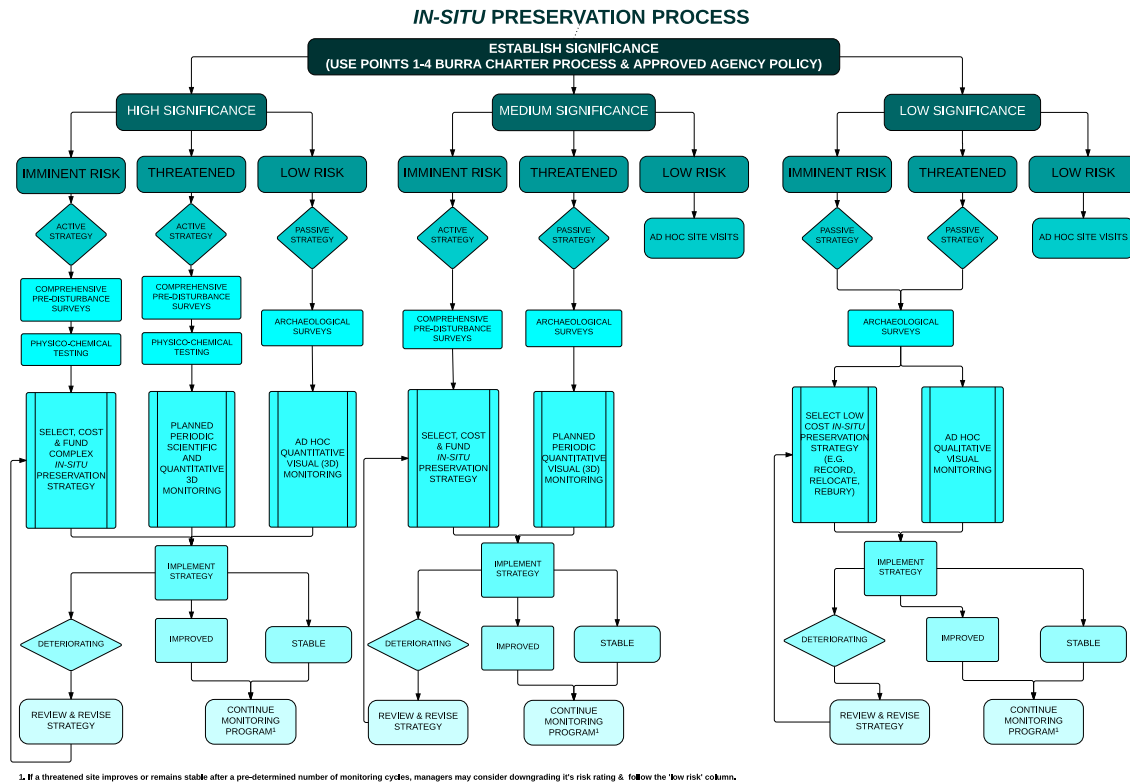
Figure 2: Flow chart for *in-situ* preservation processes.
