Rapportage  
Archeologische  
Monumentenzorg

# A Swedish man-of-war in Dutch waters

*An archaeological field evaluation of the wreck  
of the Sophia Albertina*

A.B.M. Overmeer

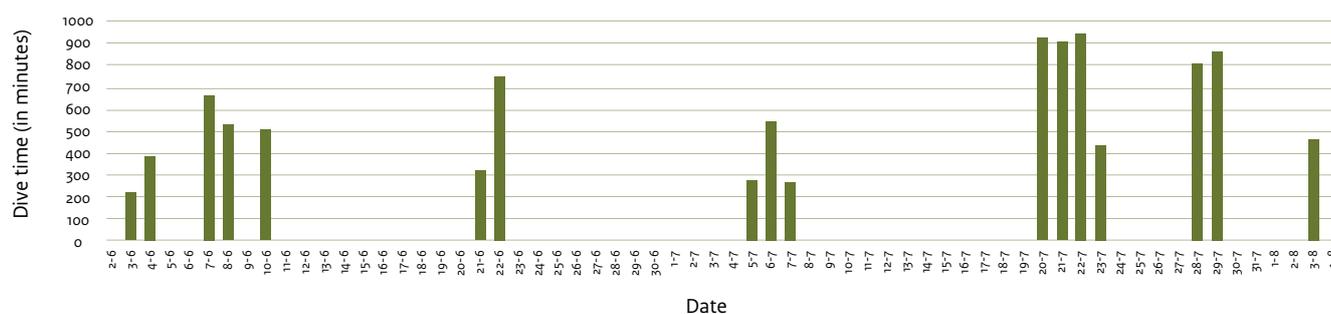
Graph 1: Total number of dive minutes per day at 'Noorderhaaks 10/Sophia Albertina'

Dives at the Noorderhaaks 10/Sophia Albertina site were made using an enriched nitrox mixture with an oxygen content of 40%. The diving team always work in compliance with the Netherlands Diving Centre (NDC) tables, especially ND88, the table for air. These tables are adapted when nitrox is used instead of air. This involves calculating an equivalent air depth (EAD) for the maximum dive depth. The EAD for the expected maximum depth of the site (21 m) is 13.5 m. With this EAD, the maximum free dive time (i.e. with no decompression stops) is 60 minutes. If the dive depth does not exceed 19 m, the EAD is 12.0 m and the associated free dive time rises to 115 minutes.

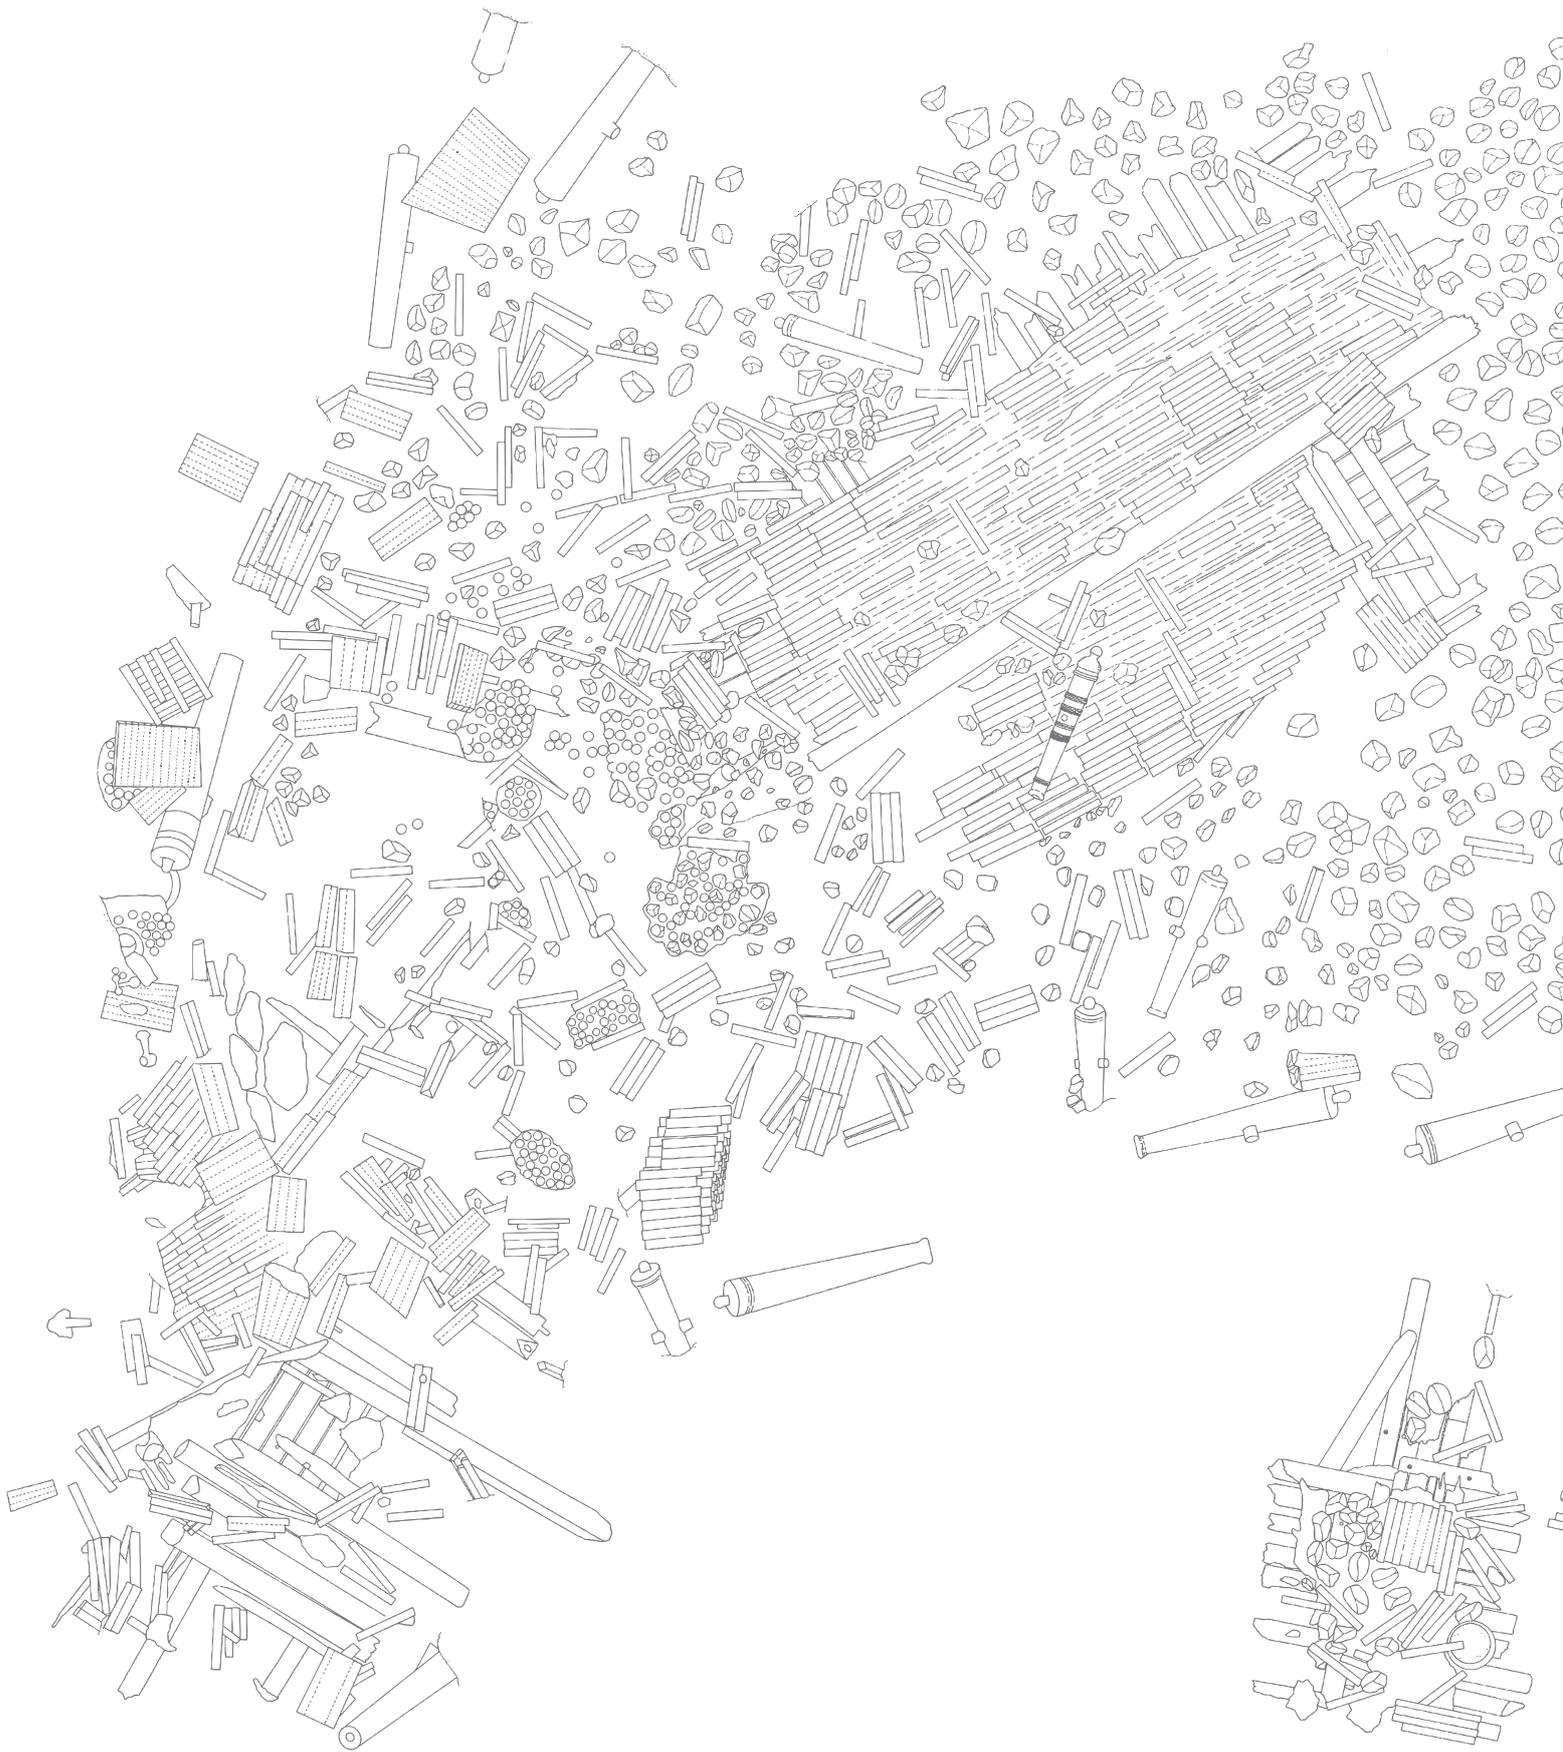
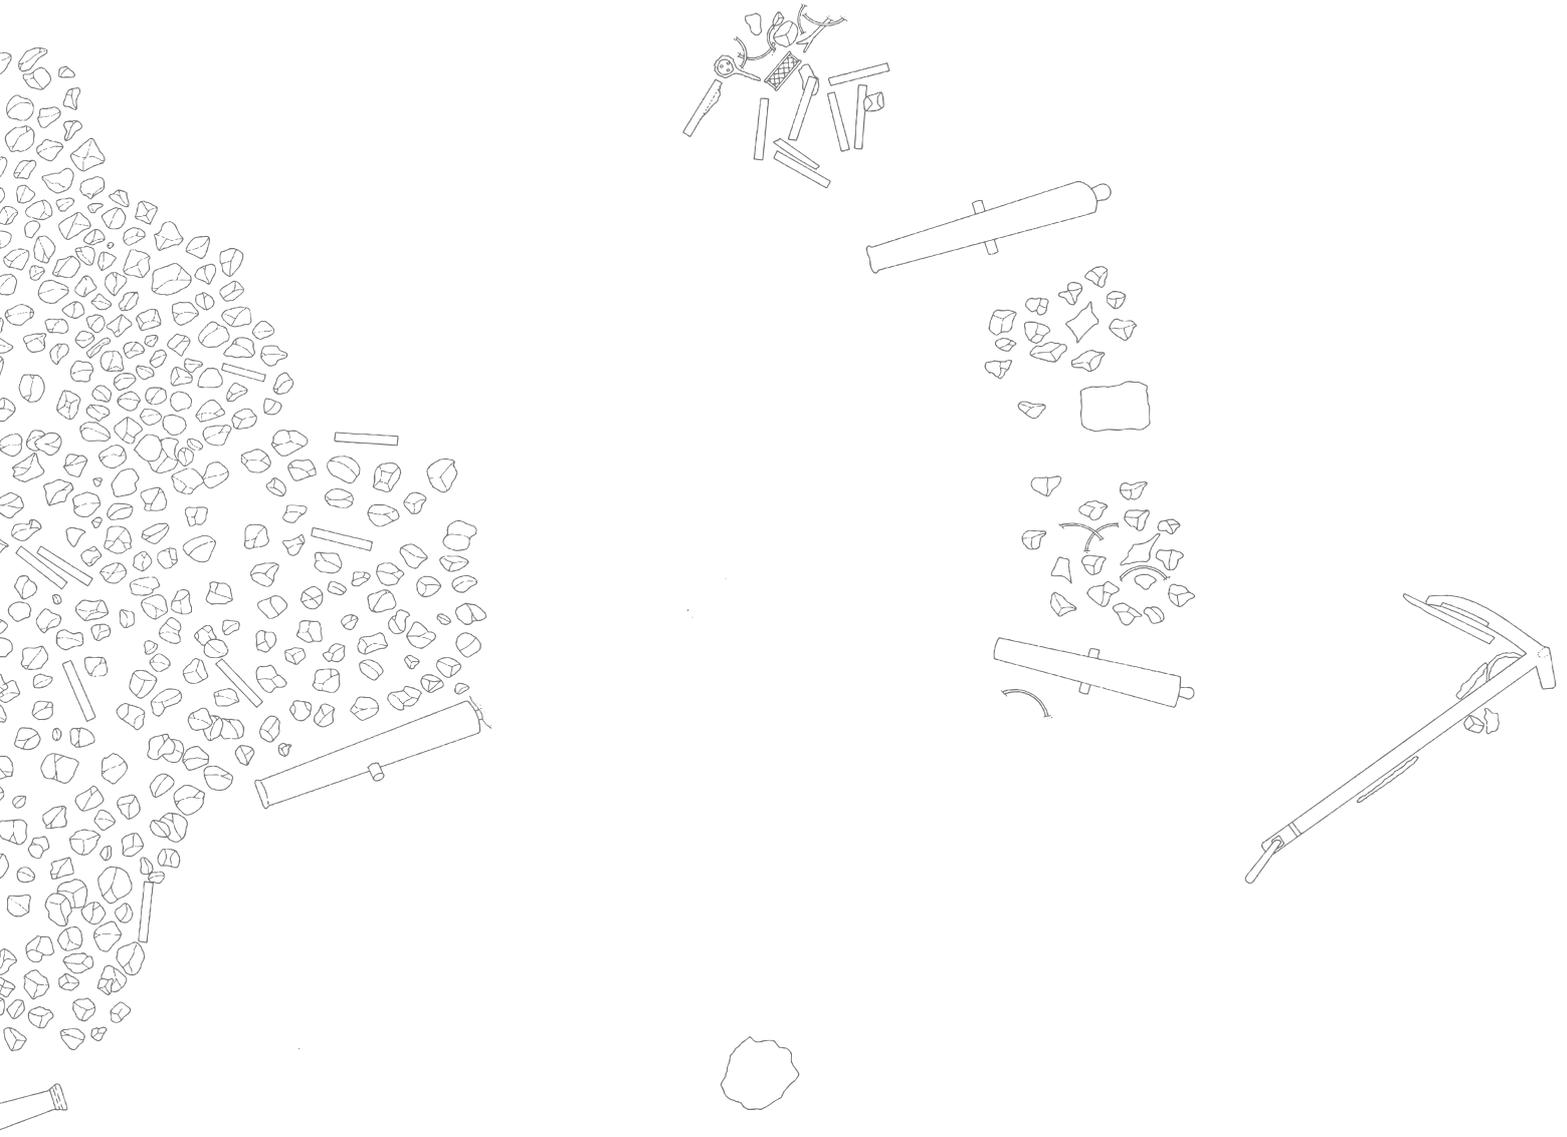
Illustration 20: Overall site plan of the Sophia Albertina (drawn by E. van Gent, RCE)

and cannonballs encrusted together. Only sporadically is the ship's structure found in association. A second fragment of the ship measuring 8 by 6 m lies in the southern part of the site. It does not appear to be associated with the ship's structure under the platform of iron, but this has not been established with any certainty. This fragment is part of the ship's bottom that is broken at the turn of the bilge. It lies upside down; the eleven heavy floor timbers have been tapered on the western side to form a scarf joint and they display a slight curvature on the underside (see also section 4.2.4). Beneath the floor timbers are seven ceiling planks, the planking from the inside of the ship.

In the southeast of the site lies a third fragment of the ship (illustration 19). Measuring 6.5 by 4.5 m, it consists of a large lump of concretion beneath which lie ten timbers and several hull and ceiling planks, probably from the ship's bottom or side. In addition, there are at least sixteen cast iron cannons scattered across the site and a large iron anchor in the northeast.

The core of the site is made up of a platform of iron bars, neatly stacked alongship on each side of the keelson. Outside this area, the bars are mainly found west and south of the platform, sometimes separate and not in association, sometimes in dozens encrusted together and stacked up to seven high.

There is a large mound of sizeable boulders in the northeast and east of the site. These ballast stones can also be found elsewhere at the site, where they are quite loosely scattered. Most of the boulders measure approximately 25 by 25 by 25 cm.

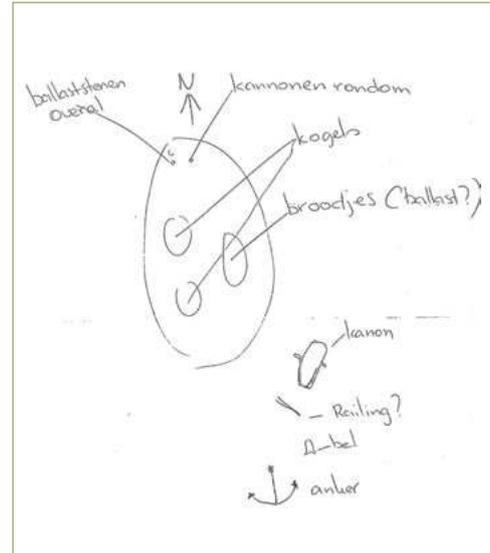
Illustration 48: Location of ship's bell sketched by H. Raven, who found it.
