## APPENDIX VII:

### Archaeological Monitoring of the Dredging for the Immersed Tunnel, Oslo, Norway. Rescuing Archaeological Heritage.

*Tori Falck (Norwegian Maritime Museum)*  
*Jostein Gundersen (Directorate for Cultural Heritage)*

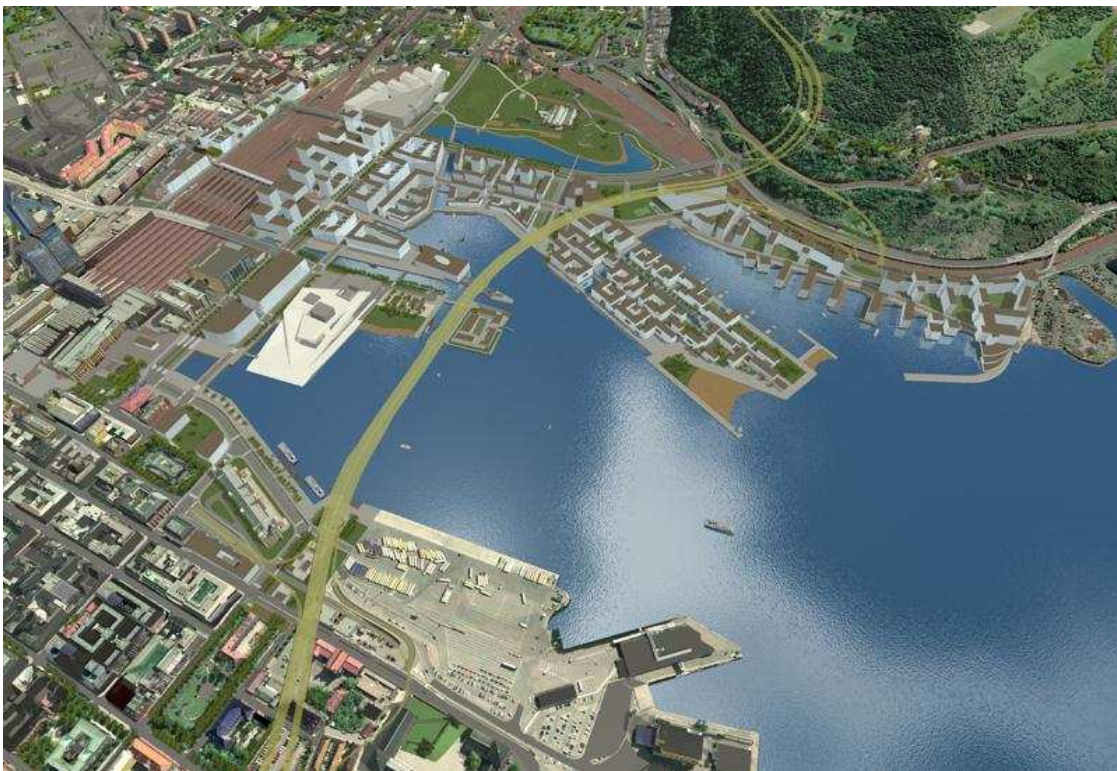
*Figure 1: The planned immersed tunnel in Bjørvika, Oslo (Norway)*  
*Source: Norwegian Road Administration*

At the turn of the last millennia, a new immersed tunnel through the central harbour was planned. The tunnel would connect to already existing tunnels on each land side, and had to cross through open water, jetties and quays (Figure 1). The water depth in the tunnel line varied from two to 16 metres and the trench for the tunnel had to be excavated down to around 22 metres the whole way. In all, the excavation of the tunnel trench included the dredging of 1,000,000 m<sup>3</sup> of harbour sediments from an area also expected to be rich in archaeological remains (Figure 2).

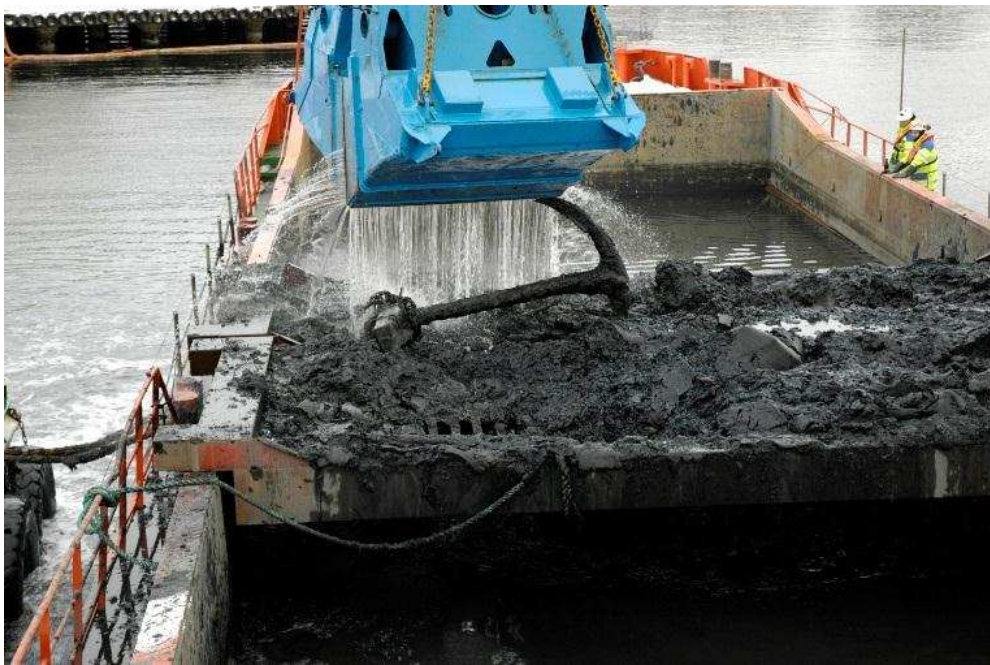
*Figure 4: Dredging from barges in open water.  
On the custom made sieve a 19<sup>th</sup> century anchor has appeared.  
Photo: Norwegian Maritime Museum.*

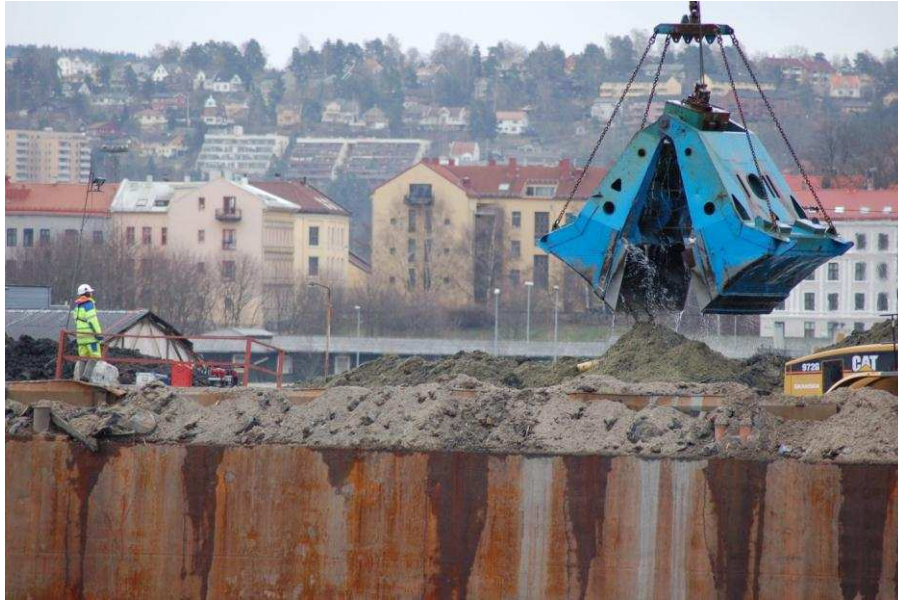
*Figure 5: Dredging old sawdust layer.  
Photo: Norwegian Maritime Museum.*

- polluted 'modern' sediments and clay was dredged with a closed clam shell dredger, into barges c. 600 m<sup>3</sup> in size for transportation to a nearby deep water deposit
- sawdust was dredged with a closed clam shell dredger onto a large flatbed barge to 'dewater', before being loaded onto lorries for transportation to a land deposit (Figure 5)

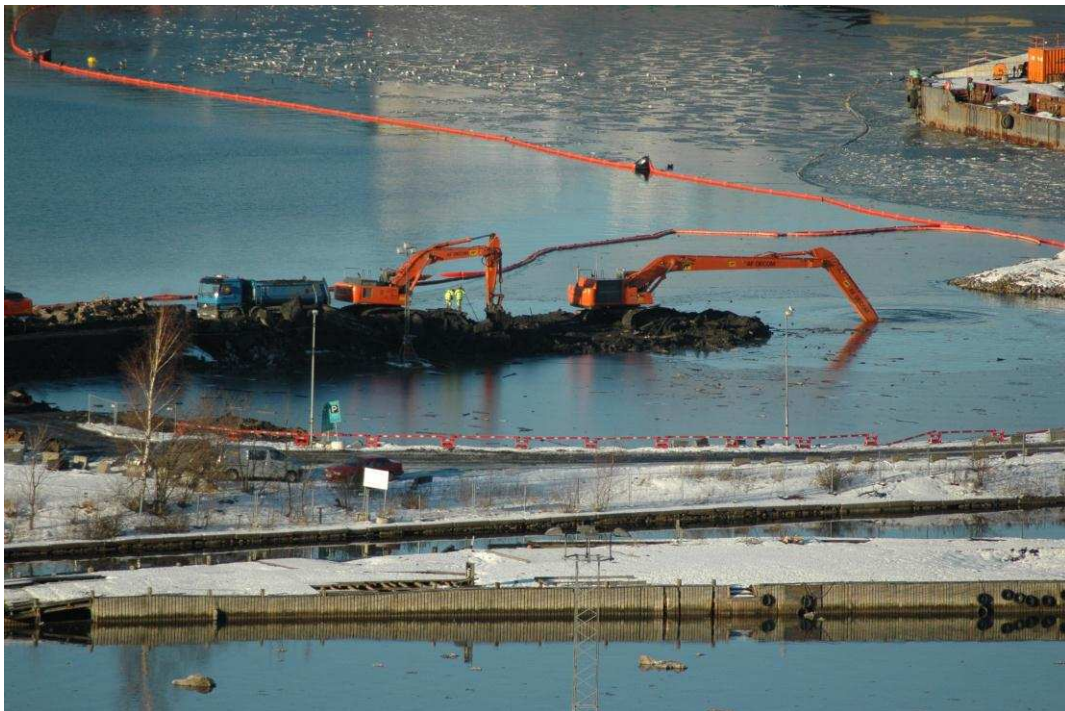
*Figure 6: Dredging from the piers.  
Photo: Norwegian Maritime Museum.*

- clean clay was dredged with an open clam shell dredger into small (c. 150 m<sup>3</sup>) barges for towing and re-deposition in nearby areas with polluted sediments
- fillings from piers and quays were excavated by large excavators into piles on land, before being transported to other deposits (Figure 6)

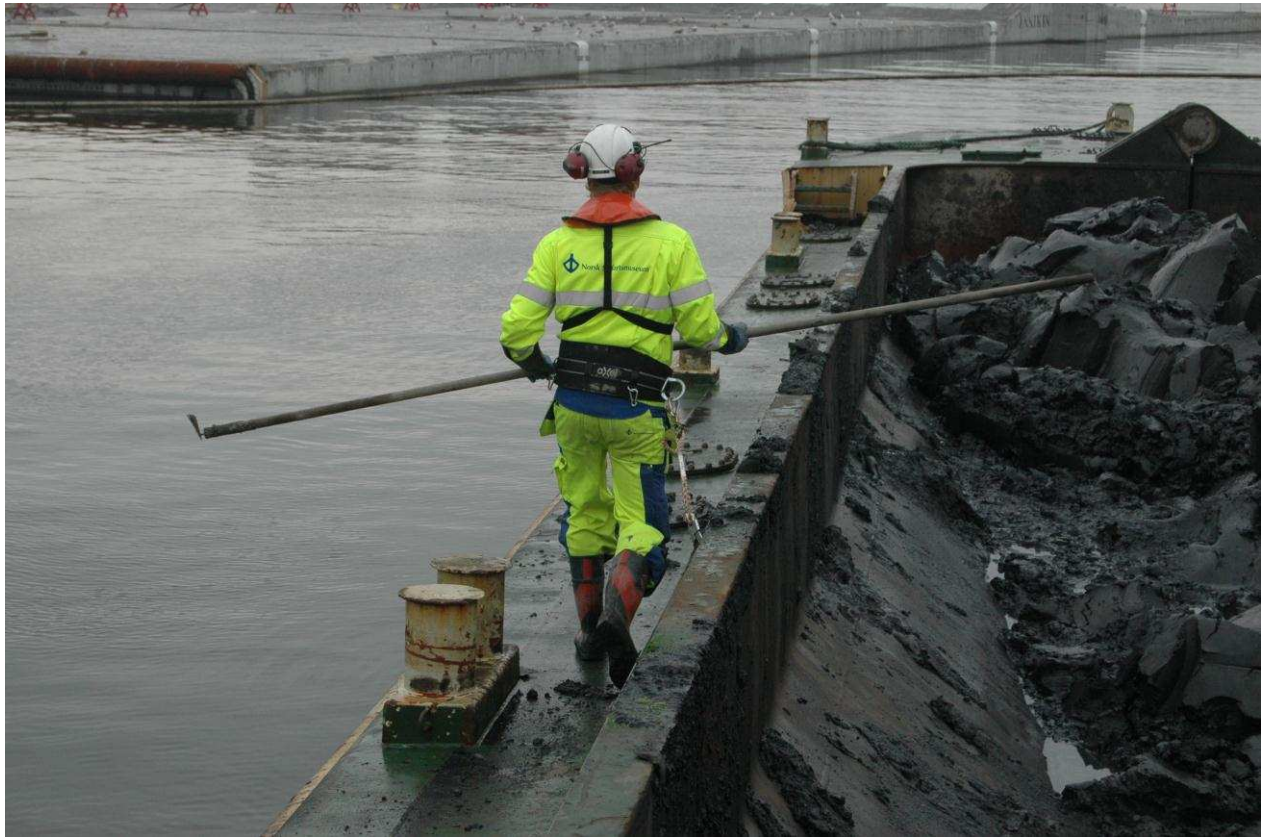
*Figure 7: Dredging from barges in open water. Archaeologist on board.  
Photo: Norwegian Maritime Museum.*

All dredging of sediments required that the archaeologist were situated directly on the different dredging barges, while the excavation of the piers and quays required that the archaeologist were on-site close to the excavator (Figure 7).

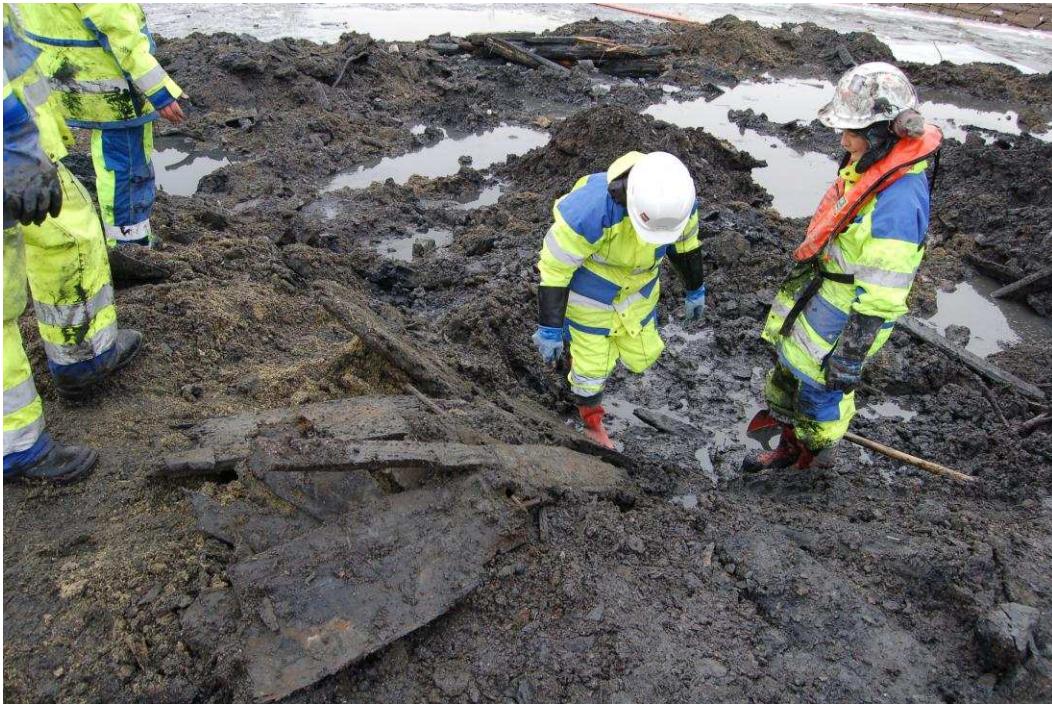
Figure 9: Finding damaged boat parts on the pier.  
Photo: Norwegian Maritime Museum.

Key archaeological results that were delivered: rescuing parts of 13 boat finds, numerous loose parts from boats, anchors and over 7,000 finds of cargo and objects lost from boats, etc. (Figure 9 and Figure 10). The 7,000 artefacts consisted of a range of different pieces of tools, ceramics, clay pipes, shoes and other personal and industrial items. Most of it was fragmented and the dating ranged from late 16<sup>th</sup> century through the industrial era. The boat finds must also be said to be very fragmented and damaged and we most certainly *lost* parts of boat – maybe even whole boat finds as a result of the monitoring situations. Still, the finds can be claimed to provide knowledge of use for further scientific investigation. We also feel very sure that if there had been a ship of larger size in the tunnel route, we would have detected it. The main conclusion when it comes to achieve best practice is to put more effort into the mapping ahead of the construction work. This would, in the case of the immersed tunnel in Oslo, most certainly have made it possible to make a better priority of the areas of investigation, but also would have provided a better understanding of the depositional and stratigraphic situations that varied from area to area in the tunnel route.
