# Death by a Thousand Cuts: an archaeological assessment of souveniring and salvage on the Australian cruiser HMAS *Perth* (I)

Kieran Hosty and James Hunter

*Key words:* Maritime archaeology, commercial salvage, HMAS *Perth* (I), Second World War, Indonesia, Australia.

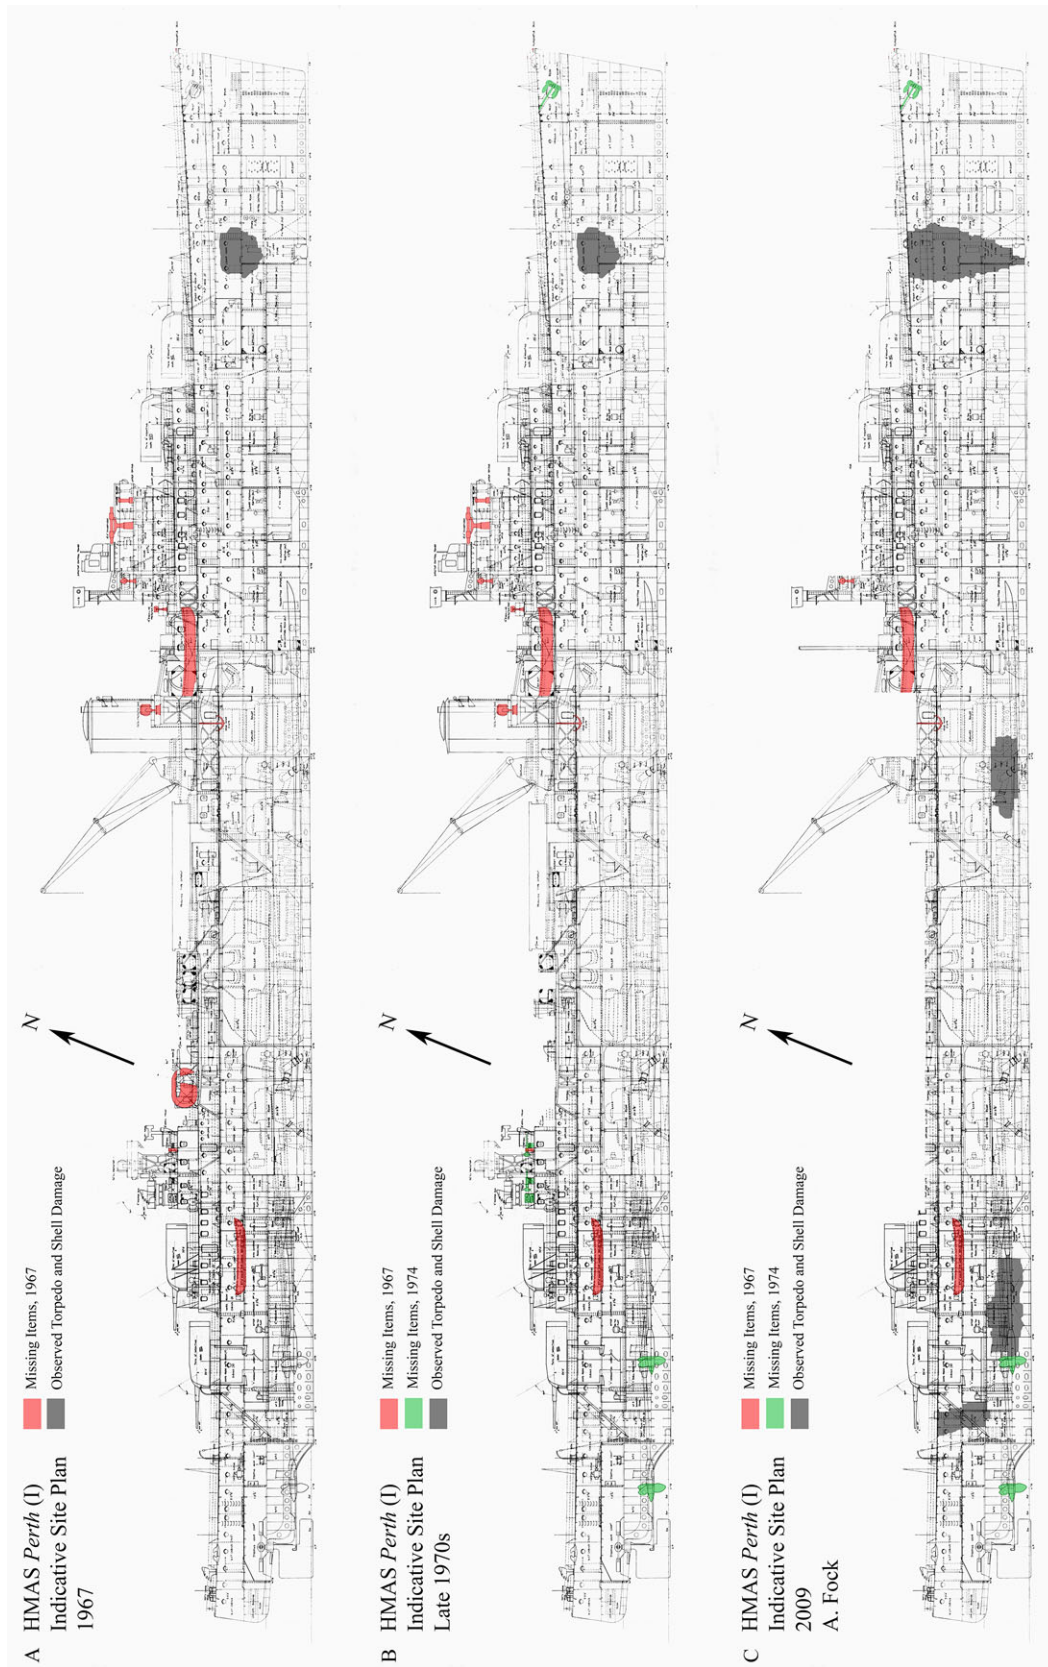
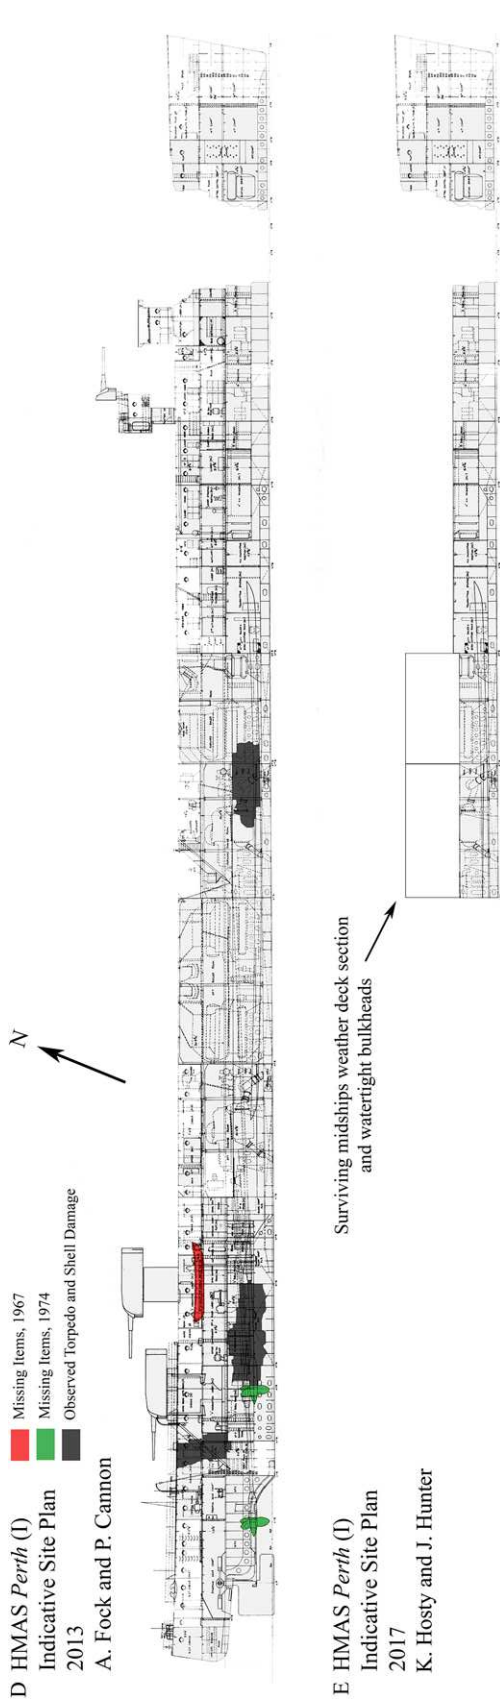
Figure 3. Indicative site plan of *Perth* adapted from original elevation schematic showing, from top, the shipwreck in: A: 1967; B: late 1970s; C: 2009; D: 2013; and E: 2017 archaeological survey (Image courtesy ANMM and ARKENAS).

By late 2013 *Perth*'s condition had radically changed and visiting divers notified the Australian Federal Government that the shipwreck appeared to have been salvaged by commercial divers (Fig. 3d). These activities resulted in removal of the cruiser's entire superstructure along with its forward 'A' and 'B' Turrets, the aircraft catapult, portside crane, and forward deck (Fock and Cannon, 2013b: 6–8).

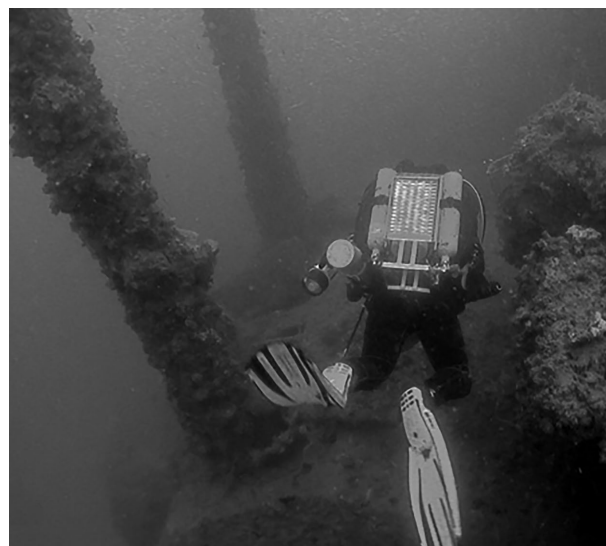
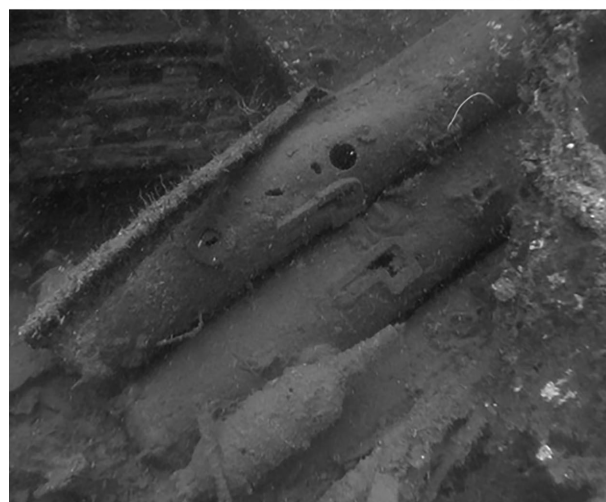
Figure 4. *Perth's* 'X' Turret *in situ* (top) and one of the torpedo launchers in the surrounding debris field (bottom) demonstrate that the shipwreck was largely intact and in a relatively good state of preservation as recently as 2010. Both of these features have since been completely removed from the site (Images courtesy Andrew Fock).

in their original positions. Other elements of ship's architecture, equipment and armament that remained *in situ* included the superstructure aft of 'B' Turret, foremast, aircraft crane and catapult, port torpedo tubes, and Admiral's accommodation area forward of 'X' Turret (Fock and Cannon, 2013a: 22–23).

Fock also noted areas where extensive salvage had occurred during the 1960s and 1970s. These included the bridge, which 'was stripped of most of its equipment, voice pipes, rangefinders etc. as well as its outer shell which contained 15 and 20Ib bullet-proof plating' (Fock and Cannon, 2013a: 23). Another area impacted by salvage was the 4-inch Gun Deck, which was intact but missing all of its twin Mark XIX mountings. The adjacent After Control position

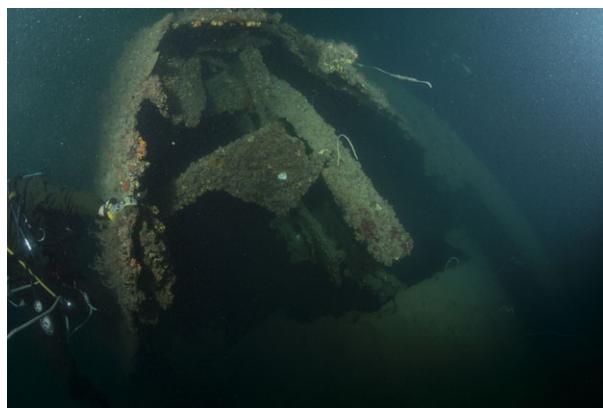
Figure 5. Damage to *Perth*'s 'A' Turret gun house, as observed during the 2015 DIVEX survey (Image courtesy Arthurgwain Marquez/US Navy).

Video footage acquired during the DIVEX 2015 survey revealed several large breaches along *Perth*'s starboard hull, as well as torn and buckled plating, damage to the forward 6-inch gun housings, and significant deposits of small artefacts that appear to have been disturbed by salvage activity (Fig. 5). The upper deck was still intact, but no evidence remained of the vessel's superstructure. Both 'X' and 'Y' Turrets were still intact, and at least one starboard-side propeller shaft and hanger remained *in situ* at the vessel's stern. However, some hull plates were torn and/or missing along the main deck at the stern near the starboard fairlead (Marquez, 2015)

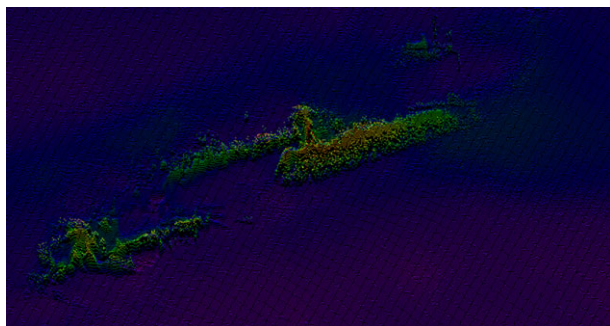
Analysis of the MBES and SSS data indicated the presence of a 60m-long linear void within *Perth*'s

Figure 6. Multi-beam Sonar and Echo Sounder image of *Perth's* shipwreck site, as recorded in December 2016. Note the large linear anomaly in the centre of the surviving hull. This was later confirmed to be a void caused by large-scale salvage activities (Image courtesy Australian National Maritime Museum and ARKENAS).

surviving hull (Setiawan and Kel, 2016: 24–27). Although this anomaly could have been caused by a build-up of seabed sediments, it also potentially indicated structural collapse or complete absence of hull structure (Fig. 6). The site's overall dimensions were also smaller than anticipated and suggested that either a 70m section of hull had become completely buried by sand or sediment, had collapsed to the seabed, or was removed as a result of salvage activities (Setiawan and Kel, 2016: 24–27).

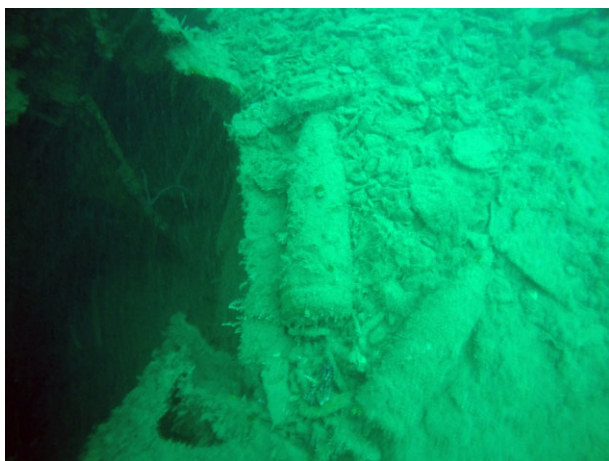
The team compared its observations with video and still imagery from past dives and determined that approximately 60% of *Perth's* starboard hull plating was removed between October 2015 and December 2016. The missing hull covers an area from just below the main deck to immediately above the turn of the bilge (between Frames 76 and 151). Missing hull plating roughly corresponds with the portion of starboard hull that was originally protected by a belt of 3-inch (76mm) thick armour plate. The armour belt was installed over 1-inch (25mm) thick hull plates in the ship's machinery spaces, while 2-inch (50mm) thick armour plating covered 1-inch (25mm) thick hull plates below the waterline in the area of the 4-inch and 6-inch magazines (NAA, MP551/1, 137/P47). In terms of

Figure 7. 4-inch and 6-inch projectiles found scattered throughout *Perth*'s surviving hull suggest the magazines have been breached as a consequence of large-scale salvage activities (Image courtesy Australian National Maritime Museum and ARKENAS).

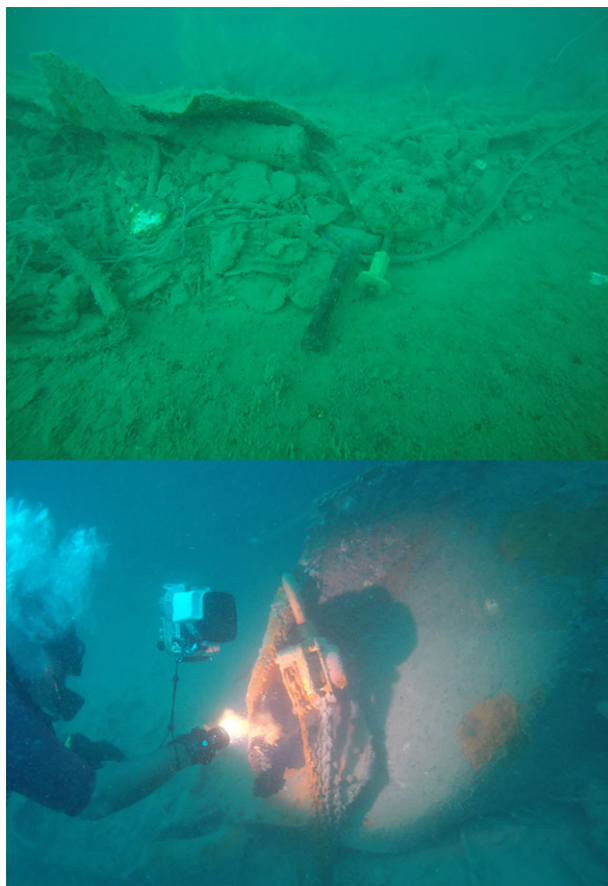
Evidence of ongoing small-scale salvage was also noted in the form of lifting slings wrapped around various hull components, a chain block, water-dredge hose, and a hammer and chisel (Fig. 8). These activities, while damaging, are relatively small scale when compared to the industrial-scale salvage that has also occurred and would not have caused the vast majority of damage observed by the survey team.

Figure 8. Evidence of small-scale salvage activities observed on the *Perth* shipwreck site in 2017 included a hammer and chisel (top) and small chain block (bottom) (Image courtesy Australian National Maritime Museum and ARKENAS).

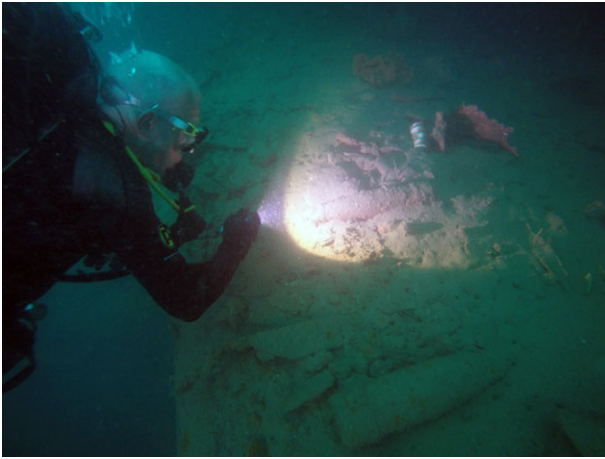
Figure 9. One of many artefact-rich sediment deposits observed on the *Perth* shipwreck site in 2017. This deposit was located atop a longitudinal bulkhead immediately forward of Frame 80 and contained buckles, buttons, a rubber Wellington boot, and a pair of spectacles (Image courtesy Australian National Maritime Museum and ARKENAS).

The largest and most diverse concentration of artefacts was noted atop a longitudinal bulkhead immediately forward of Frame 80, next to either the Number One Gunner's Store or the 4-inch Magazine (Fig. 9). It contained coverall buckles, uniform buttons, a rubber wellington boot, and a pair of spectacles. Another artefact concentration was observed in the Forward Engine Room, just forward of *Perth's* only remaining steam turbine. The deposit was located atop surviving starboard hull plating, where artefacts had settled after having been disturbed and moved by salvage activity. The most fragile artefact encountered during the survey—a cotton glove—was observed partly buried within a deep silt deposit that had fostered

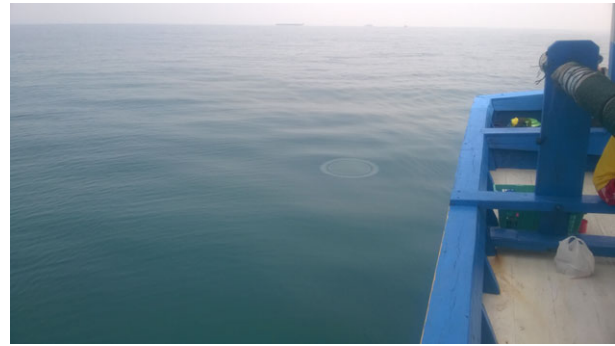
Figure 10. Localized oil slick created by bubbles of fuel oil floating to the water's surface above the *Perth* shipwreck site (Image courtesy Australian National Maritime Museum and ARKENAS).

The 2017 survey team observed and documented fuel oil escaping from *Perth's* surviving hull (Fig. 10). These contaminants present significant environmental and health hazards for divers that visit the site, as well as the local fishing community and the broader population that lives along Banten Bay's coast. In 1941, *Perth* had a total fuel oil capacity of around 1768 tons. This figure included 1535 tons of furnace oil and 233 tons of diesel oil for the ship's generators. *Perth* also stored an unknown quantity of aviation spirits. The fuel oil and aviation spirits stores were retained in 27 fuel oil tanks and one aviation fuel tank. When *Perth* departed Tanjong Priok in late February 1942, it was carrying an estimated 900 tons of fuel (NAA: MP1185/8, 1932/2/20). Fock and Cannon (2013b: 21–23) state:

There are several options available to host and flag states that wish to mitigate the release of fuel and oil and other pollutants from Second World War shipwrecks. These include ongoing monitoring and *in situ* conservation of the shipwreck and oil, sourcing the leak and capping fuel/oil contaminants using oil resistant silicon fillers and adhesives, and entombing the wreck and offloading the fuel/oil by 'hot tapping' the oil source. All options have costs associated with them. Barrett (2011) states that average recovery/mitigation costs are in the region of \$US 2.25 to \$US 200.00 per US gallon (3.78 litres).
