6. BUSSELTON JETTY: ON-SITE CONSERVATION SURVEY REPORT

By Vicki Richards

Date of inspection: 26 February 2009

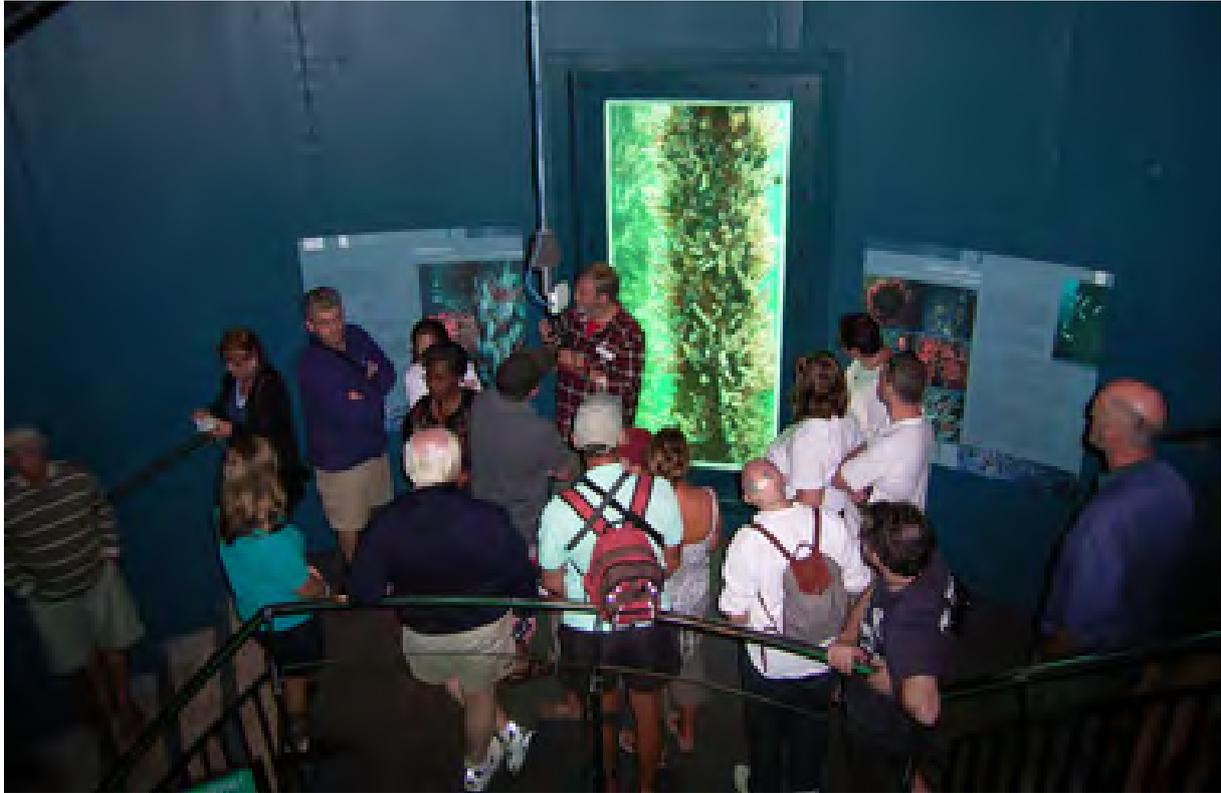
Figure 6-2 Visitors inside the Underwater Observatory. (Photograph: R. Anderson, WA Museum)

The Underwater Observatory descends 8 metres from the seawater surface and can accommodate up to 40 visitors at one time. There are eleven viewing windows located at various levels within a 9.5-metre diameter observation chamber (Figs. 6-2 and 6-4). The approximate position of the survey area was about 10 metres north-east from the seaward side of the Underwater Observatory (Figs. 6-3 and 6-5).

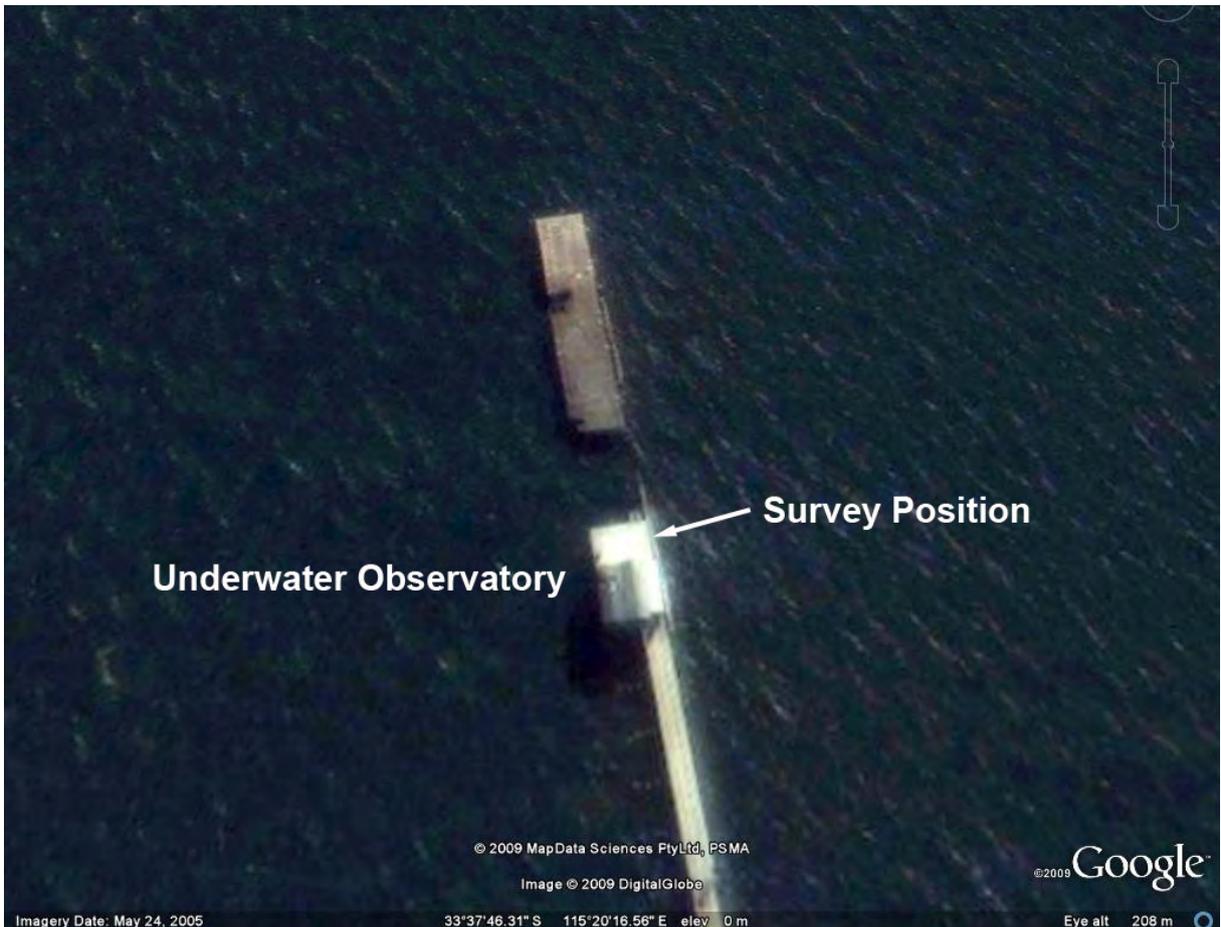
Figure 6-3 The approximate position of the survey area adjacent to the Underwater Observatory, Busselton jetty. (Google Earth 2009)

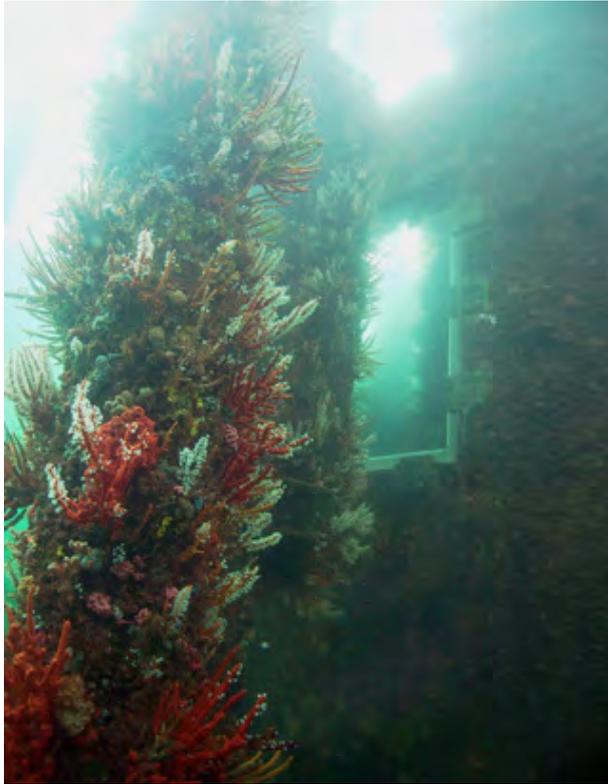
Figure 6-4 Under water view of the seaward side of the Observatory and colonised wooden piles from the Busselton jetty. (Photograph: R. Anderson, WA Museum)

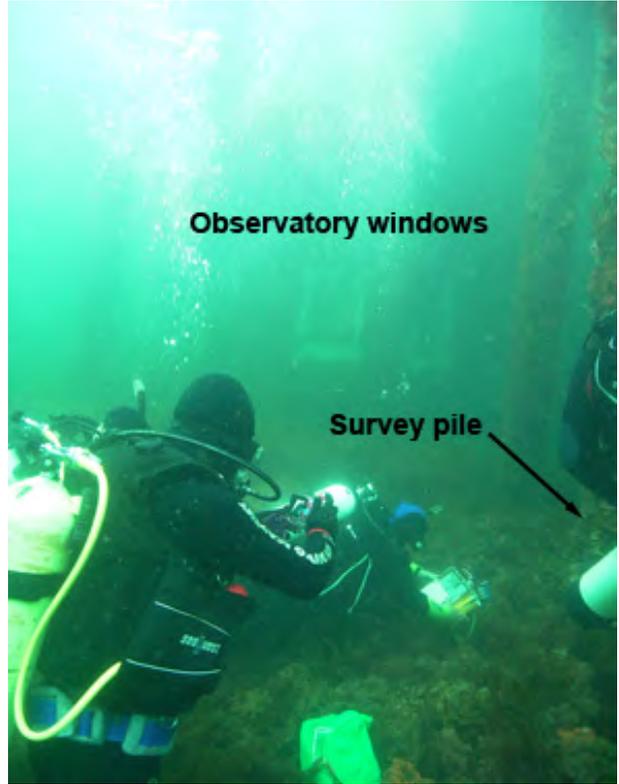
Figure 6-5 Survey pile approximately 10m north-east from the seaward side of the Observatory. (Photograph: R. Anderson, WA Museum)

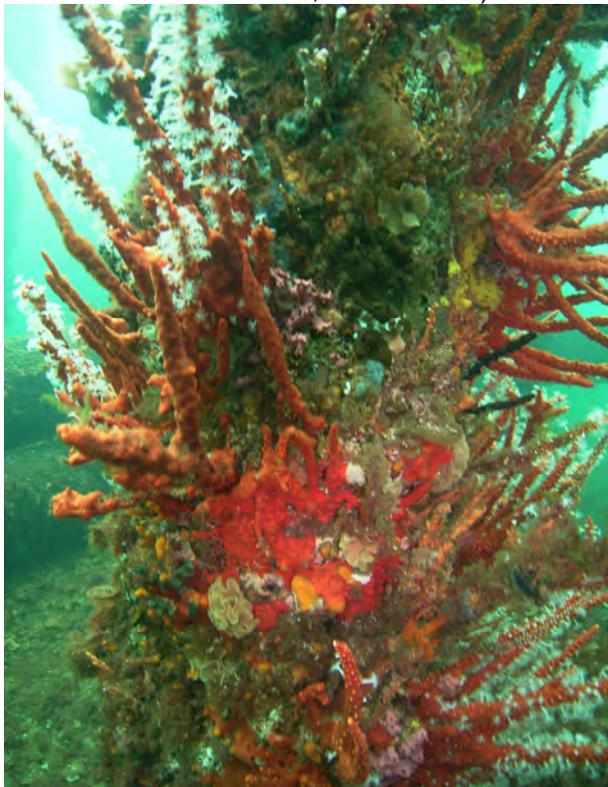
Figure 6-6 Marine growth on historical wooden piles, Busselton jetty. (Photograph: R. Anderson, WA Museum)

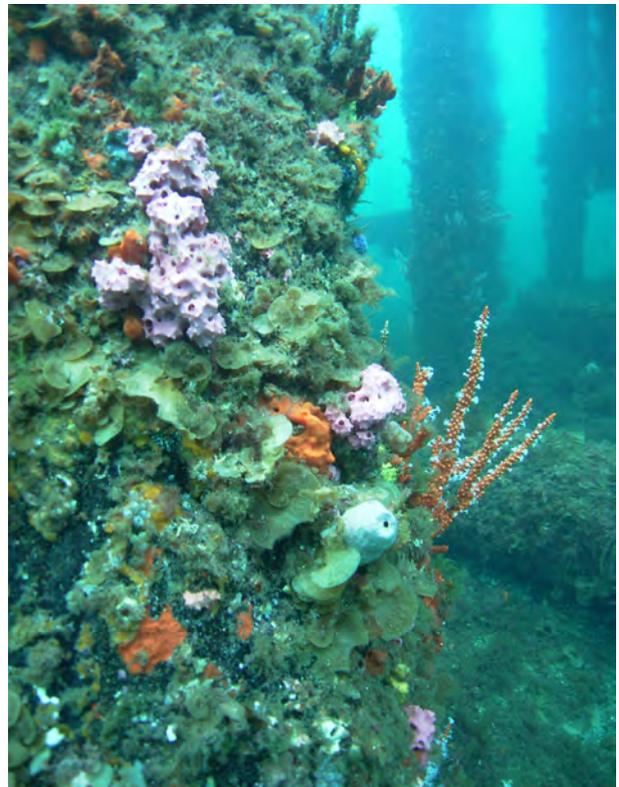
Figure 6-7 Marine growth on historical wooden piles, Busselton jetty. (Photograph: R. Anderson, WA Museum)

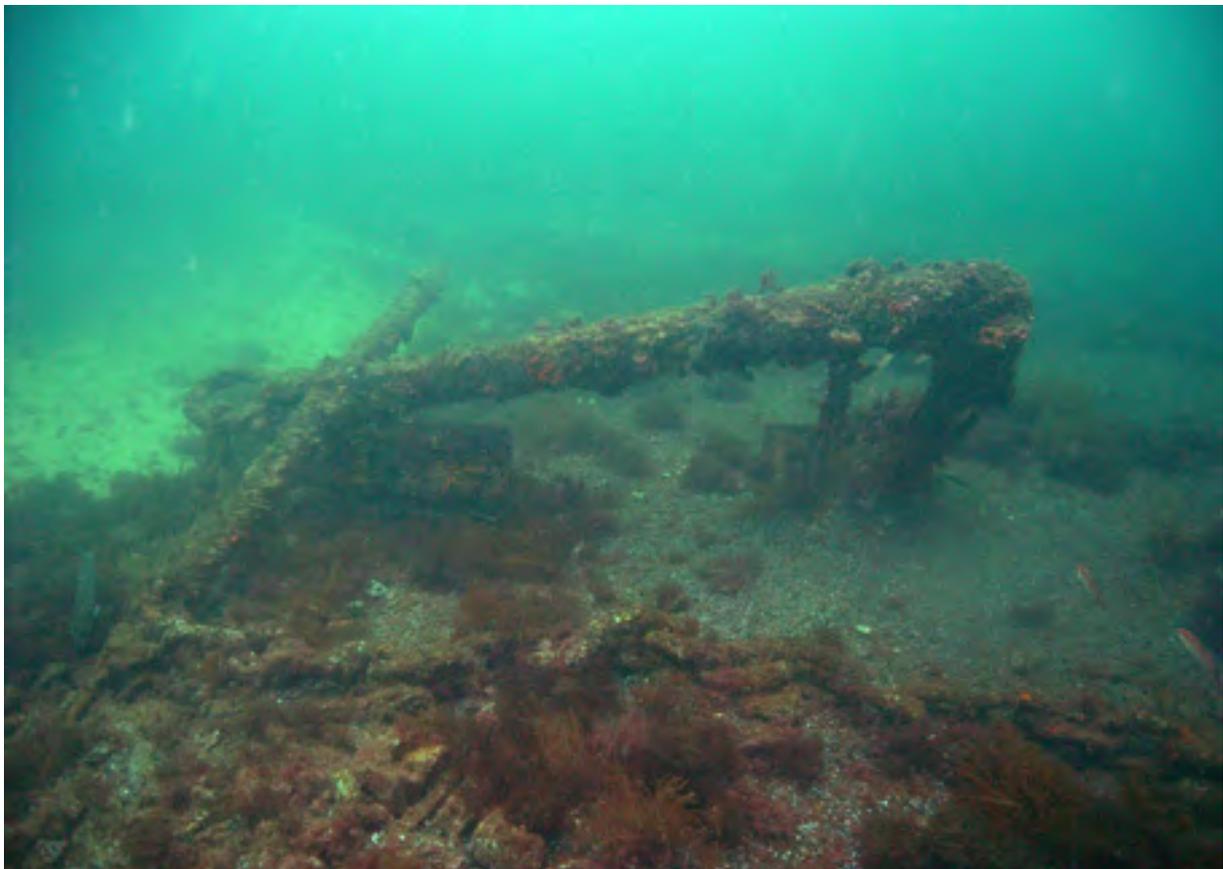
Figure 6-8 Anchor on the survey site, Busselton jetty. (Photograph: R. Anderson, WA Museum)

The historical association of the jetty with the Busselton Township has resulted in an accumulation of cultural and modern material on the site. However, there were very few historical artefacts observed in the survey area, with the exception of a large anchor (Fig. 6-8) and some large iron bollards.

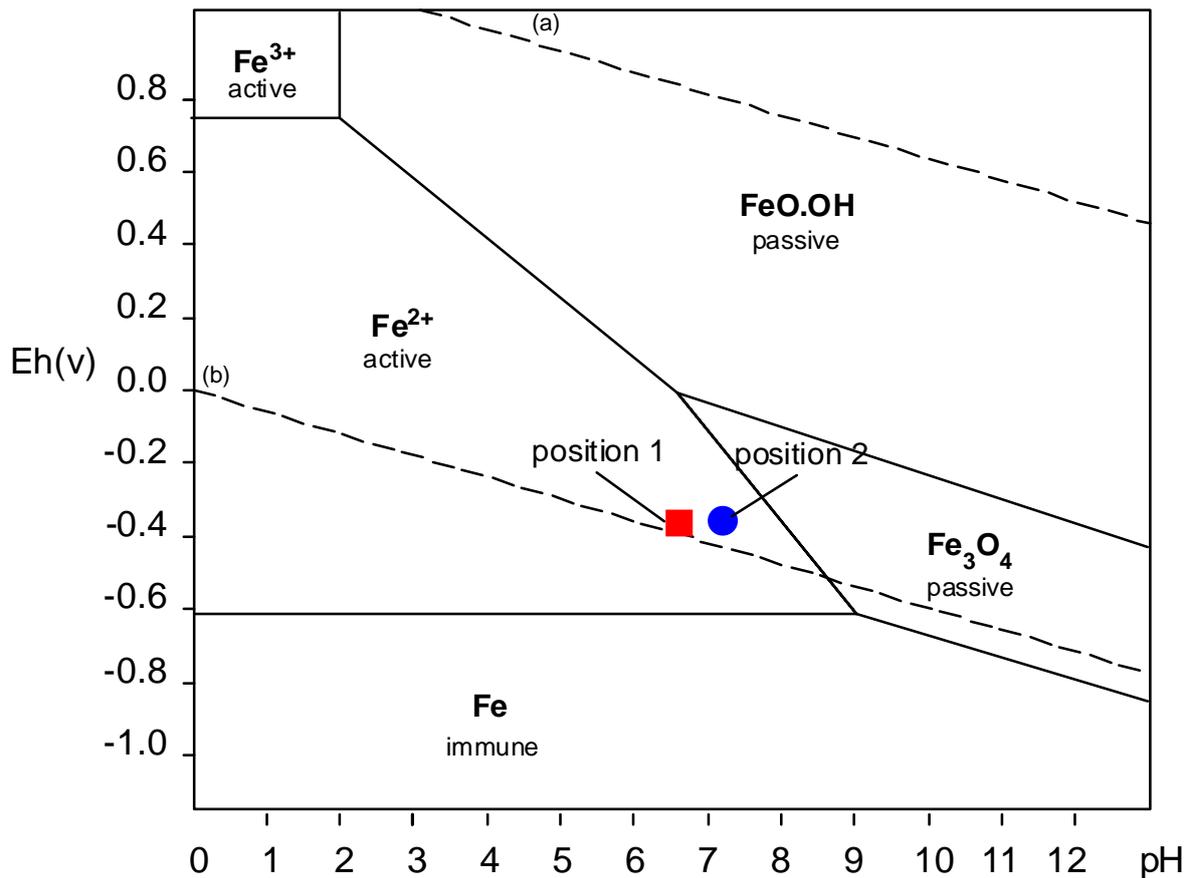
By plotting the measured voltages and the corresponding surface pH on the Pourbaix diagram for iron at 10^{-6} M in aerobic seawater at 25°C, the thermodynamic stable state of the iron can be ascertained (Fig. 6-9). Both sets of measurements of the iron bollard on the Busselton jetty indicate that it was actively corroding. This would suggest that other ferrous materials, such as the anchor, would also be actively corroding. It is important to note that Pourbaix diagrams do not include kinetic information. They are only thermodynamic stability maps that indicate the corrosion mechanisms, but not the corrosion rate. However, they can be used as a general guide for interpreting corrosion data.

Figure 6-9 Pourbaix diagram for iron (10^{-6}M) in aerobic seawater at 25°C indicating the state of the iron bollard on the Busselton jetty site. (Diagram: V. Richards, WA Museum)

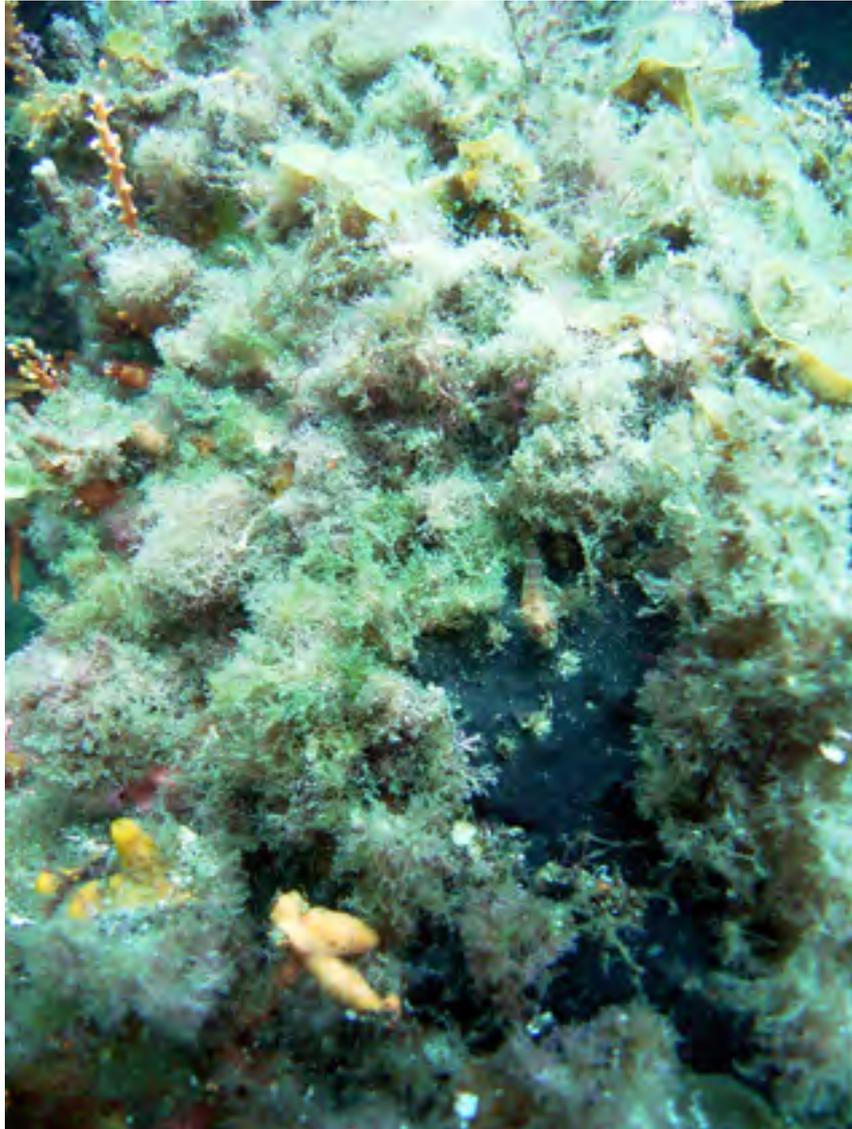
The iron bollard used in the corrosion survey was covered with thin concretion, lightly encrusted with secondary marine growth (Fig. 6-10). Iron is not biologically toxic and increases the growth rate of encrusting organisms. The relatively thin concretion and corrosion layer (7–9mm) suggest that the bollard has not been subjected to aggressive environmental conditions, although the corrosion parameters indicate that it is actively corroding. The smaller depth of penetration could also suggest that the bollard has not been exposed to this oxidising marine environment for an extended

The standard corrosion rate for isolated iron in aerobic seawater is 0.1 mmy^{-1} and the final extension to the jetty was completed in 1960. From this information, if the iron bollard is corroding at the standard rate, then the depth of corrosion should be about 5mm. Hence, based on the fact that the depth of penetration was about 7–9 millimetres, it could be safely assumed that this bollard is part of the more contemporary extensions.

Figure 6-10 Iron bollard used for the corrosion survey, Busselton jetty.
(Photograph: R. Anderson, WA Museum)

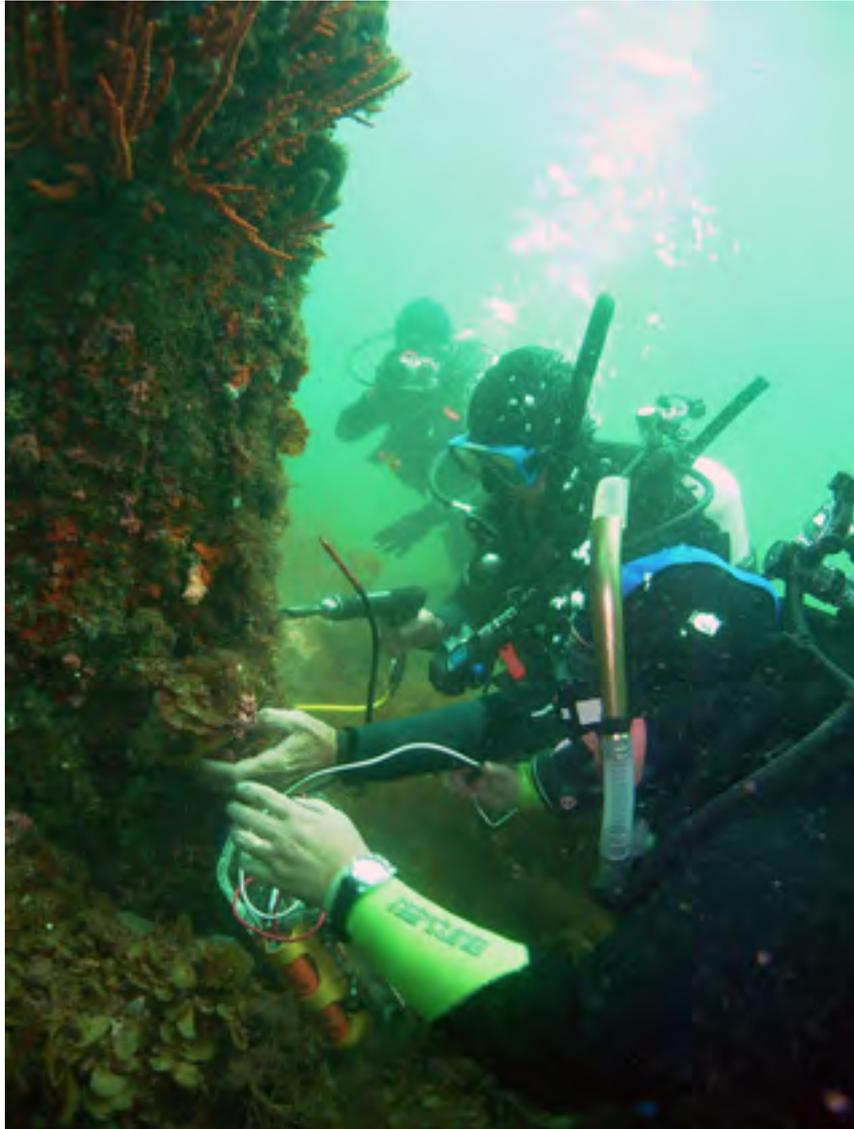
Figure 6-11 ALA fellows taking core samples from wooden pylons of the Busselton jetty. (Photograph: R. Anderson, WA Museum)

maximum water content (U_{max}) determination (Fig. 6-11). Again, the first pH profile was measured by conservation staff (Position 1: VR & JC) and an adjacent area subsequently measured by the ALA Fellows (Position 2: WH & CW). The results of the pH profiles are presented in Table 6-3 and shown diagrammatically in Figure 6-12.

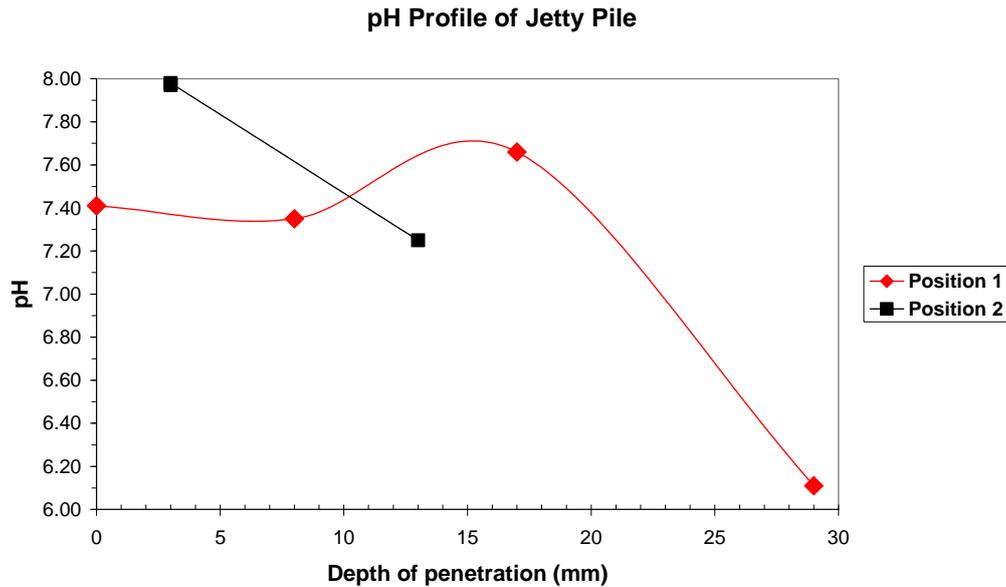
Figure 6-12 pH profiles of the wooden pile measured on the Busselton jetty. (Graph: V. Richards, WA Museum)

The pH profiles for the wooden pile on the Busselton jetty are typical of wood with a relatively thin outer layer (<20 mm) of degraded wood overlying an extensive non-degraded inner core in excellent condition. Hence, if the estimated diameter of the survey pile is about 300 millimetres, then this pile has less than 10% total deterioration. This may suggest that the pile has not been exposed to the marine environment for an extended period of time and that it is likely to be part of the more recent extensions to the jetty in the mid 1900s.

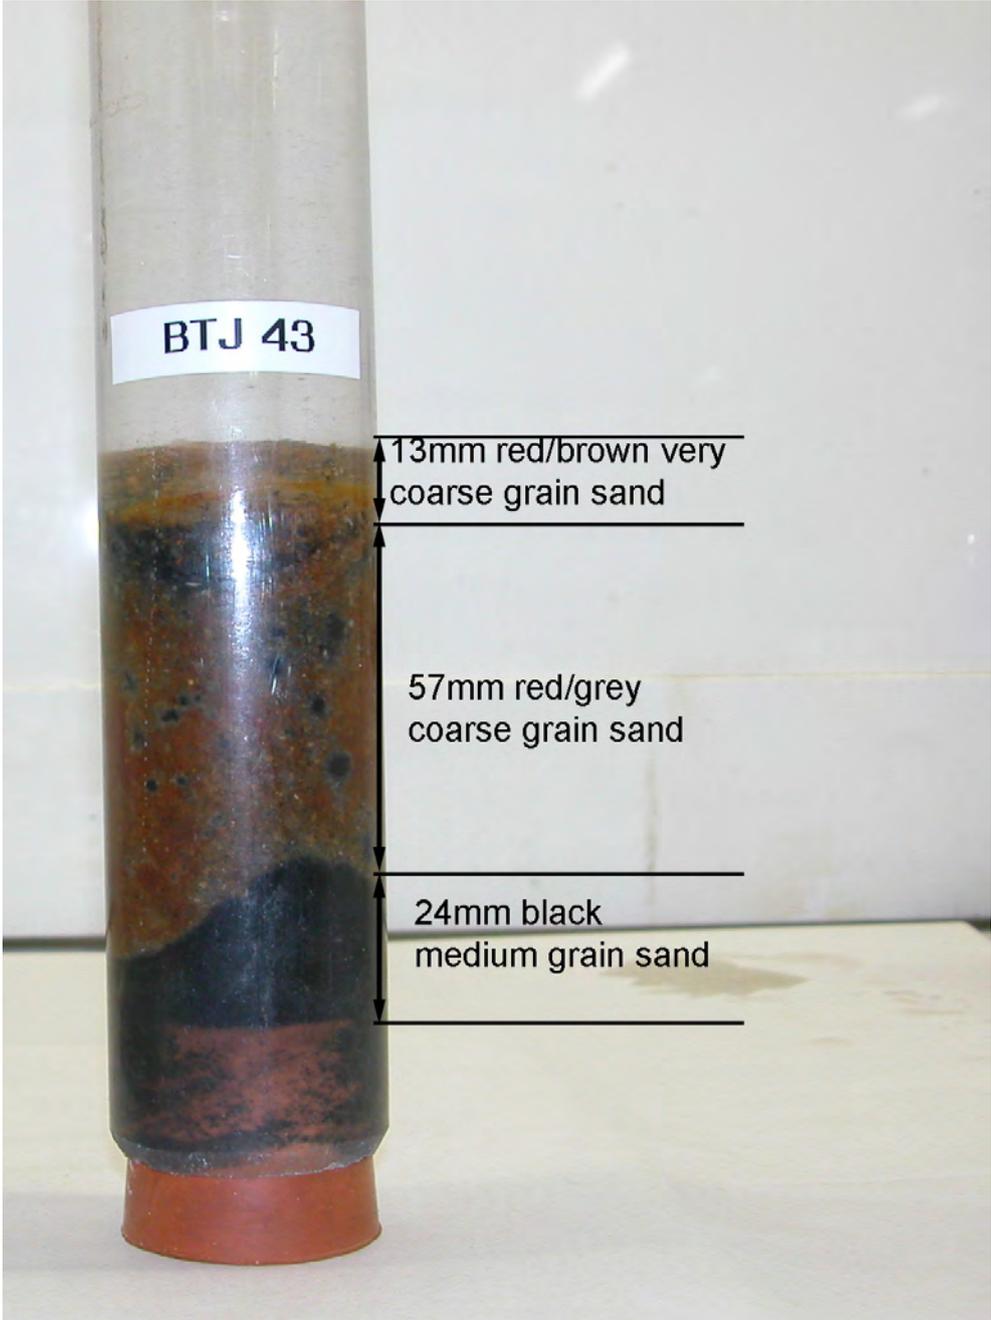
Figure 6-13 Sediment core sample (BTJ 43) from the Busselton jetty survey site. (Photograph: V. Richards, WA Museum)

The results of the sediment survey indicate that the sand in the upper 8 centimetres of the sediment column is relatively coarse, well oxygenated and thus, more oxidising in nature. After this depth, however, the particle size decreases and the sediment becomes more stable, anoxic and therefore, more reducing in nature. The conservation implications of these observations is that artefacts in the upper sediment layers would be subject to more deterioration than those materials buried at depths greater than about 10 centimetres in this survey area.

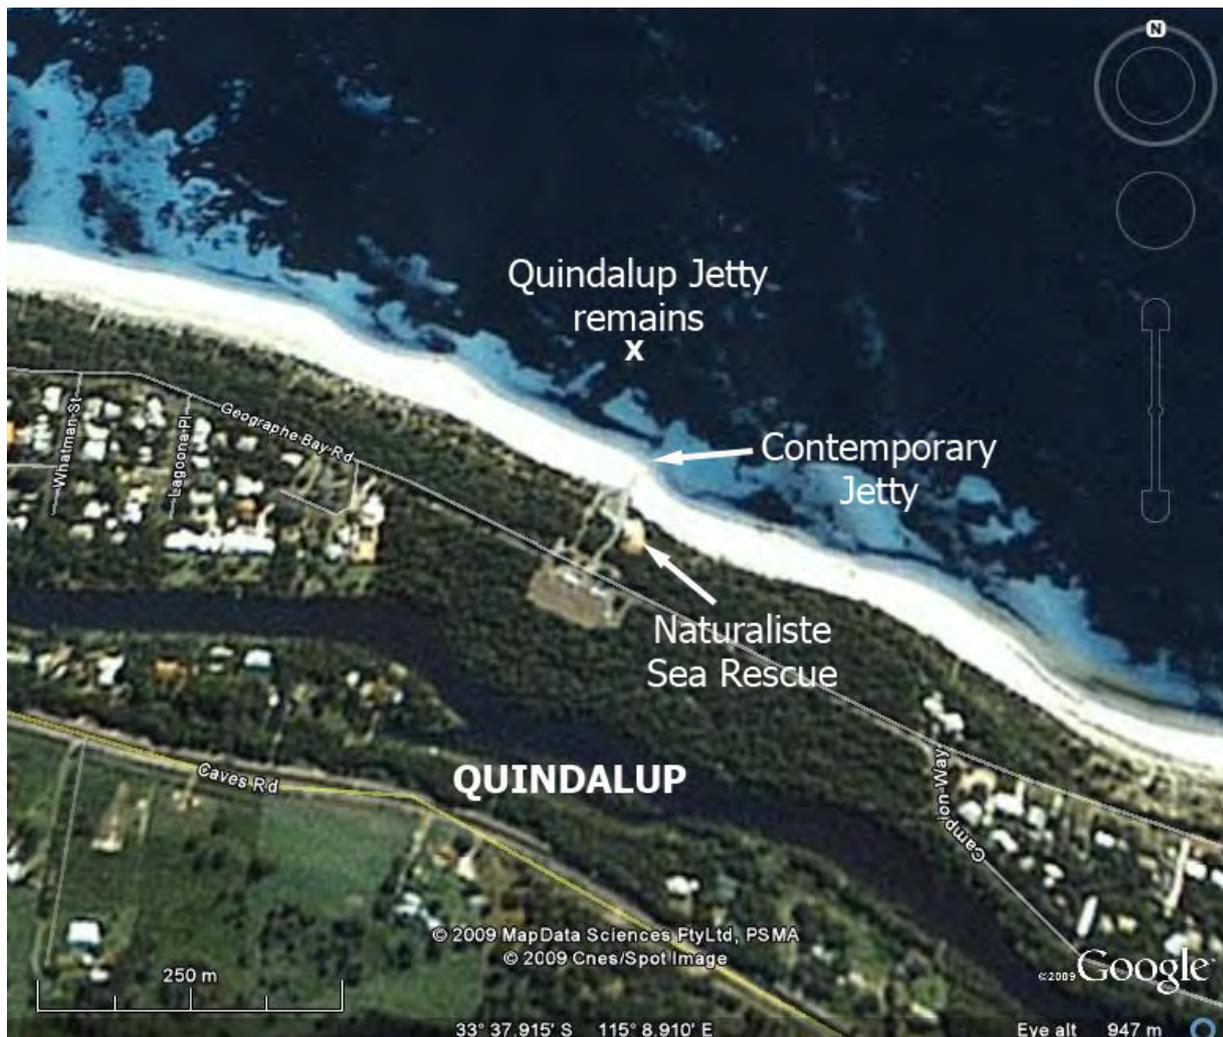
Figure 7-1 Quindalup jetty remains, Quindalup, WA (Google Earth 2009).

The contemporary Quindalup jetty is about 30 metres in length (Figs. 7-1 and 7-2). The original Quindalup jetty remains lie approximately 100 metres offshore and about 100 metres north-west from the seaward end of the contemporary jetty (Figs. 7-1 and 7-2) in about 2.5 metres of water.

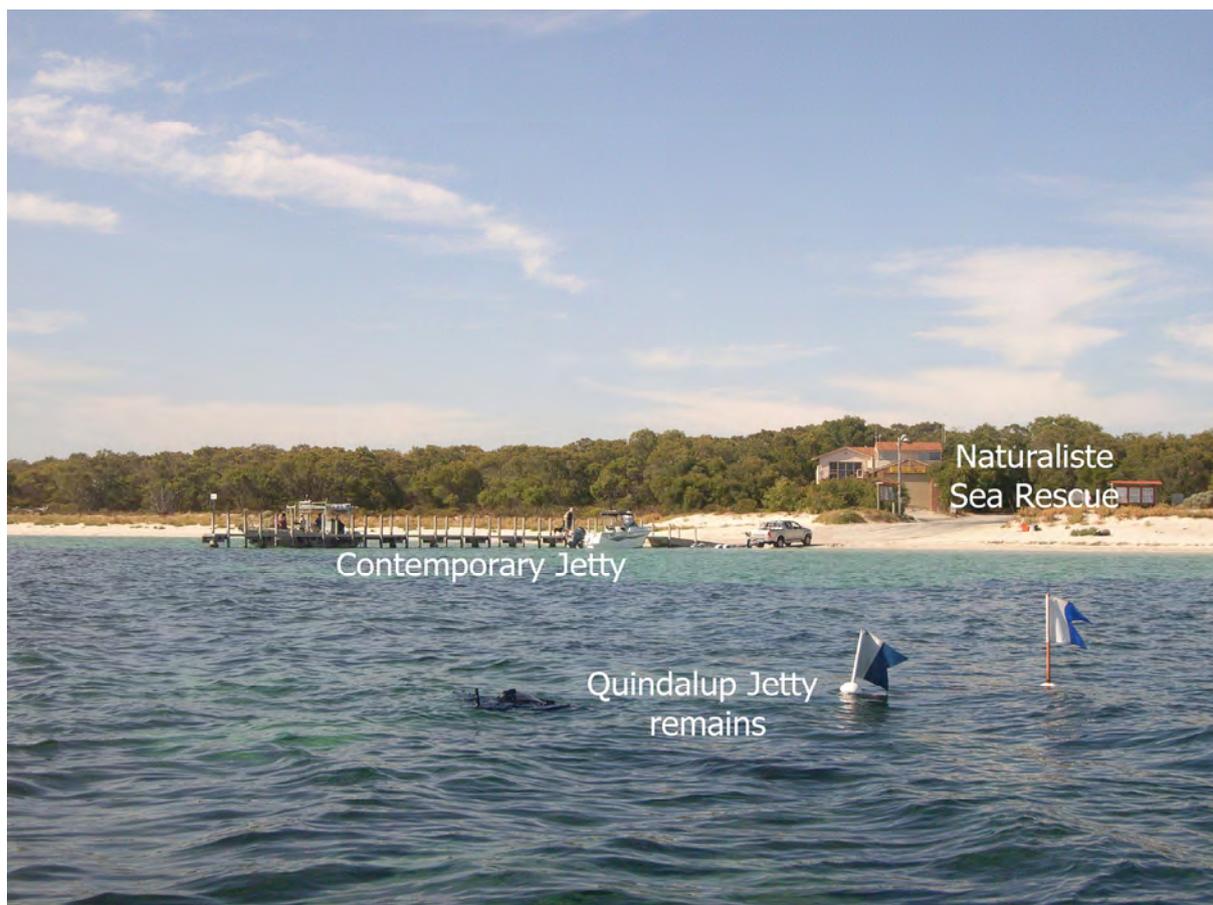
Figure 7-2 The Quindalup jetty site, Quindalup, WA. (Photograph: P. Baker, WA Museum)

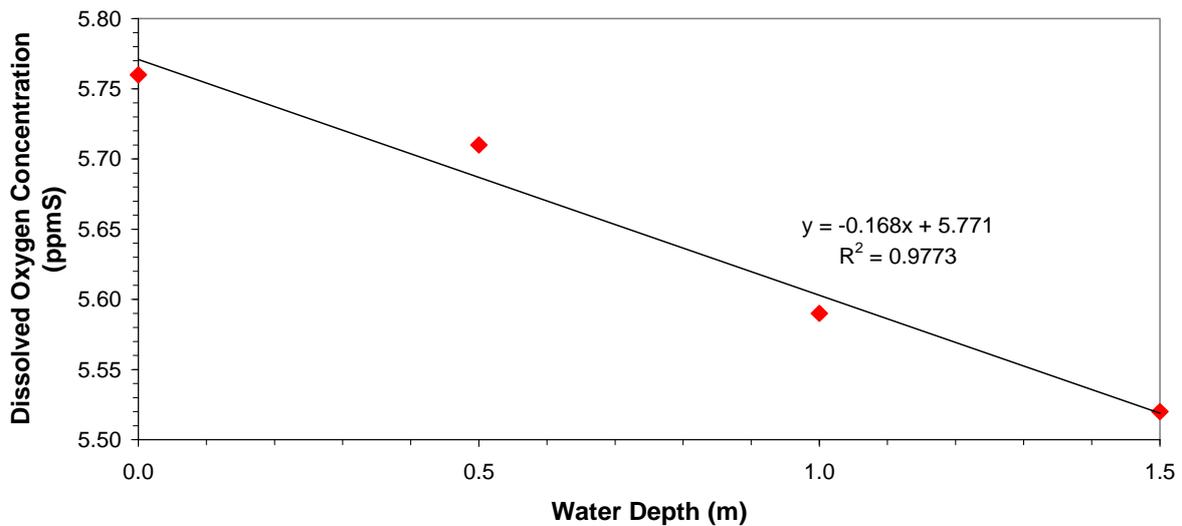
Figure 7-4 Change in dissolved oxygen concentration with increasing water depth on the Quindalup jetty site. (Graph: V. Richards, WA Museum)

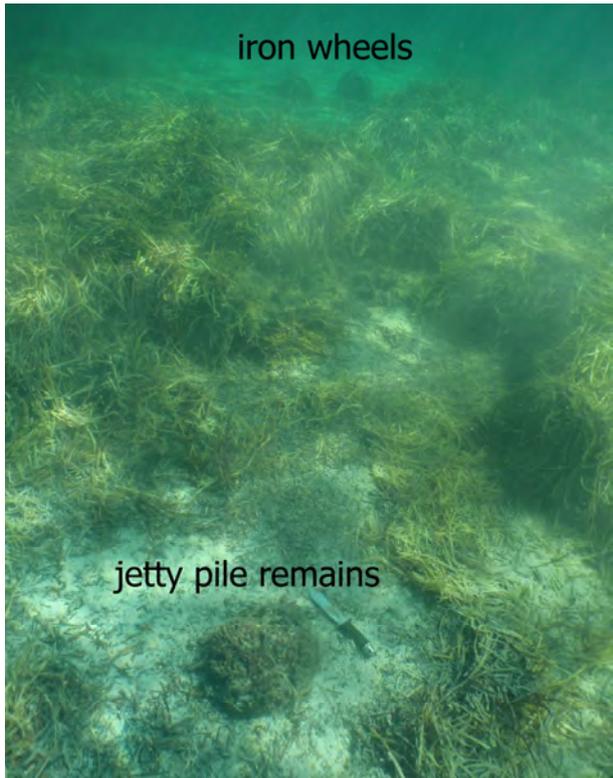
The exposed jetty remains, comprised of a few iron wheels and jetty pile remains (Fig. 7-5) and an iron railway track (Fig. 7-6), are aligned on a roughly north-south transect spread over an area approximately 10 metres² and about 2.5 metres deep.

Figure 7-5 Two iron wheels and the remains of one jetty pile. (Photograph: P. Baker, WA Museum)

on the seabed. Active marine borer damage was observed on all piles (Fig. 7-5). The iron track was also exposed in parts, in some places lying directly on the sediment surface (Fig. 7-6) while elsewhere lying buried just beneath the sediment surface. One iron wheel was almost totally buried with only a very small portion exposed, as evident from the seaweed and algal growth on the very top surface (Fig. 7-11).

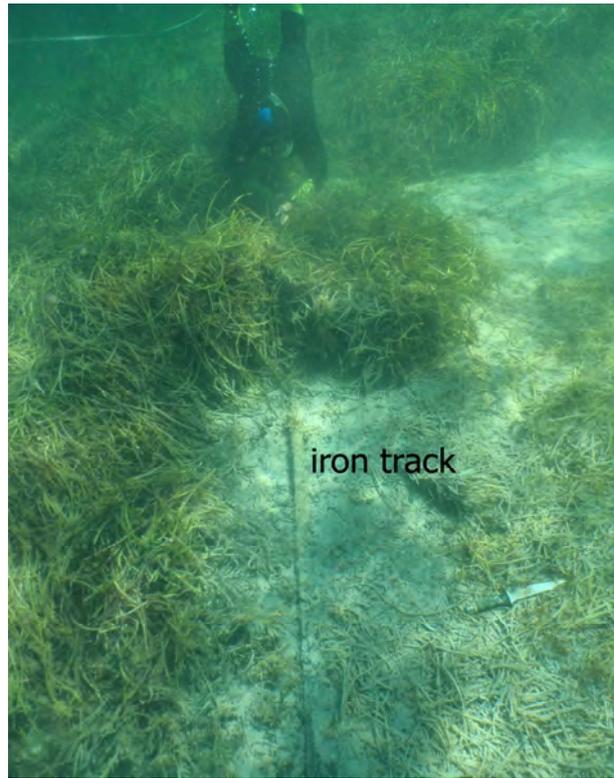
Figure 7-6 The remains of an iron track. (Photograph: P. Baker, WA Museum)

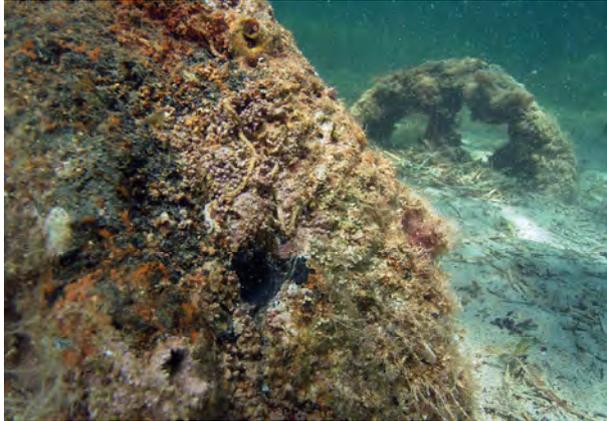
The exposed concreted surfaces of the iron structures were sparsely covered with sessile marine organisms including bryozoans, sponges, ascidians and tunicates. In less concentrated areas of growth, algal forms were present (Fig. 7-7). Exposed jetty pile remains were covered with algal mats, with very few higher marine organisms evident on the surfaces, but exhibited extensive marine borer damage (Fig. 7-8).

Figure 7-7 Concreted surfaces of an iron railway wheel. (Photograph: P. Baker, WA Museum)

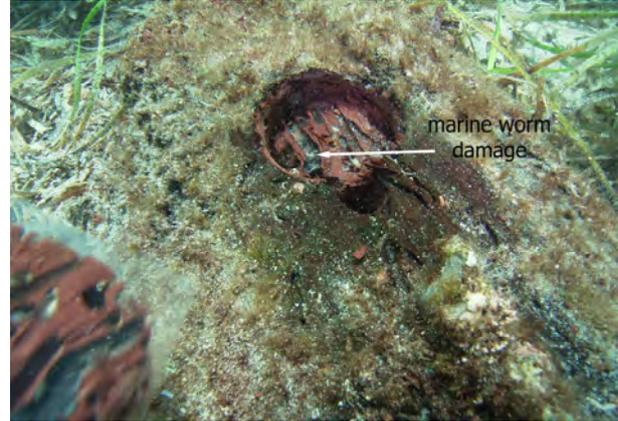
Figure 7-8 Degradation of a jetty pile by marine borers. (Photograph: P. Baker, WA Museum)

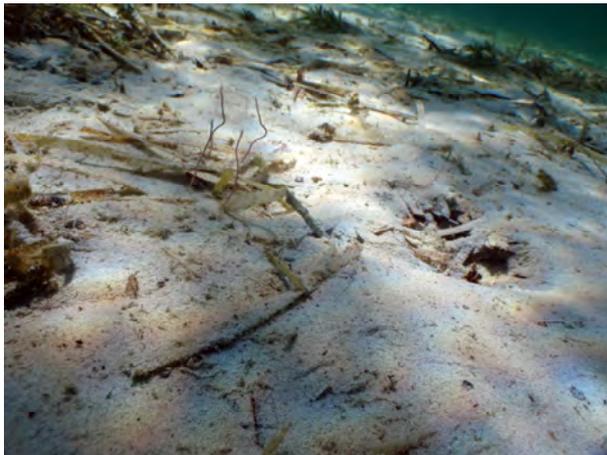
Figure 7-9 Survey area seabed with dead seagrass. (Photograph: P. Baker, WA Museum)

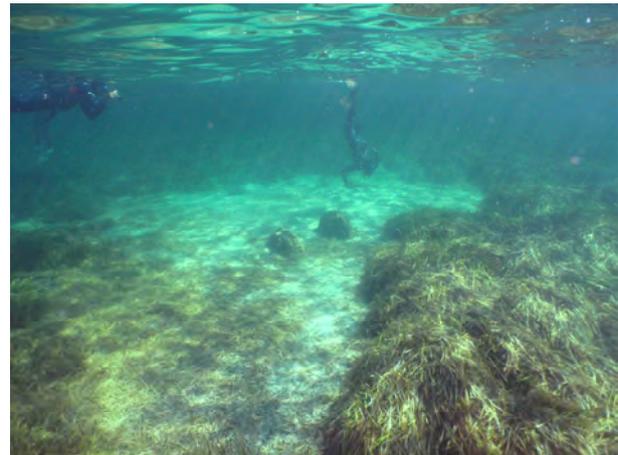
Figure 7-10 Scouring of the seagrass around the iron wheels. (Photograph: P. Baker, WA Museum)

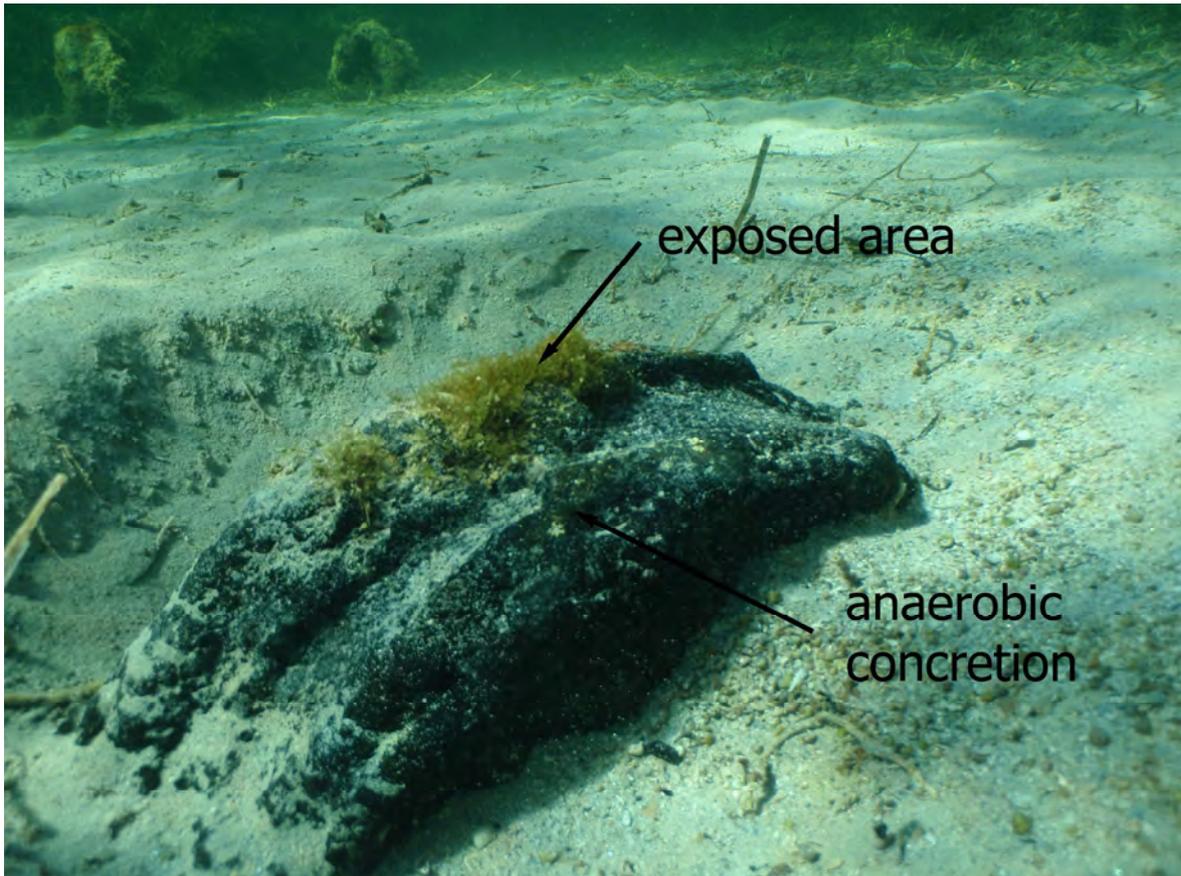
Figure 7-11 Buried iron wheel. (Photograph: P. Baker, WA Museum)

materials, with no evidence of any past exposure to a more oxygenated environment (Fig. 7-11). Alternatively, on closer inspection of the exposed sections of railway track, the concretion was thin and quite dense with very little secondary marine growth, suggesting that the track had been only recently exposed. However, the extent of exposure was only slight as the seaward end of the track remained buried immediately below the sediment surface. Hence, at the time of the survey, the site appeared to be reasonably stable with little evidence of seasonal exposure.

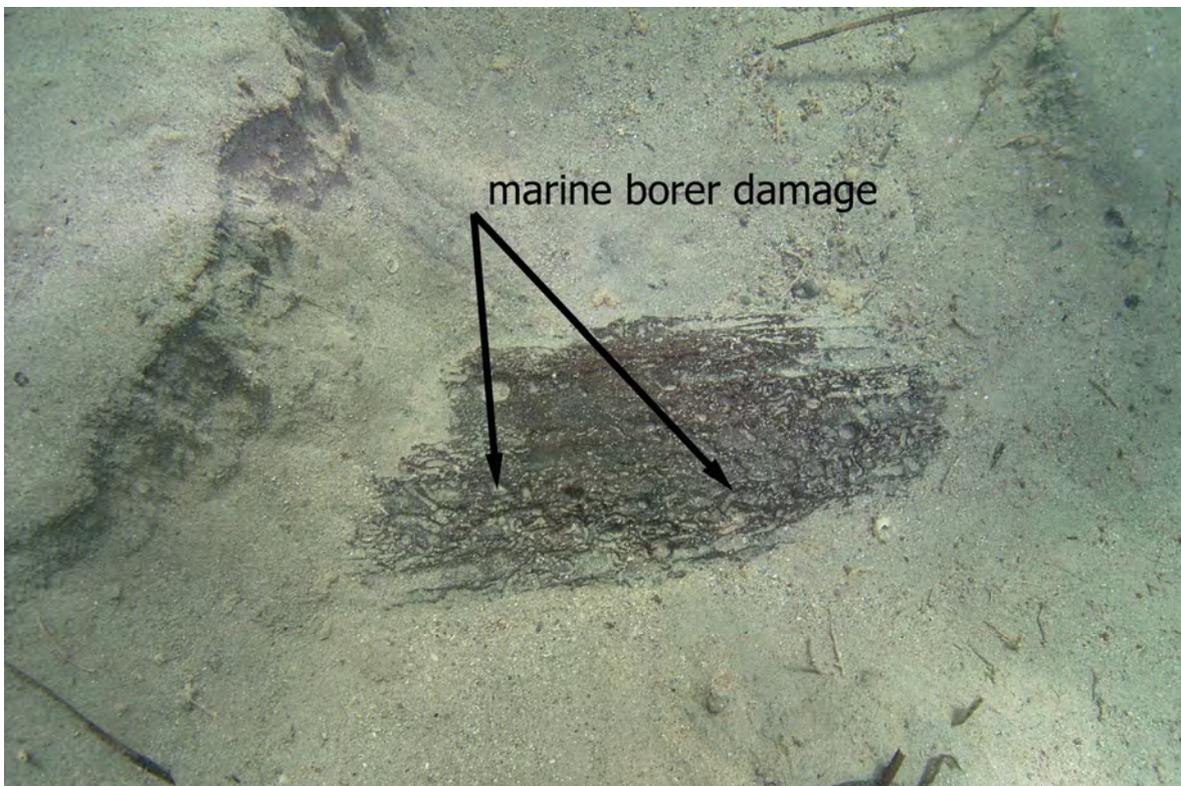
A jetty pile buried to a depth of about 20 centimetres was excavated just north-east of the pair of railway wheels. There was evidence of previous biological deterioration by marine borers, but it is impossible to determine when this degradation occurred (Fig. 7-12). More importantly, the concretion and the extent of biological growth on the exposed parts of the iron wheels suggest that these artefacts have been exposed to an aerobic marine environment for a considerable period of time, and there was no evidence of seasonal reburial/exposure cycles at the sediment/seawater interface. In addition, the rod connecting the two wheels was buried just under the sediment surface and there was no evidence of previous exposure to an aerobic marine environment. Furthermore excavation of the almost totally buried iron wheel revealed the typical black, dense concretion common to anaerobically corroded ferrous

Figure 7-12 Buried jetty pile remains with evidence of previous marine borer damage. (Photograph: P. Baker, WA Museum)

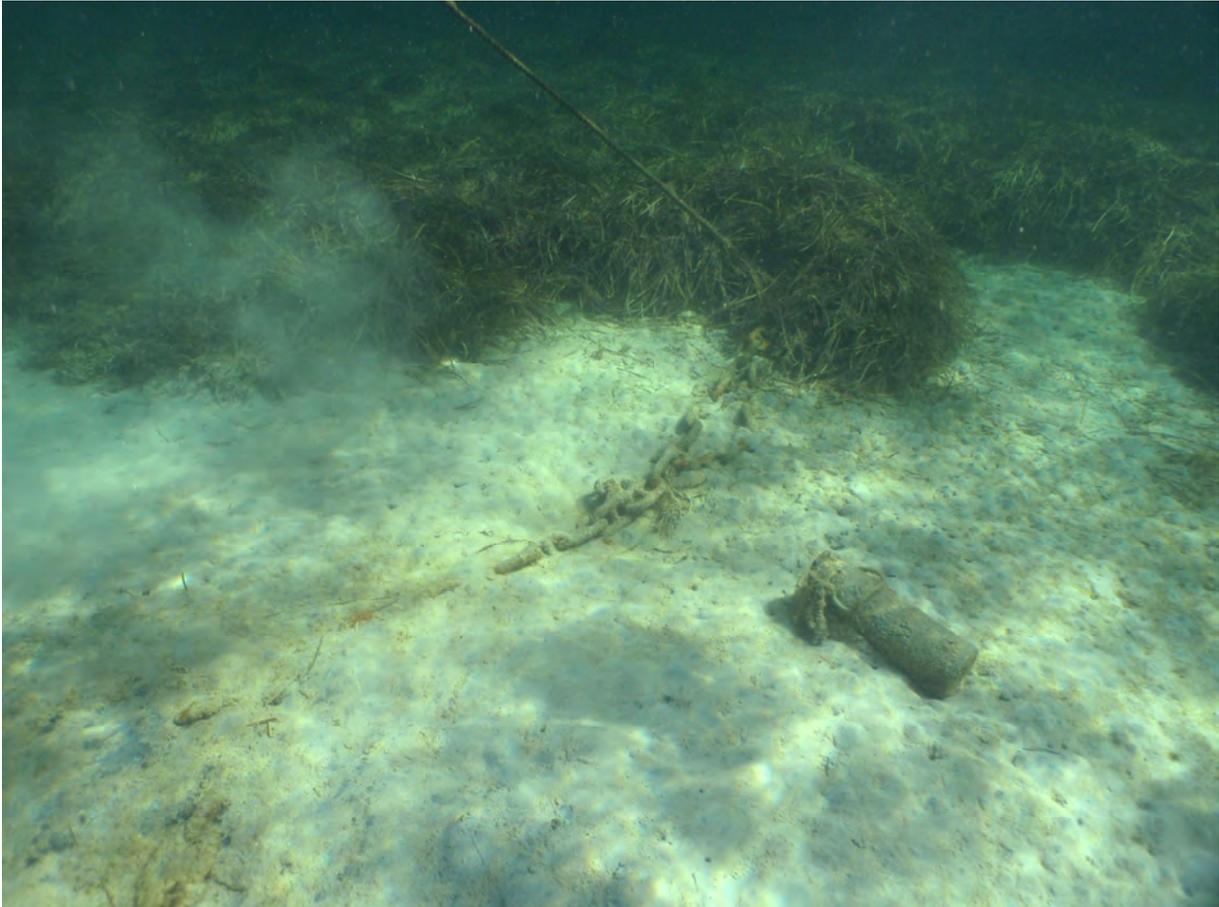
Figure 7-13 Mooring post with chain located on the Quindalup jetty site. (Photograph: P. Baker, WA Museum)

There is a mooring post and chain located on-site (Fig. 7-13) that may be connected to some buried historic structure, but without excavation this was impossible to ascertain. More importantly, it is likely that the chain is responsible for the extensive scouring and demise of the seagrass surrounding the exposed iron wheels. The loss of protection afforded by the seagrass beds could have caused increased corrosion of these artefacts by increasing the physical damage caused by water and sand impingement and by increasing the availability of dissolved oxygen at the concreted iron surfaces.

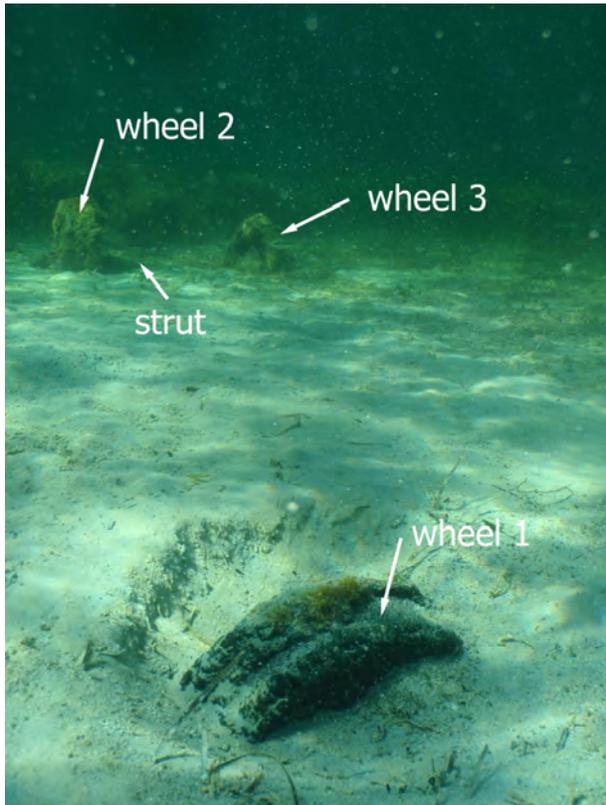
Figure 7-14 Positions of the iron wheels measured on the Quindalup jetty site. (Photograph: P. Baker, WA Museum)

The corrosion parameters of the three iron wheels and the iron railway track were measured and the measurement positions are shown in Figures 7-14, 7-15, 7-16, and 7-17. The results of the corrosion survey are presented in Table 7-3.

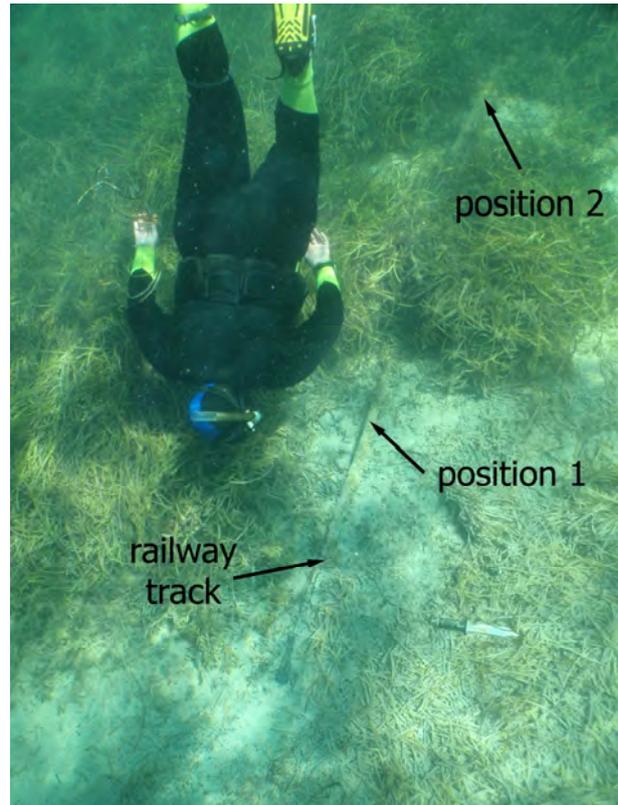
Figure 7-15 Measurement positions on the exposed sections of the railway track. (Photograph: P. Baker, WA Museum)

Position 1 on the exposed section of the railway track had the least negative corrosion potential (-0.306), which indicates that this area (Fig. 7-15) suffers the most corrosion of the artefacts measured on the site. In addition, the track was broken between position 1 and 2 and not in direct electrical contact, which is confirmed by the 40mV difference in the corrosion potentials of these two points (Table 7-3). The corrosion potentials of positions 2 and 3 on the railway track were very similar, -0.347V and -0.344V, respectively, and about 40mV more negative than position 1. This suggests that this piece of track is in one section and is corroding at a slower rate than the exposed shoreward end (Fig. 7-16).

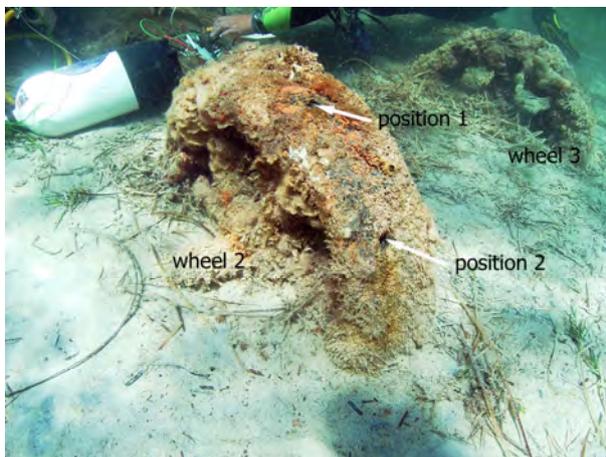
Figure 7-16 Positions of the corrosion measurements on wheel 2. (Photograph: P. Baker, WA Museum)

The pH and the depth of penetration (25 mm) of position 1 on wheel 2 (Fig. 7-16) were higher in comparison to the other aerobic measurement points [wheel 2: position 2 (15 mm) and wheel 3 (16 mm)]. Position 1 had the typical aerobic

red/brown iron oxy-hydroxide surface corrosion products (Fig. 7-16), indicating that there was a breach in the concretion layer allowing direct access to oxygenated seawater, which subsequently increased corrosion in this area.

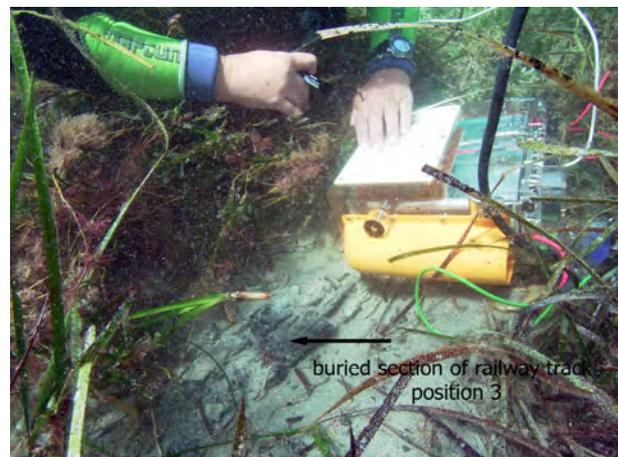
Figure 7-17 Measurement position on the buried section of the railway track. (Photograph: P. Baker, WA Museum)
