6. BUSSELTON JETTY: ON-SITE CONSERVATION SURVEY REPORT

By Vicki Richards

Date of inspection: 26 February 2009

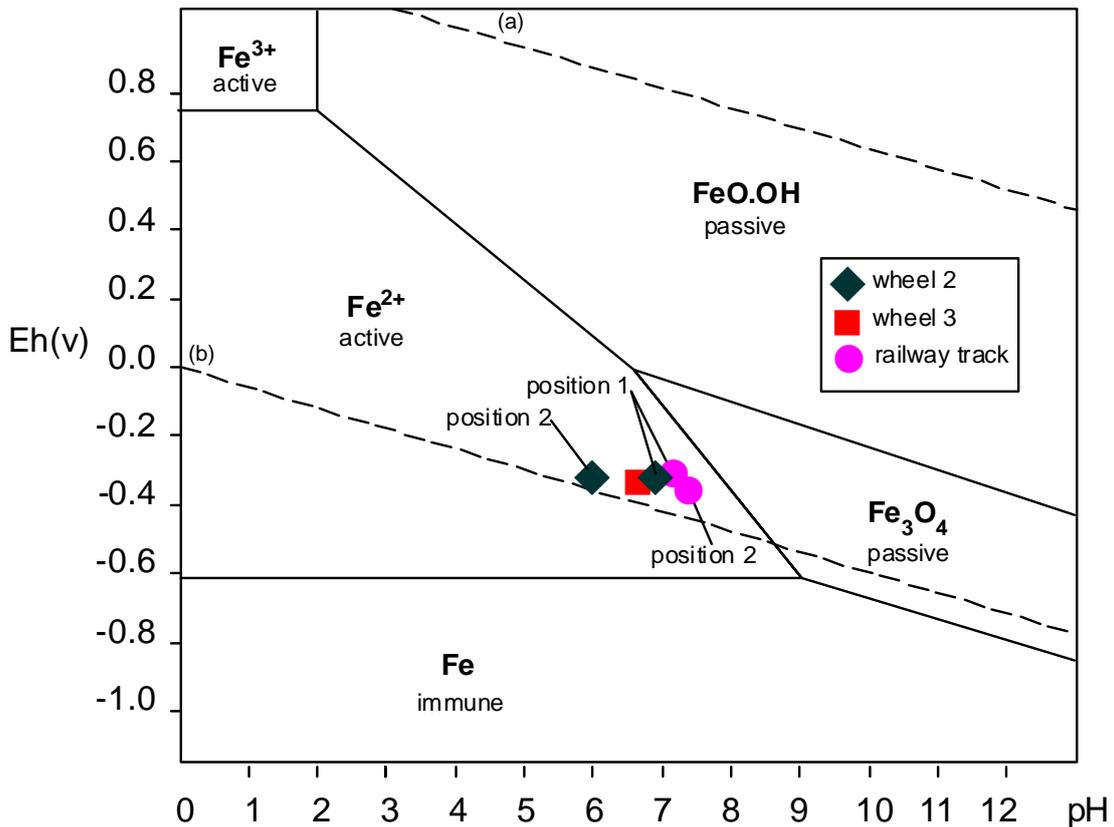
Figure 7-18 Pourbaix diagram for iron (10^{-6} M) in aerobic seawater at 25°C indicating the state of the exposed iron artefacts on the Quindalup jetty site. (Graph: V. Richards, WA Museum)

The corrosion survey indicates that all ferrous artefacts on the Quindalup jetty site are actively corroding (Figs. 7-18 and 7-19). On closer inspection of the corrosion data, it is obvious that there are some subtle differences in the corrosion behaviour of the iron artefacts. The average corrosion potential of wheels 2 and 3 and the buried strut between them was $-0.324 \pm 0.001V$, indicating that the entire structure is electrically connected. However, the differences in pHs of the residual metal surfaces and the depths of penetration indicates that different areas on the artefact are corroding at different rates.

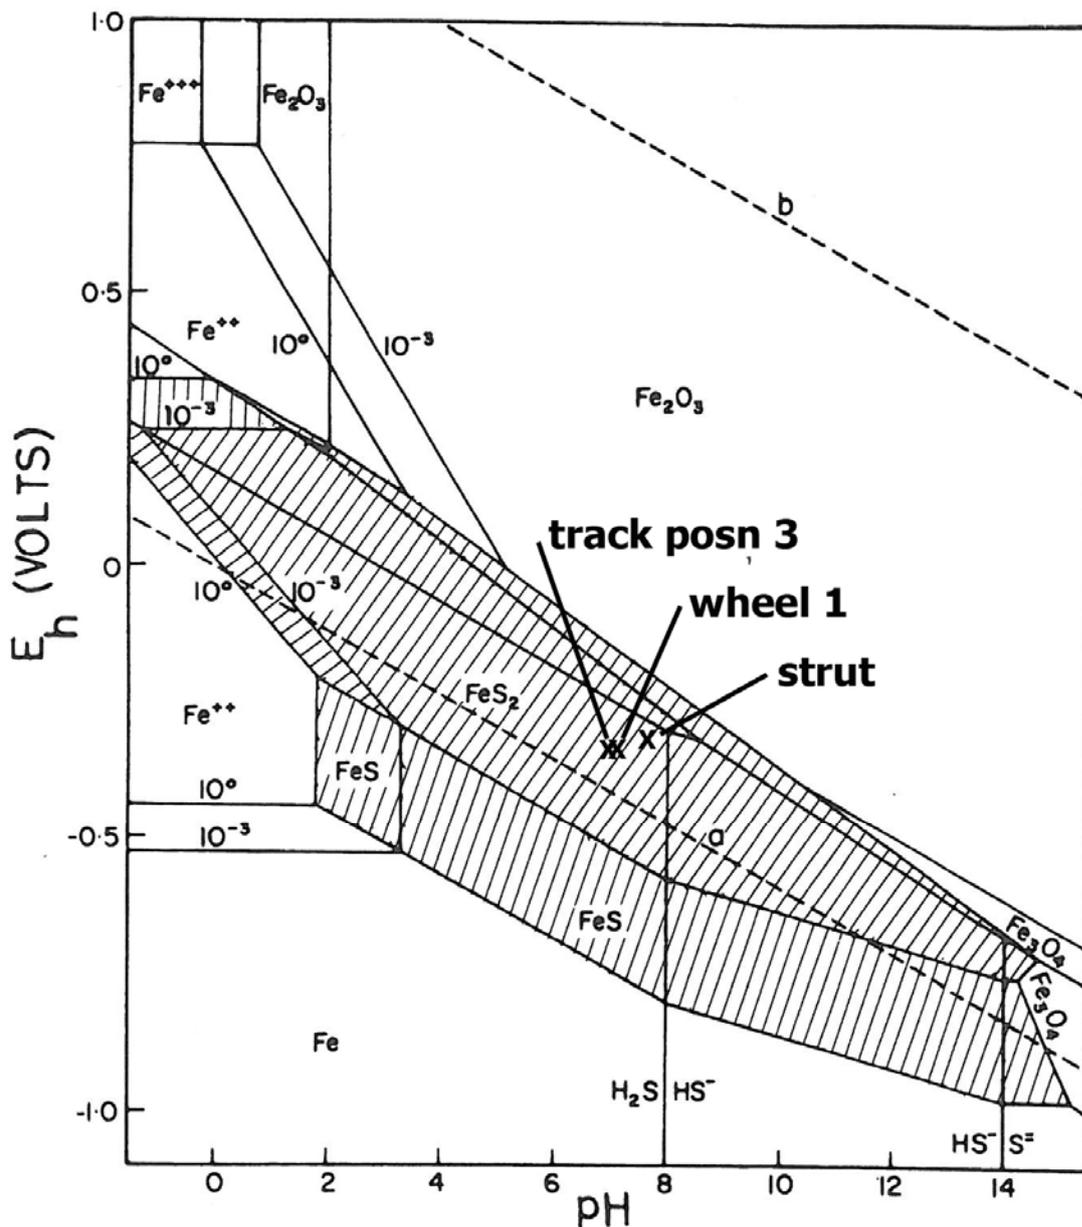
Figure 7-19 Pourbaix diagram for iron in anaerobic seawater at 25°C indicating the state of the buried iron artefacts on the Quindalup jetty site (Peters, 1977: 277).

The corrosion parameters of the buried strut, railway track (position 3) and wheel 1 are plotted on the Pourbaix diagram for iron in anaerobic seawater (Fig. 7-19). The intercepts show that these iron artefacts were actively corroding, with pyrite being the major corrosion product. Corrosion of ferrous materials under deoxygenated conditions form very dense concretions combined with iron sulphides and iron oxides of lower oxidation state, which are black in colour. This was evident on the buried artefacts. In addition, the depths of penetration on the buried objects were significantly less than those measured on the other more exposed iron artefacts.

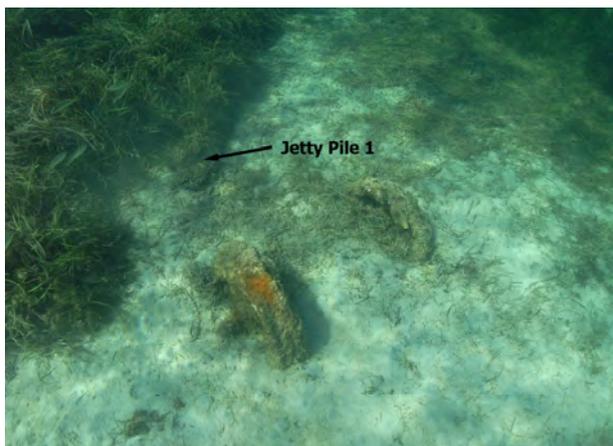
Figure 7-20 Location of Jetty Pile 1 adjacent to the iron bogey (wheels 2 and 3). (Photograph: P. Baker, WA Museum)

The exposed, algae-covered remains of two wooden jetty piles were observed on the site. They both suffered from extensive from teredo-worm damage. In-situ pH profiles were measured on the exposed pile (Jetty Pile 1), which lies horizontally on the seabed about 1m south-east of the partially buried bogey (wheels 2 and 3) (Fig. 7-20), and on the buried pile (Jetty Pile 2) (Fig. 7-21), which is located about 1m north of the same bogey under 130 millimetres of sediment (it was found when our coring tube hit the upper face of the pile during sediment sampling). The length of the drill bit used in the wood coring procedure limited the maximum depth of penetration to about 100 millimetres. A sample of Jetty Pile 1, directly adjacent to the drill hole, was collected for species identification and maximum water content (U_{max}) determination. The results of the pH profiles are presented in Table 7-4 and shown diagrammatically in Figure 7-22.

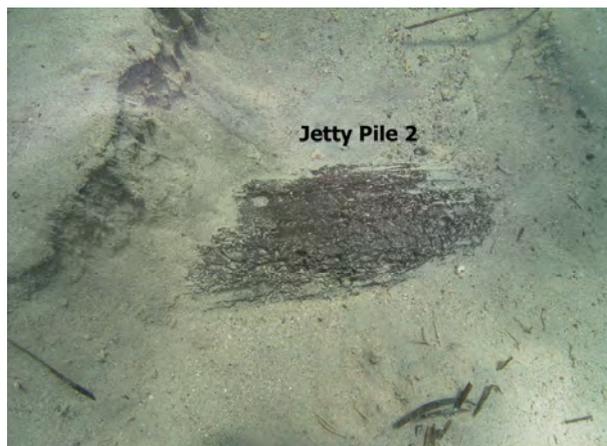
Figure 7-21 Buried jetty Pile 2 forward of the iron bogey (wheels 2 and 3). (Photograph: P. Baker, WA Museum)

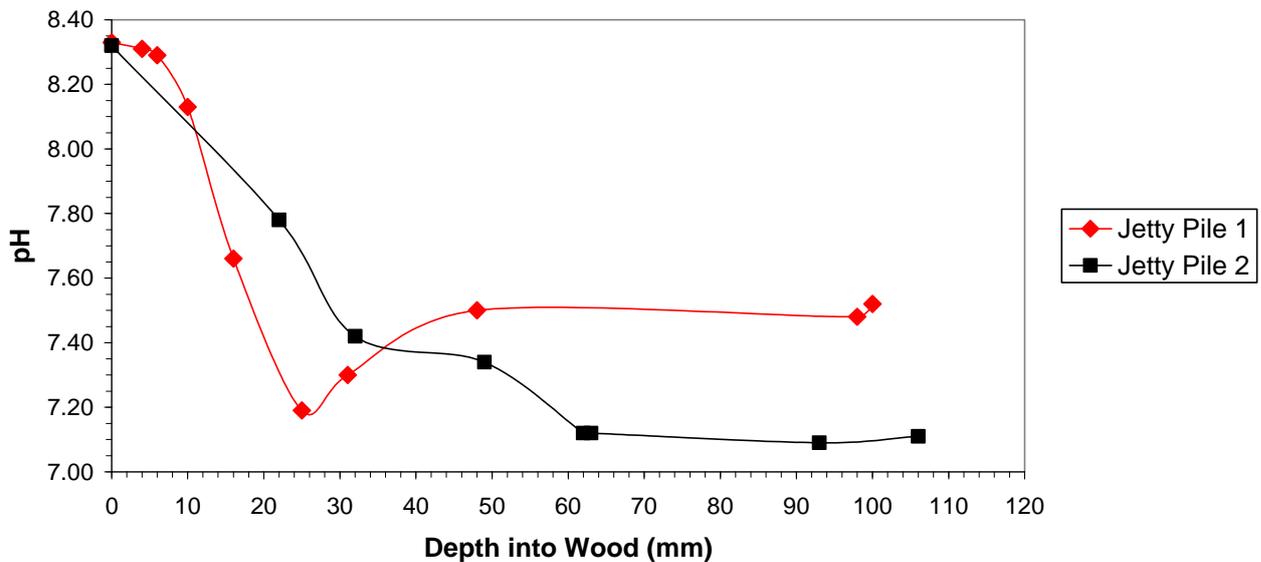
Figure 7-22 pH profiles of the jetty pile remains measured on the Quindalup jetty. (Graph: V. Richards, WA Museum)

The pH profiles for the exposed Jetty Pile 1 and the buried Jetty Pile 2 are typical of wood with a relatively thin outer layer (<20 mm) of extensively degraded wood overlying a less degraded inner core. However, the more acidic pH measurements noted for Jetty Pile 2, beyond a depth of about 50 millimetres, indicate that the inner region of this buried pile is in better condition than the exposed pile. This is not unexpected, as it is well known that wood recovered from deoxygenated environments is usually better preserved because the wood is better protected from extensive physical and biological deterioration. However, the extent of protection is directly related to the depth of burial, so, generally speaking, the deeper the burial

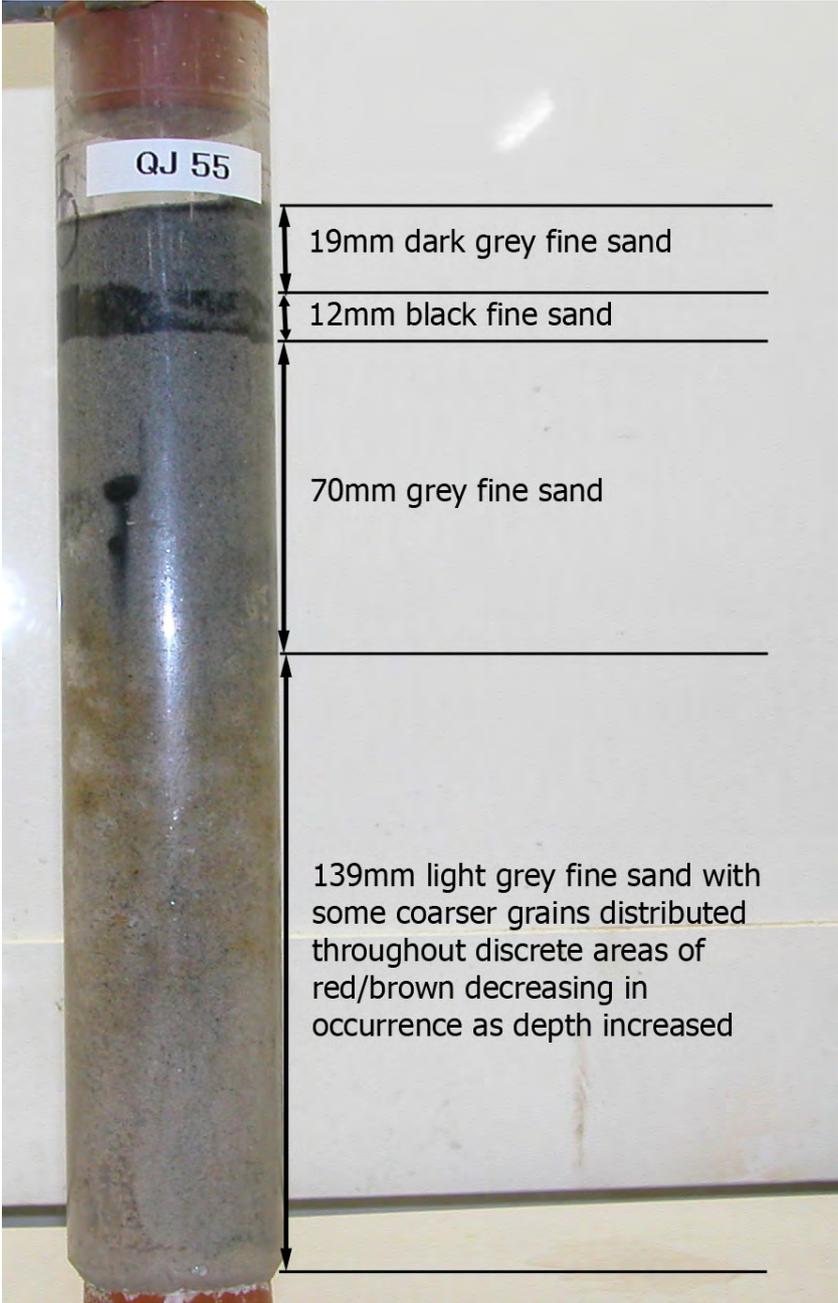
slowly turned darker over a period of a few weeks. This colour change was caused by bacterial degradation of the organic material present in these sediment layers. The bacteria utilise dissolved oxygen in the sediment for their metabolic processes and, therefore, the layer becomes deoxygenated over time, causing this black discolouration. Alternatively, there was very little colour change in the lower core section (>100 mm), with the exception of some oxidation of reduced iron species to a typical red/brown colour, indicating that there was very little organic matter present in these lower depth layers. Hence, in order to avoid possible misinterpretation of the sediment data, the core samples should be photographed as soon as possible after recovery.

Figure 7-23 Sediment core sample (QJ 55) from the Quindalup jetty site. (Photograph: V. Richards, WA Museum)

Despite these colour changes in the sediment core sample, the visual observations imply that the depth to stable sediment is approximately 10 centimetres, which supports the electrochemical measurements that indicated that the zero- E_h interface also occurs around this depth.
