# A TALE OF TWO SHIPWRECKS: U. S. STEAMER *CONVOY* AND CONFEDERATE SCHOONER *WILLIAM H. JUDAH*

A thesis submitted to the Department of Anthropology College of Arts and Sciences The University of West Florida In partial fulfillment of the requirements for the degree of Master of Arts © 2013 Christopher Todd Dewey

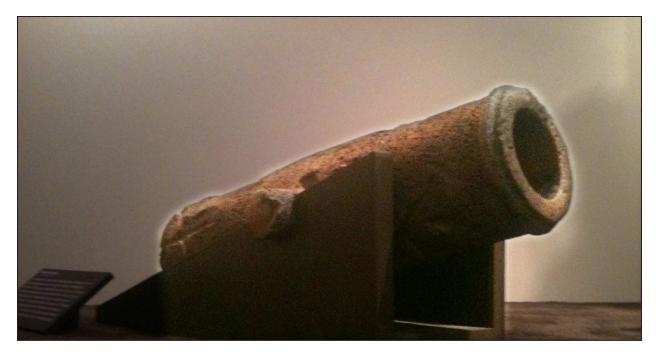
When a dredge operating in Pensacola Pass in 1990 snagged an obstruction that caused the equipment to shut down, an investigation revealed that a bronze howitzer (Figure 6) was caught in the dredge intake. The cannon was taken to the T. T. Wentworth Museum, where it was conserved and placed on display (WFHPI 1990). The wooden gun carriage was missing; however, preliminary investigations indicate that the gun is consistent with the age and style of similar weapons carried aboard ships during the American Civil War. A nearly identical howitzer is on display at the Washington Navy Yard, and that weapon is believed to date from the war with Mexico in the 1840s (Naval History and Heritage Command 2013). The only recorded location for the find was "off Perdido Key during a dredging operation to deepen the channel into Pensacola Bay. The scars on the barrel were formed when the dredge pulled the howitzer from its resting place in a sand bar" (WFHPI 1990). The dredge may have destroyed a wooden wreck in the process of deepening the channel, and "a survey of the area did not turn up any further evidence of significant remains, although ship timbers had been brought up in the dredging that produced the howitzer" (Phillips and Cozzi 2013).

FIGURE 6. Howitzer recovered from dredge. (Photo by author, 2013.)

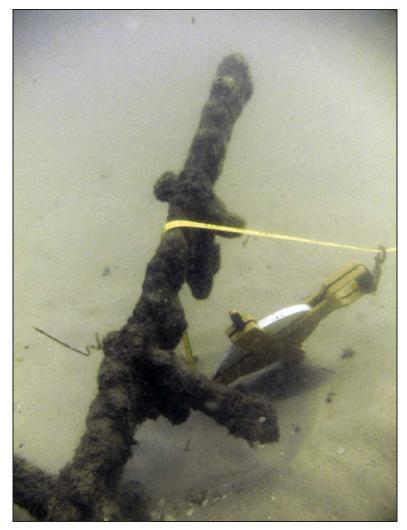
FIGURE 15. Northwest debris field. (Photo by author, 2012.)

The northwest area of the wreck took the most time to map because a significant debris field was located approximately 25 m (82 ft.) west of the north end of the baseline (Figure 15). The area initially appeared to be a separate debris scatter from the main wreck site and might have been the remains of a second wreck; however, closer inspection—including intensive hand fanning by the dive team—revealed that the wreckage was part of one continuous field of concreted ferrous metal features extending north and west of the main wreck site. No cupreous metal features were discovered in this area, indicating that the scatter was likely outside the main hull wreckage.

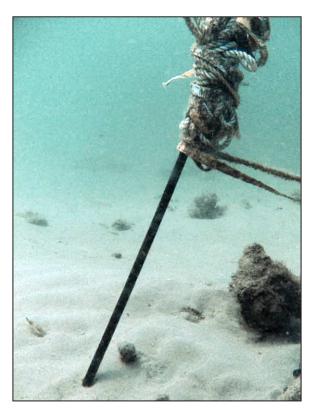
FIGURE 16. Damage to north baseline screw eye. (Photo by author, 2012.)

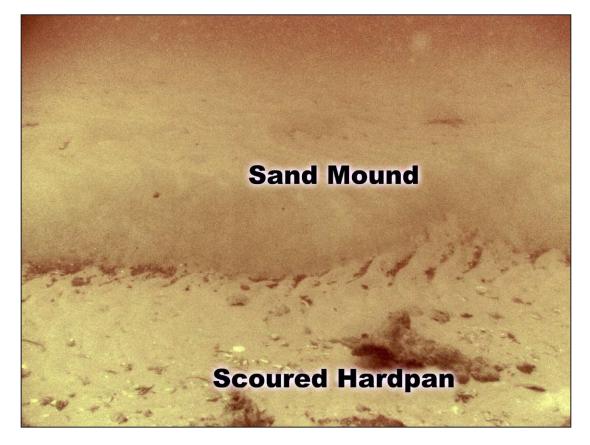
FIGURE 18. Sand mound and bottom scour. (Photo by author, 2012.)

A reexamination of the wreck revealed that during the intervening two weeks, the pass currents had scoured the new southern debris field down to the hardpan sediment beneath. Approximately one half meter (1.5 ft.) of sand had previously covered the area. Additionally, fresh sand deposits covered large sections of the east side of the wreck. A moving mound of sand, approximately 0.6 m (2 ft.) high, appeared to drift around the site, alternately uncovering, then recovering various sections of the wreck. Figure 18 shows the sand mound on the edge of the newly discovered southern debris field. The area in the foreground is newly scoured hardpan bottom, and the sand mound is visible beyond. Figure 19 is a detailed diagram of the 2012 site showing the baseline, the extents of the main debris field, the northwest artifact scatter, and the new southern debris field.

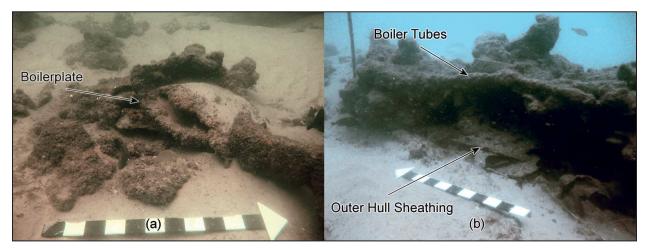
FIGURE 21. Boiler debris; scale equals 1 m. (Photo by author, 2012.)

The baseline passed directly through the boiler debris, which measured from approximately 16 m (52.5 ft.) to 20 m (66 ft.) along the baseline and extended approximately 3 m (10 ft.) from either side of the baseline. Figure 21(a) shows the boilerplate and Figure 21(b) shows the boiler tubes and the outer-hull sheathing beneath the boiler debris. The outer-hull sheathing beneath the boiler wreckage indicates that the debris lies within the limits of the hull area and was near the bottom of the ship. Another section of the boiler was found approximately 20 m (66 ft.) north of the main boiler debris field. A positive identification of this feature as part of the boiler was not possible because of the heavy concretion layers covering the ferrous metal; however, the feature was in the same vicinity and had the same basic shape as a feature identified from the 1987 U. S. Navy survey (Figures 19 and 22).

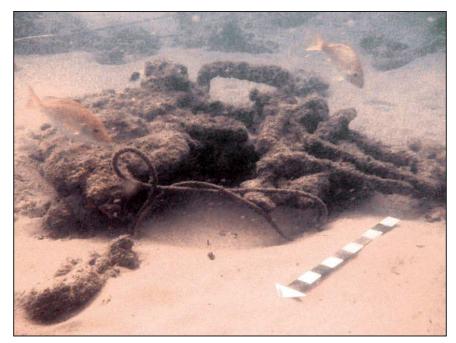
FIGURE 22. Northern boiler fragment; scale equals 1 m. (Photo by author, 2012.)

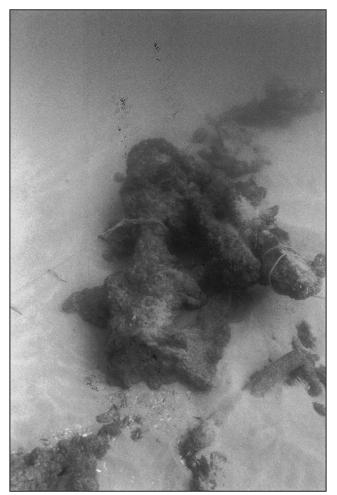
FIGURE 24. 1987 Photograph of Convoy's steam windlass. (Photo courtesy of U. S. Navy 1987).

The final feature that helped orient the 2012 wreck site with the 1987 survey was the steam windlass. Dive teams searched the area several times before they recognized the windlass. The feature was difficult to identify because of the heavy accumulation of concretion on the object since the 1987 survey and because the windlass appears to have been reoriented on the bottom. Figure 24 is a photo of the steam windlass taken in 1987 by divers from Tidewater Atlantic Research. When compared to the drawing of the windlass near the southern end of Figure 14, the apex of the windlass was clearly pointing toward the west. Figure 25 shows the windlass as it lies on the bottom today, with the apex pointing toward the north. The object appears to have rotated 90° to the right and may also have flipped over. The size, shape, and location of the object match the description of the windlass from the 1987 survey despite its unusual orientation, the reasons for which are discussed in detail in Chapter V.

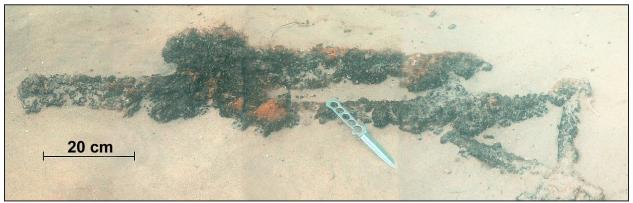
The debris scatter to the northwest of the main wreck site was different from the other areas. The main site consisted of concreted ferrous metal features most likely associated with the steam plant, including segments of the boiler and engine, their associated piping, and the steam powered windlass near the bow. Straight and twisted linear features characterized the debris scatter to the northwest. The features did not resemble any known parts of a steam propulsion plant from the 19th-century. Although the features were twisted and heavily concreted, they resembled the frame assembly around the ship's engine depicted in Valentine's 1863 painting (Figure 2). Figures 27 and 28 illustrate the linear nature of the northwest debris. The structures measured approximately 8 cm (3.1 in.) by 10 cm to 15 cm (4 in. to 6 in.) in width.

FIGURE 28. Northwest debris. (Photo by author, 2012)

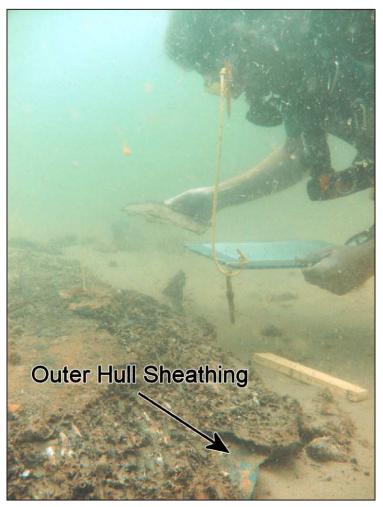
FIGURE 30. Outer hull planks with attached sheathing. (Photo by author, 2012.)

Much of the wooden hull structure described in the 1987 U. S. Navy survey was absent from the 2012 wreck site. The presence of nearly intact sections of cupreous sheathing with its associated fasteners indicates the location and extents of the now-missing hull (Figure 29). Despite the dearth of wooden hull structure on the wreck site, two sections of the outer hull survived on the eastern limits of the wreck (Figure 19.) The timbers in Figure 30 measured 168 cm (66.1 in.) long by 78 cm (30.7 in.) wide; the outer hull sheathing is visible in the triangular notch near the bottom of the photo. The hull structure in Figure 31 was 90 cm (35.4 in.) by 32 cm (12.6 in.); the light strip across the top of the plank is intact sheathing. Both structures were 7.5 cm (3 in.) thick and both showed extensive shipworm damage.

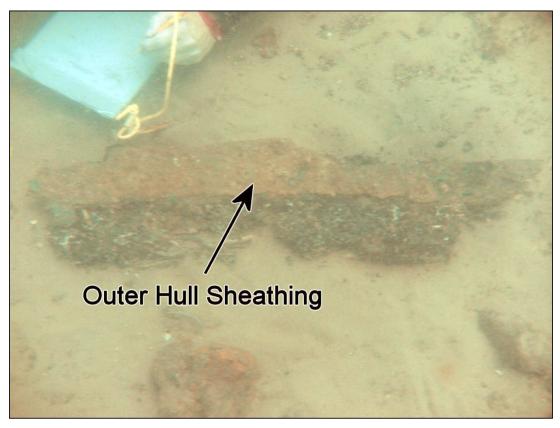
FIGURE 31. Outer hull plank with attached sheathing. (Photo by author, 2012.)

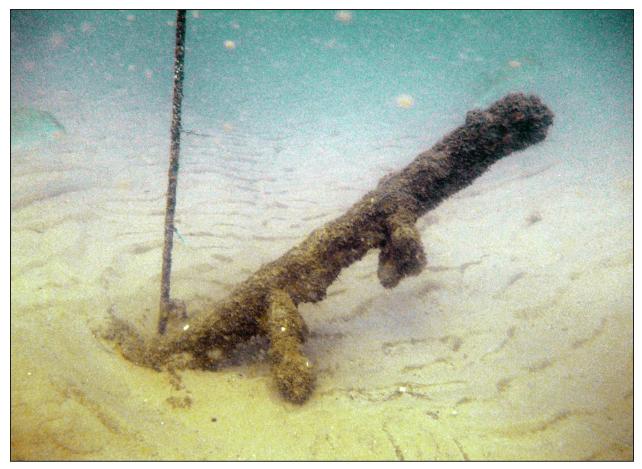
In order to access *Convoy*'s engine and boiler, the 1879 salvage crew probably had to remove the frame structure around the engine as seen in Figure 50. The framework resembles much of the debris found in the northwest scatter area (Figure 51).

FIGURE 51. Northwest debris. (Photo by author, 2012.)

The 19th-century salvage work acted as both an extraction filter and as a scrambling device. Clearly, the extraction of much of the ship's engine and half of its hull influenced the wreck site visible on the bottom today. Besides the possible removal and deposition of the engine framework and the anchor windlass main gear, the salvage crew likely moved other sections of the ship in order to access other areas or to reduce the wreck's profile above the bottom.

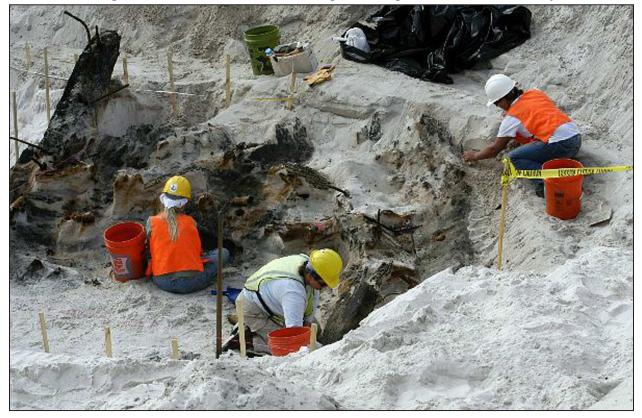
shipwreck during excavations for a new pool on NAS in 2006 (Nichols 2006). Figure 54 shows the U. S. Navy archaeologists excavating the site. Based on the ceramic assemblage recovered, UWF archaeologists assessed the wreck to be of Spanish origin from the 18th century or later.

FIGURE 54. U. S. Navy archaeologists excavating a shipwreck on NAS Pensacola, 2006. (Photo by Nichols, courtesy of U. S. Navy Newstand, 2006.)
