# Floating photovoltaic systems: photovoltaic cable submersion and impacts analysis

The problem under study is related to the potential submersion of photovoltaic cables, that can lead to a degradation of its electrical insulation capabilities and, consequently, higher energy production losses and water contamination.

In the present study, the submersion of photovoltaic cables (with two different insulation materials) in freshwater and artificial seawater was tested, in order to replicate real life conditions, when FPV systems are located in reservoirs or in the marine environment. Electrical insulation tests were carried out weekly to assess possible cable degradation, the physical-chemical characteristics of the water were also periodically monitored, complemented by analysis to detect traces of copper and microplastics in the water.

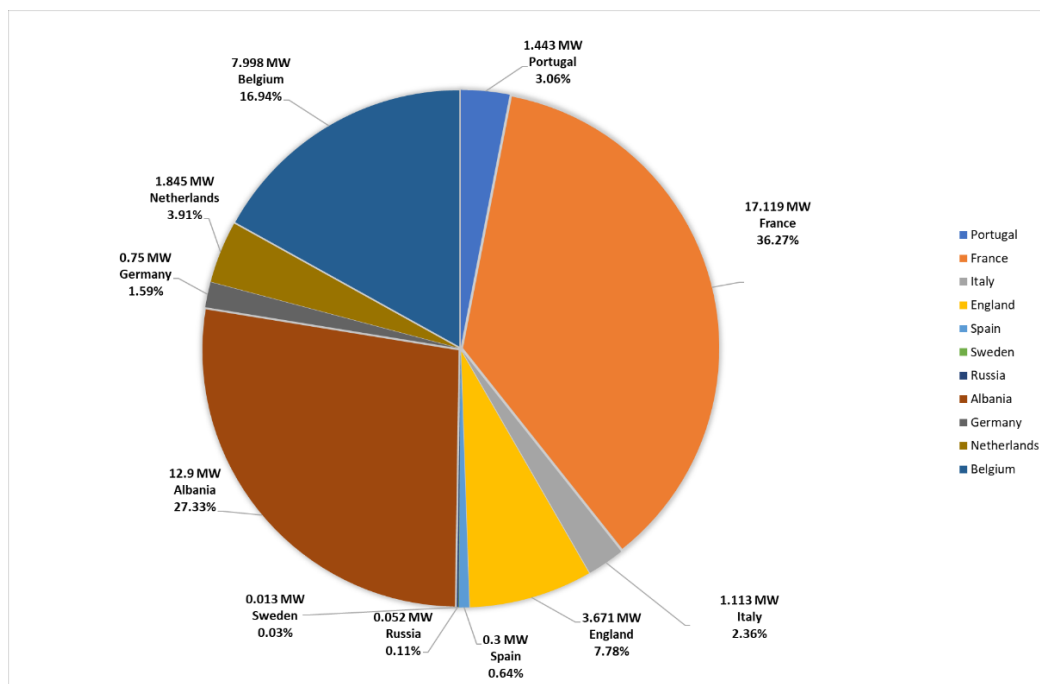
Figure 1 Floating Photovoltaic Power Installed in Europe [6], [7], [16]–[25], [8]–[15]

In Europe, this technology has had a slow growth, accelerating in the last years and currently the total installed capacity is 47.20 MW. Portugal may top this list when the construction of 50 MW in the Alentejo region is concluded, estimated to be commissioned by the end of 2021, thus increasing the total European installed capacity to 97.201 MW.

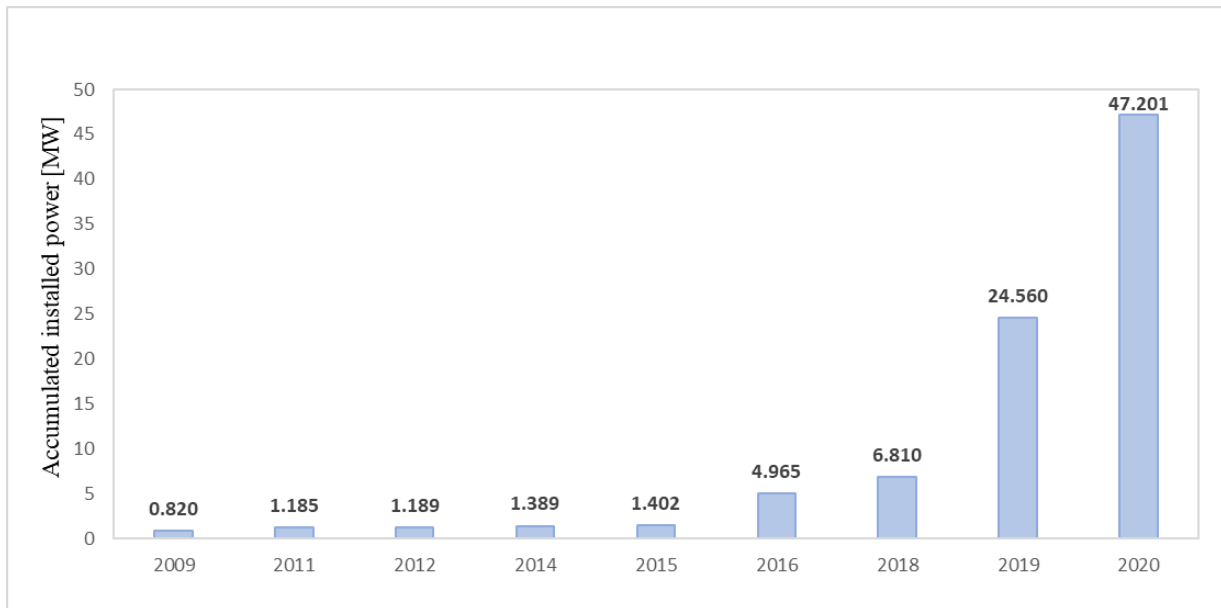
Figure 2 Evolution on FPV installed capacity in Europe [6], [7], [16]–[25], [8]–[15]

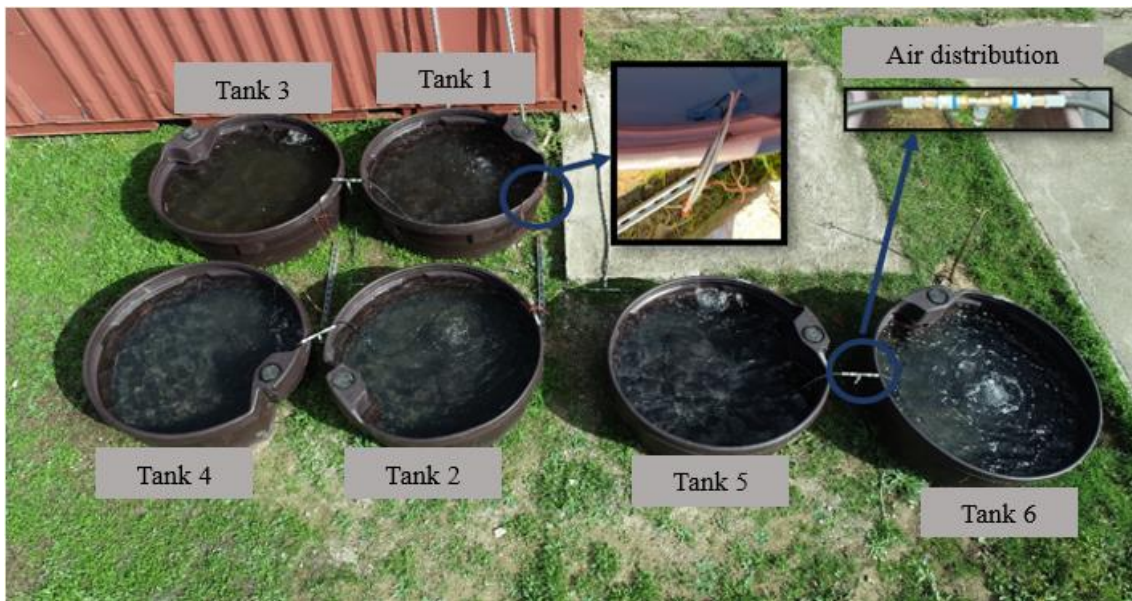
Figure 3: Experimental setup with the 6 water tanks. The air compressor and timer system are installed inside the red container (top of the image).

Six large tanks were used to simulate freshwater and marine environments, with a radius of 0.75m, 0.3m in height and a total volume of 0.53m<sup>3</sup>, made of high-density polyethylene POLYCHOC™ with anti UV treatment, and a food safe rating.

The six tanks were installed outdoors, filled with water, and equipped with a water mixing and oxygenation system in order to prevent algae growth and bacterial organic matter degradation. This system is composed by an air compressor and a compressed air distribution network for the six tanks. A timer system controller was installed, performing 10 daily cycles of 20 minutes, from 9:00 until 18:00. The experimental setup is presented in detail in Table 2. The outdoor distribution of the test tanks is illustrated in figure 3. This outdoor test setup was installed in the experimental campus of the University of Évora (Polo da Mitra, GPS coordinates: 38°31'53.3"N, 8°00'43.3"W). The test site is framed in a rural context, with characteristics similar to the framing of these FPV

To simulate freshwater systems, tanks 1, 3 and 5 were filled with ca. 500 L of tap water, and for marine environments simulation, ca. 18kg of marine salt was added to the tanks 2, 4 and 6, to achieve a salinity level of about 3.5% (Figure 4 a). The salinity value was monitored using a TROLL 9500 PROFILER XP multi parametric probe [28] (Figure 4 b).

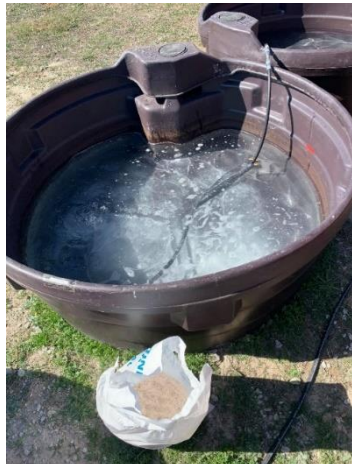
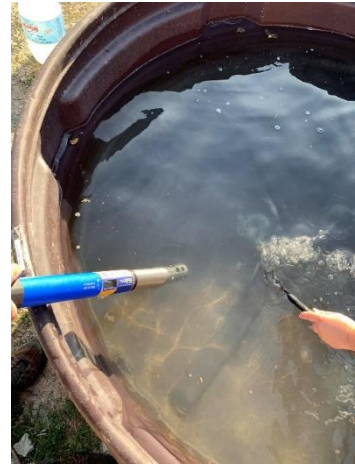
Figure 4 a) Preparation of saltwater; b) Physical-chemical characterization with the multiparametric probe

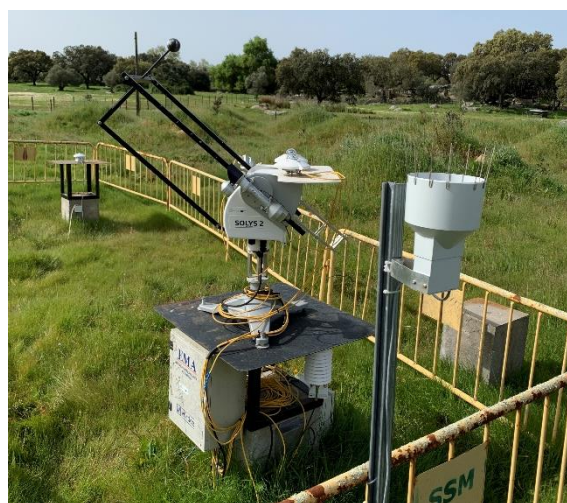
Figure 5: Onsite meteorological station.

Weather and ambient variables were continuously monitored by a meteorological station installed 100m away from the water tanks, also in the open field. This station is equipped with a two-axis fully automatic sun tracker SOLYS2 [29], with two CMP11 pyranometers [30] to monitor global and diffuse solar radiation, one CHP1 pyreliometer [31] to measure direct solar radiation, one air temperature and relative humidity sensor [32] and one precipitation sensor [33]. This station is presented in Figure 5.

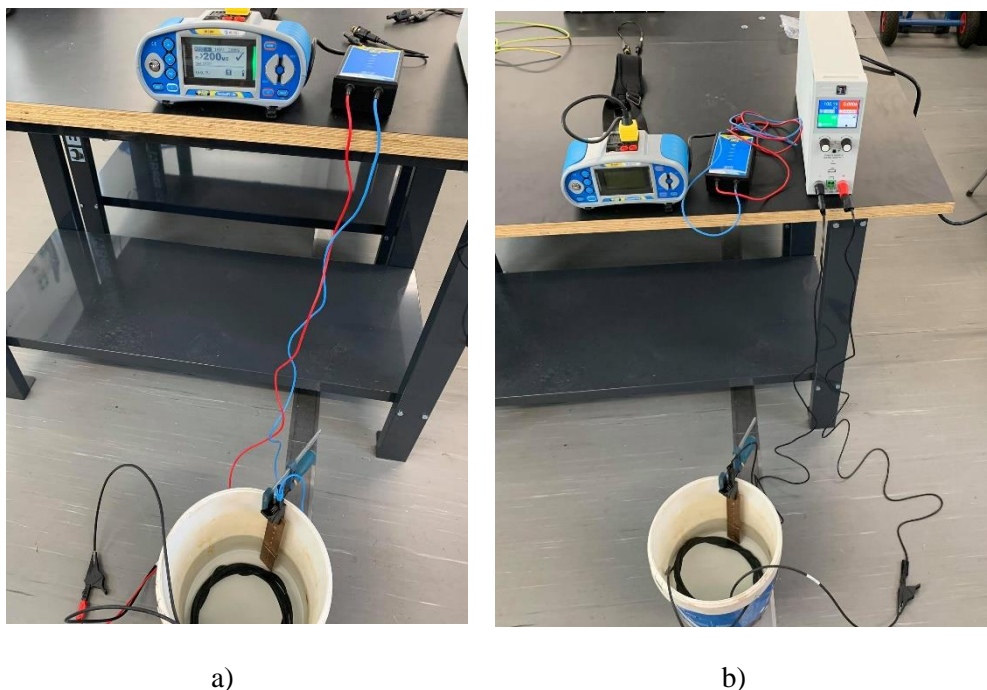
Figure 6 a) Resistance measurement with the I-V curve tracer; b) Application of 100 V with the voltage source.

For the purpose of this electric tests, a voltage source [34] was used, as well as a photovoltaic and electrical installation tester [35] to measure the insulation resistance. For safety, a galvanic isolation device was also used between the electrical installer tester and the cable being measured. For measuring the cable insulation resistance, the following procedure was used:

1. Visual inspection of each cable, checking for any fault or degradation of the dielectric layer.
2. Measuring of the cable resistance with the electric tester, applying a voltage of 100 V. If the resistance result is above the minimum limit, the next step was carried out. This initial step is important in order to assess the safety conditions of the cable and allow to proceed safely in the next steps of the test.

3. As indicated by the test procedure in the standards, it is necessary to apply a voltage between 80-500 V for one minute to the photovoltaic cable submerged in water, in a small test tank, where the measurements were periodically made. For this, the voltage source was used to apply 100 V to the cable conductor and the water through a solid copper bar.

4. Finally, the cable resistance is measured with the electric tester equipment. After the resistance is measured, the cables were submerged again in the outdoor tanks. Electrical insulation tests were carried out once a week for 12 weeks.

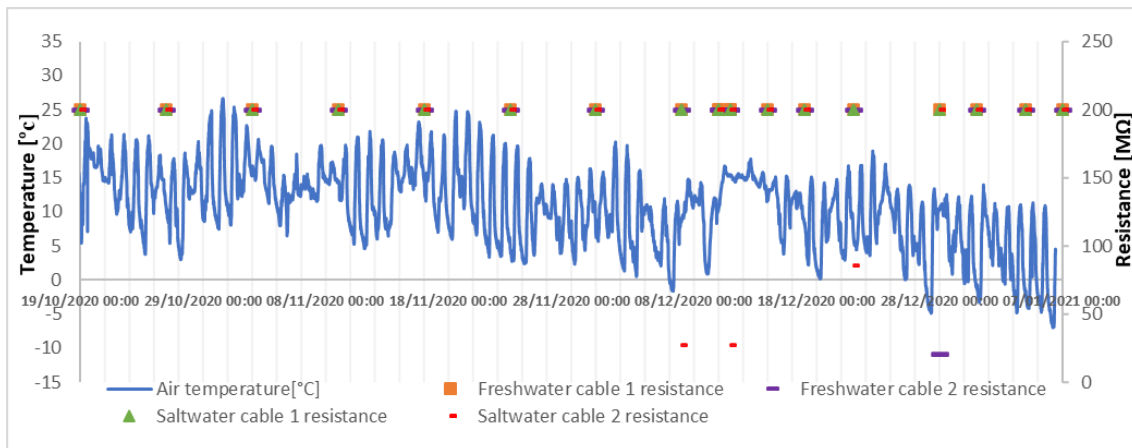
Figure 7 Air temperature and electric insulation resistance over time.

In the first measurement, all cables reached the maximum measurement limit of the device, 200 MΩ. The first cable to record electrical insulation losses was cable 2, in salt water in the eighth week, with a resistance value of 27 MΩ, and in the same week the presence of copper was detected with a significant concentration (Table 3). This decrease in the resistance value occurred when the air temperature dropped below 0°C for the first time in that year, as showed in Figure 7. The cable 2 (saltwater) presented again resistance values below 200 MΩ during the test period, nevertheless these resistance values were higher than 2.9 MΩ, the minimum insulation resistance value for a 4 mm<sup>2</sup> cross-section cable. Cable 2 (freshwater) had also a one low resistance value, recovering to a higher value the next week. The cable 1, either submerged in freshwater, either in saltwater, never presented lower electrical resistance values.

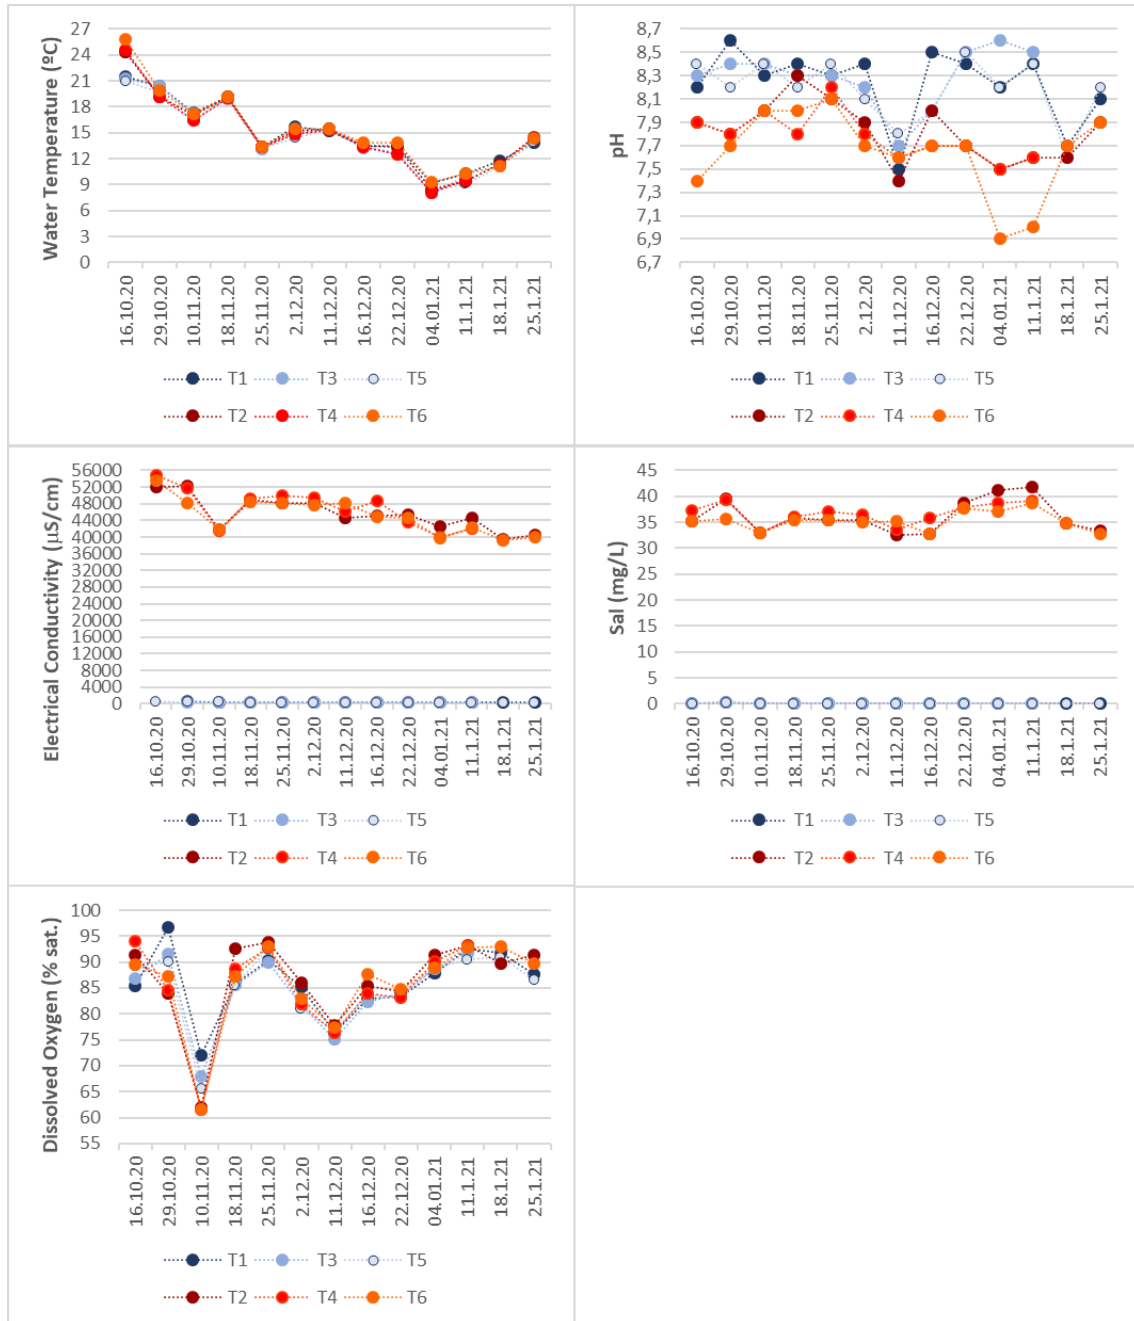
Figure 9: Physical-chemical characterization during the study period.

The test conditions were maintained during the experimental period, in order to have aquatic environments as stable as possible, as depicted in Figure 9.

In Figure 9 (and in Tables S1 and S2 in Supplementary Material) is clear that most parameters were stable during the test period, and no major differences between freshwater and saltwater tanks for water temperature and dissolved oxygen were detected. Clearly, all parameters that evaluate the amount of dissolved substances and minerals in the water, as the salinity, electrical conductivity and total dissolved solids, reflect the experimental conditions, distinguishing saltwater and freshwater tanks. In spite of the efforts to keep salinity values around 35 mg L<sup>-1</sup>, some variations can be observed (it ranges between 32.5 and 41.9 mg L<sup>-1</sup>), since some dilution occurred due to precipitation events and sometimes an excess of salt was added since heavy precipitation events were predicted. We can also see that oxygenation levels have always been high, so there was a good circulation of water. Water temperature decreased with time, in accordance with the atmospheric temperature decrease and the seasonal changes from Autumn to Winter progression.
