S0300-B5-RPT-010

U.S. NAVY SALVAGE REPORT SPACE SHUTTLE COLUMBIA

SEPTEMBER 2003

**Prepared by ROH Incorporated under
contract with Naval Sea Systems Command**

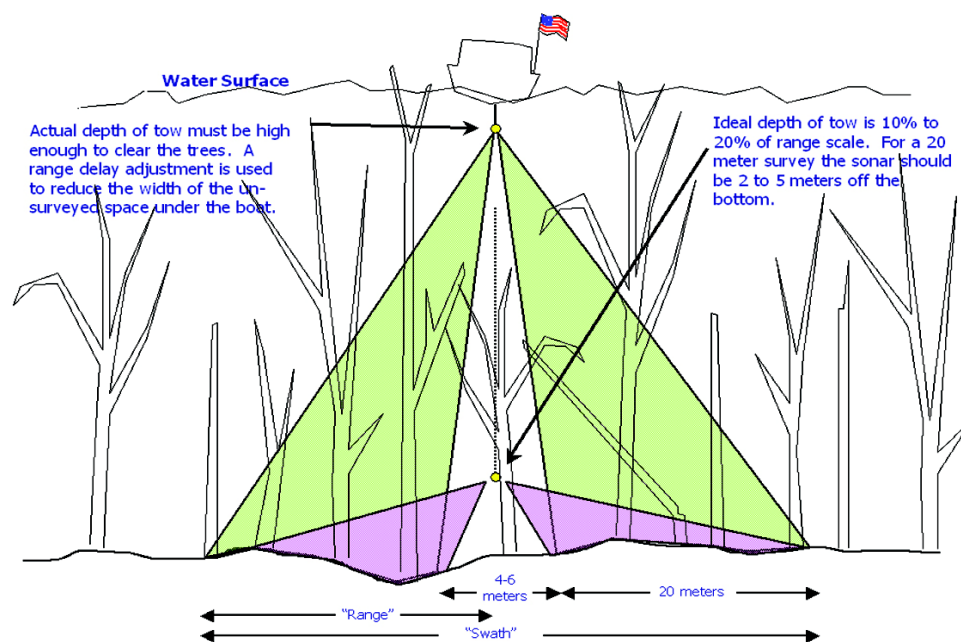
Figure 3-8. Typical Side Scan Sonar Configuration.

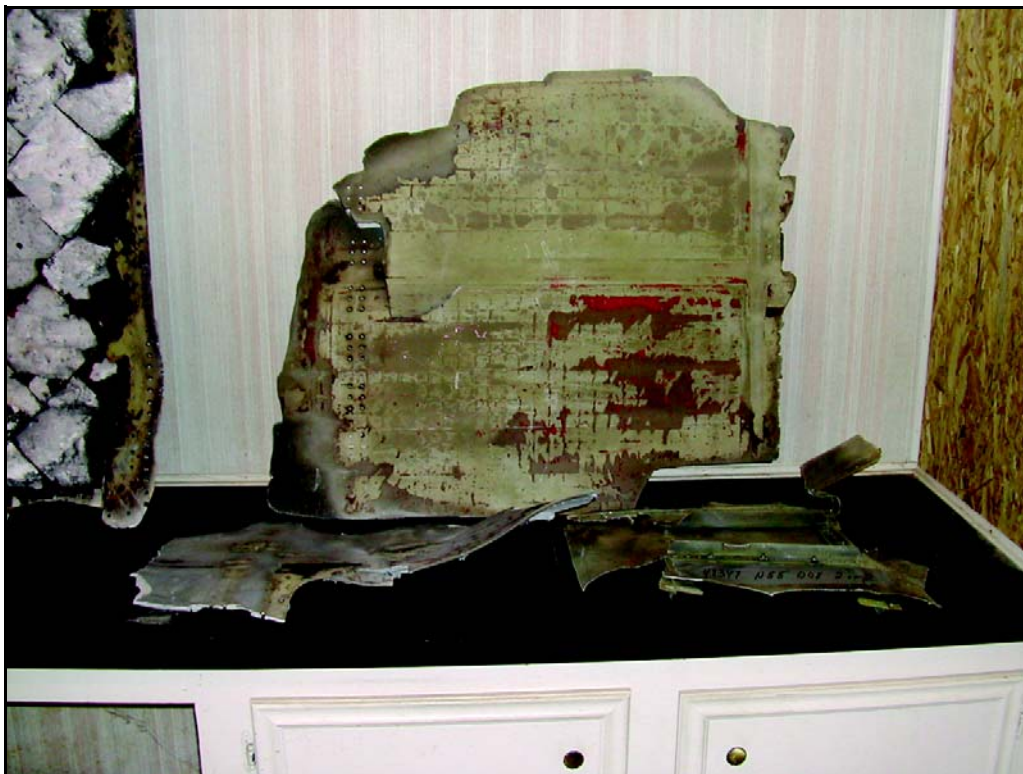
Figure 3-14. Actual Shuttle Pieces Used as Test Targets.

Tests were conducted over a two-week period during the operation to ensure the equipment being used was able to achieve the expected results. SUPSALV ordered the first series of tests on March 2 as the water search organization had yet to find any shuttle debris. NASA provided 4 pieces of shuttle skin material that had been recovered on land for controlled testing. The dive team tied these pieces to buoys and dropped them in approximately 20 feet of water in a relatively clear bottom in front of the Fin and Feather. These pieces ranged in size from the largest being 1 by 2 meters to the smallest measuring 0.4 by 0.5 meters. See Figure 3-14 for photos of these shuttle pieces. Search boats operating both multibeam system and a Marine Sonic side scan ran the test range. It was noted that detection of the largest target was possible, while detection of the smaller targets was uncertain.
