Effective Guided Wave Technique for Performing Non-destructive Inspection on Steel Wire Ropes that Hoist Elevators

Peter W. Tse and J.M. Chen

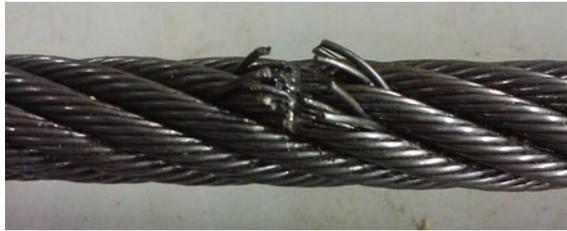
Fig. 12 The broken wire defects in the hoist wire rope

The defect of broken wires as shown in Fig. 12 is apart from the left end of the rope for about 300 mm. The amplitude of wave packet “Echo from left end” reduced because a part of the guided wave energy was reflected by the defect before it propagated to the left end of rope. Reflected wave signals were recorded when the number of broken wires increased. The reflected signal waveforms are shown in Fig. 13. It is obvious that no signal was reflected at the marked position of defect in a healthy rope. When four wires were cut off in the defect location, an obvious

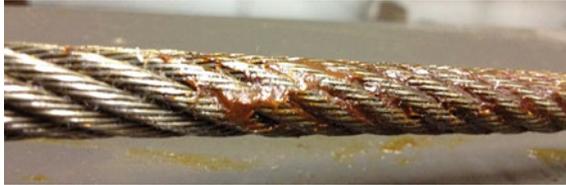
Fig. 15 The lubricating grease coated on the surface of the tested wire rope

Because of improper maintenance, the elevator ropes are inevitable become dirty and makes the lubrication grease become dirty too. A proper inspection may not be possible unless the dirt or excess lubricant has been removed. Form our experiments, we found that the dirt or dirty grease will increase the attenuation of the guided wave, hence, reduce the propagating distance of the guided wave. In this study, lubricating grease was applied to the inspected rope to observe the effect on the reflected guided wave. The installation locations of PZT and MsS are shown in Fig. 14. The distance of two transducers was 800 mm apart and the pulse-catch mode was used. The surface of the wire rope was coated with lubricating grease as shown in Fig. 15.
