## UNDERWATER STEEL STRUCTURES: INSPECTION, REPAIR AND MAINTENANCE

### ABSTRACT

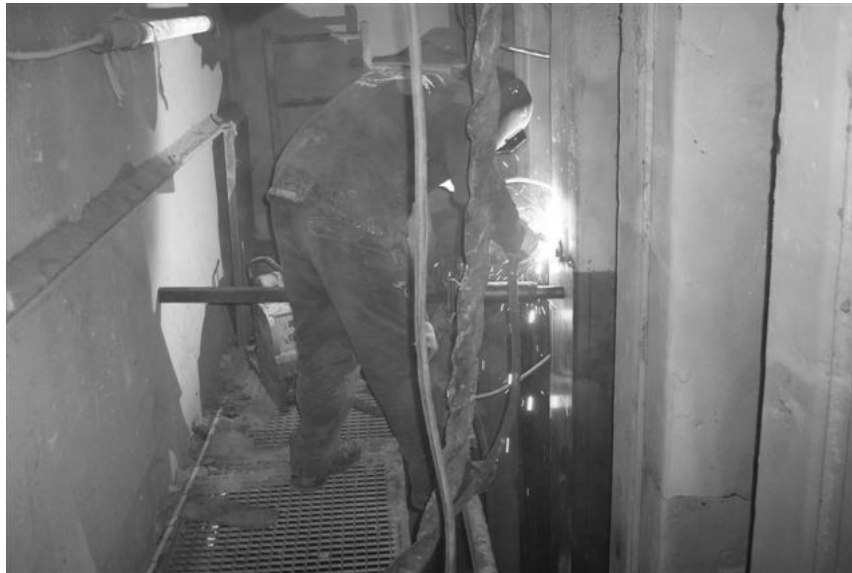
**Figure 1. Worker repairing steel sheet piling in a limpet cofferdam**

- Restore the existing steel sheet pile walls to original working capacity and possibly to near design capacity (figure 1).
- Extend the service life of steel sheet piling walls longer than traditional methods
- Significantly reduce the life cycle costs of steel bulkhead sheet pile
- Root cause analysis of corrosion mechanisms that include bacterial activity on the water and land side of a bulkhead.

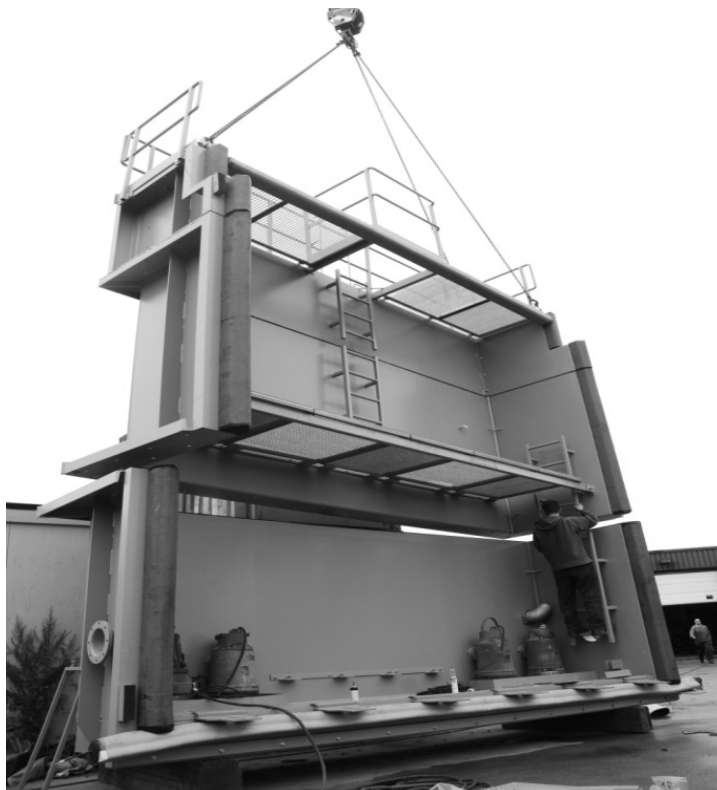
**Figure 2. On-site assembly of a modular prefabricated limpet**

The limpet cofferdam is a portable, three-sided rectangular steel box similar to one shown in figure 2. A modular design can facilitate future modifications. It will also allow storage and shipment in containers. Seals are a critical design element. They should allow for misalignment of sheet. Poor sealing efficiency will adversely impact progress, costs, and quality. Other design features include dewatering equipment, egress openings and ladders, platforms and railings, containment of fugitive emissions, provisions for ventilation and illumination. Auxiliary equipment includes dust collectors and water filters. Advance designs will allow field retrofit of the limpet to various bulkhead configurations.

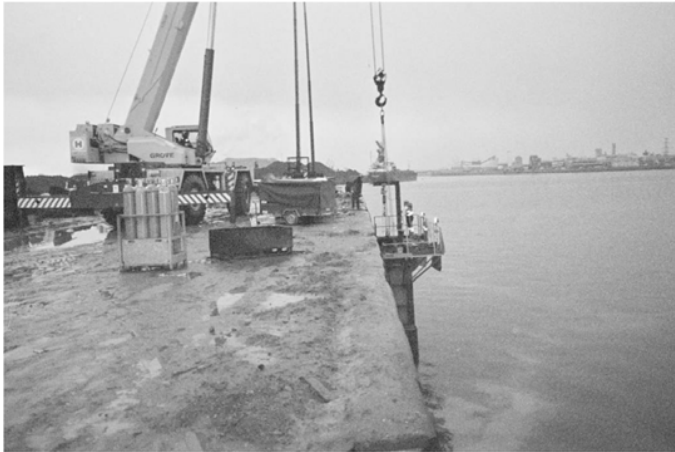
**Figure 3, Shore crane deploying a limpet**

The limpet is lowered into place by gantry or crane, with the open side against the face of the bulkhead. The work site can be on the shore or a spud barge. The entire work site can readily moved out of the way of ship movements, stevedoring activities, and other port operations. A crane or gantry lowers the limpet cofferdam alongside a bulkhead. Various deployment options are shown in figures 3 and 4.

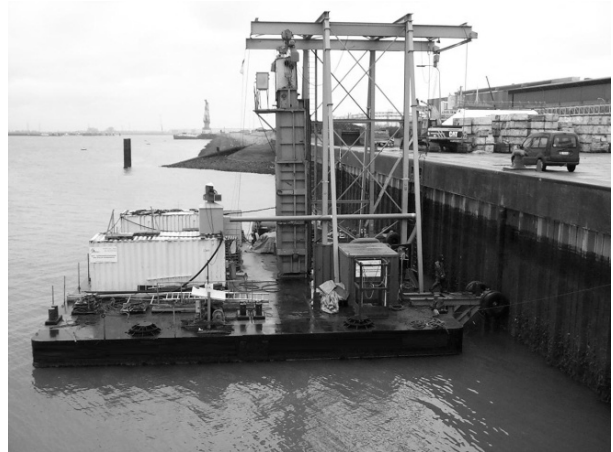
**Figure 4, Limpet and gantry on a barge**

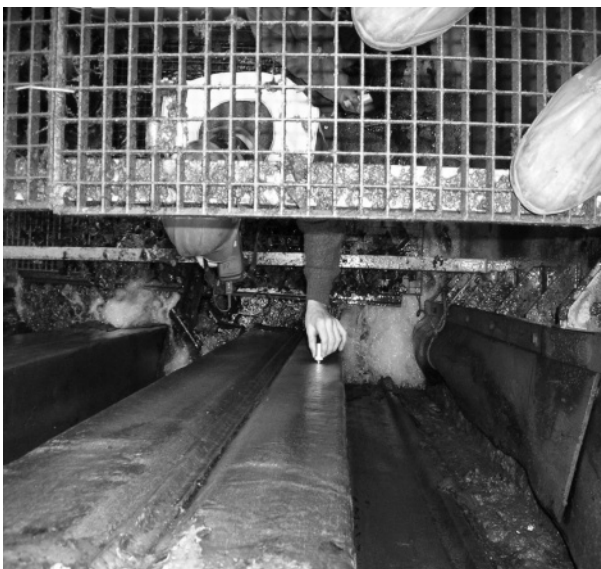
**Figure 5. Structural inspection for steel thickness and holes**

Dewatering equipment evacuates the limpet in few minutes. Once installed, loose rust and corrosion products are manually and mechanically removed. The surface is cleaned for inspection and welding repairs. An inspector conducts structural and corrosion inspections, shown in Figure 5. Structural inspection for steel thickness and holes, and Figure 6. Corrosion inspection of surface condition, shown in Figure 6

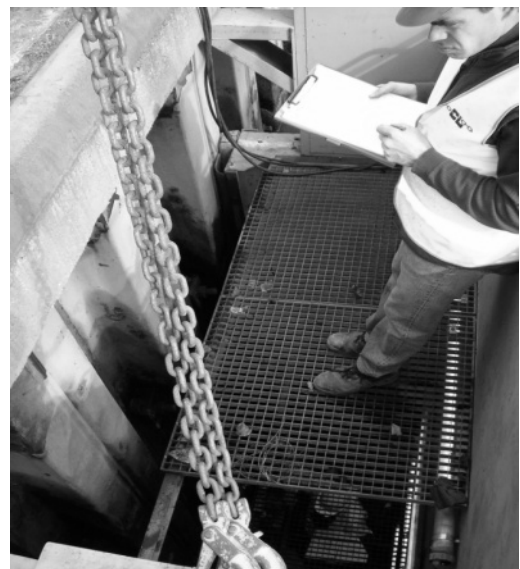
**Figure 6. Corrosion inspection of surface condition**

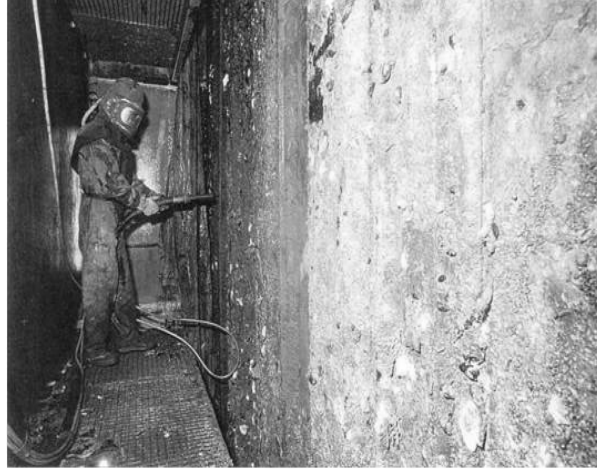
Figure 7. Abrasive blast cleaning inside a limpet. Adequate personal protection equipment, ventilation and illumination are essential.

**Figure 7. Abrasive blast cleaning inside a limpet**

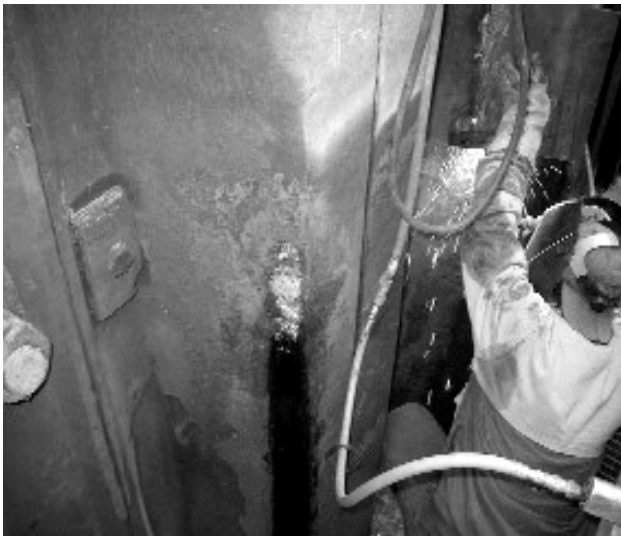
**Figure 8. Sealing wet holes**

A common result of ALWC are localized regions of holes, pitting and thin sections of steel from mean low water to approximately 2 meters down. After de-watering, water from the backfill will flow through the holes. These wet holes must be sealed dry prior to welding patch plates (figure 8) Reinforcing, or doubling steel plates are welded over thin sections (figure 9). Thin sections are typically areas where residual steel thickness is less than 50% of the original thickness.

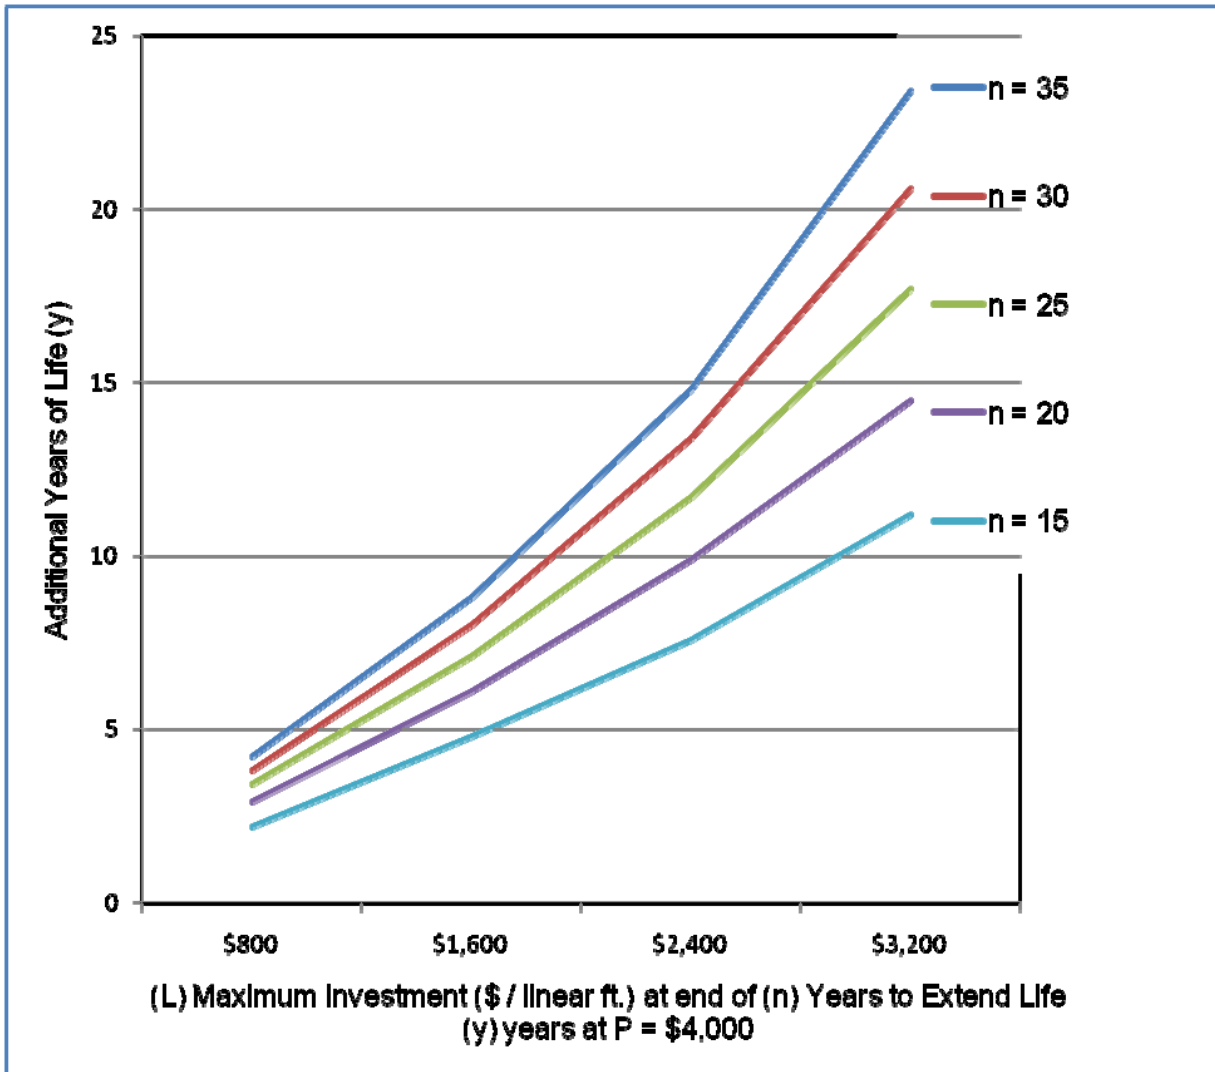
**Figure 10. Example of how much can be spent at the end of normal life to extend the lifetime of a structure by different periods of years.**

Based on values where cost per linear foot of new sheet piling,  $P = \$6,800$ ; expected service life,  $n = 30$  years; time value of money,  $i = 5\%$ , expected additional service life,  $y = 20$  years, and; cost or repair does not exceed,  $L = \$3,000$ , the annual baseline costs will decrease at least 10% per linear foot per year. The service life at working capacity should increase more than two-thirds.
