# Revisiting the MV Estonia Accident Using Numerical Simulations with a Statistical Approach

Shinwoong Kim \*

Hamburg Ship Model Basin, Bramfelder Strasse 164, D-22305 Hamburg, Germany; valanto@gmx.de

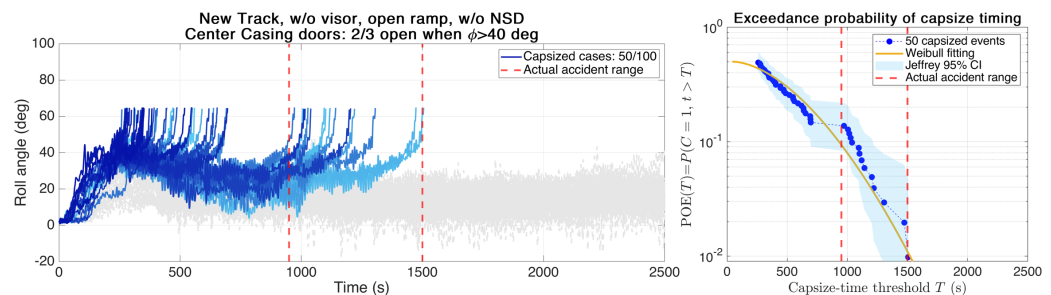
As presented in Figure 8, the damaged ship with the reference center casing door opening conditions capsizes in 50 out of 100 cases, each using a different wave sequence reproducing the JONSWAP spectrum sea state with  $H_s = 4.2$  m and  $T_p = 8.3$  s.

**Figure 8.** “Reference” condition: center casing doors 2/3 open when  $\phi > 40^\circ$ . Weibull fit (shape = 1.74, scale = 674.10).

The majority of capsizing cases (36/50) occur during the turn, yet a number of cases (14/50) closely resemble the actual heeling and sinking process. Within the capsizing range of 950–1500 s in Figure 8, there are some cases, in which the ship appears to stabilize temporarily, with the roll motion reduced below  $20^\circ$  after the turn, but which subsequently capsizes, likely due to encountering unfavorable wave sequences.

Based on the unconditional POE distribution of the capsizing times for the 50 events under the 2/3 door opening conditions, with no significant deviations among individual events and a continuous occurrence of capsizing times up to 1500 s, the 2/3 opening conditions appear physically reasonable and largely reproduce the actual accident scenario. The 3-parameter Weibull fit also closely follows the empirical distribution, indicating a high likelihood of capsizing within the actual accident time range (950–1500 s).

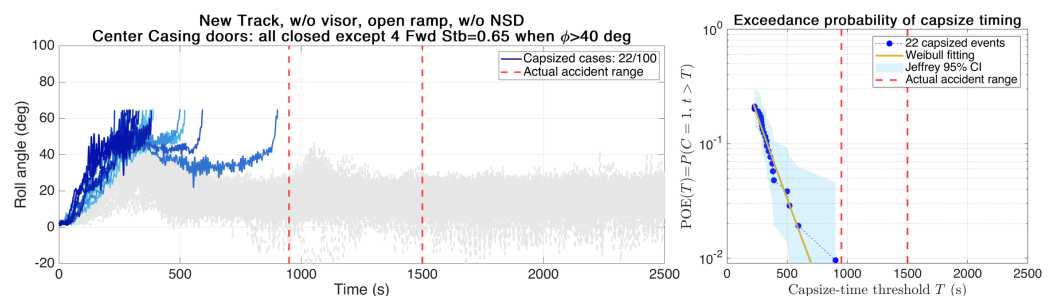
As shown in Figure 9, the capsize probability ( $P_{\text{capsize}}$ ) under the “All closed” opening condition in 100 different wave sequences is 22%, which is significantly lower than under the “Reference” condition (50%). Most capsize events occur during the turning phase, with only one case observed after the turn, at around 900 s. Thus, although the risk of capsize is significantly reduced compared to scenarios with some center casing doors open, the timing and pattern of the 22 capsized cases are not comparable to the actual accident.

**Figure 9.** “All closed” condition: All unknown doors closed, with other surveyed door conditions as observed. Weibull fit (shape = 0.97, scale = 143.51).

Due to water accumulating mainly on the vehicle deck in the “All closed” condition, the draft increase from the additional weight is smaller than in the reference condition. The flood water is largely confined to the vehicle deck and can flow back out at the bow, limiting the draft increase. This reduces the likelihood of waves continuing to surge into the vessel thereby increasing the vessel’s survivability. Nonetheless, 22 capsize events occur during the turn.

In the POE distribution of the limited number of capsize events under the “All closed” condition, only the last event in the tail slightly deviates from the main trend, representing an outlier. Up to the POE level of 0.02, the distribution shows generally a low scatter, indicating that if the damaged ship under the “All closed” opening condition does capsize, it most likely occurs within the time range of 230–600 s. This suggests that the center casing doors were likely not in the “All closed” condition at the time of the accident.

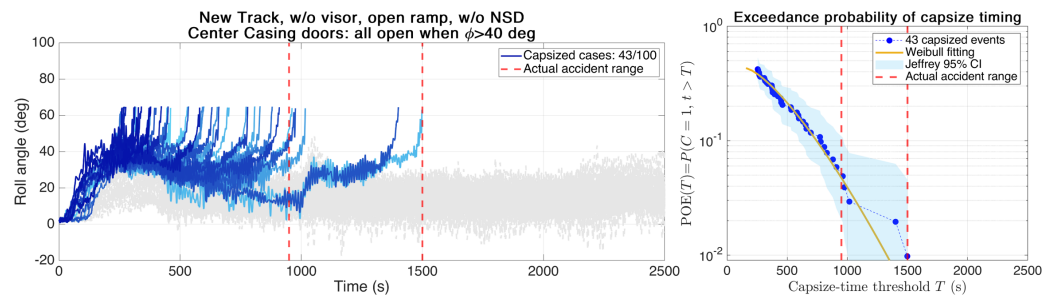
As shown in Figure 10, a total of 43 capsize events in the “All open” condition are observed, fewer than the 50 events under the 2/3 open condition, suggesting that the large volume of water entering the lower compartments leads to a relatively slower reduction in stability over time, thereby contributing to survival in certain wave sequences. Regarding

**Figure 10.** “All open” condition: All unknown doors open ( $C_d = 0.65$  when  $\phi > 40^\circ$ ), with other surveyed door conditions as observed. Weibull fit (shape = 1.37, scale = 444.48).

The time series results of the capsized cases indicate that large water ingress into the lower compartments generally tends to accelerate the sinking process. Specifically, while 14 capsize events occur between 950 s and 1500 s under the 2/3 open condition, this number decreases to 5 under the “All open” condition. Instead, more capsizes are observed between 665 s and 950 s, immediately after the turning phase.

Among the 43 capsize cases, 5 occur within the 950–1500 s range, although all these are positioned at the outer edges of this interval, according to the POE results in Figure 10. Compared to the “All closed” condition, the “All open” condition yields more plausible results, which better resemble the actual accident scenario, suggesting that it represents a more probable center casing opening configuration than the “All closed” condition.

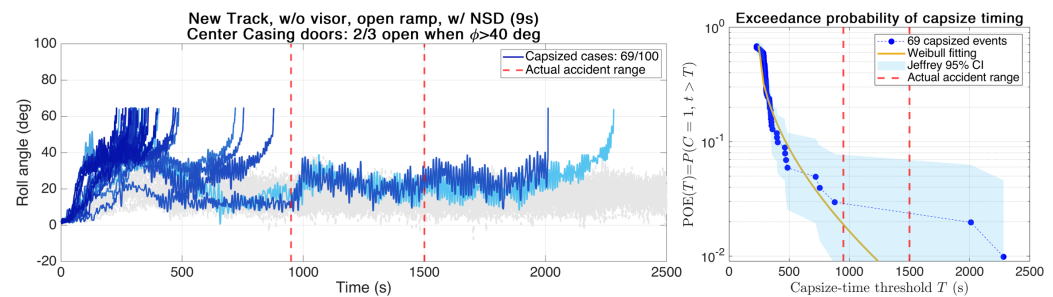
As shown in Figure 11 for the damaged vessel under the “Reference” condition with the NSD, a total of 69 capsize cases out of 100 are observed. This represents a notable increase compared to the same opening configuration without the NSD, exhibiting 50 capsize events (see Figure 8).

**Figure 11.** Roll response time–history for “Reference” condition with NSD. Weibull fit (shape = 0.54, scale = 66.33).

Most capsizing events occur during the early stage of the turning phase, except for five cases. Although water ingress through the NSD is relatively small, its presence induces an additional heeling moment toward starboard. The resulting additional heeling angle causes the large volume of flood water on the vehicle deck, coming from the open bow, to flow toward starboard, contributing to an early and abrupt capsizing.

The additional water ingress through the NSD opening ultimately causes 19 previous survival cases without NSD to capsize with NSD. Furthermore, for those cases that were already observed to capsize under the “Reference” condition without the NSD, the time to capsize in most cases is either significantly shortened to around 300 s or prolonged to approximately 2000 s. In both scenarios, these capsizing times are far outside the timeframe of the actual accident. The capsizing time distribution of the 69 capsized cases is as follows:

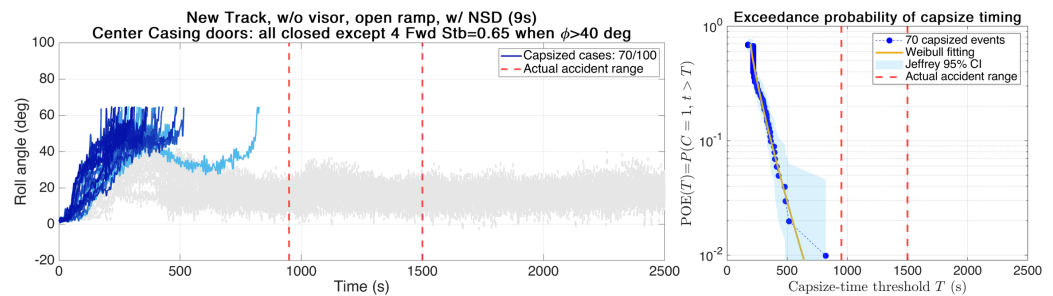
Figure 12 shows the results of the “All closed” condition with the NSD. The number of capsizing incidents increases significantly from 22 to 70 compared to the same opening configuration without the NSD (see Figure 9), while the overall trend in capsizing timing remains largely unchanged, with most cases occurring during the turning maneuver.

Considering the vertical position of the NSD, which is normally partially submerged below the waterline, the substantial water volume already taken in through the bow, and the additional heeling moments induced by turning, the NSD is likely to submerge deeper during the maneuver. This increases the hydrostatic pressure at the submerged inlet, thereby enhancing water ingress through the NSD and acting as a trigger that further

**Figure 12.** Roll response time–history for “All closed” condition with NSD. Weibull fit (shape = 0.84, scale = 77.00).

Regarding the POE distribution in Figure 12, all capsizing events except the last in the tail exhibit a smooth probability distribution, suggesting that under the 2/3 center casing door opening condition with the NSD, capsizing is highly likely to occur within 500 s. Thus, when the NSD occurs in the “All closed” condition, reproducing a scenario similar to the actual accident is extremely unlikely.

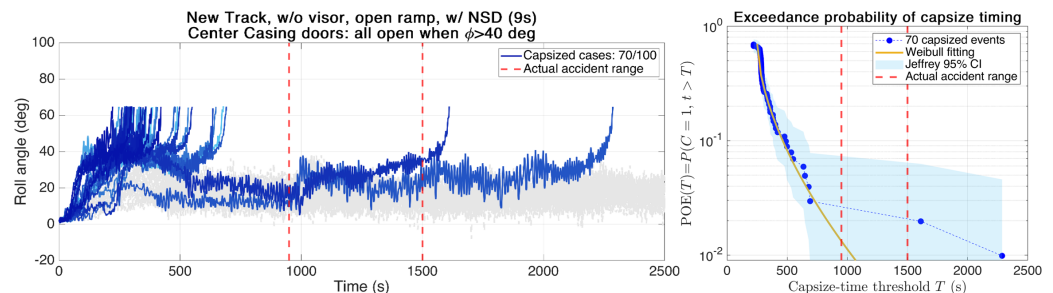
Figure 13 shows the simulation results for the “All open” condition with the NSD reaching a total of 70 capsizing events. As observed also in other cases with the NSD, a significant increase in the number of capsizing events is shown compared to the case without the NSD (43 capsizing events, see Figure 10).

**Figure 13.** Roll response time–history for “All open” condition with NSD. Weibull fit (shape = 0.60, scale = 69.21).

The impact of additional water ingress through the NSD on the capsizing process is substantial, as seen in other cases, 68 capsizing events occur during turning, while the remaining 2 occur much later around 1600 s and 2300 s.

Notably, the roll response trend due to the application of the NSD closely resembles that of the 2/3 door open condition with the NSD (see Figure 11). The POE distribution indicates that if capsizing occurs under this opening condition, it is highly likely to happen within 700 s, although in rare cases it may occur after 1600 s. This also suggests that the simultaneous occurrence of the bow opening and NSD under this condition is unlikely.

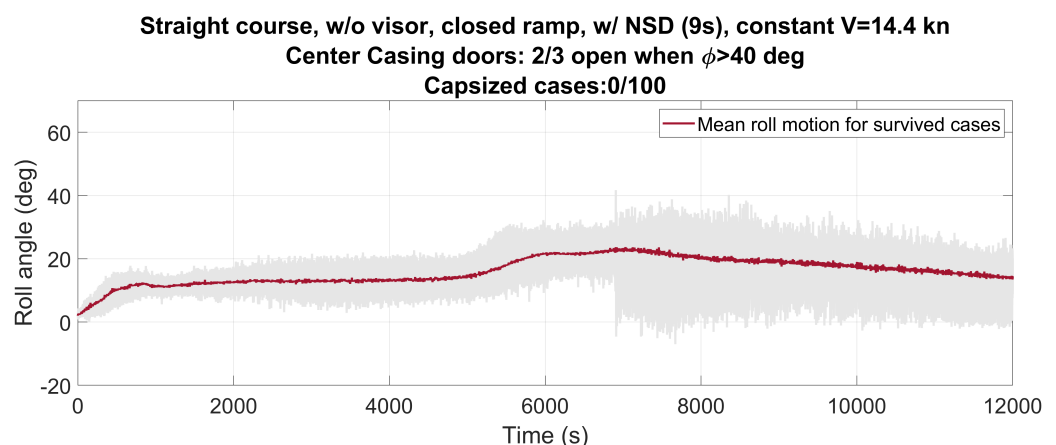
Figure 14 shows the simulation results for the damaged vessel experiencing water ingress solely through the NSD under 100 different wave sequences at a constant speed of 14.4 kn. The individual roll responses, shown as gray curves, indicate that variations among wave sequences do not lead to significant differences in ship motion, and the overall response trends remain similar.

The red curve, the mean roll response of all realizations, indicates a steady roll increase of approximately  $10^\circ$  due to water ingress during the initial phase of the simulation, lasting up to around 700 s. After this period, the rate of increase slows down, and the ship stabilizes at approximately  $10^\circ$ , with only minor fluctuations in the heeling angle until around 5000 s. Between 5000 s and 7000 s, the heel increases steadily again, reaching a peak of about  $25^\circ$ . After 6500 s, that is, almost after two hours, although the magnitude of roll variations induced by various wave scenarios increases, these fluctuations can be regarded as negligible in assessing, whether the actual accident was caused solely by NSD. After reaching its peak, the damaged vessel gradually stabilizes, maintaining a roll angle below  $20^\circ$  for the remainder of the simulation.

**Figure 14.** Ship on a straight course with lost visor, intact ramp, and NSD at constant speed.

The roll response in Figure 14 between 0 s and 250 s shows an increase of  $3\text{--}4^\circ$  (from the initial  $2^\circ$  to approximately  $5\text{--}6^\circ$ ), which is much less than in the actual accident. Such a small increase can be considered insufficient for the bridge crew to initiate a rapid turn while on a straight course. Furthermore, as shown in the period between 0 s and 4000 s, where the heeling angle remains around  $10^\circ$  with almost no increase, the computed results

suggest that the water ingress through the NSD alone does not induce sufficient heeling to cause the damaged vessel traveling on a straight course to capsize.

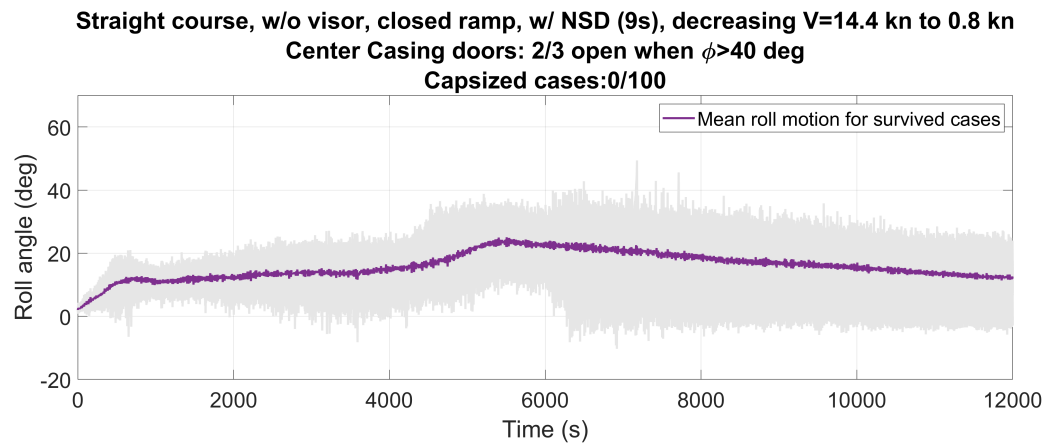
The same damage configuration as in Section 7.2 is applied, but with a speed reduction from 14.4 kn to 0.8 kn, as on the new track. The results are presented in Figure 15.

**Figure 15.** Ship on a straight course with lost visor, intact ramp, and NSD at decreasing speed.

Up to 4000 s, the trend of mean roll response is observed to be fairly similar to that of the ship traveling on a straight course at constant speed in Figure 14. However, after 4000 s, the roll increase becomes more pronounced, reaching its peak around 5500 s, which is slightly earlier. Afterwards, the roll response gradually decreases and the damaged vessel stabilizes with the roll response of below  $20^\circ$ .

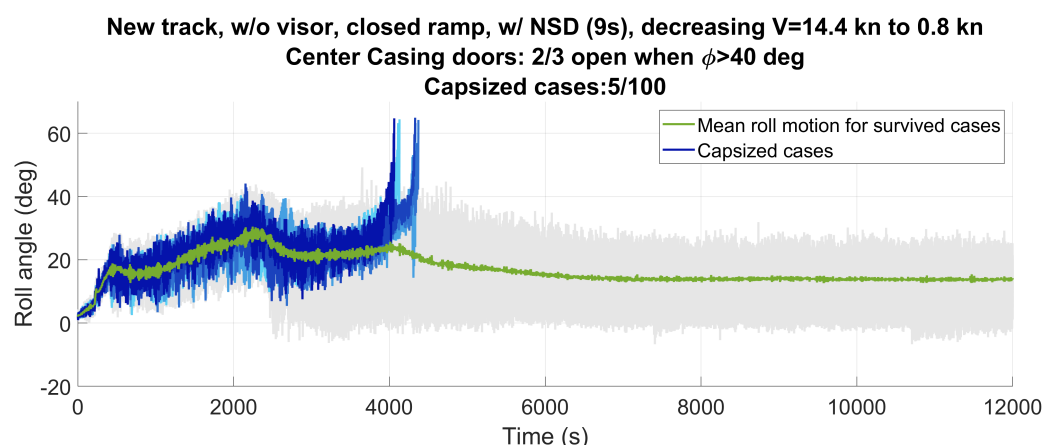
The simulation results for the damaged vessel, having the water ingress solely from the NSD, on the new track are presented in Figure 16.

**Figure 16.** Ship on the New Track, with lost visor, intact ramp, and NSD at decreasing speed.

In the time period before the turning phase (0–250 s), the mean roll response reaches nearly  $10^\circ$  and continues to increase, reaching approximately  $20^\circ$  during the initial turning phase (250–500 s). The peak response, reaching approximately  $30^\circ$  (mean value), is observed around 2300 s, before the heeling angle begins to continuously decrease until 3000 s.

Compared to results on a straight course (see Figures 14 and 15), the overall response appears to develop faster, and it is more pronounced in terms of its magnitude and timing of peak response occurrence. Furthermore, given the 5 capsize cases, applying the same opening conditions, but running on the new track appears to be more prone to induce capsizing scenarios.

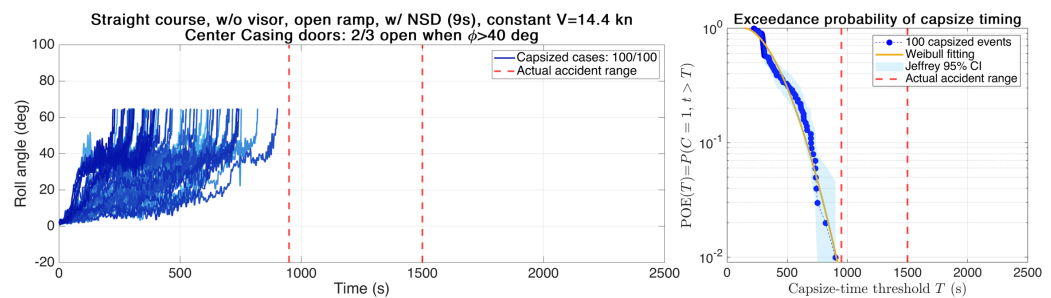
Figure 17 presents the results of this scenario on a straight course at constant speed. It can be observed that capsizing occurs in all 100 cases, with the bow ramp and the NSD open leading to a capsize mostly between 250 s and 750 s. In a few cases, capsizing occurs later, around 800 s to 900 s.

**Figure 17.** Ship on a straight course with a lost visor, open ramp, and NSD at constant speed. Weibull fit (shape = 1.76, scale = 321.35).

Comparing straight ahead results at constant speed (100 capsizes, see Figure 17) to the straight ahead results at decreasing speed (65 capsizes, see Figure 18), the very clear positive effect of reducing ship speed on the survivability of the vessel is observed. A major reason for this is the reduced speed of the water inflow at the open bow.

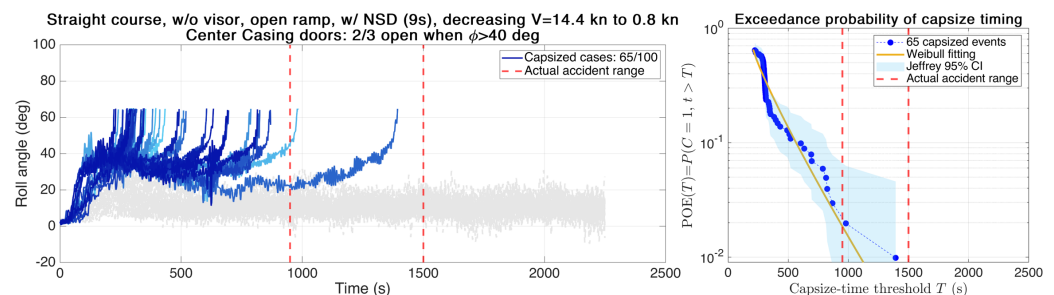
Figure 18 presents the results of this scenario on a straight course at decreasing speed. The only difference from Figure 11 is that the vessel continues straight instead of turning on the new track. On a straight course, capsizing occurs in 65 cases, compared with 69 cases

on the new track out of 100. The difference is small, slightly favoring the straight course with decreasing speed.

**Figure 18.** Ship on a straight course with lost visor, open ramp, and NSD at decreasing speed. Weibull fit (shape = 0.88, scale = 174.32).

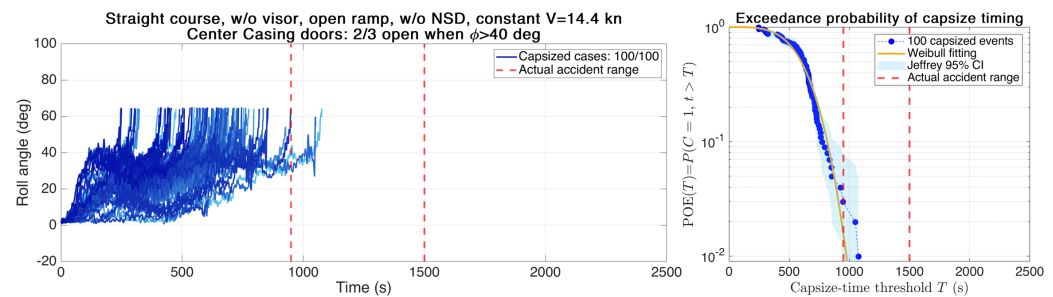
Figure 19 presents the results for the MV Estonia with bow damage only, 2/3 center casing doors open, without NSD, traveling on a straight course at a constant speed of 14.4 kn. Capsizing occurs in all 100 wave sequences, mostly between 240 and 850 s, with a few cases observed later around 940–1100 s. Compared to the scenario with NSD (see Figure 17), the timing of capsizing is slightly delayed, as expected.

**Figure 19.** Ship on a straight course with lost visor, open ramp, and no NSD at constant speed. Weibull fit (shape = 3.94, scale = 669.81).

Similar to the case with bow damage and NSD open (see Figures 17 and 18), the comparison of straight-ahead results at constant speed (100 capsizes, see Figure 19) and at decreasing speed (20 capsizes, see Figure 20) clearly demonstrates the remarkable positive effect of speed reduction on vessel survivability.

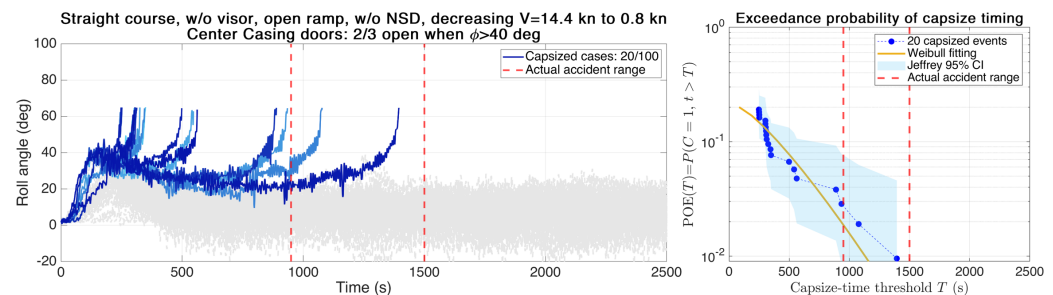
Figure 20 presents the results of this scenario on a straight course at decreasing speed. This enables a direct comparison with the results presented in Figure 8, where the vessel follows the new track with the same speed decrease.

**Figure 20.** Ship on a straight course with lost visor, open ramp, and no NSD at decreasing speed. Weibull fit (shape = 1.24, scale = 432.97).

The only difference to Figure 8 is going straight ahead instead of turning on the new track. On a straight course, capsizing occurs in 20 cases, compared with 50 cases on the new track out of 100. There is a clear difference in favor of continuing on straight course, but reducing speed, as on the new track.

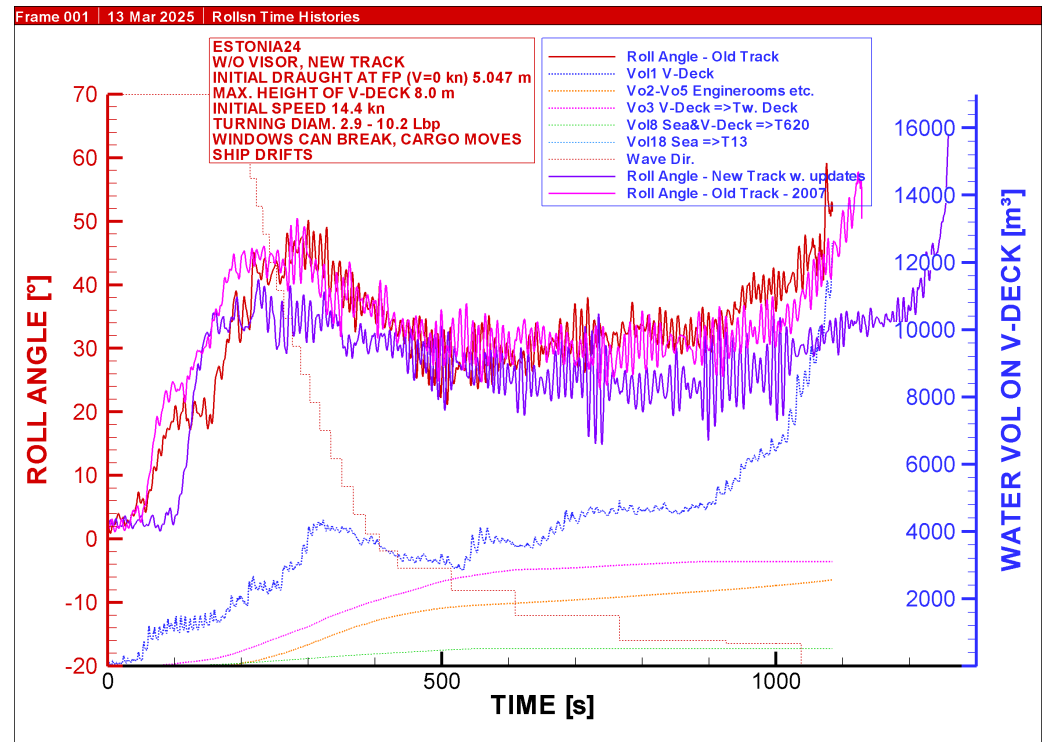
As shown in Figure 21, altogether the simulation on the new track with updated input data provides a very similar heeling behavior of the ship to that on the old track with original (2008) [5] input data. Differences between the heeling behavior are more due to the random character of the waves than to the small differences between the two tracks used.

**Figure 21.** Heeling angle and water volumes on the vehicle deck, lower deck, and machinery spaces as a function of time. Cargo shift and ship drift are included. Red curve: old track computed with the current compiler and computer. Blue curve: new HSVA track. Purple curve: old track from HSVA Estonia Investigation, 2008.

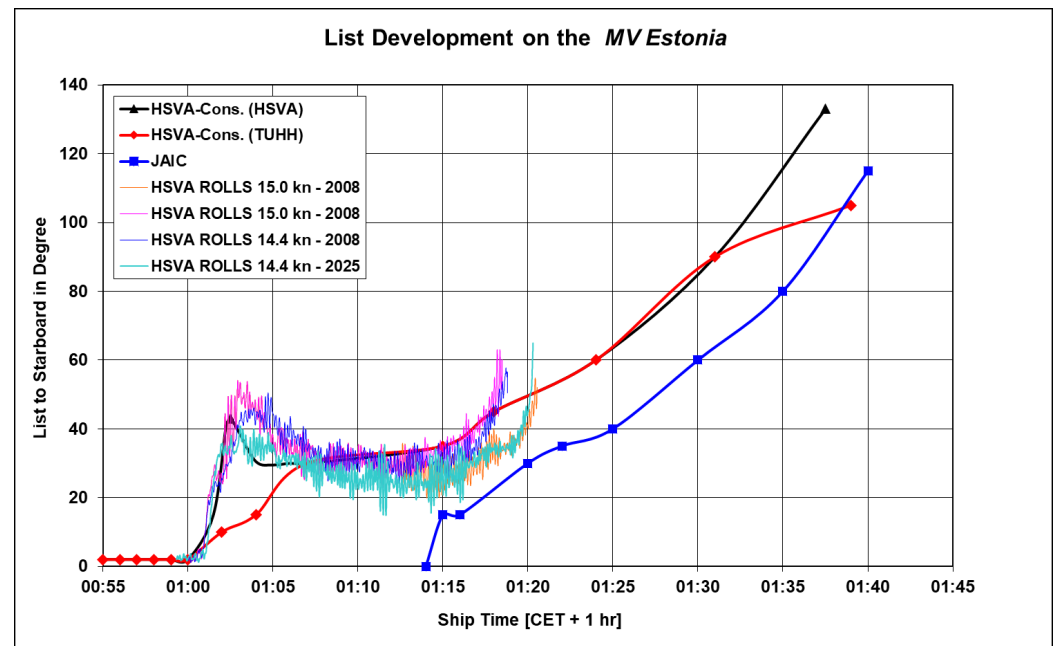
Figure 22 shows the development of the heeling angle according to HSVA (2008), TUHH (2008), and JAIC (1997), based on survivors' testimonies and according to numerical simulations. The black curve shows the development of the heeling angle, including the rapid sudden heeling in the beginning, as described by many survivors. This curve is a suitable reference curve for dynamic simulations. The red curve does not show this initial, dynamic heeling, and is suitable reference curve for quasi-hydrostatic calculations. The blue curve is the time-history concluded by JAIC after the accident.

Aside from older simulated time-histories (HSVA 2008), also the time-history of the heeling angle on the new HSVA track in the present study (HSVA 2025) is shown. The initial rise time of the heeling angle in the HSVA 2025 curve is reasonably comparable to that in earlier simulations from 2008, although the peak heeling angle is slightly lower. This may partly be due to the new track, but it is certainly also influenced by the different individual wave sequence used to describe the irregular seaway. As the new HSVA track represents an improvement over the older tracks, and the simulations does not reveal any significant deviations, the new HSVA track is adopted in all further simulations.

Figure 22. Development of list to starboard during the MV Estonia accident.

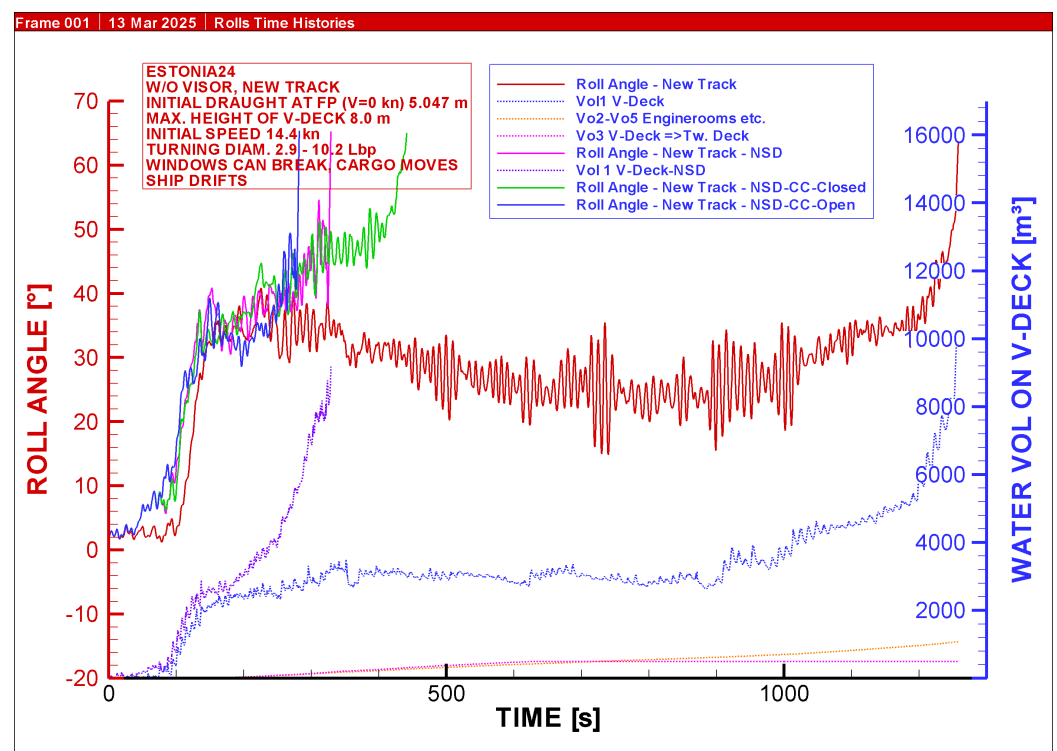
Figure 23 shows the MV Estonia on the new HSVA track with and without new side damage (NSD) on the starboard side of the ship. The long red curve corresponds to the development of the heeling angle on the new HSVA track without the NSD. The much shorter pink curve shows this development with the NSD. Most plausible assumptions on the opening conditions (reference  $\approx 2/3$  open) of the center casing doors are used in computing this curve.

Figure 23. The MV Estonia with the bow damage on the new HSVA track with (blue, pink, green) and without the new side damage (red).

As the conditions of the port and starboard side center casing doors during the accident are not accurately known, two additional curves, one with open center casing doors (blue) and one with closed center casing doors (green) on both sides of the center casing were computed. As the blue and green curves show, the effect of opening or closing all center casing doors is not very large. Thus, the assumptions made in modeling the center casing doors do not appear to have a significant influence on the simulation results.

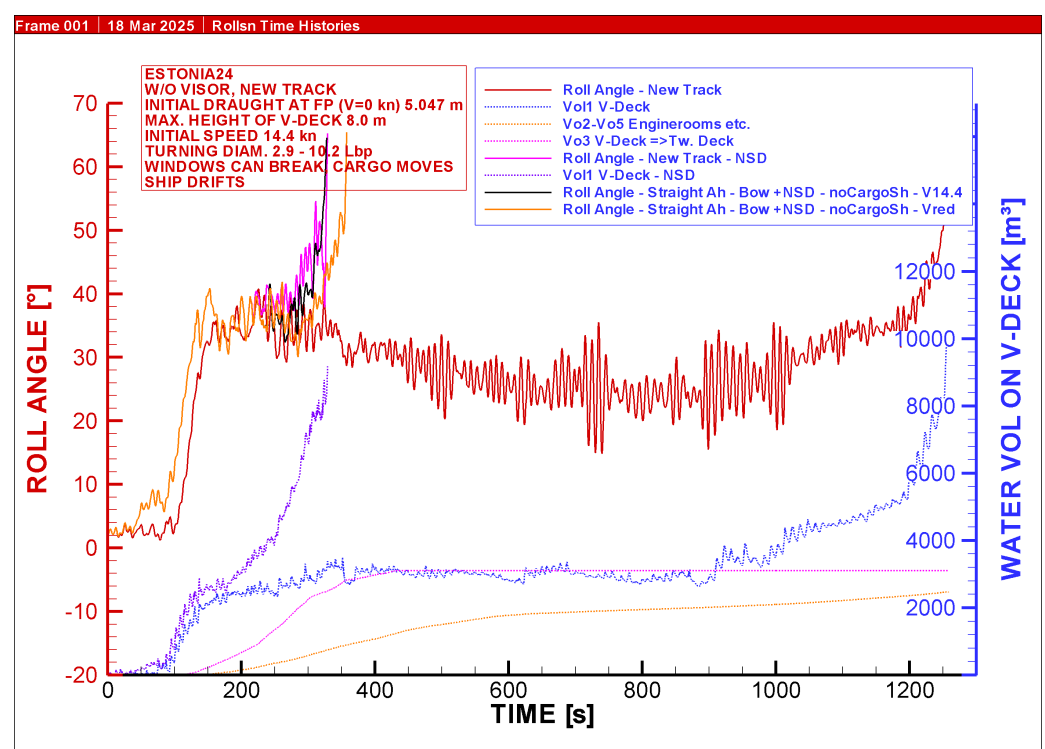
Figure 24 shows the heeling angle on the new HSVA track with the bow damage, with (pink) and without the NSD (red). In addition, two simulations with the NSD on a straight track with (yellow) and without (black) speed reduction are shown. In these cases, the presence of the NSD on the hull of the MV Estonia leads to a rather rapid capsizing of the vessel, which did not take place. The speed reduction on a straight track is identical to the speed reduction on the new HSVA track.

**Figure 24.** The MV Estonia with the bow damage on the new HSVA track with (pink) and without the NSD (red). The yellow and black curves show the ship behavior with the bow and new side damage on a straight track with and without speed reduction.

Thus summarizing, across all tested conditions—including different tracks, center casing door configurations, and speed assumptions—the presence of the NSD consistently results in a rapid capsizing within approximately 4–7 min, a scenario that does not align with the actual accident sequence. These findings suggest that the NSD was unlikely to have been present during the ship capsizing process while still afloat.

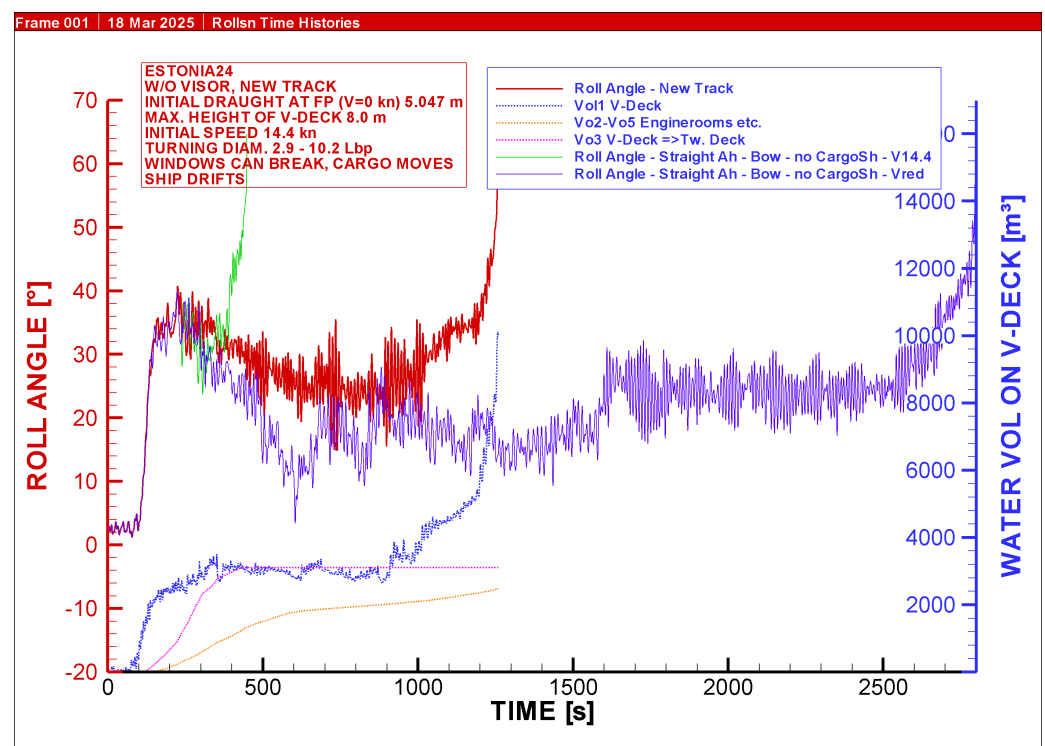
Figure 25 illustrates the situation of the MV Estonia with the lost visor and bow ramp completely open on a straight course with and without speed reduction. The red curve in Figure 25 shows the heeling angle of the MV Estonia on the new HSVA track until capsizing for comparison. The dotted curves show the computed water volumes on the vehicle deck, tween deck, and other compartments. The green curve shows the case with the MV Estonia on a straight course at a constant original speed of 14.4 kn, while the violet curve shows the speed as reduced along the new HSVA Track. There is no centrifugal acceleration on a straight course, and no cargo shift is modeled.

**Figure 25.** The MV Estonia on the new HSVA track and on a straight course with and without speed reduction, with lost visor and bow ramp completely open.

With only the original bow damage and no NSD, the heeling process and capsizing are sped up, if the ship maintains the constant speed of 14.4 kn. If the speed is reduced as on the HSVA new track, the ship capsizing is significantly postponed. These two simulated time-histories of the heeling angle do not correspond to that observed by the survivors (see Figure 22). The results in Figure 25 show the following: The speed reduction of the MV Estonia on a straight course leads to a clearly longer survival of the vessel than maintaining a constant speed. This is to be expected, as the inflow at the damaged bow is strongly dependent on the ship speed. The turning of the vessel towards the waves causes

additional heeling and centrifugal forces, which have an adverse effect on the ship survival. Accordingly, the time to capsize on the new track is shorter than on a straight course.

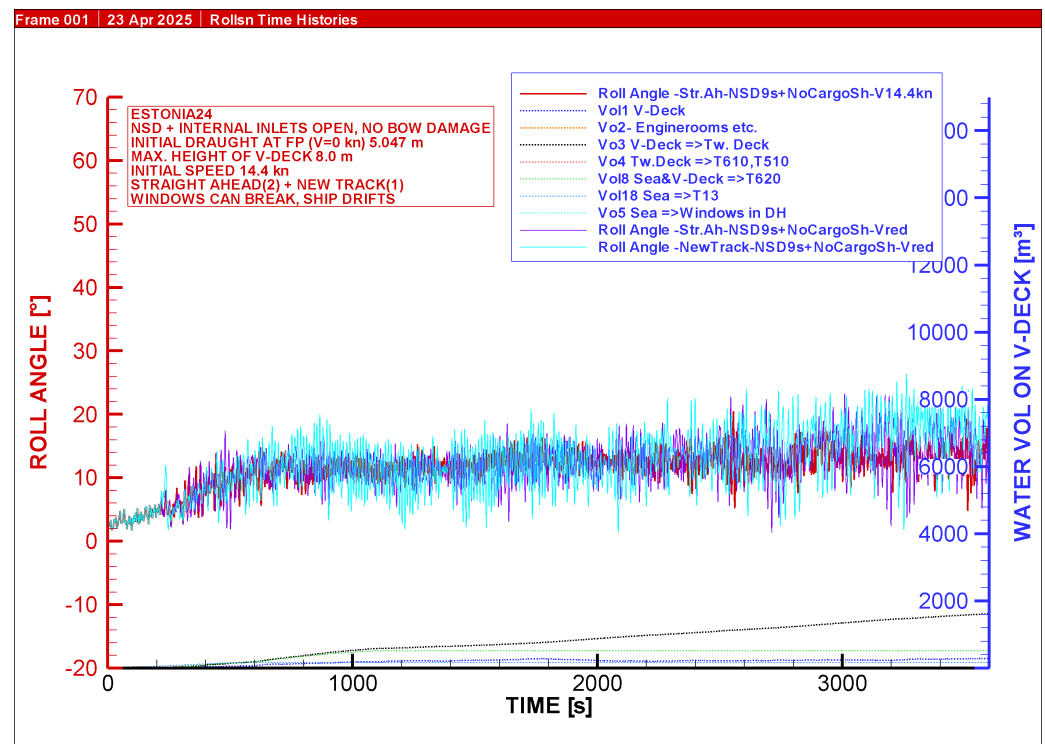
Figure 26 shows the time–history of the heeling angle of the MV Estonia on a straight track with NSD only, represented by the nearly horizontal red and purple curves. The red curve corresponds to the constant speed of 14.4 kn and the purple one to the speed reduction exactly as on the new HSVA track. For comparison, the case of the MV Estonia on the new HSVA track with the side damage only is shown with the light blue curve.

**Figure 26.** The MV Estonia on a straight course with (purple) and without (red) speed reduction, with the new side damage only. The light blue curve shows for comparison the heeling angle of the MV Estonia on the new track with the new side damage only.

For the two straight course results (red and purple curves), the heeling increases first very gradually, in a relatively steady manner for about 1–1.5 h, until it starts a long decrease towards its final value of about  $10^\circ$ . The ship survives the flooding with this final heeling angle in a stable floating position. The difference to the time–histories based on survivors’ testimonies as shown in Figure 22 is very clear. Thus, the accident scenario of the MV Estonia on a straight track with new side damage only is very unlikely.
