Corrosion and Conservation Management of the Submarine HMAS AE2 (1915) in the Sea of Marmara, Turkey

Ian D. MacLeod

Western Australian Maritime Museum, Victoria Quay Drive, Fremantle, WA 6160, Australia;
ian.macleod@museum.wa.gov.au

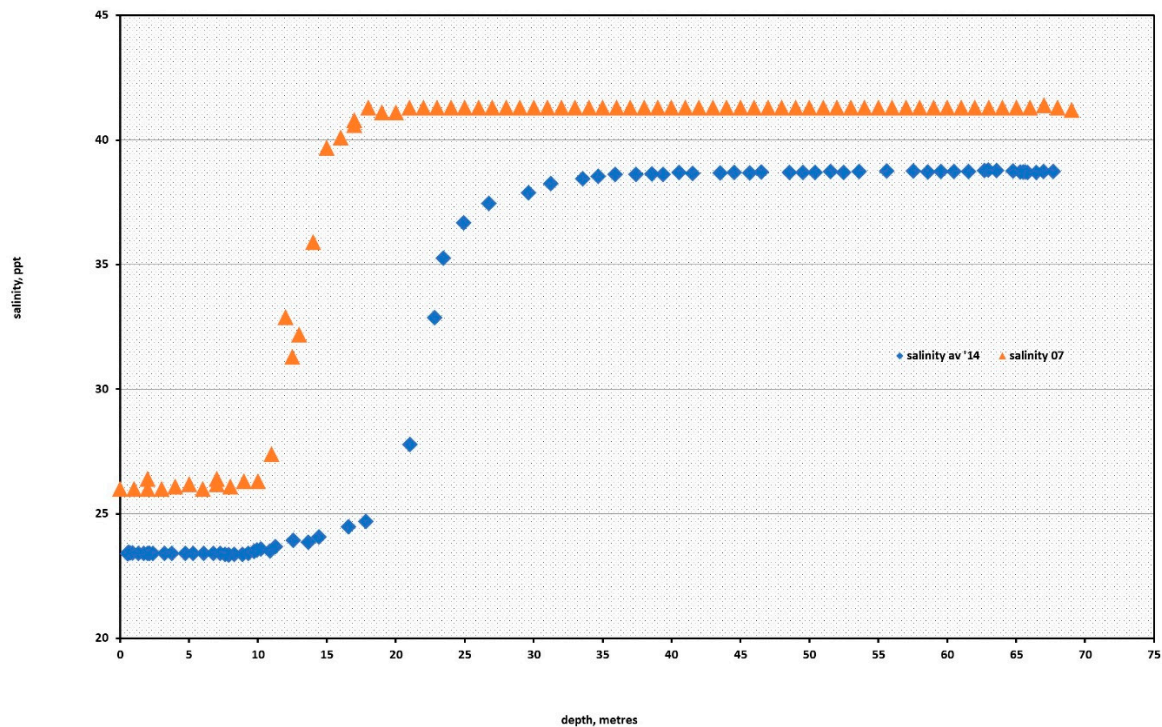
During the 2004 assessment, the water column above the wreck was measured for salinity, dissolved oxygen (YSI probe) and temperature at 0.5-m intervals, using a TPS 90DC meter that logged the data, to a maximum depth of 73 m. The first 13 m had a mean salinity of $26.1\text{‰} \pm 0.1\text{‰}$, which reflects evaporative concentration of the 18‰ water inflowing from the Black Sea. Over the next eight metres, the salinity rapidly increased to $41.3\text{‰} \pm 0.8\text{‰}$ at the bottom of the halocline. The higher salinity is typical of the hypersaline Aegean Sea, which enters the Sea of Marmara via the Dardanelles. Captain Stoker had used this counter current to help him penetrate the mined straits. At the 2004 halocline there was a corresponding thermocline (change in temperature) where the temperature fell from 26 to 18 °C and a second thermocline, at 40 m, saw the temperature fall from 18 to 16 °C, which was due to the heat capacity of the higher salinity water (Figure 1).

Figure 1. Salinity on the AE2 site in September 2007 (orange triangles) and June 2014 (blue diamonds).

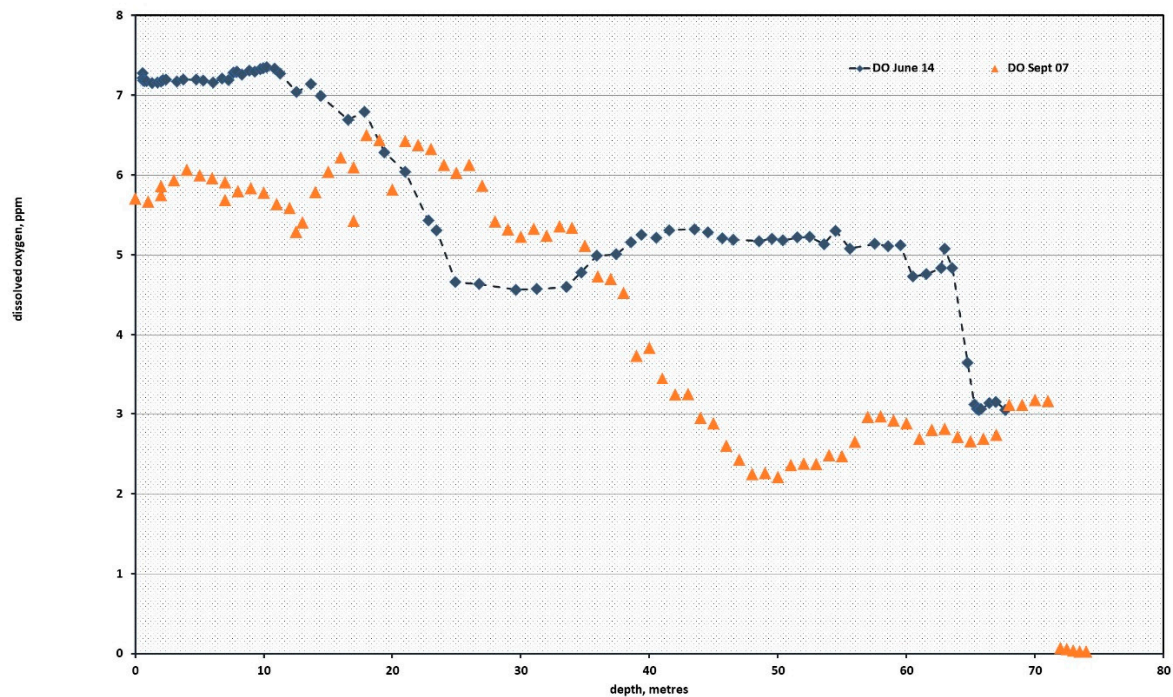
The surface waters in the Sea of Marmara were well oxygenated between 7 and 5.5 ppm, as shown in the 2007 and 2014 profiles shown in Figure 2. The data from 2007 shows the dissolved oxygen falling from 5 to 3 ppm as the depth increases from 35 to 50 m. At the upper sections of the submarine, the dissolved oxygen was recorded at 2.8 ± 0.2 ppm, which represents 36% saturation of the seawater for a salinity of 41.3‰ at 16 °C [6].

The data from June 2014 showed a dissolved oxygen that fell with increasing salinity, to reach a minimum of 4.5 ppm, and then increased in response to currents flowing in the hypersaline waters at depths until the submarine environment was reached, at 67 m, where it fell to the 3-ppm level seen in 2007.

Figure 2. Dissolved oxygen vs. depth for the AE2 site; the zero-ppm data in 2007 (orange triangles) is when the weighted probe penetrated the silt mound. June 2014 data blue diamond shapes.

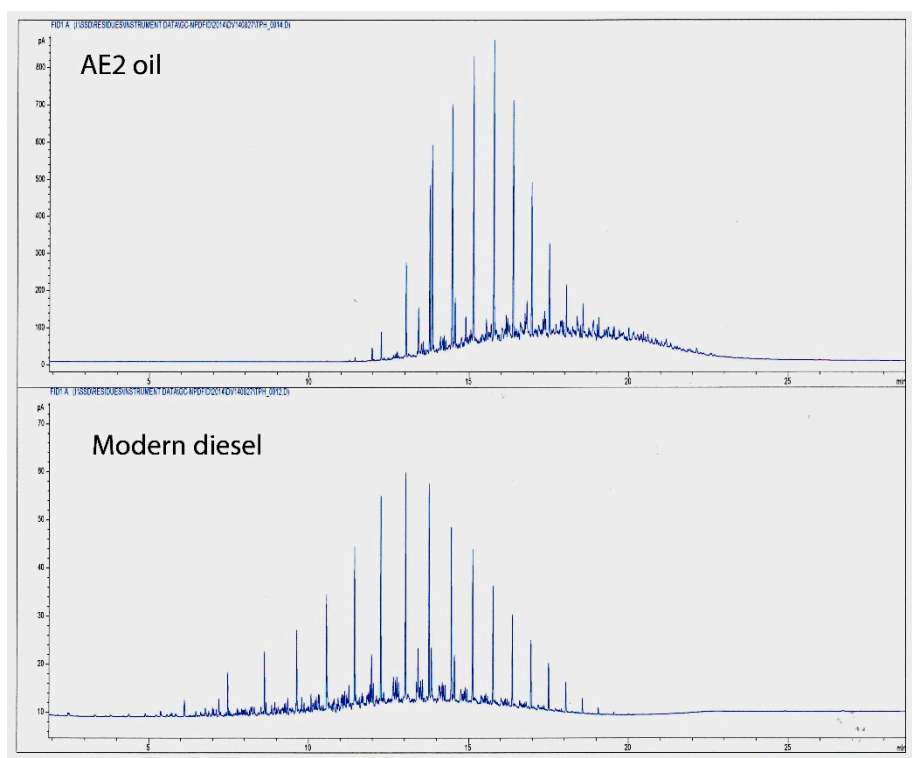
Samples of oil from inside the boat were collected from the surface of the ROV following its successful navigation of the internal spaces of the engine room. Viscosity data and gas chromatographic analysis of the volatile organic compounds coming from the oily residue indicated that it was diesel fuel, which had been leaking from the forward tanks. The analysis showed that the oil was biologically fractionated through removal of the sour and acidic smelling thiols and thiophenes. The bacteria preferentially consumed much of the long chain alkanes of the general formula C_nH_{2n+2} (Figure 6). The biodegradation of the AE2 oil mixture was indicated by the presence of the branched alkanes, norpristane ($C_{18}H_{38}$), pristane ($C_{19}H_{40}$) and phytane ($C_{20}H_{42}$), which are much more stable than the branched hydrocarbons. It is interesting that pristane is derived from shark liver oil and so this may be one of the principal components of lubricating oils and diesel fuel for the generators that was recovered from the surface of the ROV. The video inside the submarine has evidenced movement of large black mats of biological growth, which are the by-products of the microbiological attack on the diesel fuel.

Figure 6. Gas chromatograms of AE2 oils compared with undegraded diesel fuel.

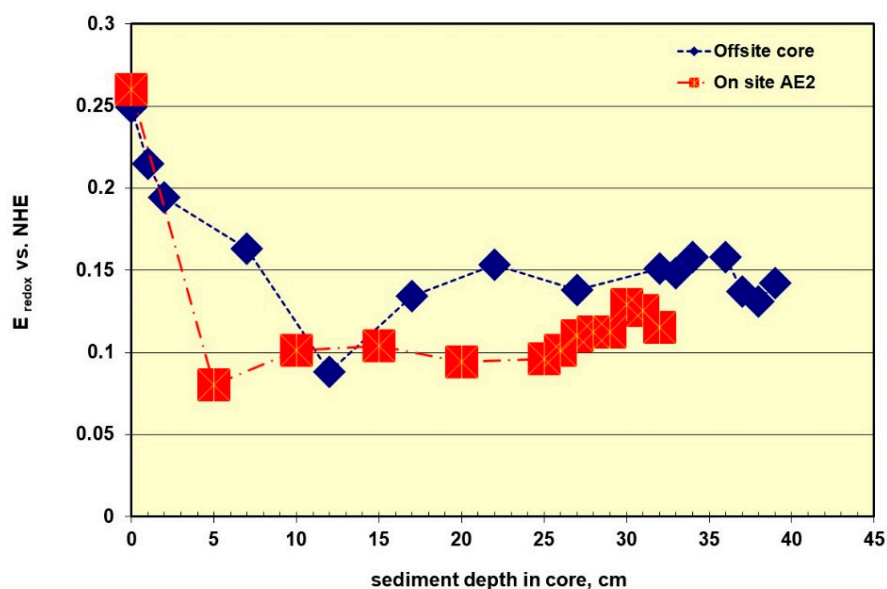
A fundamental archaeological principal is to establish what impact a given deposit has on its immediate microenvironment and vice versa. Thus, core samples were recovered in the immediate vicinity of and at 20 m distance from *AE2*. The cores were chemically characterized through measurements of the dissolved oxygen, pH and redox potentials. The mean redox potential of the sediment core adjacent to the vessel was $+0.119 \pm 0.044$ volts vs. NHE (Normal Hydrogen Electrode), which was statistically indistinguishable from the off-site core, $+0.157 \pm 0.038$ volts (Figure 7).

Figure 7. Voltage E_h readings on the two cores relative to the Normal Hydrogen Electrode.

The *AE2* E_h fell by 180 mV, from 0.260, in the first five cm of sediment, while the off-site sample took 30 cm to fall to the same minimum value of 0.082 ± 0.003 volts. The more rapid fall in the redox potential for the *AE2* core indicates that the microenvironment near the submarine rapidly becomes anaerobic as a direct result of the corrosion process consuming oxygen trapped in the silt. This is supported by the observation that as the core depth increased the *AE2* core remained relatively constant at 0.107 ± 0.014 volts, while the off-site redox potential had a mean value of 0.142 ± 0.020 or some 35 mV more oxidizing than that by the submarine (Figure 7). This indicates that the distance of the impact of the submarine on the microenvironment is less than 20 m.

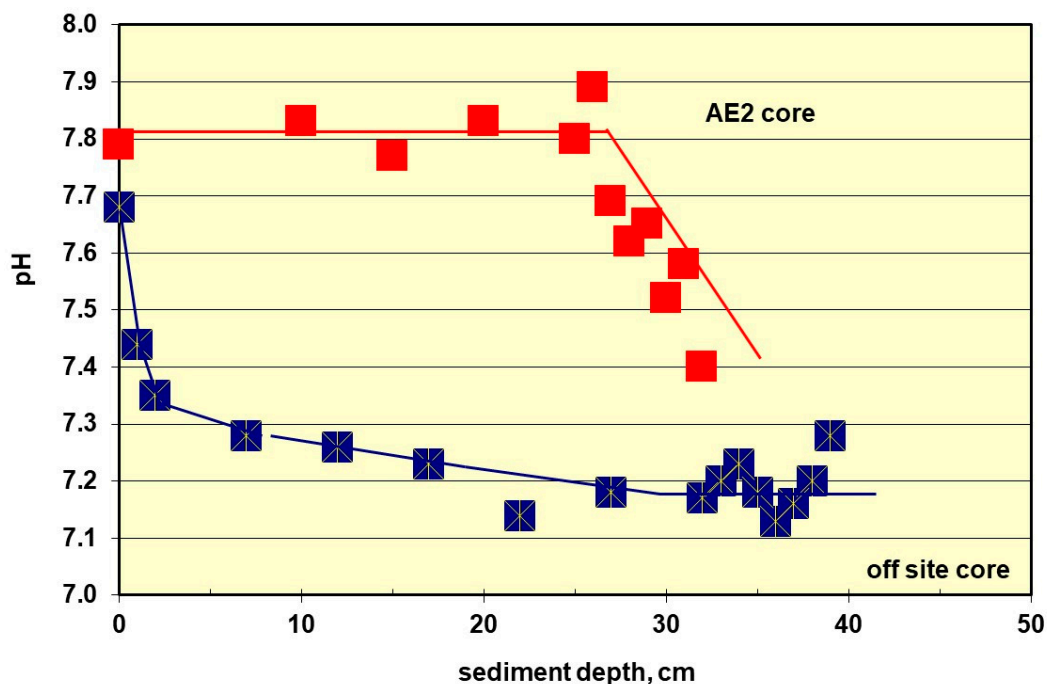
The $^{AE2}\text{pH}_{\text{core}}$ values showed a steady alkaline microenvironment for the initial 25 cm at $\text{pH } 7.80 \pm 0.02$, before rapidly falling over the last 7 cm at a rate of -0.05 pH/cm distance down the core (Figure 8). The change in $^{AE2}\text{pH}_{\text{core}}$ may reflect a limiting impact of the vessel on the sediment, since the pH values for both cores coincided at 7.3 ± 0.1 after a core depth of ≈ 30 cm of sediment. The $^{\text{off-site}}\text{pH}_{\text{core}}$ rapidly fell from its initial value of 7.7 to 7.1 ± 0.1 in the first 25 cm of sediment. The dissolved oxygen measurements in the AE2 core recorded seven zero values, with a mean of 0.018 ± 0.023 ppm (i.e., essentially zero), while the off-site core mean was 0.067 ± 0.068 ppm with five zero values.

Figure 8. pH of AE2 core profiles and off-site values.

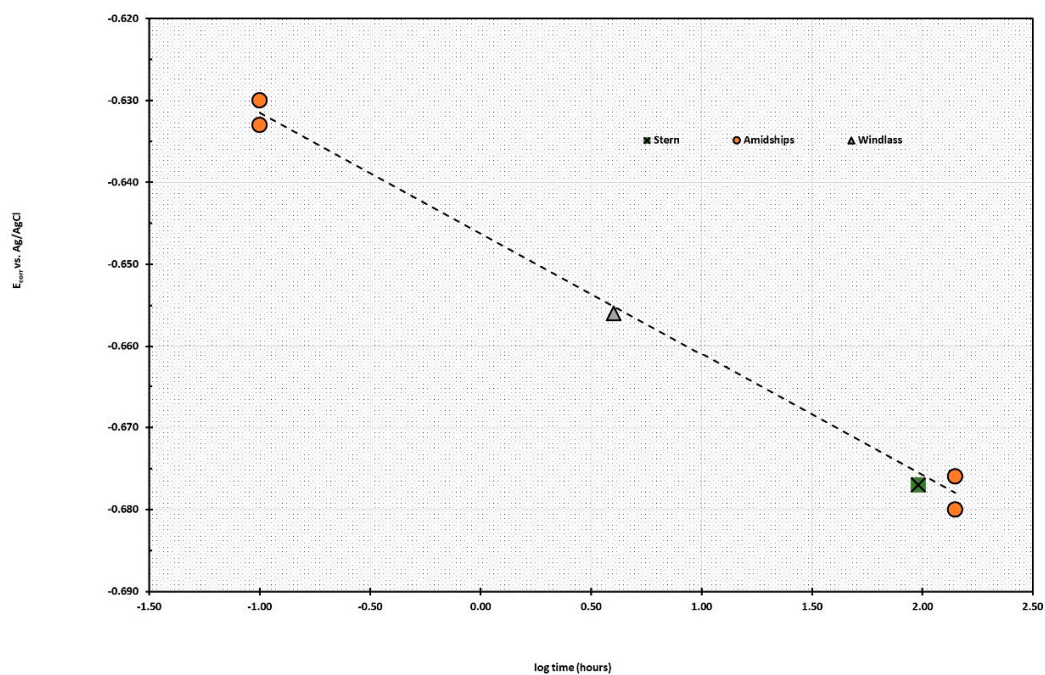
The numbers in parentheses are the errors associated with the intercept and the rate at which the submarine was being cathodically polarised. Since all the measurements fall along the same line, this indicated that the submarine was acting as an interconnected electrical unit, which was an unexpected bonus as it indicated that the overall condition of the submarine was structurally sound.

The data in Table 1 shows that the greatest voltage drop between the natural cathodic protected E_{corr} of the conning tower was 50 mV after 141 h or close to eight days. This voltage drop is the equivalent of a 42% drop in the corrosion rate of the submarine, which is remarkable given the size of the boat! The E_{corr} values are diagrammatically illustrated in Figure 11. This calculation is based on a combination of theoretical and practical determination of the rate at which the corrosion changes for concreted materials. For electrochemically controlled reactions, such as the in-situ treatment of the AE2 submarine, the log of the corrosion rate can be calculated according to the changes in E_{corr} values, with a drop of approximately 330 mV needed for a ten-fold decrease in the rate of corrosion.

Figure 11. Plot of the E_{corr} values vs. log time (hours) after application of anodes.

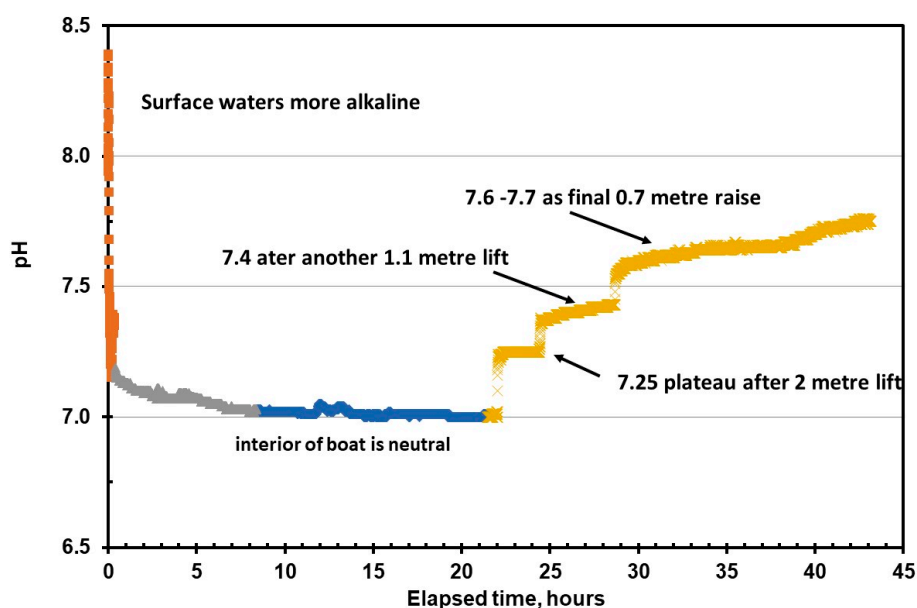
The pH data recorded by the Sonde is shown versus time inside the conning tower (Figure 12). The red-brown line shows a fall from the surface value that is within the normal range of pH for the Sea of Marmara, which has an average pH of 8.26 ± 0.18 . The green line represents the period when the Sonde was inside the submarine and operating as normal, which shows an average pH of 7.15 ± 0.03 , which is typical of marine sediments that have bacteria active in them.

Figure 12. Plot of the pH of the water column and interior of the submarine.

The extended blue line represents the period when the oxygen and salinity sensors were “poisoned” by sulphur species in the stirred-up sediment. When the divers began to recover the Sonde, the purple line and the plateau value of 7.2 represents the solution value in the water column above the sediment. As the instrument recovery operations increased, the plateau readings of 7.4 and 7.6 represent the different chemical microenvironments inside the submarine. The value of 7.4 is for the water 3.1 m up from the floor of the control room and 7.6 is for water at 3.8 m. The latter pH corresponds to the mean pH of the sediment cores from outside the submarine. The values between 7.2 and 7.4, those closer to the internal spaces of the lower control room, correspond with the mean pH (7.26 ± 0.08) from the external core adjacent to the submarine. The equivalent value at the first plateau region of the pH with the sediment core close to the submarine is a strong indication that the chemical processes of diagenesis inside the submarine were the same as those externally, but near the hull.

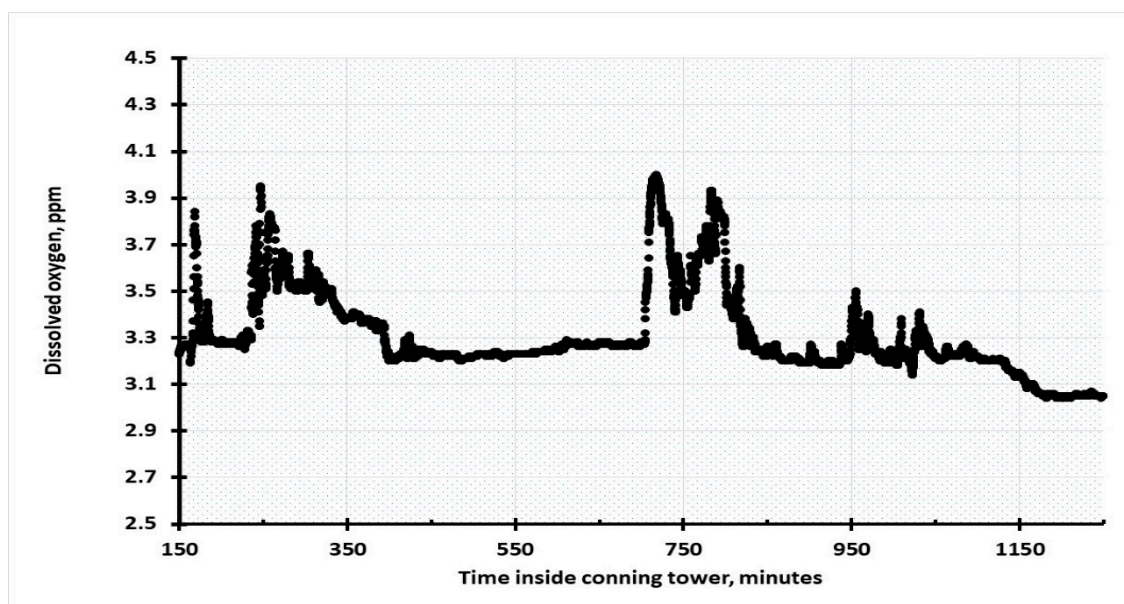
The dissolved oxygen inside the conning tower was generally around 3.2 ± 0.1 ppm but there were a series of rapidly rising and falling spikes, which saw an upward excursion to approximately 4.0 ± 0.2 ppm. At times these elevated levels were restored to their former values with a sigmoidal decrease in the concentration of oxygen. This is probably due to bacteria that consumed oxygen. More generally,

there was a rapid return to the steady state value, as shown in Figure 13. These phenomena indicate that there is mixing of different bodies of water inside the conning tower and that there is a significant level of microbiological activity inside the submarine.

Figure 13. Plot of dissolved oxygen vs. time inside the conning tower.
