Documenting Change on the SS *Thistlegorm*, Red Sea, Egypt: Using Underwater Photogrammetry to Record Natural Deterioration and Human Impacts on a World War II Shipwreck

Simon Brown¹ and Jon C. Henderson^{2,*}

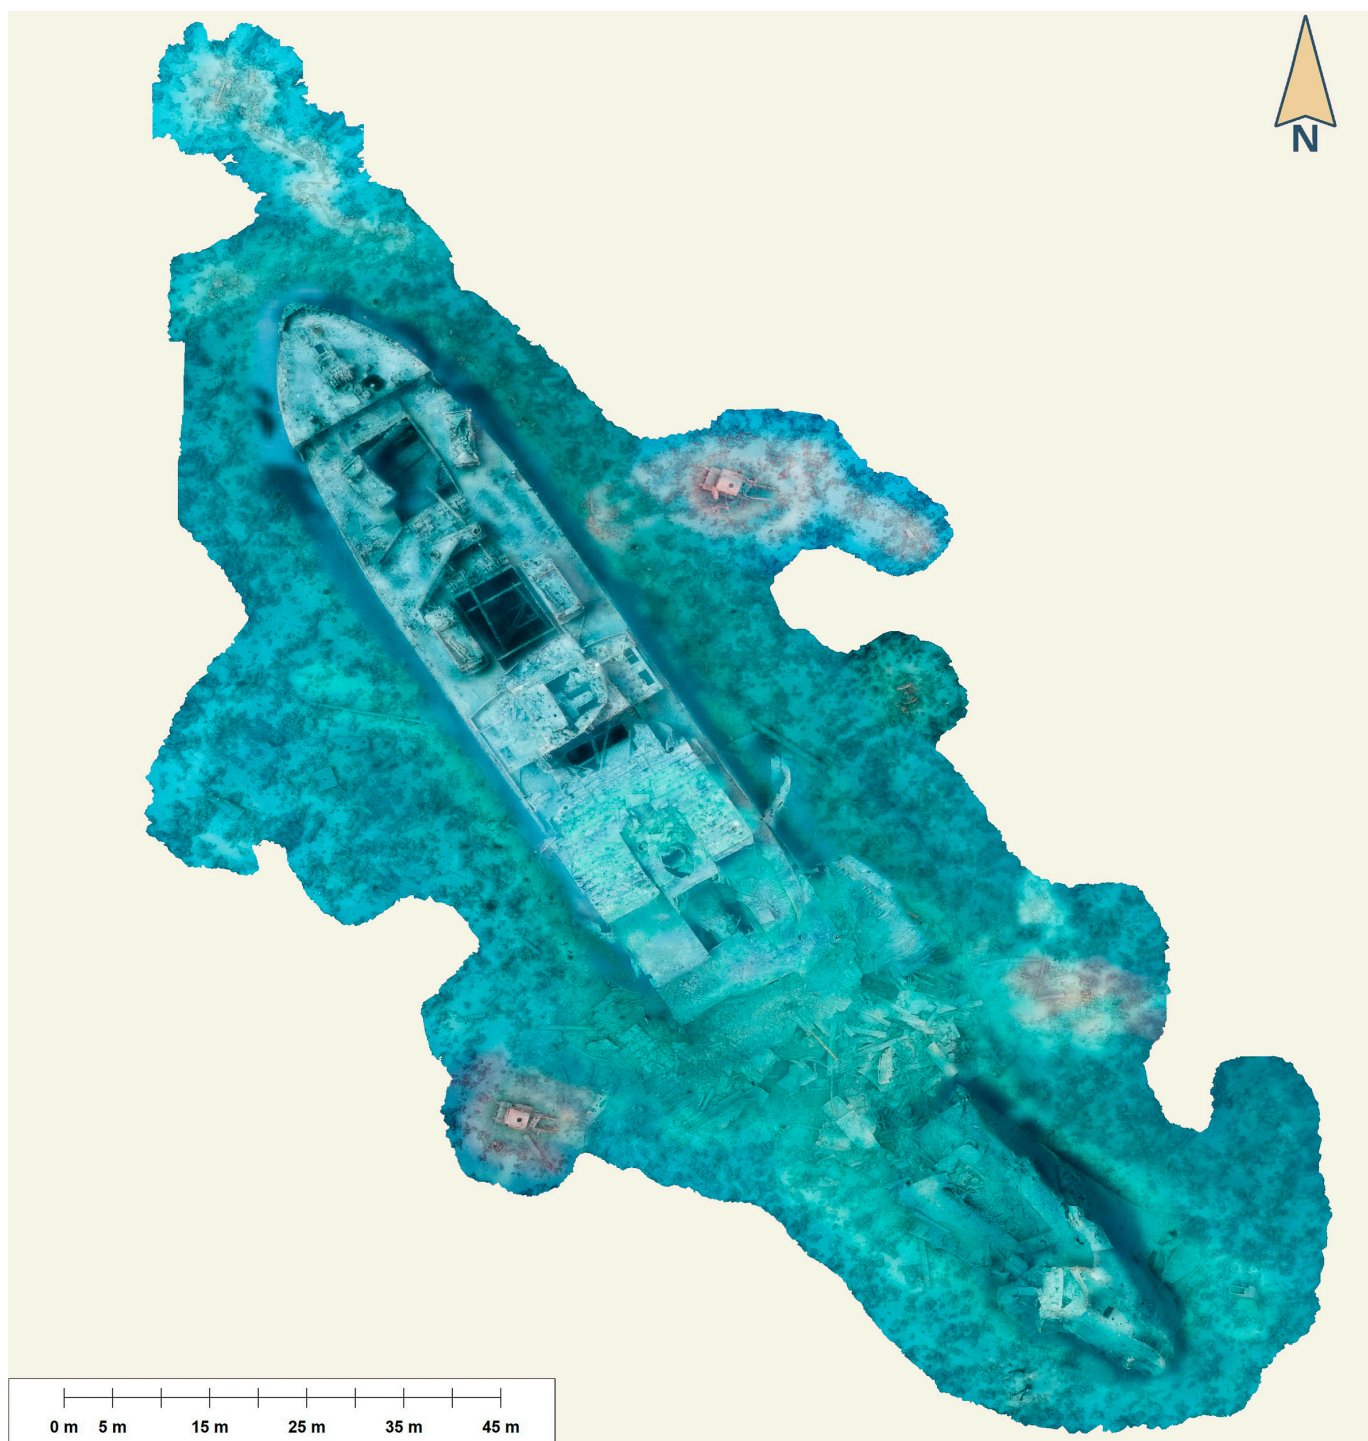
Figure 12. Orthomosaic derived from the 3D model of the SS *Thistlegorm*. Here, the wreck and surrounding seabed are viewed from the surface. The main deck from bow to just aft of the engine room have been well preserved. The explosion centred at Hold No. 4 has completely destroyed the ship in this section. The stern, now lying on its port side, remains preserved.

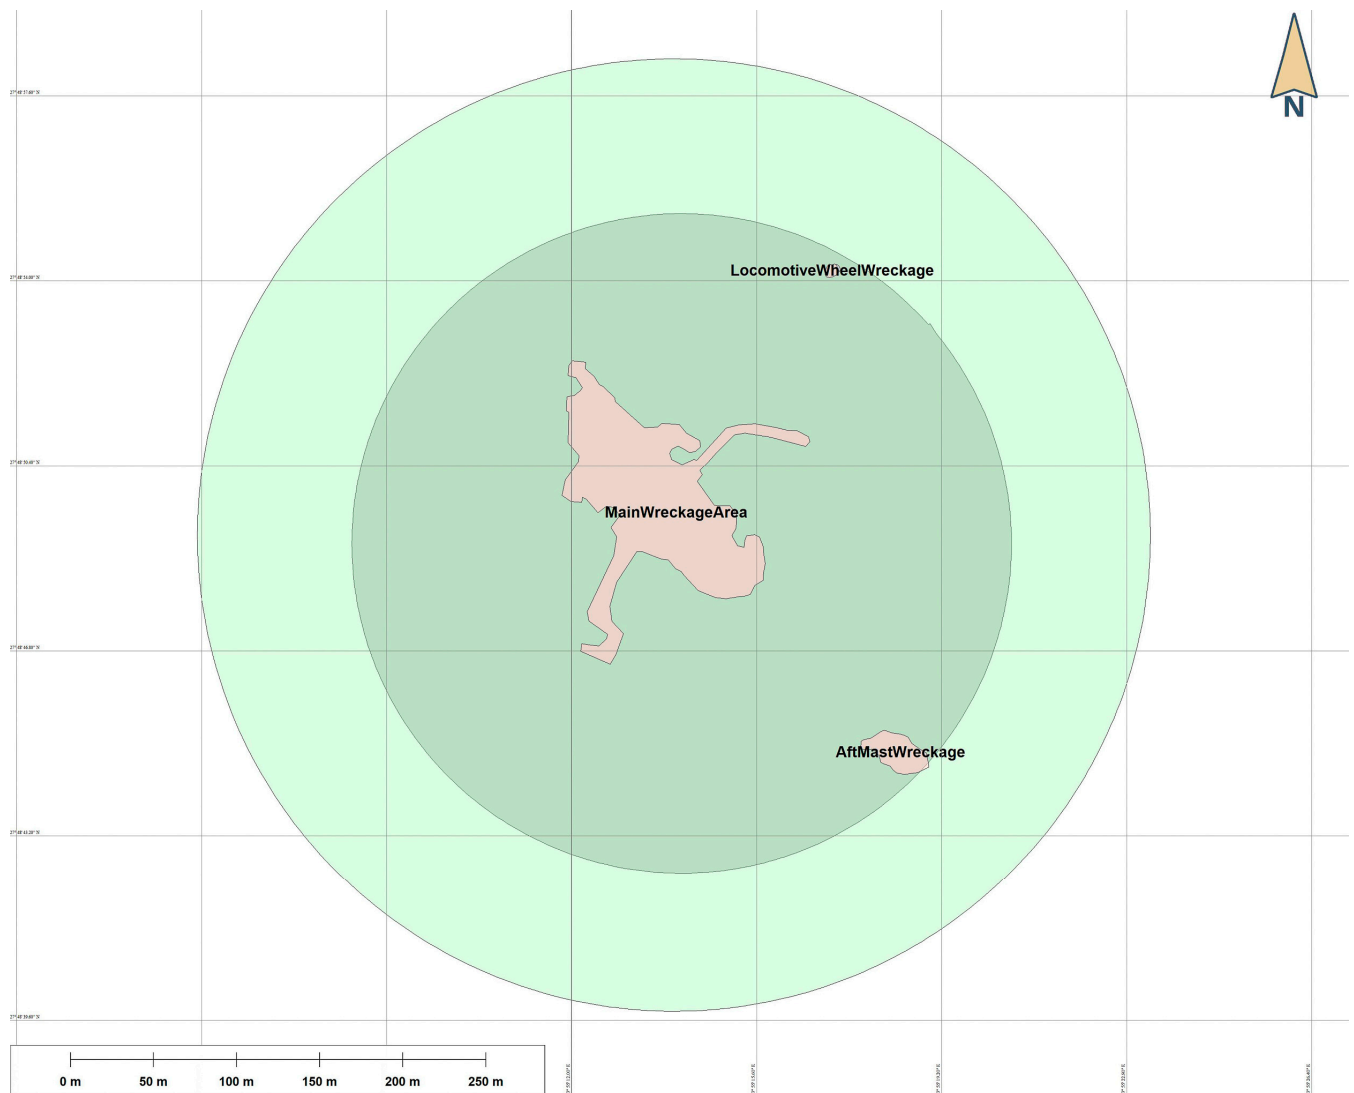
the known debris field to at least 21.9 hectares, doubling the recorded area of dispersed artefacts and wreckage (Figure 23).

Figure 23. Original 2022 estimate (dark green) of debris field with post-fieldwork revised estimate (light green) overlaid.

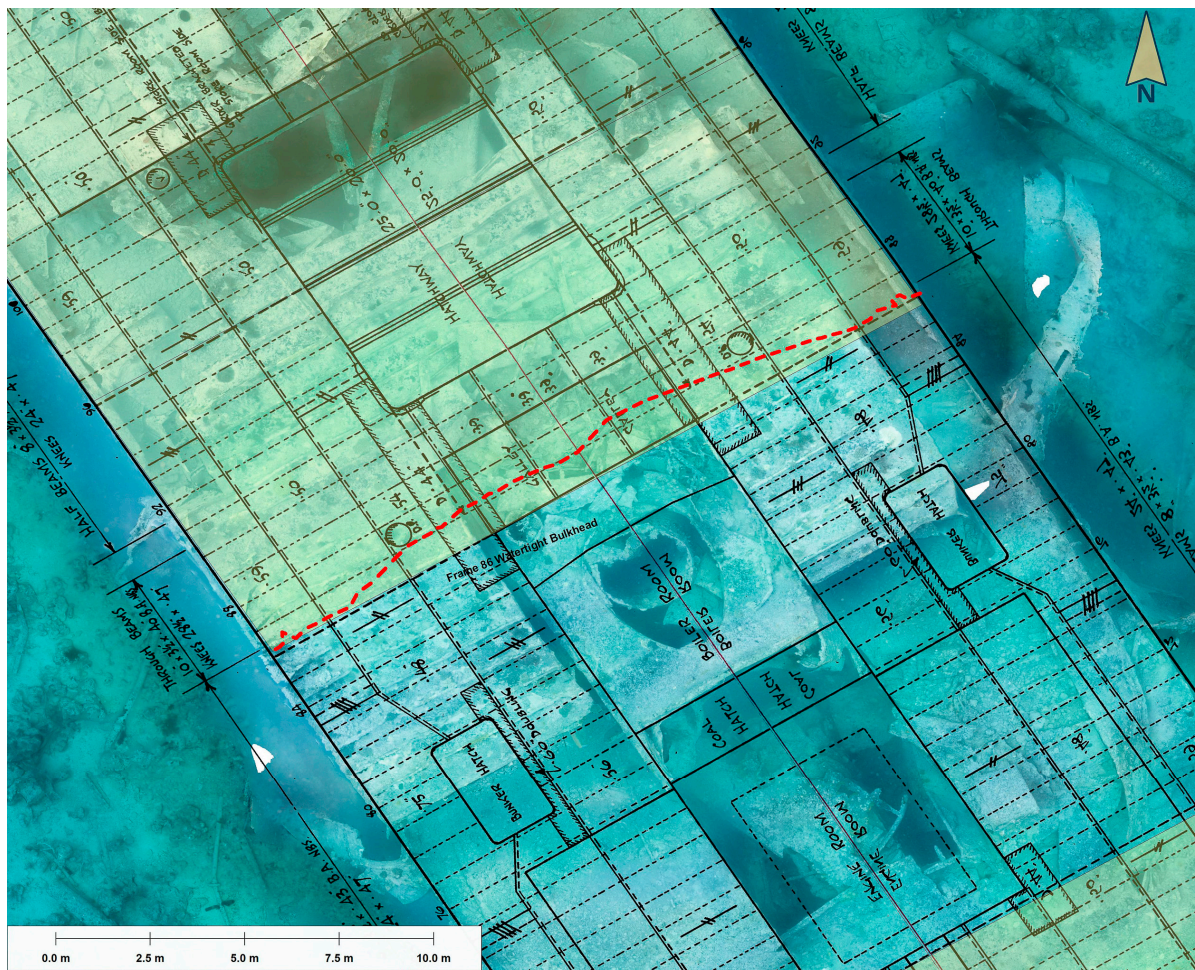
Initially overlooked in 2017 due to its apparent lack of cargo, Hold No. 3 was fully surveyed in 2022. The hold is loaded with coal to an estimated depth of 3 m and is devoid of the more exotic cargo such as Norton motorbikes found in Hold No. 2. Despite this, the survey revealed further evidence of the impact of the secondary explosion and subsequent sinking. Close inspection of the 3D photogrammetric model of Hold No. 3 revealed the aft watertight bulkhead at frame 86 was deformed, and that the deformation was not uniform. The model was compared in Global mapper to the as-designed bulkhead position extracted from the ship builders' plans. These plans, held by Tyne and Wear Archives and the Lloyds Register Foundation, clearly indicate the presence of a linear and uniform watertight bulkhead at frame 86. Analysis of 3D models and plans showed the bulkhead had shifted by up to 1.2 m from its original position, most likely due to the pressure wave from flooding during the sinking, rather than the secondary explosion itself (Figure 24). This deformation can also be seen by the curvature observed in the vertical stiffening ribs within the hold (Figure 25).

Figure 24. The wreck orthomosaic overlaid with the builders' plans of the main deck. Hatched yellow area represents the extents of the holds. Red dashed line represents shape and form of the watertight bulkhead recorded in 2022 at frame 86, separating Hold No. 3 from the engine room.

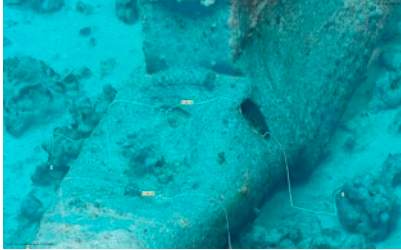
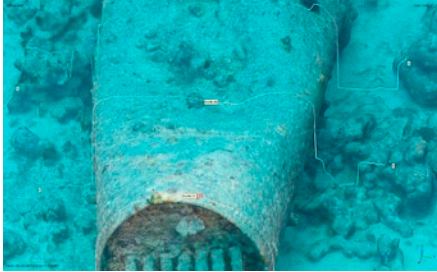
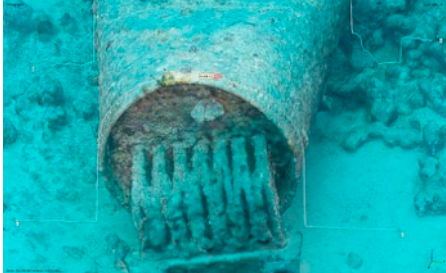
Table 2. Comparative measurements between the as designed engineering drawing measurements of the port boiler and physical measurements taken underwater in 2022.

Dimension	As Designed Value	As Measured Value	Variation	Screenshot of Model
AA	1.697 m	2.08 m	+0.383 m

BB	1.659 m	2.05 m	+0.391 m

CC	1.524 m	1.58 m	+0.056 m

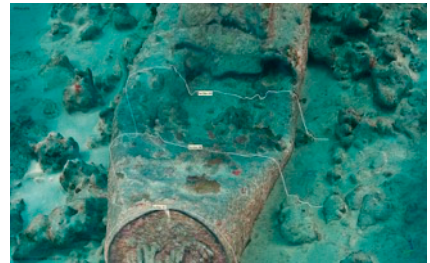
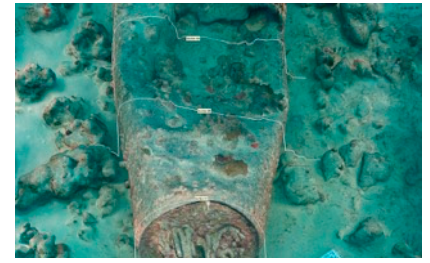
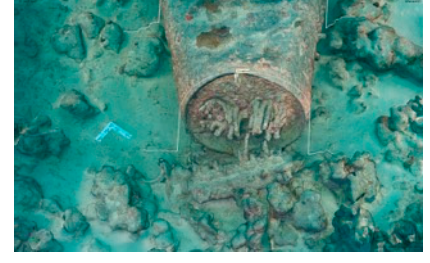
Table 3. Comparative measurements between the as designed engineering drawing measurements of the starboard boiler and physical measurements taken underwater in 2022.

Dimension	As Designed Value	As Measured Value	Variation	Screenshot of Model
AA	1.697 m	2.08 m	+0.383 m

BB	1.659 m	2.04 m	+0.381 m

CC	1.524 m	1.56 m	+0.036 m
