# Management Plan and Public Outreach for WWII Submerged Resources in Saipan

Jennifer F. McKinnon and Toni L. Carrell

2014

Grant Agreement No. GA-2255-11-018  
Final Report

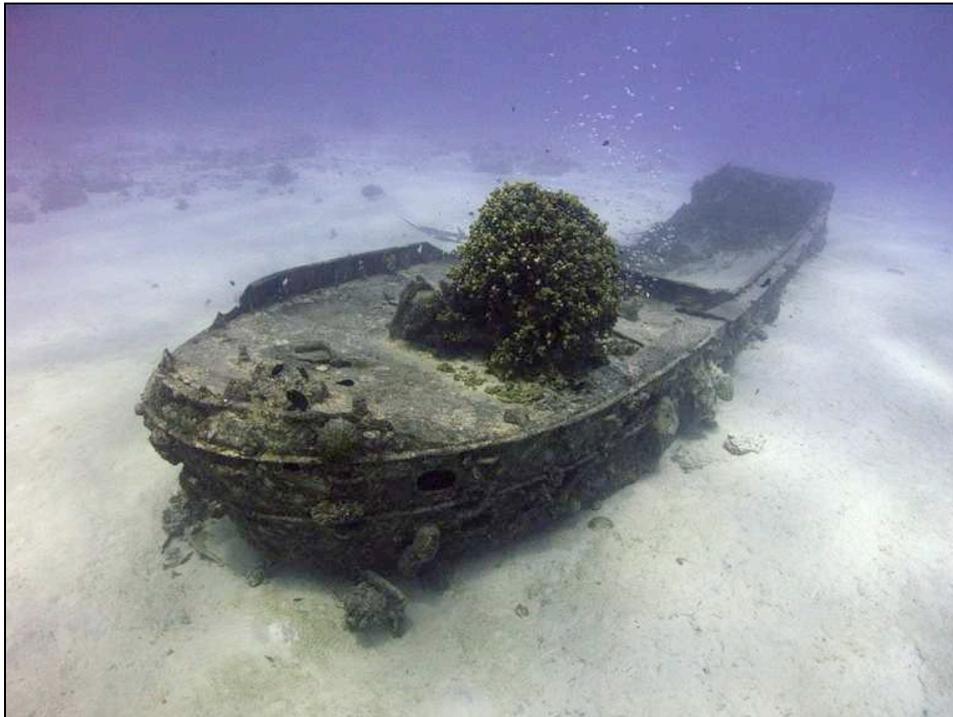
The vessel is upright and is reasonably intact except for the port side amidships region that has collapsed. A deck winch with wire remains in position on the upper stern deck level. The steering wheel has been displaced and is also lying on this upper deck level. Hull plates are holed in many places and the armor shield lies on the seabed on the port side of the wheelhouse. The vessel is partially buried in the stern and the upper half of the rudder is visible. Limited burial has occurred with sand accumulation in the cargo bay. The maximum height of the main structure rises approximately 2-3m above the seabed. There are some areas of active corrosion evident on the site, indicated by the presence of the typical red/brown “rust” spots on the surface of the vehicle.

The wreck lies on a flat, slightly undulating sandy seabed that is comparatively devoid of marine biota. It is covered in brown algal forms and some sporadic secondary colonization was evident (e.g. tunicates, soft and hard corals, seaweed, etc.). Isolated hard coralline growths have formed in places with one large coral formation on the upper stern deck. It appears that the wreck is not subjected to regular burial/exposure cycles. Sediment has partly covered the lower profile areas but the establishment of some hard corals indicates that significant accumulation of sediment does not readily occur. The site lies in the comparatively protected lagoon area but the site has the potential to be affected by storm conditions.

**Figure 3. Daihatsu Landing Craft 1 - stern to bow view (Carpenter 2012).**

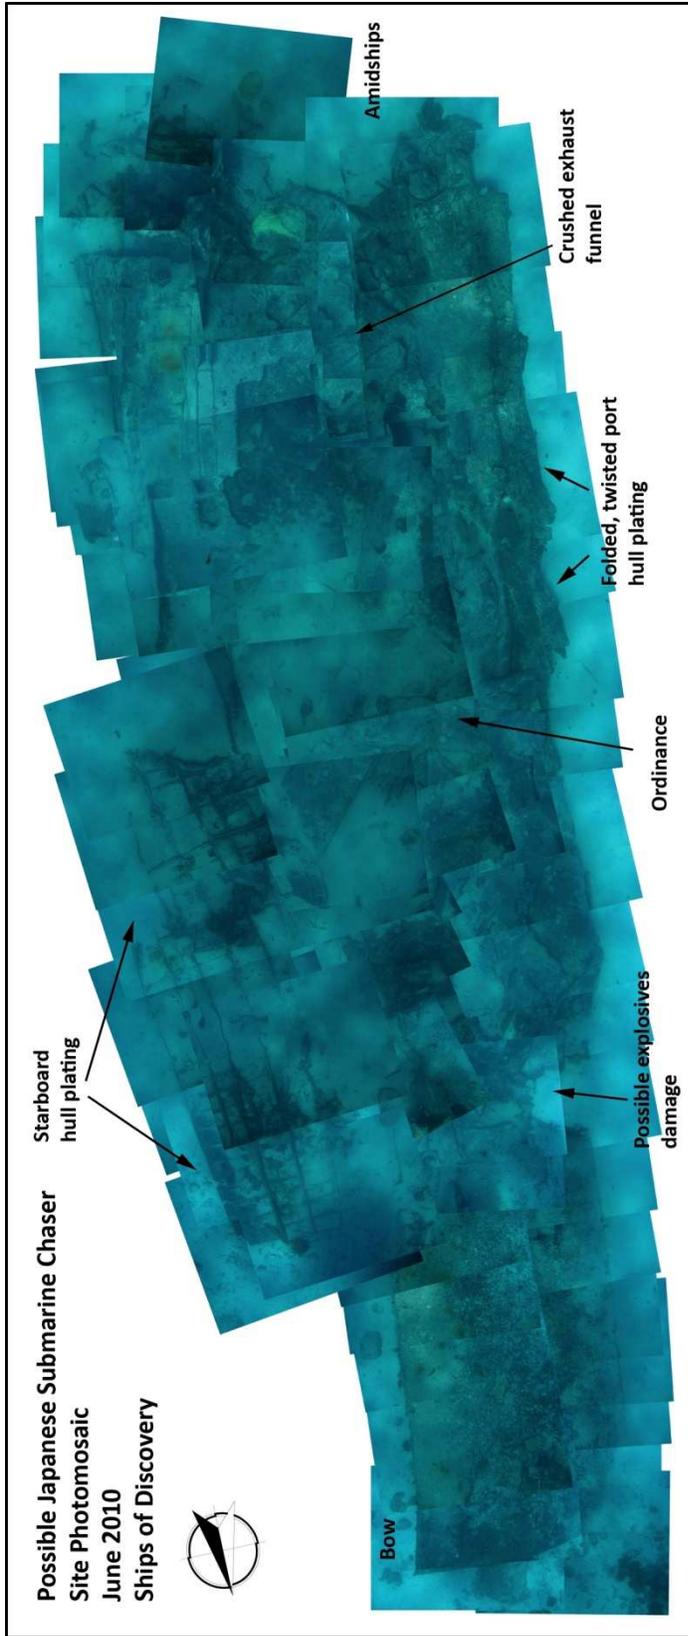
The site is located on the southwest side of Saipan, inside Tanapag Harbor (UTM [REDACTED]). It lies on its starboard side in approximately 30 ft (9.1 m) of water. It is discrete and comprised of a tightly-clustered linear deposit of bow, disarticulated hull plates and minor structural elements approximately 60 m (200 ft) long by 15 m (50 ft) maximum width (Figure 13). There is little scattered debris away from the main concentration and it is fully submerged at all times.

Figure 13. Photomosaic of possible auxiliary submarine chaser site.

Approximately 12 m (40 ft) of the sharp bow section remains intact and it appears that the upper deck of the bow has been cut away from the vessel. Small hatch holes are present just aft of the stem leading into the narrow below deck space. The beam of the aft end of the remaining bow section is 3.9-4.8 m (13-16 ft) wide. The remainder of the ship is badly disarticulated, although the wreckage generally follows the original line of the ship. No evidence of the engine or boilers is present but there is what appears to be a section of a funnel in the amidships section. Just aft of the amidships section is where the ship is highly fragmented and missing components. There is no obvious evidence of the stern, steering gear, or propellers. The disarticulated nature and missing features makes it difficult to understand what has happened to the site; however this could be the result of post-war cleanup, salvage or explosives training operations. In 1984, munitions were visibly scattered in the wreckage. These were reported as "4 inches in diameter and 15.6 inches long" (101 mm by 396 mm long) (PBEC 1985:10-11). Recent examination of the wreckage site reveals there are still munitions left on the site.

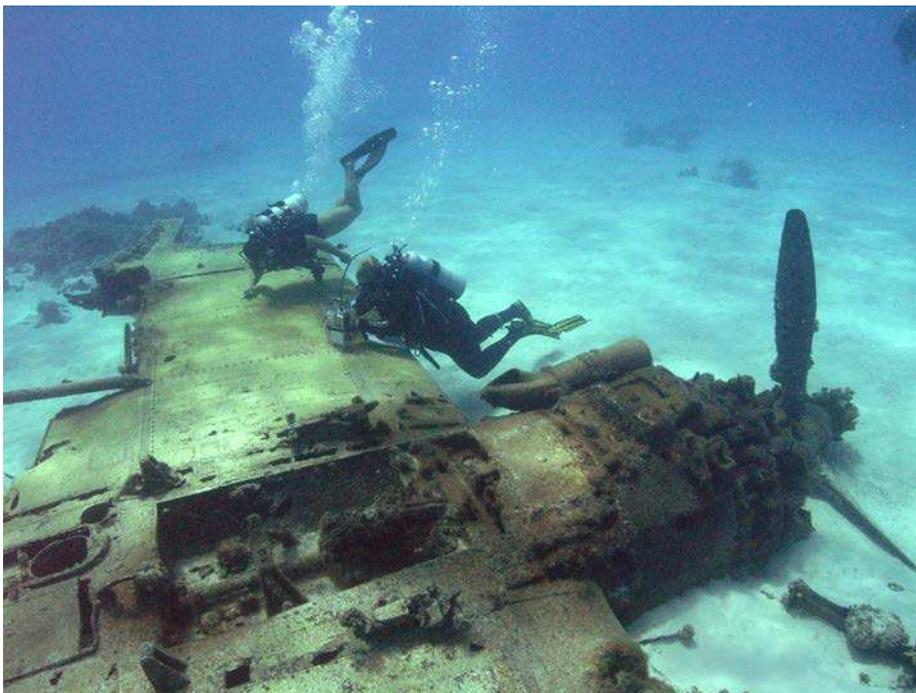
The aircraft remains measure 36 ft (10.9 m) in length from bow to stern with a wingspan of 46 ft (14 m) and it is constructed most probably of duralumin (an aluminum alloy). The aircraft is relatively intact lying inverted on the seabed. It is listing to port with the end of the port wing buried in the surrounding sediment and the starboard wing rising above the seabed with no support. One of the two floats is absent the other lies in close proximity to the port wing. The aircraft structures and components, although damaged, remain in relatively good condition and still retain strength and resilience as attested by the unsupported starboard wing. A piece of landing gear is located a short distance from the tail of the aircraft but does not appear to be associated with the aircraft (McKinnon and Carrell 2011:55). Overall damage to the aircraft structure is not readily distinguishable between crash, storm or potential war damage, however it is thought that the aircraft was intentionally scuttled (McKinnon and Carrell 2011: 57).

**Figure 15. Overview photograph of Aichi E13A JAKE (Carpenter 2012).**

The aircraft remains are located on a relatively flat, undulating seabed with sporadic large coral outcrops. The port wing and the end of the tail are partially buried in fine sediment and localized, seasonal exposure/reburial cycles occurs in this area as changes to sediment levels are noted with each

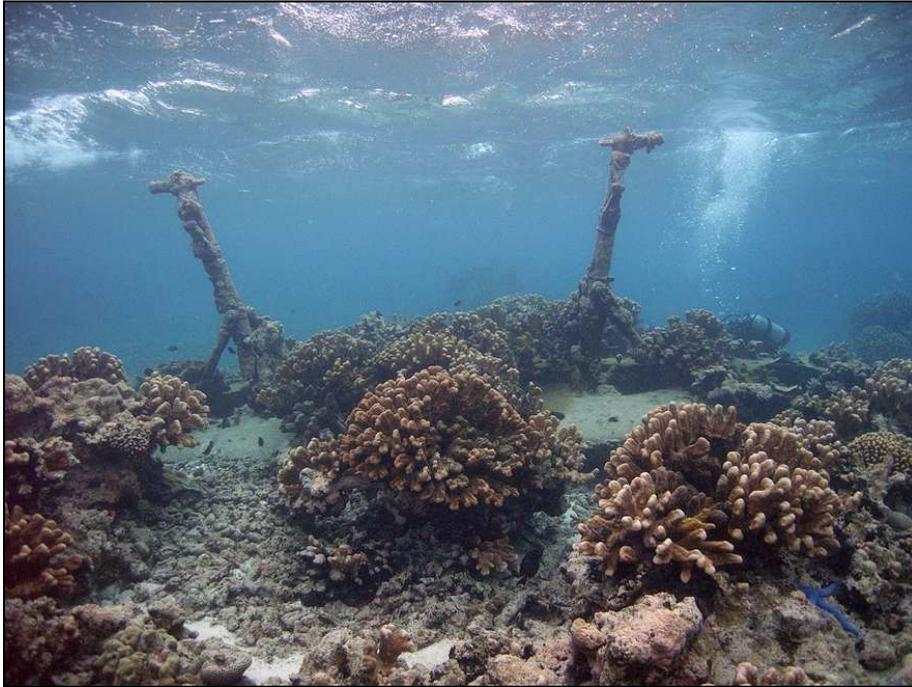
The aircraft is most probably constructed of duralumin (an aluminum alloy) and was 12.19 m in length, 5.00 m high and had a 16.51 m wingspan. The aircraft is inverted on the seabed with a concentrated site distribution consisting of the central portion of the wing. The wing measures approximately 50 ft (15 m) in length and is 8 ft (2.5 m) in width at the fuselage. The aircraft remains are mostly submerged, however the hydraulic landing gear, which is in the fully extended position, is exposed to the

atmosphere at extreme low tides. The aircraft is missing its tail section, engine and propeller. A few small sections of wreck are scattered within 65-130 ft (20-40 m). The sections include part of a radial engine, a section of fuselage with an observation port and a turret ring. Also, what appears to be a radio box is approximately 20 ft (6 m) aft of the wreckage.

**Figure 18. Grumman TBM Avenger (Carpenter 2012).**

The aircraft remains are located on the top of the barrier reef that creates Tanapag Harbor and are subjected to considerable water movement due to this high energy environment. Large quantities of dead coral are strewn over the seabed, which is comprised of coarse-grained calcareous sediment. The surviving aircraft structure is slowly being integrated into the reef through the growth of corals. The maximum exposure height of the main structure is approximately 1.5 m above the seabed. The aluminum skin of the wings is corroded and has a number of irregular holes and smaller perforations.

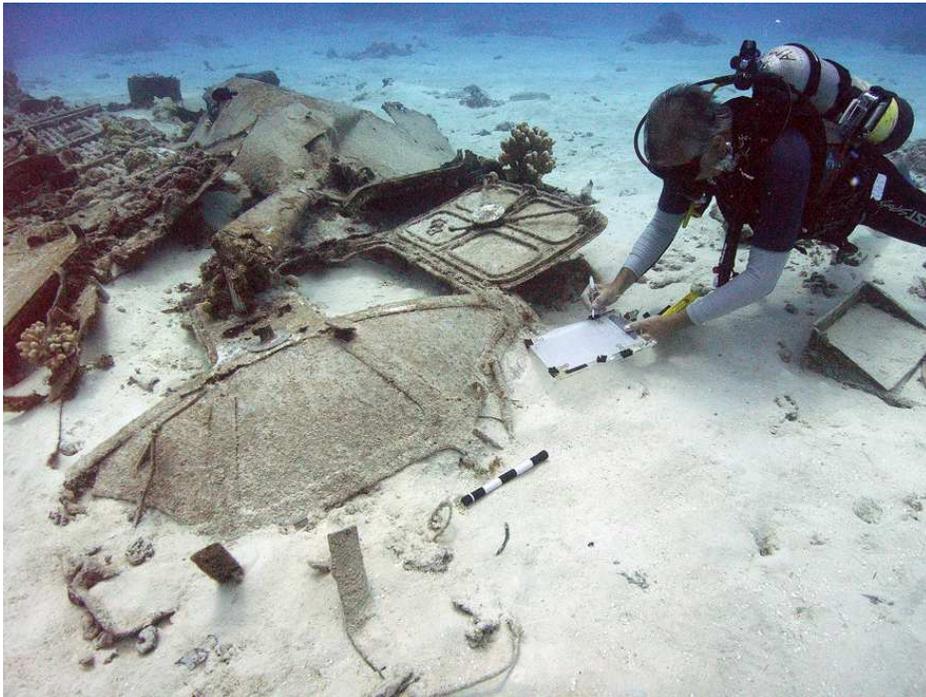
Based on the findings of Richards and Carpenter (2012) the surfaces of the aluminium alloy sections of the Coronado exhibited significant pitting and perforation of the residual metal. The average corrosion potentials of the float strut, an area of unidentified wreckage, and the control panel suggest that these have different metal compositions (i.e. higher aluminium contents) than other sections resulting in a higher rate of corrosion. The Coronado is more deteriorated than the Jake and Emily even though they are in similar environments at similar depths. This is due in part to the increased stress and metal fatigue resulting from damage and because it is disarticulated and spread over a wider area, and therefore not afforded the beneficial effects of proximity to other sections to slow rates of deterioration.

**Figure 19. Consolidated PB2Y Coronado (Carpenter 2012).**

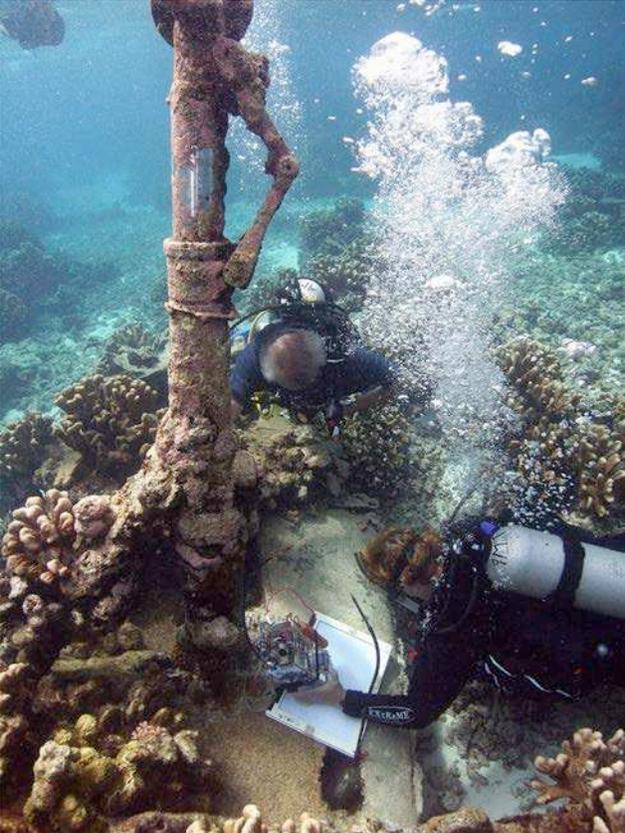
However, for those sites outside of the Marine Conservation Area there is no mandate or support for installing moorings so anchor damage is a greater risk. Conversations with a local boat driver disclosed the Avenger’s landing gear is regularly used as a boat mooring for local surfers (Sheldon Preston personal communication, 2010). The effects of mooring are seen on the landing gear where exposed metal is obvious (Figure 21). Continued use of the landing gear as a mooring will eventually cause severe damage if the boats collide with the aircraft or break the landing gear during rough swell conditions.

Figure 21. Avenger landing gear, note shiny metal where concretion has been rubbed away due to mooring (Carpenter 2012).

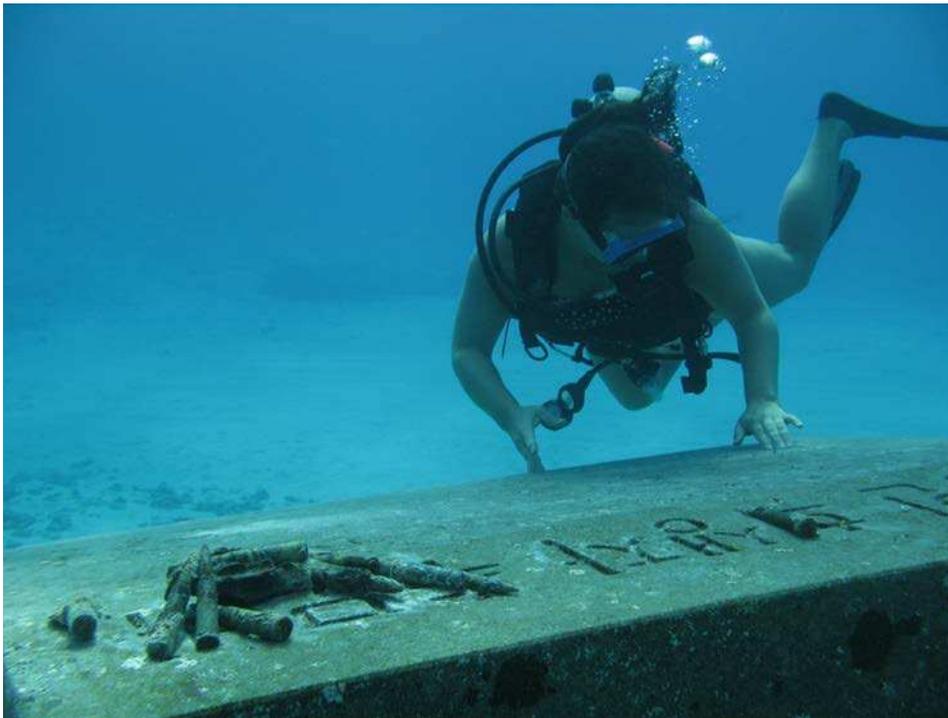
Of the nine sites on the trail, four have had some form of looting or movement of artifacts. At the Daihatsu 1 site the steering wheel for the craft was propped up on the stern deck and glass bottles, not associated with the site, are regularly re-arranged on the deck. The Japanese merchant ship site aka *Shoan Maru* includes a Korean monument on which 50-caliber bullets have been placed and rearranged into patterns (Figure 22). It is uncertain where the bullets actually originated and if they are from the wreck or another site.

**Figure 22. Korean monument with .50 caliber rounds (Gauvin 2010).**

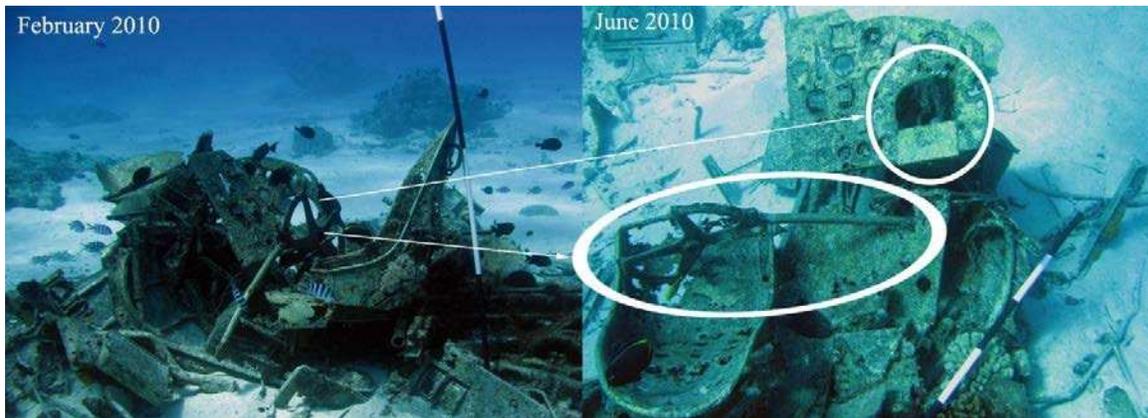
Divers are having a major impact on the Kawanishi H8K (EMILY). Impacts in the cockpit area were photographically documented during the February and June 2010 field seasons (McKinnon and Carrell 2011) (Figure 23). The cockpit control panel was shifted and subsequently balanced on its mount giving the appearance of its original position. Furthermore, the steering column was moved to the opposite side of the cockpit chair. Consultation with dive operators confirms that tourist divers like to take photographs while seated in the cockpit. This behavior is detrimental to the preservation of the site and will eventually destroy these unique features.

**Figure 23. Cockpit configuration changes over time on Kawanishi H8K (Bell 2010).**

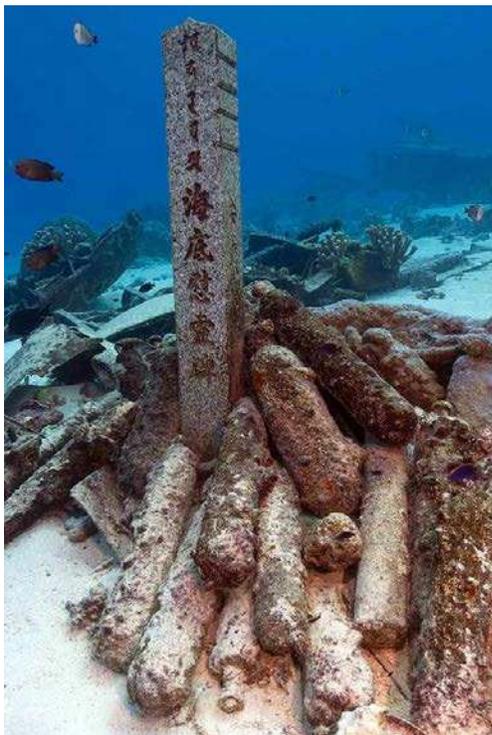
A ladder-like metal object was propped up against the southern side of the aircraft wing. Smaller artifacts located on the Kawanishi site have been moved from their original positions including stacking ordnance and gas cylinders around the Japanese monument (Figure 24). It is possible that these artifacts were moved to enhance the memorialization of the site. While such movement of artifacts on a historic site destroys contextual evidence, from a socio-cultural perspective it reflects the different norms by which cultural groups memorialize sites and commemorate their visits.

**Figure 24. Japanese monument surrounded by gas cylinders and other moveable objects (Seymour 2012).**

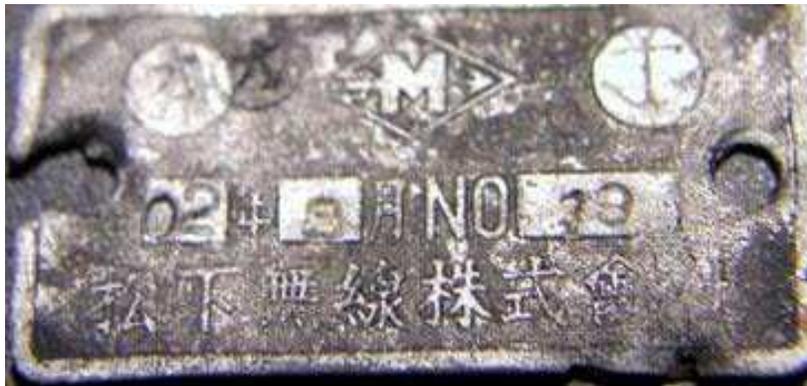
While there is no evidence of any systematic salvage at the Kawanishi, there are indications of opportunistic salvage. A local dive shop owner is in possession of “identification plates” that were reportedly removed from the plane (McKinnon and Carrell 2011) (Figure 25). Upon further research, the plate was identified as from the plane’s wireless radio. Separately, the Historic Preservation Office was informed of a piece of aircraft deposited on a beach, suspected to have come from the Kawanishi (Figure 26). After careful review of photographs it was determined to be a portion of the nose area. There is no way to accurately determine the extent of or damage caused by such activities.

**Figure 25. Wireless radio Identification plate recovered from the Kawanishi H8K sites (masadive-saipan.com, accessed June 2010).**

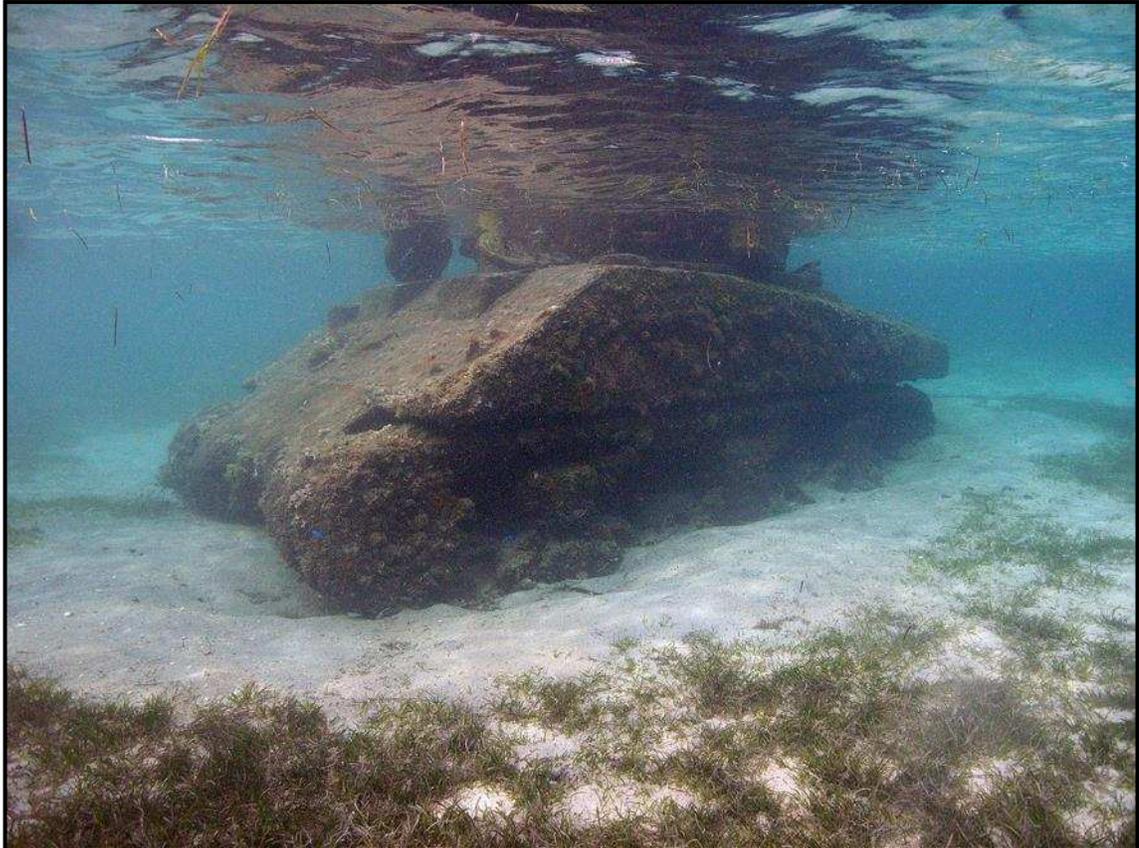
**Figure 1. M4 Sherman Tank 1 (Tank 1) – port side view (Carpenter 2012).**

The main body of the vehicle is mostly intact but other smaller components are missing. This loss may be due to corrosion and/or cultural impacts, such as salvage. There are many areas of active corrosion evident on the site, indicated by the presence of the typical red/brown “rust” spots on the surfaces of the tank (Figure 1). There are also signs of accelerated corrosion on the upper sections of the tank (flaking, spalling and cracking of the metal surfaces and gun barrel) that are cyclically exposed to the atmosphere. Children were observed playing on the tank, walking along the main gun barrel and jumping or diving into the water. In time, this practice may become a health and safety issue due to the extensive corrosion exhibited by these exposed sections and the ever increasing probability that these areas may collapse or fragment. However, divers and snorkelers are actively encouraged to visit the site through the WWII Maritime Heritage Trail – Battle of Saipan, provided they follow the visitation guidelines and do not interfere with the site (i.e. disturb or attempt to remove any components).

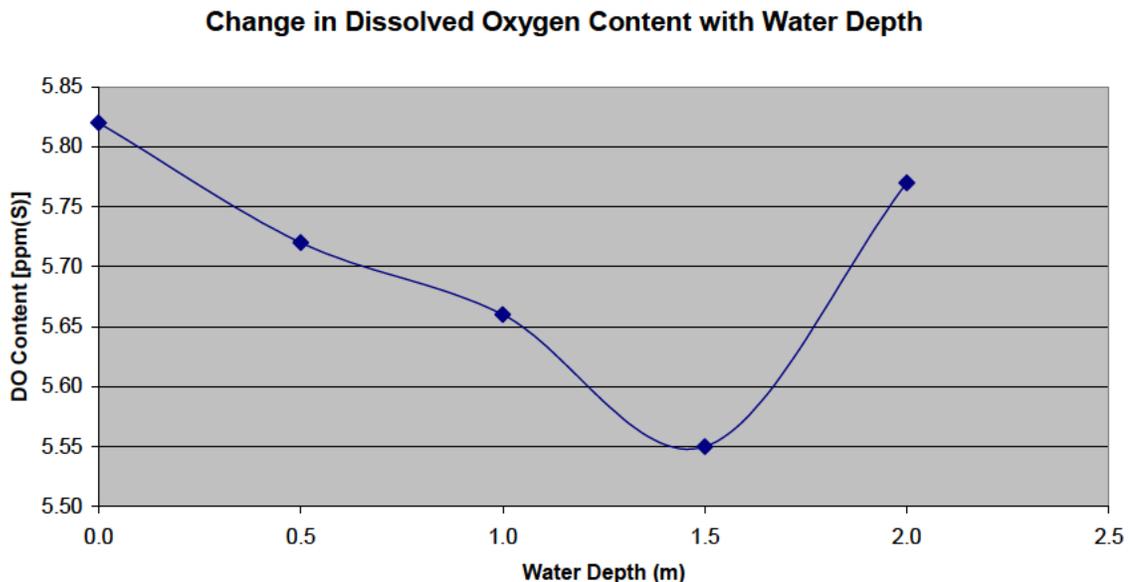
**Figure 2. Change in dissolved oxygen content with increasing water depth measured on the M4 Sherman Tank 1 site (Richards 2012).**

For open circulation ocean environments, there is usually a surface maximum in the dissolved oxygen concentration. This maximum is a direct result of absorption from the atmosphere interface, increased water movement and photosynthetic activity by plants and cyanobacteria. Typically, after this surface maximum the dissolved oxygen concentration of the water column will decrease with increasing depth. Factors contributing to this trend are decreasing water movement, which leads to less oxygen exchange with the atmosphere, decreasing photosynthetic activity due to less light penetration and increasing aerobic respiration of plankton in the photosynthetic zone. However, the relatively small standard deviation between the measurements and a decrease of only 0.25ppm over the first 1.5m

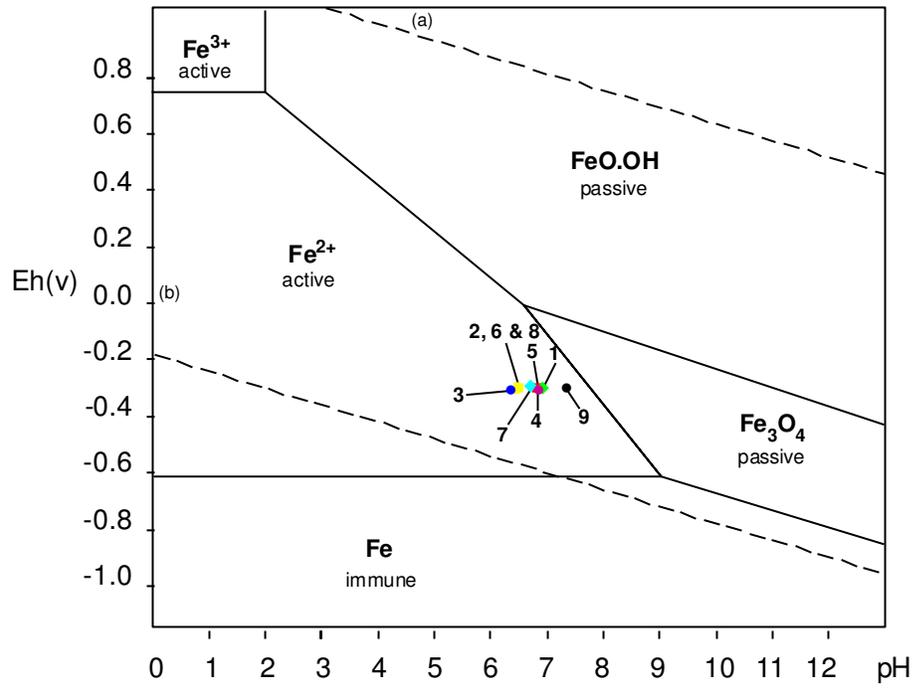
Figure 4. Pourbaix diagram for iron ( $10^{-6}$  M) in aerobic seawater at 25°C indicating the intercepts of the areas measured on the M4 Sherman Tank 1 (Richards 2012).

From the Pourbaix diagram (Figure 5), the intercepts of all points (**1 – 9**) measured on the iron alloy sections of tank 1 (no stable corrosion potential could be obtained on the gun turret **10**) lie in the active corrosion region, where ferrous ions are the thermodynamically stable chemical species and corrosion will continue until all iron is consumed. Generally, with film free corrosion mechanisms, such as occurs on concreted iron artefacts, an increase in the corrosion potential (tending more positive) indicates an increase in the corrosion of the metal. However, the average corrosion potential of the nine measurement points was  $-0.305 \pm 0.003V$ . This 3mV standard deviation is comparatively small and within experimental error for the equipment and measuring procedure suggesting that the entire tank is in electrical connection and the same film free corrosion mechanism applies to all areas on the tank. Hence, it is not possible to determine any differences in corrosion between the positions based on the  $E_{corr}$  data.

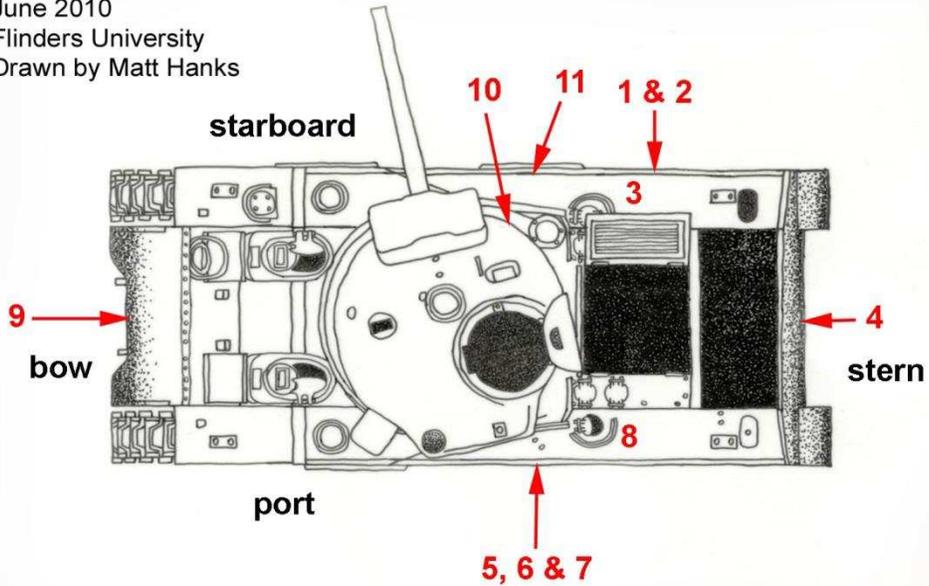
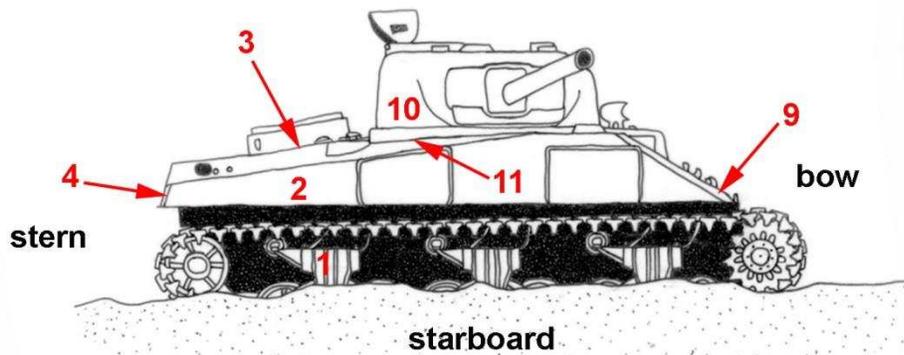
The corrosion parameters of eleven different areas on Tank 1 were measured over a 70 minute dive on 20 February 2012. The results are presented in Table 3 and the on-site positions shown in Figure 5. In order to compare the corrosion data collected from the different positions measured on Tank 1 and ascertain the thermodynamically stable state of the iron, the corrosion potentials ( $E_{corr}$ ) and the pH of the residual iron alloy surfaces were plotted on the iron Pourbaix diagram in aerobic seawater at 25°C (Figure 4). The exception being the exposed weld as this particular Pourbaix diagram is not applicable due to the high nickel content which will significantly change the corrosion mechanism. The temperature of the seawater on-site was 26°C, however this 1°C increase does not significantly affect the nature or equilibria of the chemical species described in this diagram.

Figure 5. Schematic plan and profile views of the M4 Sherman Tank 1 indicating the corrosion parameter measurement positions (Richards 2012 after Hanks 2010 in McKinnon and Carrell 2011:107).

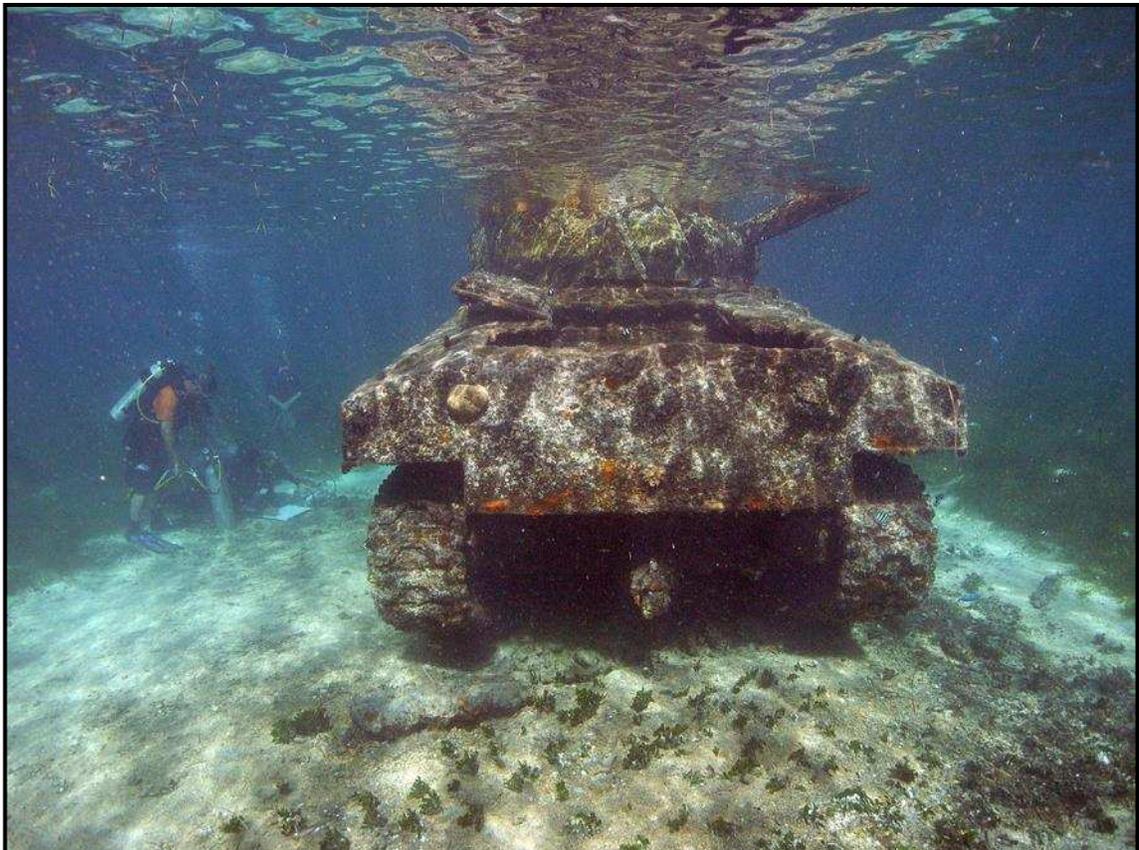
Figure 6. M4 Sherman Tank 3 (Tank 3) – stern view (Carpenter 2012).

As mentioned previously, the pH is often a more reliable indicator of changes in localised corrosion rates, however the pHs measured on Tank 3 were very inconsistent in comparison to those measured on Tank 1. Therefore, no statistically valid relationships between depth of immersion and changes in pH could be observed for Tank 3. The areas that are constantly immersed (water depth >1m) will tend to provide more consistent corrosion parameter results. Therefore, the average pH values of these areas for Tank 1 (1, 4, 5 & 7) and for Tank 3 (1, 2, 5, 6, 7 & 11) were  $6.86 \pm 0.09$  and  $6.34 \pm 0.33$ , respectively. This decrease of 0.52 pH units for Tank 3 indicates that there has been a statistically significant increase in the corrosion rate of Tank 3 as compared to Tank 1 and in conjunction with the thinner  $d_{total}$  measured on Tank 3, suggests that the natural and cultural impacts of the local environment on Tank 3 are more aggressive than those experienced by Tank 1. More importantly, as there appears to be more tourist activity associated with Tank 3, it may be this increase in human interference that is causing the accelerated deterioration of Tank 3.

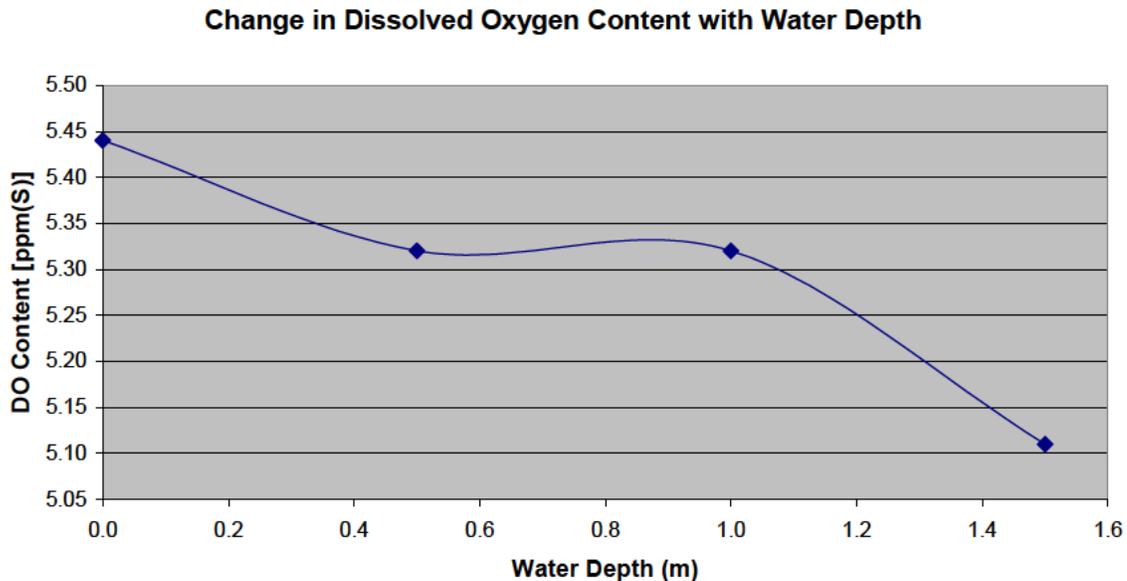
**Figure 7. Change in dissolved oxygen content with increasing water depth measured on the M4 Sherman Tank 3 site (Richards 2012).**

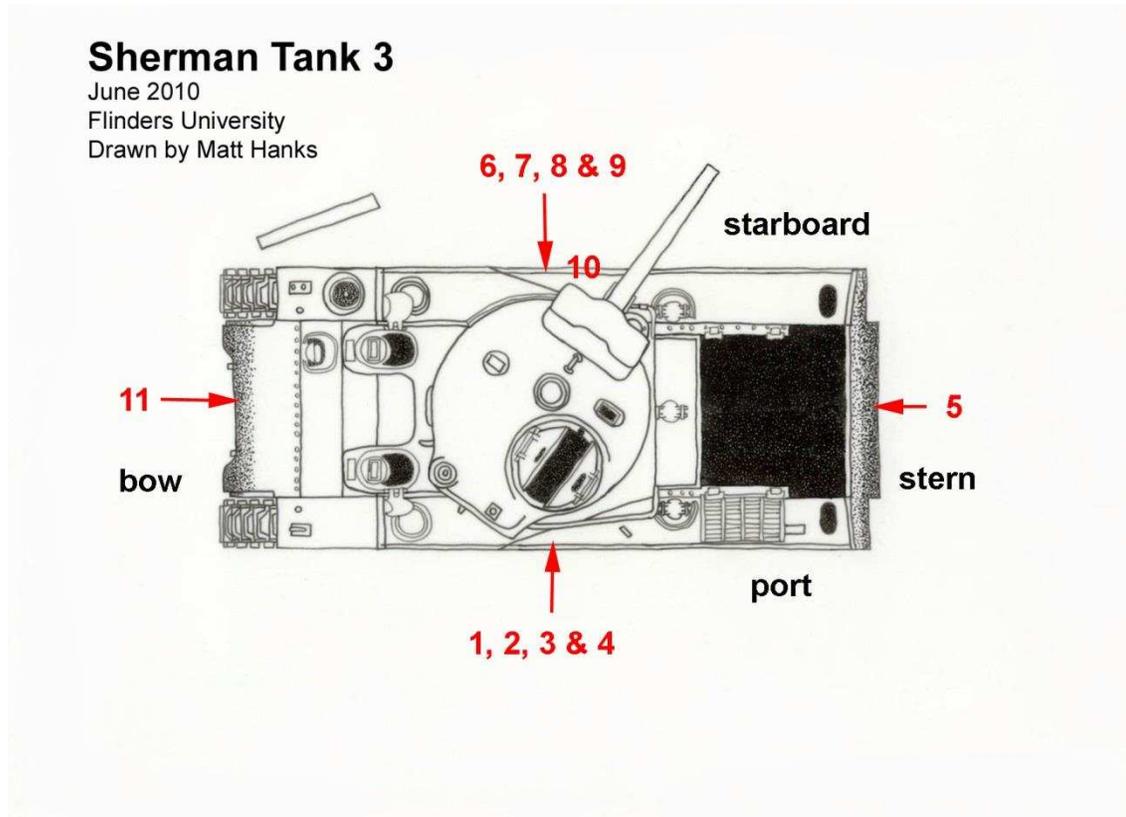
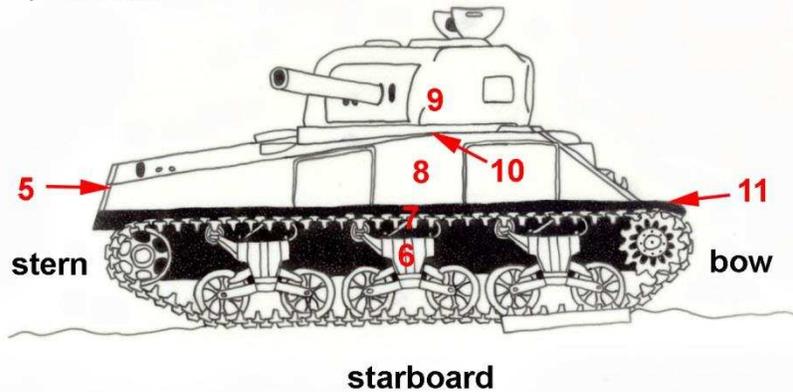
Figure 8. Schematic plan and profile views of the M4 Sherman Tank 3 indicating the corrosion parameter measurement positions (Richards 2012 after Hanks 2010).

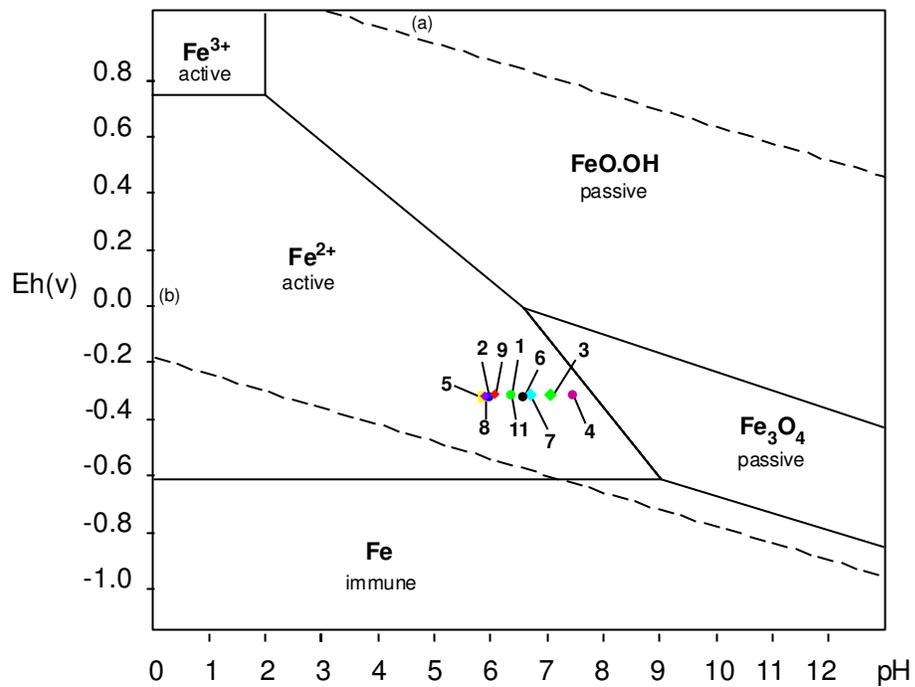
Figure 9. Pourbiax diagram for iron ( $10^{-6}M$ ) in aerobic seawater at 25°C indicating the intercepts of the areas measured on the M4 Sherman Tank 3 (Richards 2012).

Generally, the areas measured on Tank 3, whether they are constantly immersed or lie in the splash zone, were covered with relatively thin aerobic concretions (<11mm) in comparison to Tank 1. Unlike

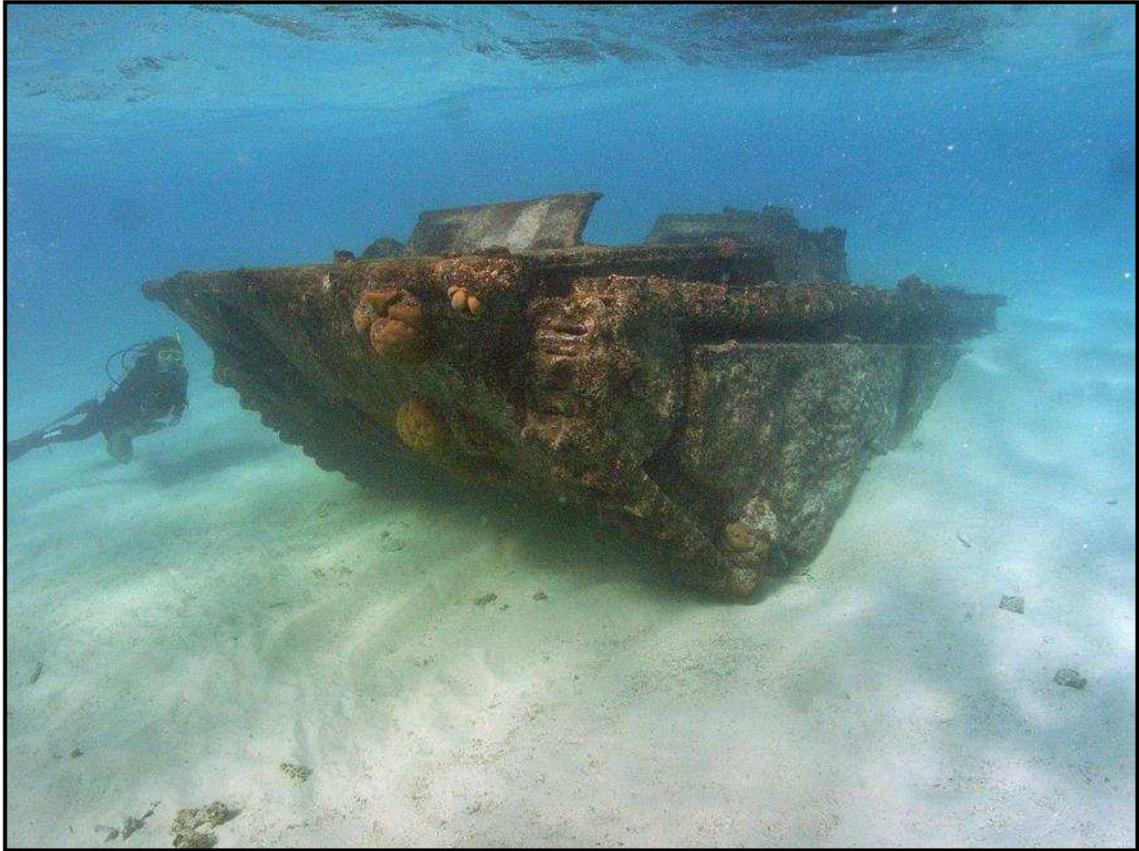
**Figure 10. Landing Vehicle Tracked 1 (LVT1) – port side view (Carpenter 2012).**

The wreck lies on a flat, slightly undulating sandy seabed, comprising of calcareous sediment. There are small and larger patches of reef surrounding the wreck but none are in direct contact with the wreck. The stern of LVT1, which faces shoreward, was partially buried in the seabed and there appeared to have been significant scouring around the bow (seaward side) of the vessel. The rear and lower track were entirely buried and the upper surfaces were fully exposed to the marine environment. Stormy sea conditions could result in sand movement that is likely to affect the extent of burial/exposure, however it is not anticipated that the entire vehicle would ever become totally buried. The wreck was covered in brown algal forms and some sporadic secondary colonisation was evident (e.g. tunicates, soft and hard corals, seaweed, etc).

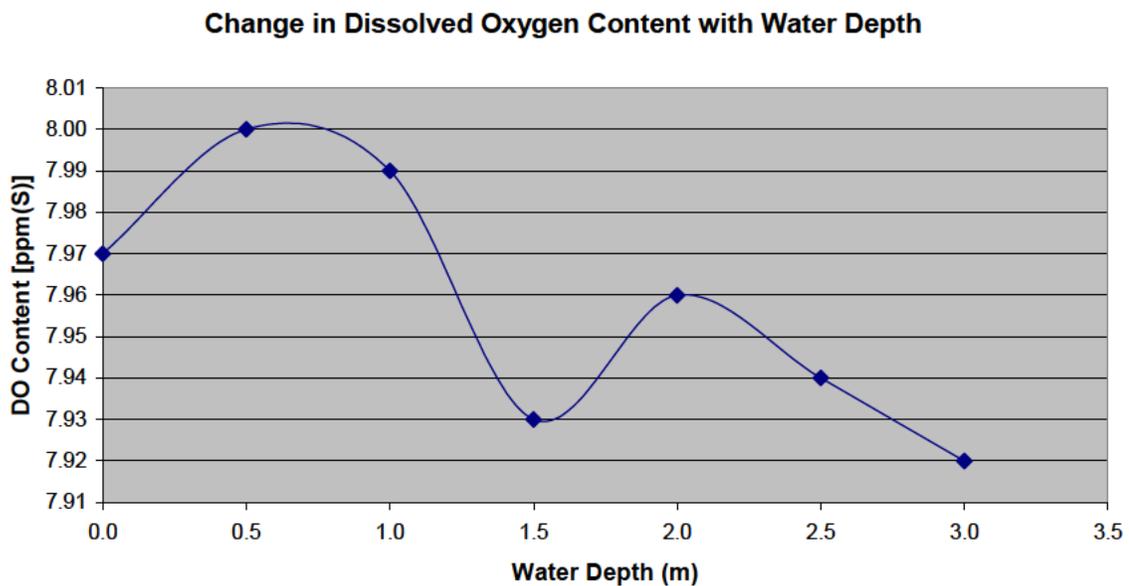
**Figure 11. Change in dissolved oxygen content with increasing water depth measured on the LVT1 site (Richards 2012).**

Similar to the tank sites, the very small standard deviation between the dissolved oxygen measurements and a decrease of only 0.08ppm over 3.0m indicates that there is almost no variation in the dissolved oxygen content with increasing water depth on this shallow site. All measurements are typical for a shallow, near coastal, open circulation, well-mixed oxidising marine environment, where corrosion rates are likely to be relatively high.

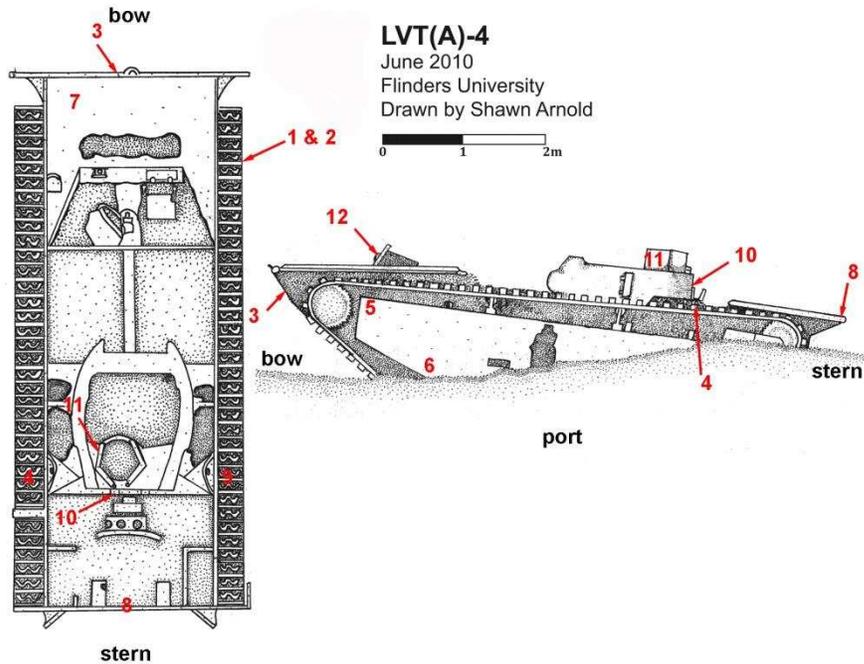
Figure 13. Schematic plan and profile views of the LVT1 indicating the corrosion parameter measurement positions (Richards 2012 after Arnold 2010 in McKinnon and Carrell 2011:118).

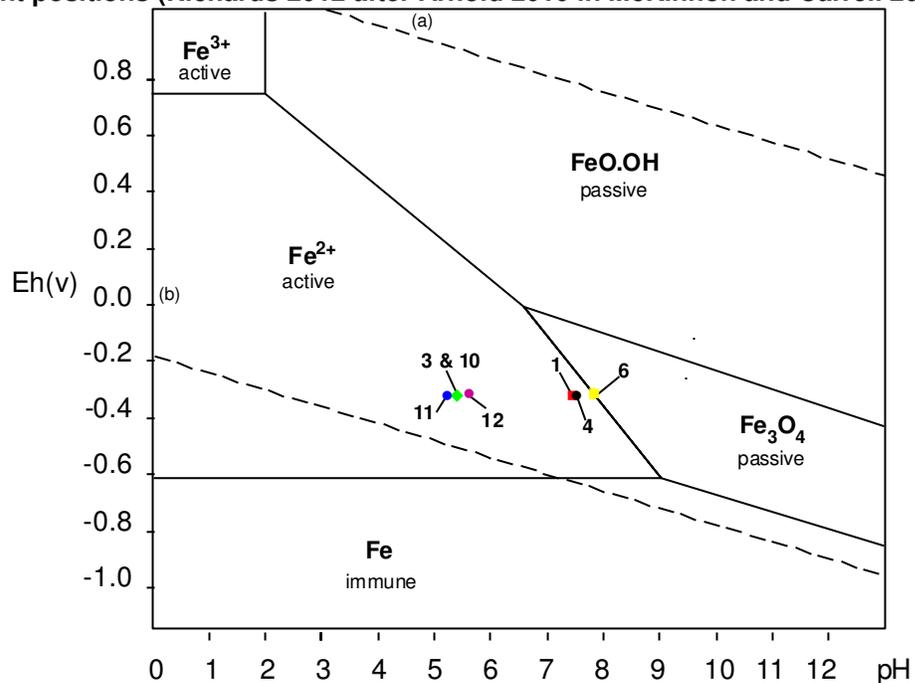
Figure 14. Pourbiax diagram for iron ( $10^{-6}\text{M}$ ) in aerobic seawater at  $25^{\circ}\text{C}$  indicating the intercepts of the areas measured on the LVT1 (Richards 2012).

Generally, the areas measured on LVT1 were covered with relatively thick aerobic concretions (average  $d_{\text{total}} = 18 \pm 7\text{mm}$ ). There were very few secondary colonising organisms on the concretion suggesting that there is a significant amount of water movement on this shallow site and possible sediment impingement during periods of rough sea conditions, which would significantly reduce colonisation rates and increase corrosion rates.

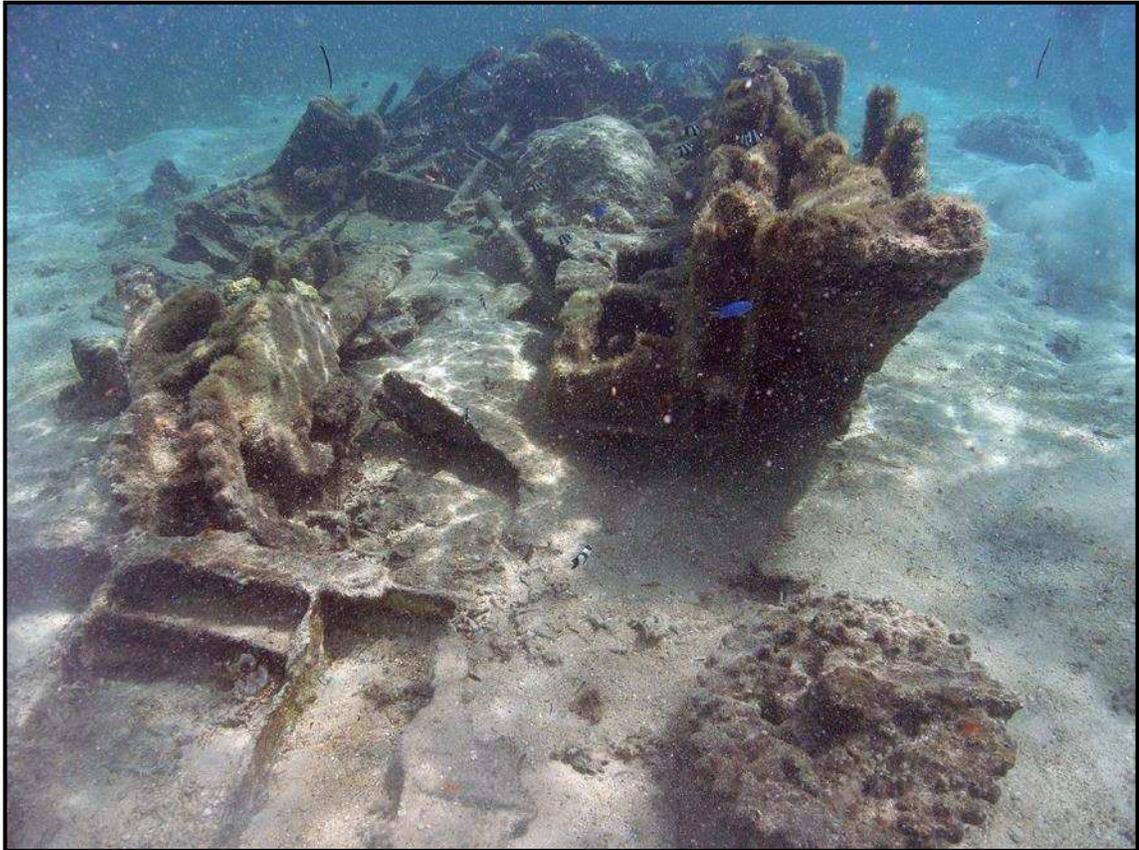
Figure 15. Landing Vehicle Tracked 2 (LVT2) – front view (Carpenter 2012).

Based on the corrosion parameter measurements it is difficult to say whether the LVT2 is corroding at a faster rate than the LVT1 as all average measurements are within their respective statistical errors. However, considering the extent of deterioration of the LVT2 as compared to the LVT1 it would appear that the natural and cultural impacts on the LVT2 would be greater than those experienced by the LVT1.
