# Management Plan and Public Outreach for WWII Submerged Resources in Saipan

Jennifer F. McKinnon and Toni L. Carrell

2014

Grant Agreement No. GA-2255-11-018  
Final Report

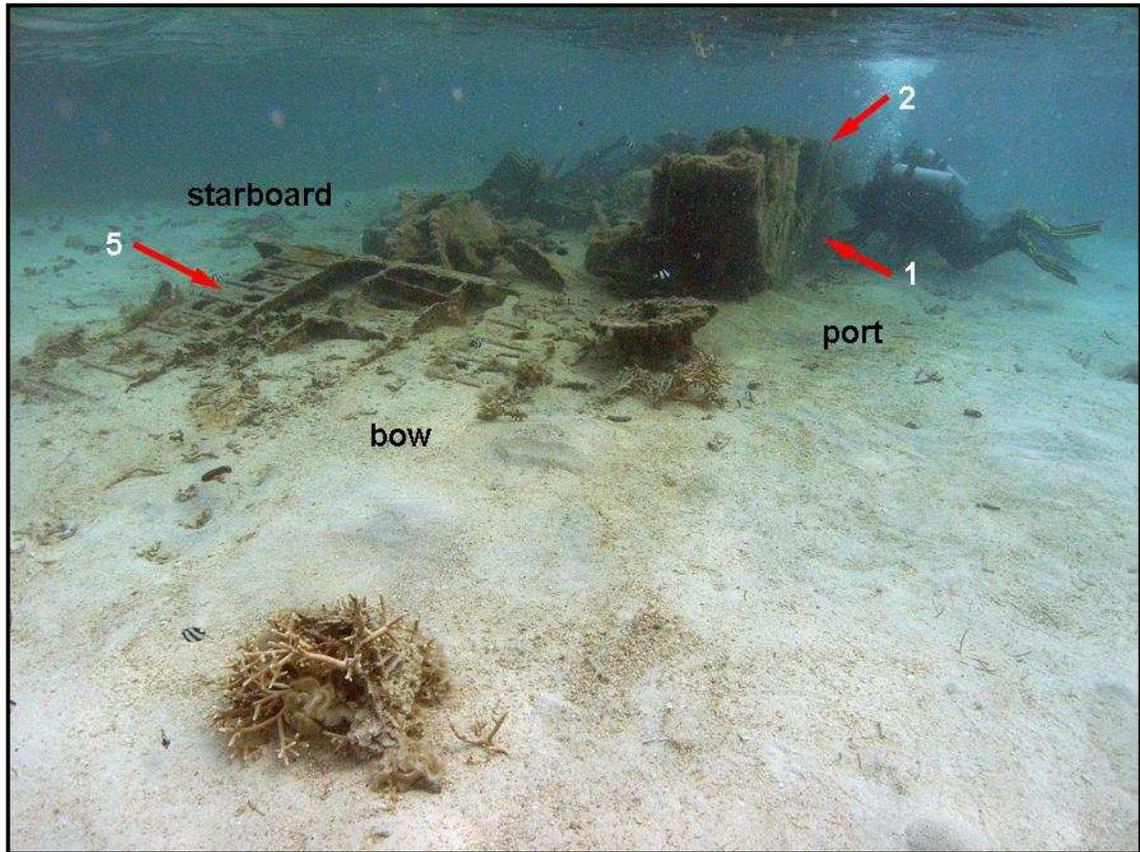
Figure 16. Image indicating the corrosion parameter measurement positions 1, 2 and 5 on the LVT2 (Richards after Carpenter 2012).

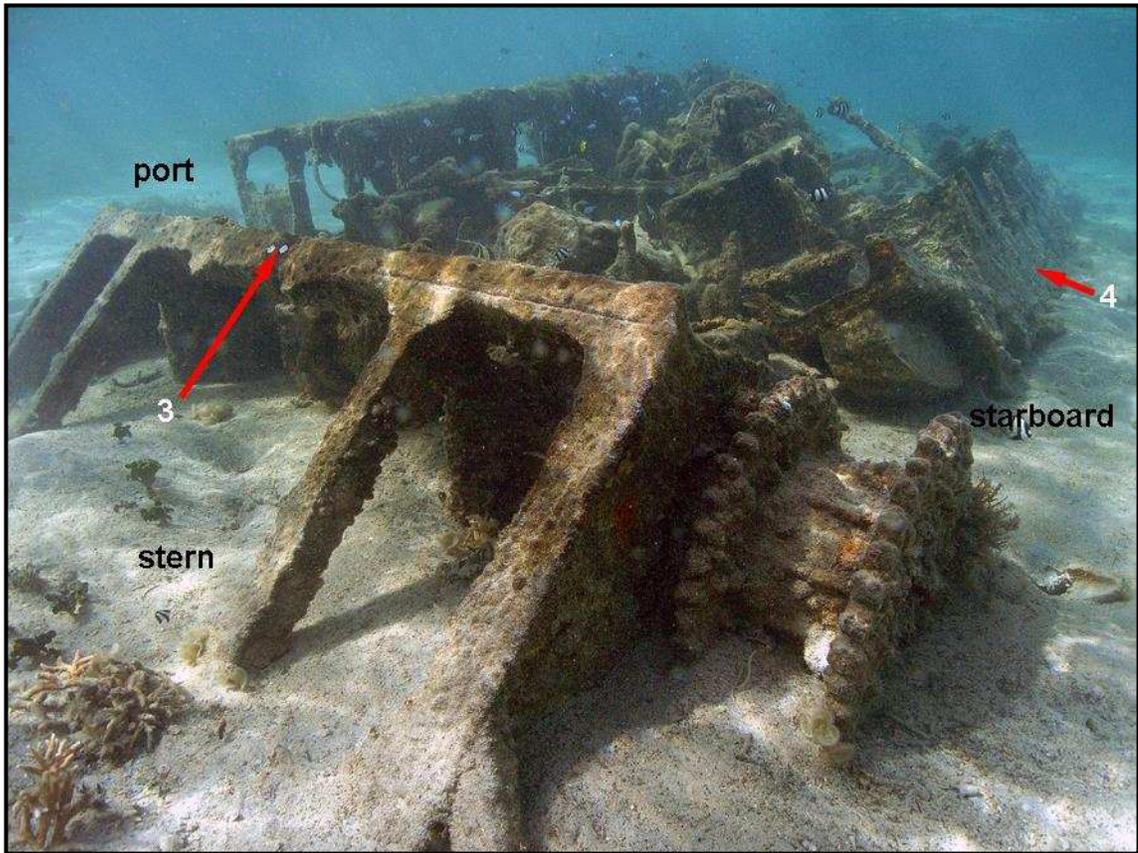
Figure 17. Image indicating the corrosion parameter measurement positions 3 and 4 on the LVT2 (Richards after Carpenter 2012).

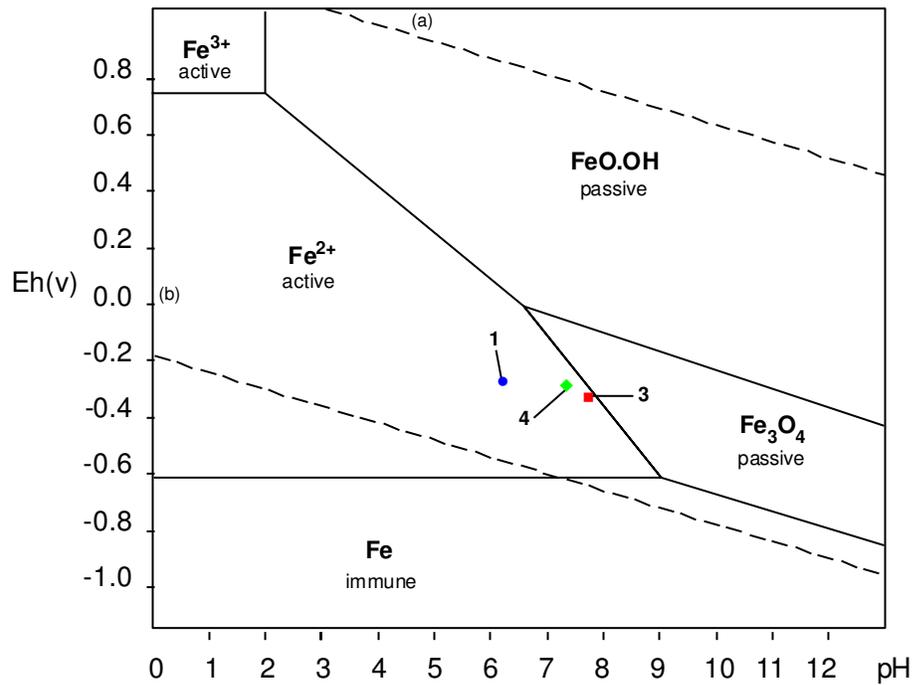
Figure 18. Pourbiax diagram for iron ( $10^{-6}M$ ) in aerobic seawater at 25°C indicating the intercepts of the areas measured on the LVT2 (Richards 2012).

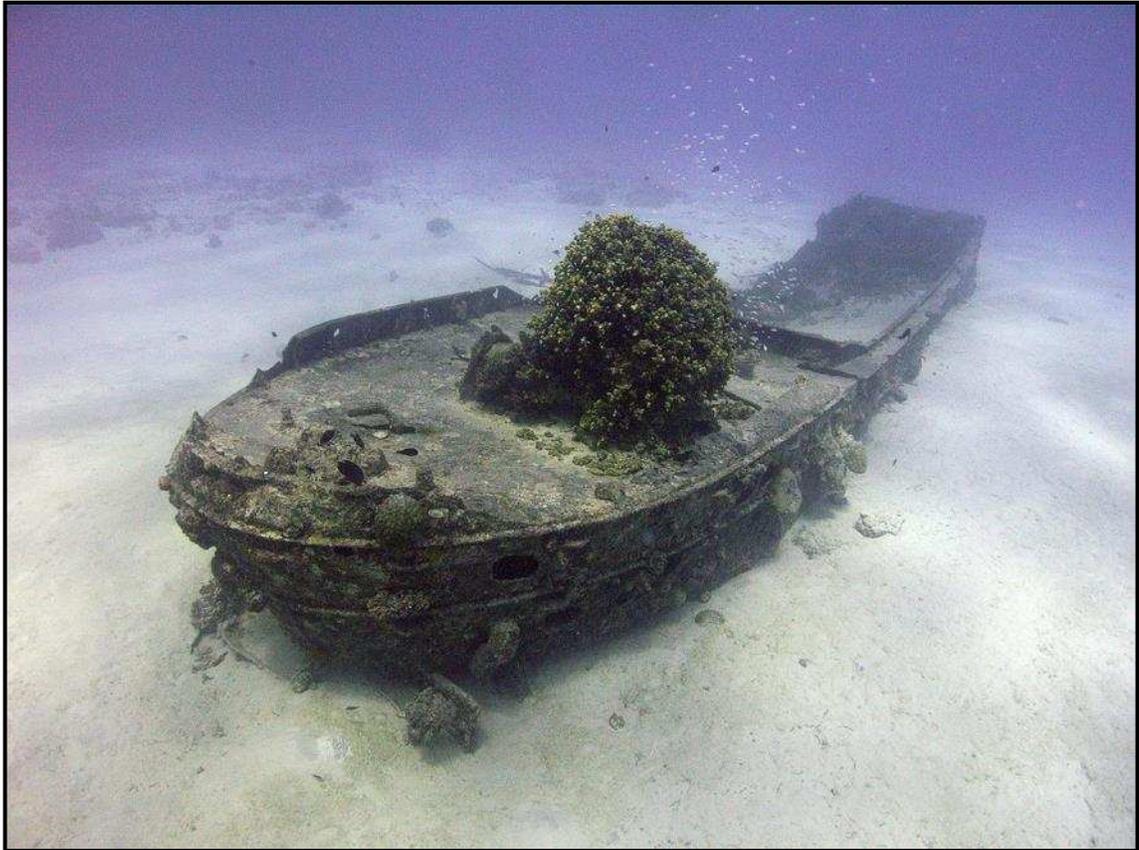
**Figure 19. Daihatsu Landing Craft 1 (DAI1) – stern to bow view (Carpenter 2012).**

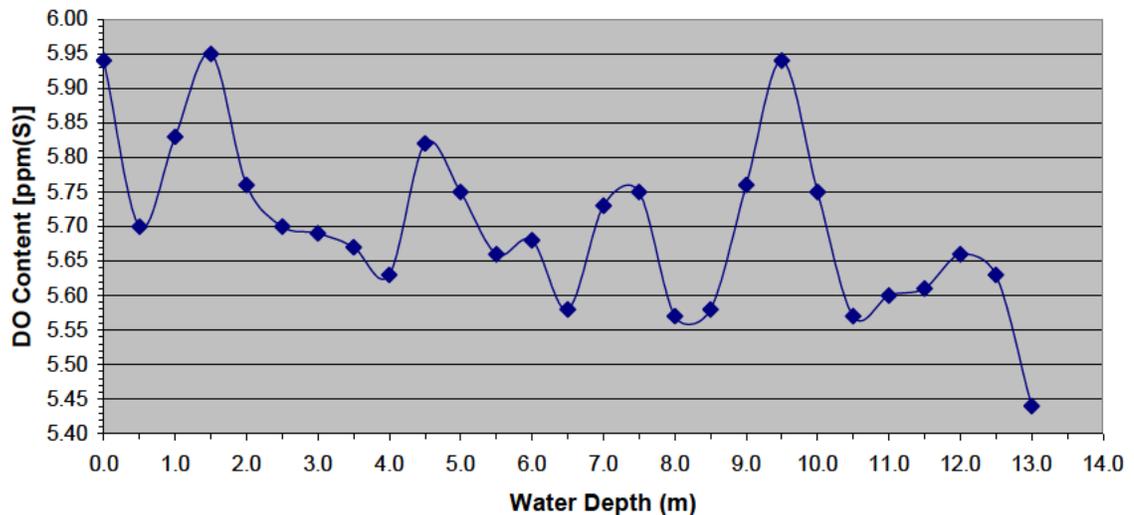
**Figure 20. Change in dissolved oxygen content with increasing water depth measured on the DAI1 and DAI2 sites (Richards 2012).**

For open circulation ocean environments, there is usually a surface maximum in the dissolved oxygen concentration. This maximum is a direct result of absorption from the atmosphere interface, increased water movement and photosynthetic activity by plants and cyanobacteria. Typically, after this surface maximum the dissolved oxygen concentration of the water column will decrease with increasing depth. Factors contributing to this trend are decreasing water movement, which leads to less oxygen exchange with the atmosphere, decreasing photosynthetic activity due to less light penetration and increasing aerobic respiration of plankton in the photosynthetic zone. Despite the variability in the dissolved oxygen measurements, which would indicate a quite dynamic physical environment on this site, the overall trend was decreasing dissolved oxygen content with increasing water depth. This trend coupled with the other physico-chemical measurements, are typical for a shallow, near coastal, dynamic, open circulation, oxidising marine environment, where corrosion rates are likely to be relatively high.

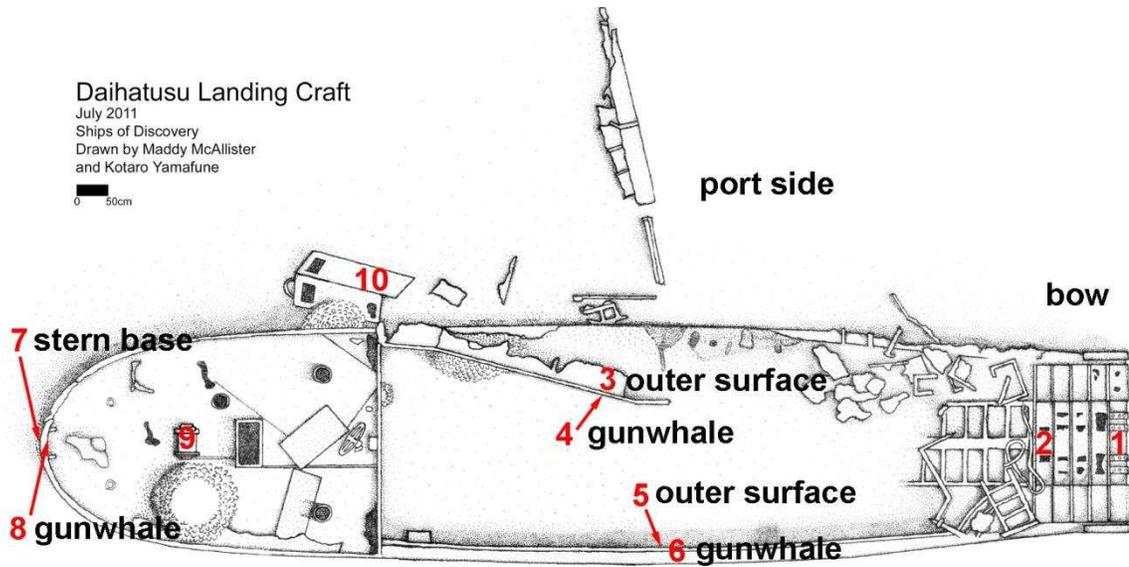
Figure 22. Schematic plan view of the DAI1 indicating the corrosion parameter measurement positions (Richards 2012 after McAllister and Yamafume 2011 in McKinnon and Carrell 2011:94).

Generally, most areas measured on the DAI1 were covered with relatively thin aerobic concretions (average  $9 \pm 7\text{mm}$ ). There were hard corals and more varieties of colonising biota on this wreck compared to the shallower wrecks, such as the LVTs and the tanks, however, the distribution was sporadic suggesting there is still a significant amount of water movement on this site despite the increase in water depth.

It was not possible to discern the interface between the concretion and the corrosion product layers on DAI1 so the depth of corrosion could not be measured, therefore it was not possible to calculate the annualised corrosion rate for this wreck.

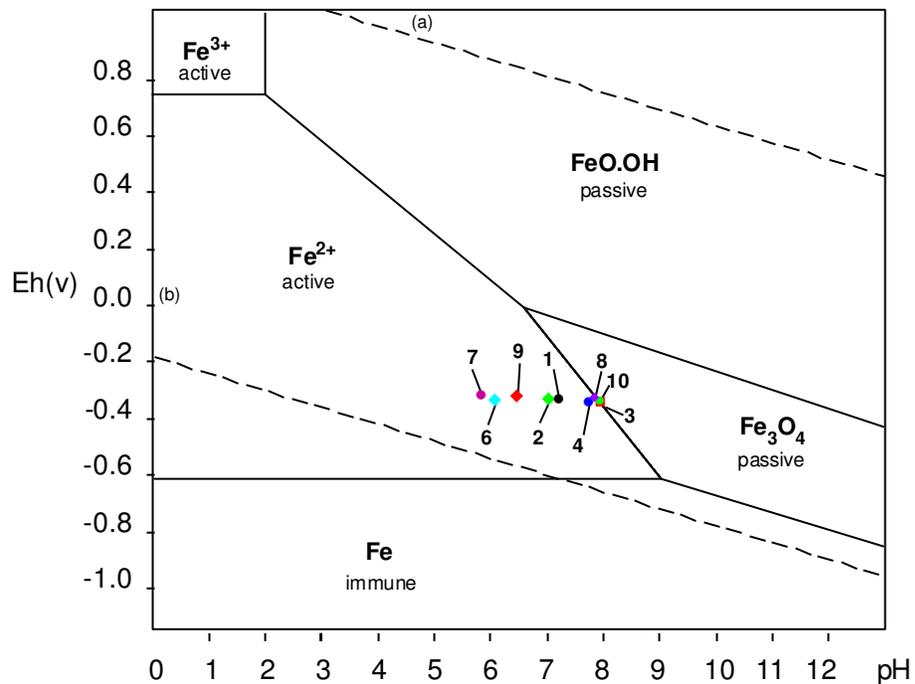
Figure 23. Pourbiac diagram for iron ( $10^{-6}\text{M}$ ) in aerobic seawater at  $25^{\circ}\text{C}$  indicating the intercepts of the areas measured on the DAI1 (Richards 2012).

From the Pourbiac diagram (Figure 23), the intercepts of points 1, 2, 4, 6-9 measured on DAI1, lie in the active corrosion region, where ferrous ions are the thermodynamically stable chemical species and corrosion will continue until all iron is consumed. Positions 3 and 10 lie on the equilibrium line between

active corrosion and the passive region, which implies that the typical aerobic corrosion mechanism where the major stable chemical species is the ferrous ion ( $\text{Fe}^{2+}$ ) is in equilibrium with the formation of an insoluble corrosion product layer of magnetite ( $\text{Fe}_3\text{O}_4$ ). This is a very common corrosion state for large steel ships where a large proportion of the vessel remains are still in electrical contact. No stable voltage could be obtained for position **5** (starboard hull structure, outer surface), which indicates that there was no residual metal remaining in that particular area. Generally, with film free corrosion mechanisms, such as occurs on concreted iron artefacts, an increase in the corrosion potential (tending more positive) indicates an increase in the corrosion of the metal. The average corrosion potential of the nine measurement points was  $-0.334 \pm 0.009\text{V}$ . This 9mV standard deviation is comparatively small and within experimental error for the equipment and measuring procedure suggesting that the entire vessel is in electrical connection and the same film free corrosion mechanism applies to all areas on the DAI1. This very small standard deviation also means that it is not possible to determine any differences in corrosion behaviour between the measurement points based on the  $E_{\text{corr}}$  data.

The pH is often a more reliable indicator of changes in localised corrosion rates. The average pH value for the more acidic areas (**6, 7 & 9**) was  $6.17 \pm 0.32$  and for the more alkaline positions (**1 – 5, 8 & 10**) was  $7.68 \pm 0.36$ . There appeared to be no obvious relationship between water depth and the average pH values as the difference in water depth from the shallowest to the deepest measurement positions was only 1.5m. However, the large difference between the average pH values (1.51) indicates that the more acidic positions are corroding at a faster rate than the more alkaline areas. The greater corrosion rate for position **7**, which is located on the base of the stern section, could be explained by the fact that there may be some form of galvanic coupling occurring between the lower stern area and the engine remains, the propeller shaft and the propellers, which will have different metal compositions (i.e. copper alloy propellers). This form of galvanic corrosion would cause the stern section to corrode preferentially to the other electrically connected parts, hereby increasing the corrosion rate in that area. Isolated iron features tend to possess higher corrosion rates than those experienced on large iron vessel remains, where the current density is dispersed over a much larger surface area. This would explain the increase in the corrosion rate of the windlass, position **9**. More difficult to explain is the increase in the corrosion rate of position **6**, which was on the starboard gunwale, midway along the length of the wreck. However, position **5**, which was directly below position **6**, on the starboard hull was totally corroded with no residual metal remaining. This particular area on the vessel stands upright approximately 1.5m above the sediment level and is not protected by any other sections of the wreck. Hence, the starboard side, as compared to the port side which lies almost level with the seabed and the bow section which is protect inside the hull structure, would be subjected to the full force of the current, which tends to run north-south across the wreck, increasing the amount of oxygen impingement to the concreted metal surface, subsequently increasing the corrosion rate on the starboard side. Most of the more alkaline areas (**1 - 4 & 8**) were measured on the hull remains, which are in electrical connection, dispersing the current density over the entire hull and lowering the overall corrosion rate.

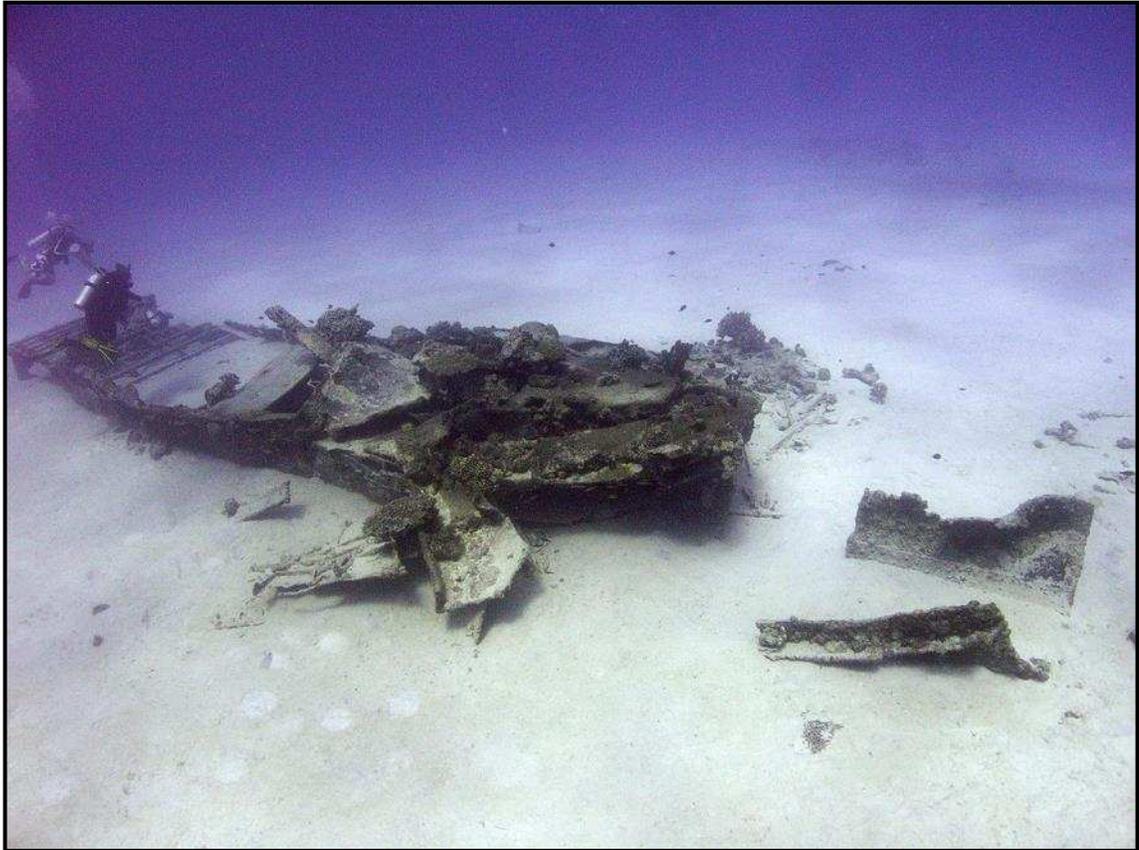
**Figure 24. Daihatsu Landing Craft 2 (DAI2) – port side view (Carpenter 2012).**

The wreck lies on a flat, slightly undulating sandy seabed, comprising of calcareous sediment. The surrounding seabed is relatively devoid of marine biota. The wreck was covered in brown algal forms and some sporadic secondary colonisation was evident (e.g. tunicates, soft and hard corals, seaweed, etc). Isolated hard coralline growths have formed in some places (Figure 24).

The vessel is upright on the seabed and is in poor structural condition. DAI2 is considerably more disarticulated than DAI1. Large sections lie separate, astern of the wreck and substantial remains have collapsed on the port side of the vessel. The engine is missing and presumed salvaged but the rudder and propeller shaft remain *in situ*.

There are some areas of active corrosion evident on the site, indicated by the presence of the typical red/brown “rust” spots on the surface of the vehicle. This DAI2 is included on the WWII Maritime Heritage Trail – Battle of Saipan and divers are actively encouraged to visit the site provided they follow the visitation guidelines and do not interfere with the site (i.e. disturb or attempt to remove any components).

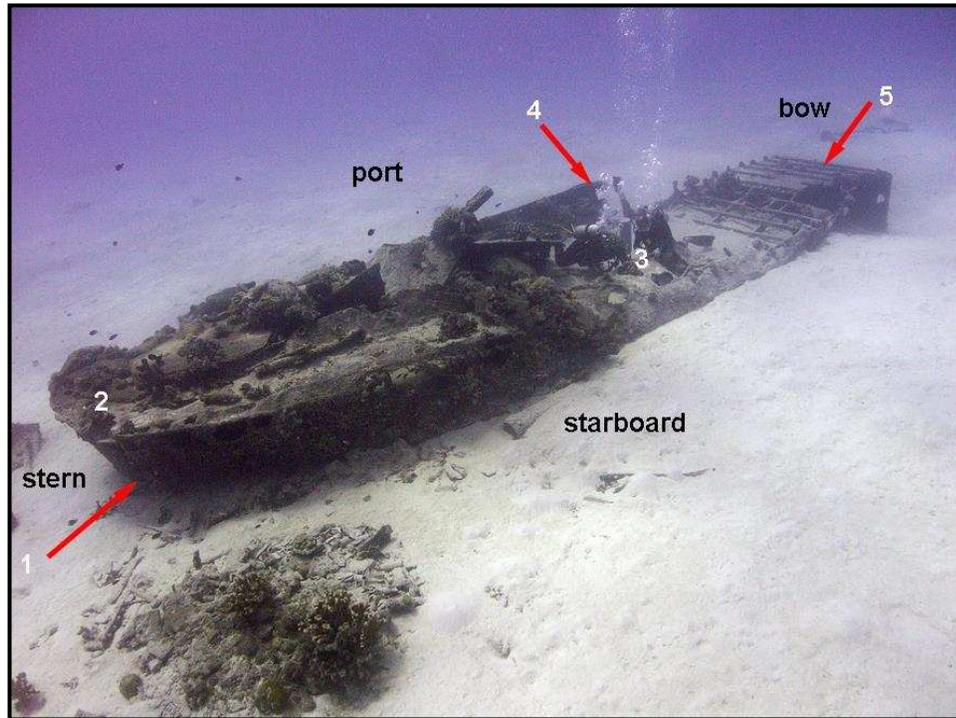
The corrosion parameters of five different areas on the DAI2 were measured over a 56 minute dive on 22 February 2012. The results are presented in Table 11 and the on-site positions shown in Figure 25. In order to compare the corrosion data collected from the different positions measured on the DAI2 and ascertain the thermodynamically stable state of the iron, the corrosion potentials ( $E_{\text{corr}}$ ) and the pH of the residual iron alloy surfaces were plotted on the iron Pourbaix diagram in aerobic seawater at 25°C (Figure 26). The temperature of the seawater on-site was 28°C, however this 3°C increase does not significantly affect the nature or equilibria of the chemical species described in this diagram. Total penetration occurred at position **1** on the base of the stern structure indicating that there was no residual metal remaining in that particular area.

Figure 25. Image indicating the corrosion parameter measurement positions on the DAI2 (Richards after Carpenter 2012).

Some areas measured on the DAI2 were covered with relatively thin aerobic concretions (average 2, 3 & 5 =  $5 \pm 3mm$ ) while positions 1 and 4 had thicker concretions with an average  $d_{total}$  of  $22 \pm 9mm$ . There were hard corals and more varieties of colonising biota on this wreck compared to the shallower

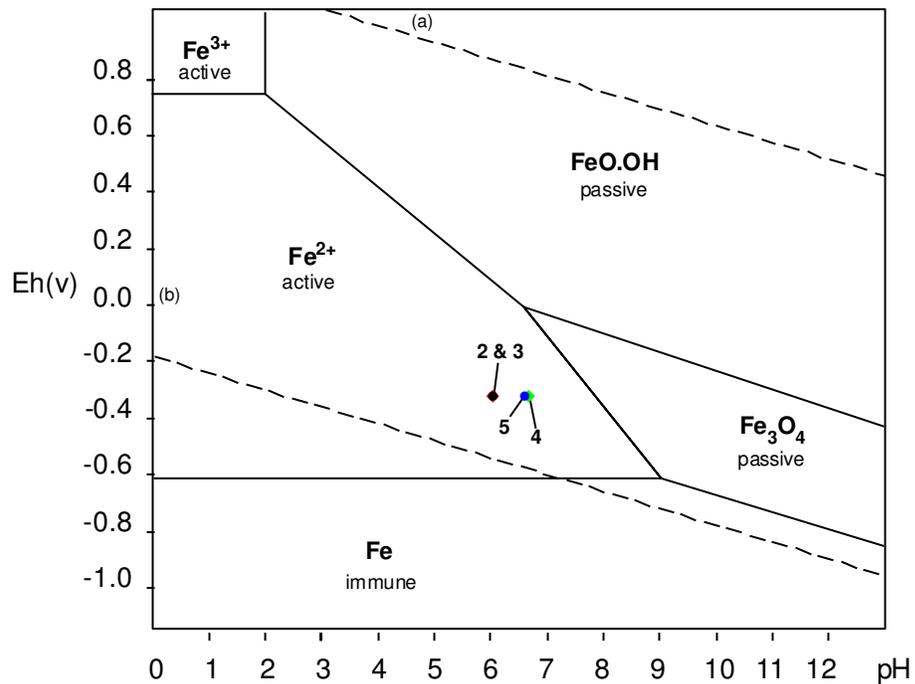
Figure 26. Pourbiax diagram for iron ( $10^{-6}M$ ) in aerobic seawater at  $25^{\circ}C$  indicating the intercepts of the areas measured on the DAI2 (Richards 2012).

From the Pourbaix diagram (Figure 26), the intercepts of points **2** - **5** measured on DAI2, with the exception of position **1** where there was total penetration of the metal and no corrosion parameters could be recorded, lie in the active corrosion region, where ferrous ions are the thermodynamically stable chemical species and corrosion will continue until all iron is consumed. Generally, with film free corrosion mechanisms, such as occurs on concreted iron artefacts, an increase in the corrosion potential (tending more positive) indicates an increase in the corrosion of the metal. The average corrosion potential of the four measurement points was  $-0.325 \pm 0.002\text{V}$ . This 2mV standard deviation is comparatively small and within experimental error for the equipment and measuring procedure suggesting that the entire vessel is in electrical connection and the same film free corrosion mechanism applies to all areas on the DAI2. This very small standard deviation also means that it is not possible to determine any differences in corrosion behaviour between the measurement points based on the  $E_{\text{corr}}$  data.

The pH is often a more reliable indicator of changes in localised corrosion rates. The average pH value for the more acidic areas (**2** & **3**) was  $6.09 \pm 0.00$  and for the more alkaline positions (**4** & **5**) was  $6.68 \pm 0.05$ . There appeared to be no obvious relationship between water depth and the average pH values as the difference in water depth from the shallowest to the deepest measurement positions was only 1.0m. However, the difference between the average pH values of 0.59 indicates that the more acidic positions are corroding at a faster rate than the more alkaline areas. The greater corrosion rate for position **2** (top deck of the stern section) and the total corrosion of position **1** (base of the stern section near the rudder) could be explained by the fact that there may be some form of galvanic coupling occurring between the lower stern area and the propeller shaft, rudder, etc, which will have different metal compositions. This form of galvanic corrosion would cause the stern section to corrode preferentially to the other electrically connected parts, hereby increasing the corrosion rate in that area. The increase in the corrosion rate of position **3** (starboard gunwale) may be due to its higher profile above the seabed, where dissolved oxygen impingement to the concreted gunwale surface will be greater than on more protected, lower profile areas, such as on the bow ramp (**5**) and port gunwale (**4**). However, the fact that the  $d_{\text{total}}$  for position **4** (port gunwale) was 23mm, the thickest of all areas measured during this survey tends to suggest that the more alkaline pH for position **4** may not represent a slower corrosion rate but be due to the port gunwale having almost no residual metal remaining and under these conditions there is no longer the driving force to maintain the lower pH and  $E_{\text{corr}}$  values inside the concretion and the solution slowly equilibrates to those values of the local environment (higher  $E_{\text{corr}}$  and more alkaline pH).

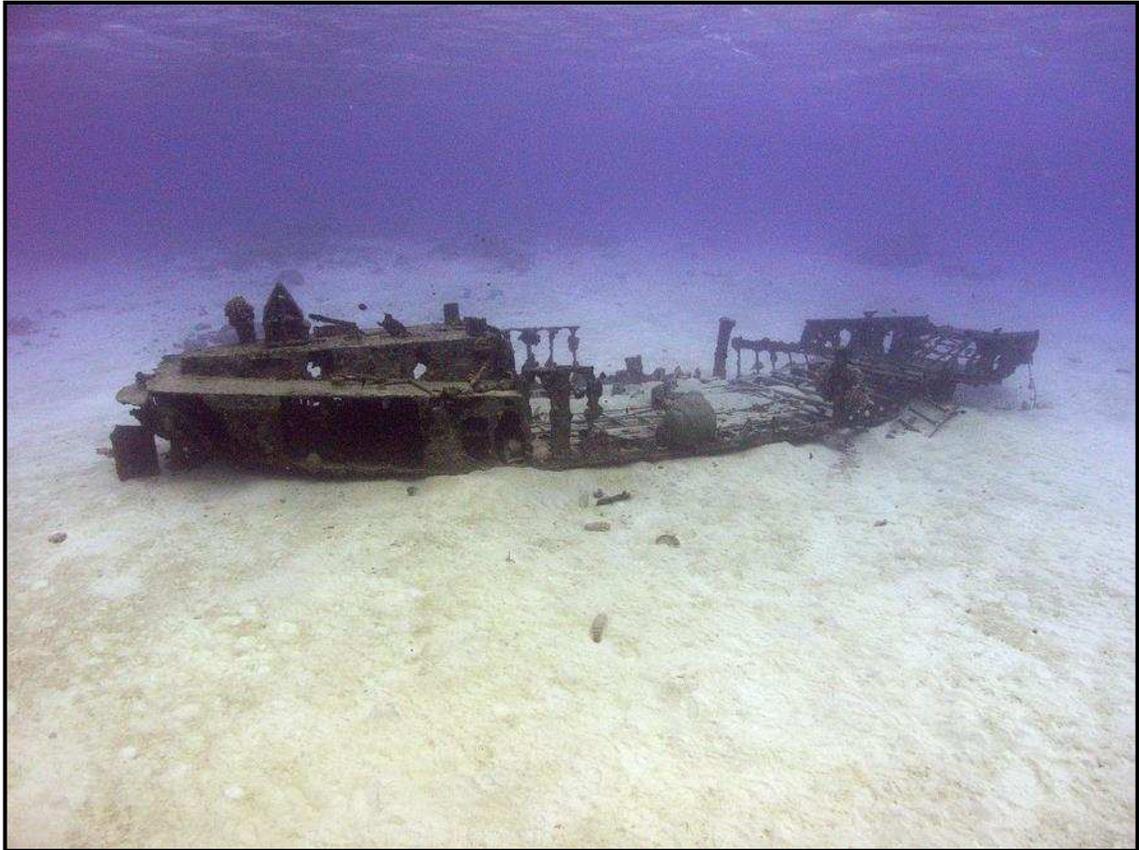
Figure 27. Daihatsu Landing Craft 3 (DAI3) – starboard side view (Carpenter 2012).

The vessel is upright on the seabed and is reasonably intact. The maximum height of the main structure rises approximately 2m above the seabed. Some scouring has occurred around the stern and the rudder and propeller are exposed. Many hull plates are either missing or considerably corroded with significant areas of loss. Most of the port and starboard side hull structure in the midships area has collapsed. The engine room of this vehicle is visible through perforated hull plates. The engine remains *in situ* and is complete with the exhaust system and other associated features and ancillary equipment. For example, a funnel is located in the starboard forward corner of the engine room.

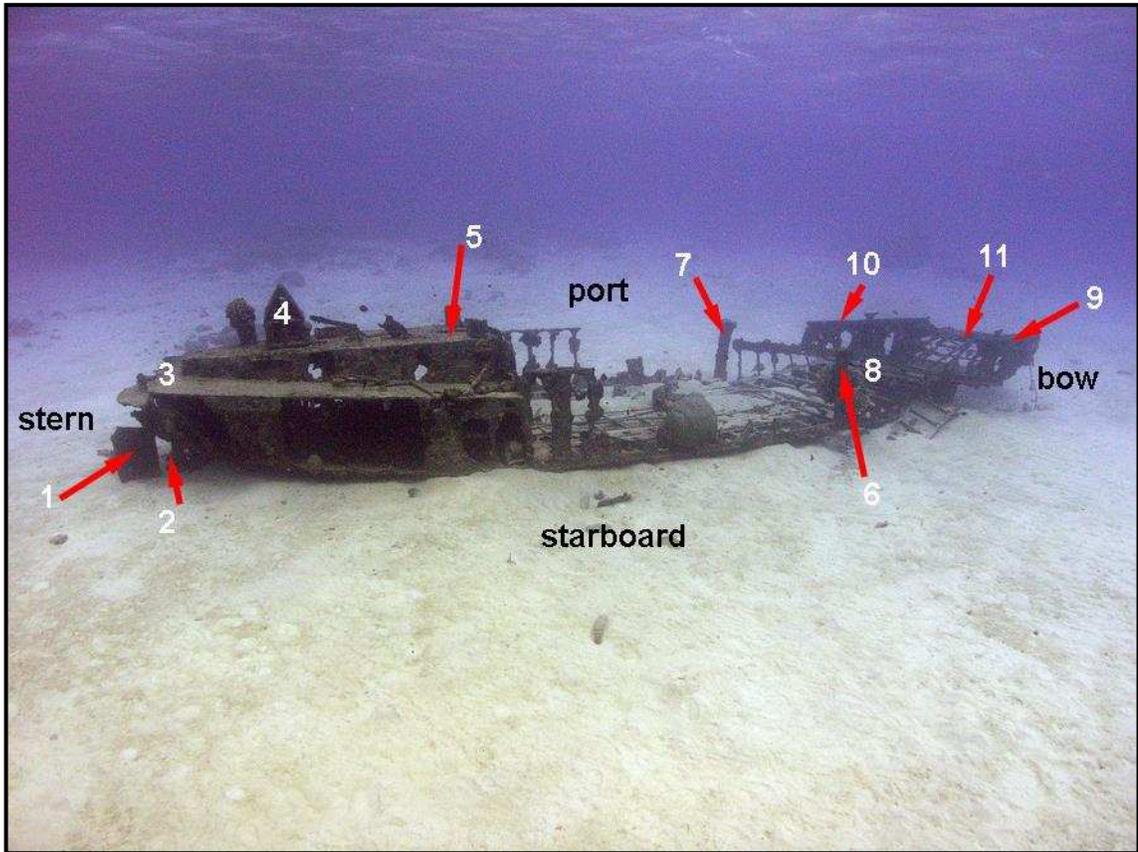
Figure 29. Image indicating the corrosion parameter measurement positions on the DAI3 (Richards after Carpenter 2012).

Generally, the areas measured on the DAI3 were covered with relatively thin aerobic concretions (average  $6 \pm 4\text{mm}$ ). There were more hard corals and more varieties of colonising biota on this wreck compared to the shallower wrecks, such as the LVTs and the tanks, which are subjected to more natural and human interference and the other two Daihatsu landing crafts (DAI1 and DAI2), which were at a depth of about 11m almost twice that of DAI3. This suggests that the DAI3 is subjected to a less aggressive environment however, the distribution of marine biota on the upper surfaces was still sporadic suggesting there is still a significant amount of water movement on this site.

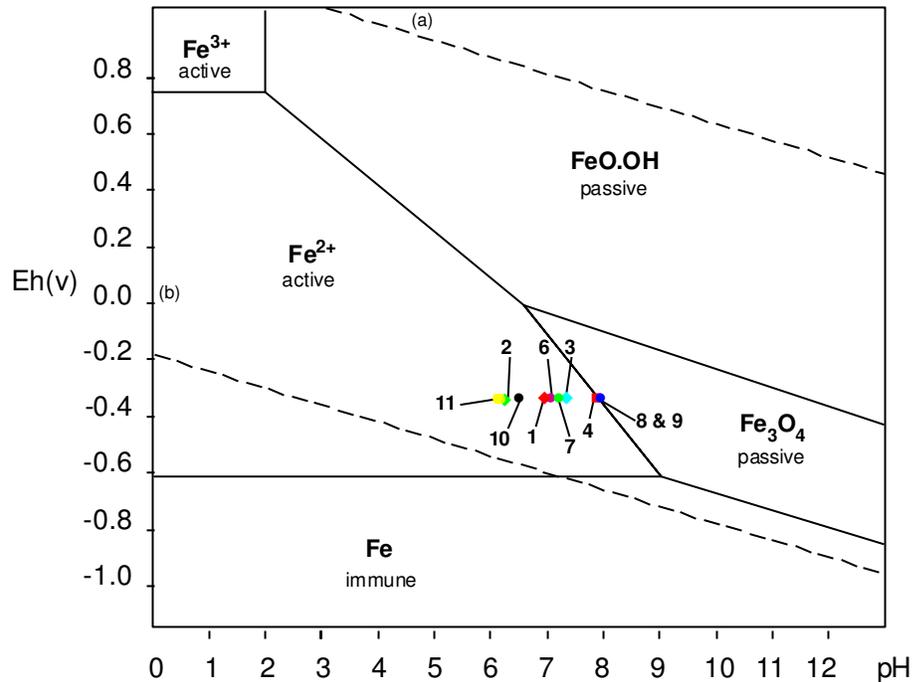
**Figure 30. Pourbaix diagram for iron ( $10^{-6}\text{M}$ ) in aerobic seawater at  $25^\circ\text{C}$  indicating the intercepts of the areas measured on the DAI3 (Richards 2012).**

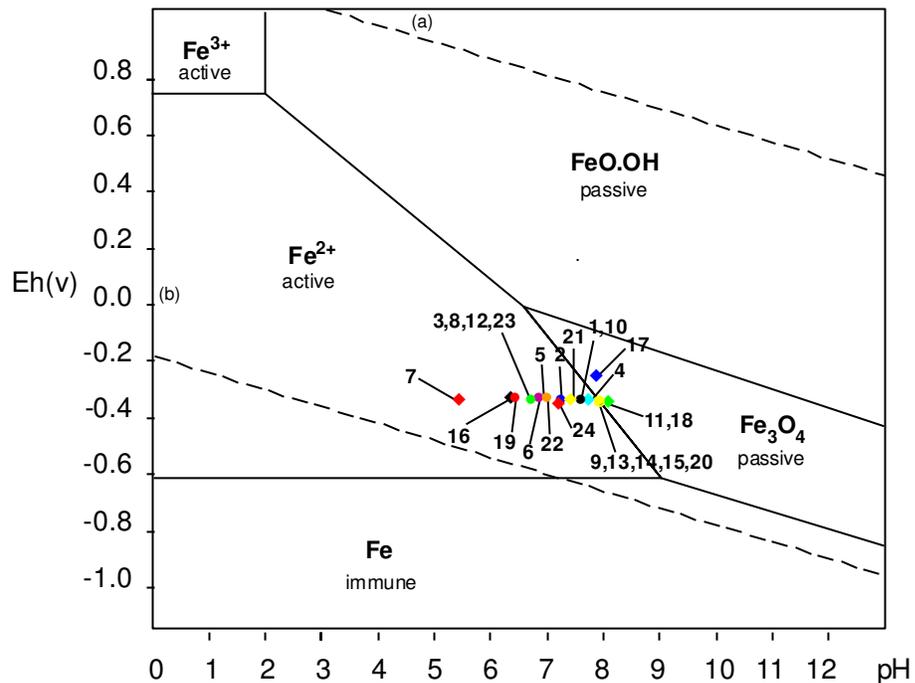
Figure 33. Pourbaix diagram for iron ( $10^{-6}M$ ) in aerobic seawater at 25°C indicating the intercepts of the areas measured on the JFR site (Richards 2012).

Due to the thinner nature of the concrete and corrosion product layers on the JFR ( $5 \pm 4\text{mm}$ ), it was possible to discern the interface between the concrete and the corrosion product layer on many of the measurement positions so the depth of corrosion ( $d_c$ ) was measured at about  $2 \pm 1\text{mm}$ . It should be noted that the  $d_c$  measurements are not extremely accurate and the subsequent calculated annualised corrosion rates should only be treated as approximations. If we assume that the JFR was sunk in 1944 then it has been immersed for 68 years at the time of this corrosion survey. Therefore the calculated annualised corrosion rate was  $0.03 \pm 0.01\text{mm}^{-1}$  which is about a third of the average long-term corrosion rate for isolated iron in aerobic seawater at  $0.11\text{mm}^{-1}$ . This lower corrosion rate is not unexpected as the corrosion parameter measurements indicate that most of the structural remains on this very large vessel (about 125m in length) are in electrical connection, dispersing the current density over the entire hull thus lowering the overall corrosion rate.

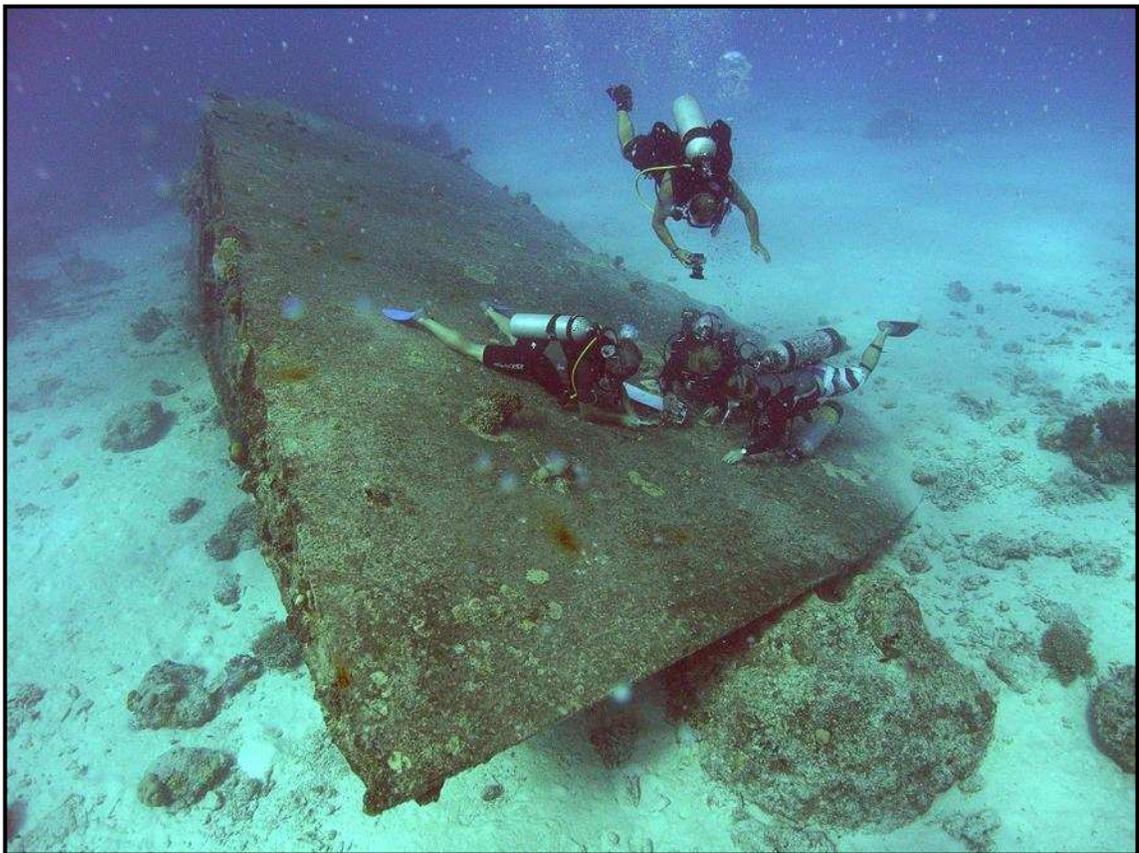
Figure 34. Auxiliary Submarine Chaser (ASC) – bow view (Carpenter 2012).

The vessel lies on its starboard side with approximately 12m of the bow section is still intact (Figure 34). The remainder of the hull structure has collapsed. The aft hull structure, stern, propeller, propeller shaft, engines and ancillary equipment all appear to be missing. A small anchor, probably originally stored on the deck, judging by its present location, appears to be in reasonable condition and state of preservation. Most notably were some munitions lying inside the midships structure. The disarticulated nature and missing features could be the result of post-war salvage and clean-up and possible explosive training operations (McKinnon and Carrell 2011:47).

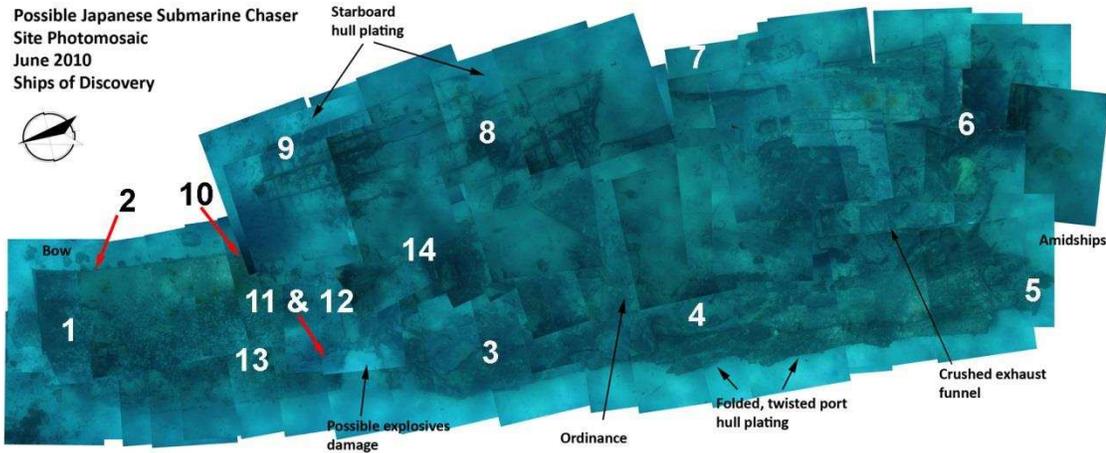
**Figure 36. Photomosaic indicating the corrosion parameter measurement positions on the ASC (Richards after McKinnon and Carrell 2011:49).**

Generally, the areas measured on the ASC were covered with relatively thin aerobic concretions (average  $6 \pm 7\text{mm}$ ). There were more hard corals on this wreck compared to the shallower wrecks, such as the LVTs and the tanks, which are subjected to more natural and human interference but possessed similar growth densities as was evident on the DAI1 and DAI2 sites (11m), suggesting there is a significant amount of water movement on this site despite the increase in water depth (10m).

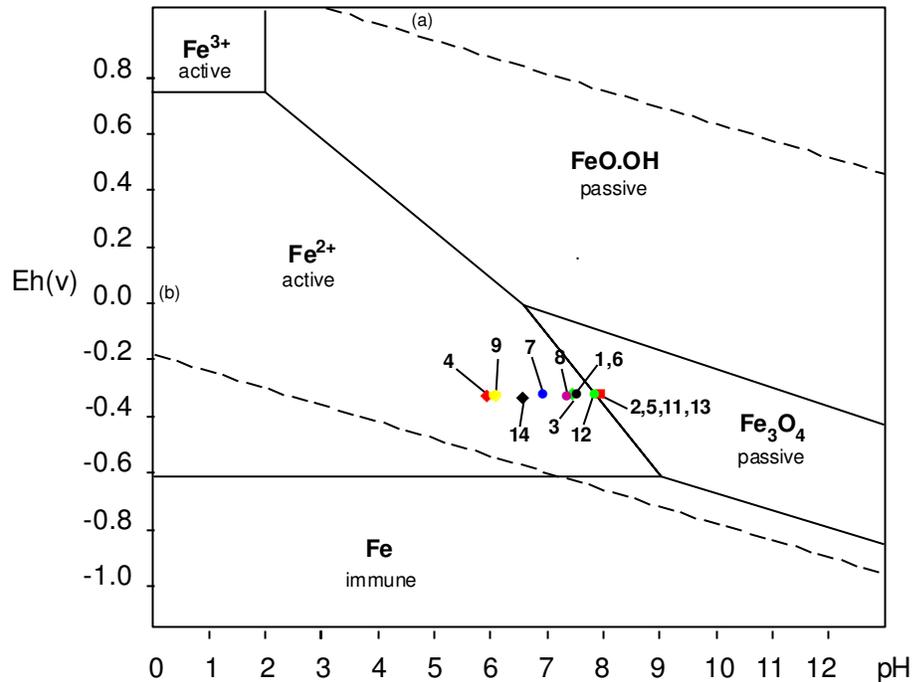
From the Pourbaix diagram (Figure 37), the intercepts of points **1, 3, 4, 6-9, 14** measured on the ASC, lie in the active corrosion region, where ferrous ions are the thermodynamically stable chemical species and corrosion will continue until all iron is consumed. Positions **2, 5, 11-13** lie on the equilibrium line between active corrosion and the passive region, which implies that the typical aerobic corrosion mechanism where the major stable chemical species is the ferrous ion ( $\text{Fe}^{2+}$ ) is in equilibrium with the formation of an insoluble corrosion product layer of magnetite ( $\text{Fe}_3\text{O}_4$ ). This is a very common corrosion state for large steel ships where a large proportion of the vessel remains are still in electrical contact. No corrosion parameters could be measured for position **10**, where total penetration of the metal occurred. Generally, with film free corrosion mechanisms, such as occurs on concreted iron artefacts, an increase in the corrosion potential (tending more positive) indicates an increase in the corrosion of the metal. The average corrosion potential of the thirteen measurement points was  $-0.327 \pm 0.004\text{V}$ . This 4mV standard deviation is comparatively small and within experimental error for the equipment and measuring procedure suggesting that the entire vessel is in electrical connection and the same film free corrosion mechanism applies to all areas on the ASC. This very small standard deviation also means that it is not possible to determine any differences in corrosion behaviour between the measurement points based on the  $E_{\text{corr}}$  data.

**Figure 37. Pourbaix diagram for iron ( $10^{-6}M$ ) in aerobic seawater at  $25^{\circ}C$  indicating the intercepts of the areas measured on the ASC site (Richards 2012).**

The pH is often a more reliable indicator of changes in localised corrosion rates. Similar to the JFR the measurement positions from the Pourbaix diagram were separated in cluster groups based on their pH values. Again, there appeared to be no obvious relationship between water depth and the average pH values of the different groups as the difference in water depth from the shallowest to the deepest measurement positions was only 3.1m. Positions **4** and **9** had the most acidic average pH value at  $6.02 \pm 0.08$  indicating the highest corrosion rate. Position **4** was on the upper surface of the port side hull structure, where there was extensive explosive damage and position **9** was an isolated hull plate on the collapsed starboard side of the wreck. Similarly, position **10**, which had totally corroded was located on the deck next to the broken end of the bow section where increases in micro-structural stress of the metal would lead to concomitant increases in corrosion rate. Positions **14**, a stanchion and **9**, a box both located midway along the site possessed the next most acidic pH values at 6.58 and 6.95 respectively. These were also isolated iron features and as such will corrode at a faster rate than positions that are in electrical connection over a larger surface area (i.e. the hull structure). For example, positions **1**, **3** and **6**, which were on the hull structure and position **8**, which was an anchor lying in direct contact with the collapsed starboard hull plates lying flat on the seabed surface and was hence, in a more protected area had a more alkaline average pH value of  $7.48 \pm 0.08$ , indicating a lower corrosion rate than the previously mentioned positions. Similarly, positions **2**, **5**, **11-13** were all part of the hull structure in relatively protected areas and possessed the most alkaline average pH value of  $7.97 \pm 0.06$  indicating the lowest corrosion rate. In addition, generally it appears that the starboard side is corroding at a slightly elevated rate compared to the port side, which would be a reflection of the increased damage, disarticulation and collapse on this side of the vessel.

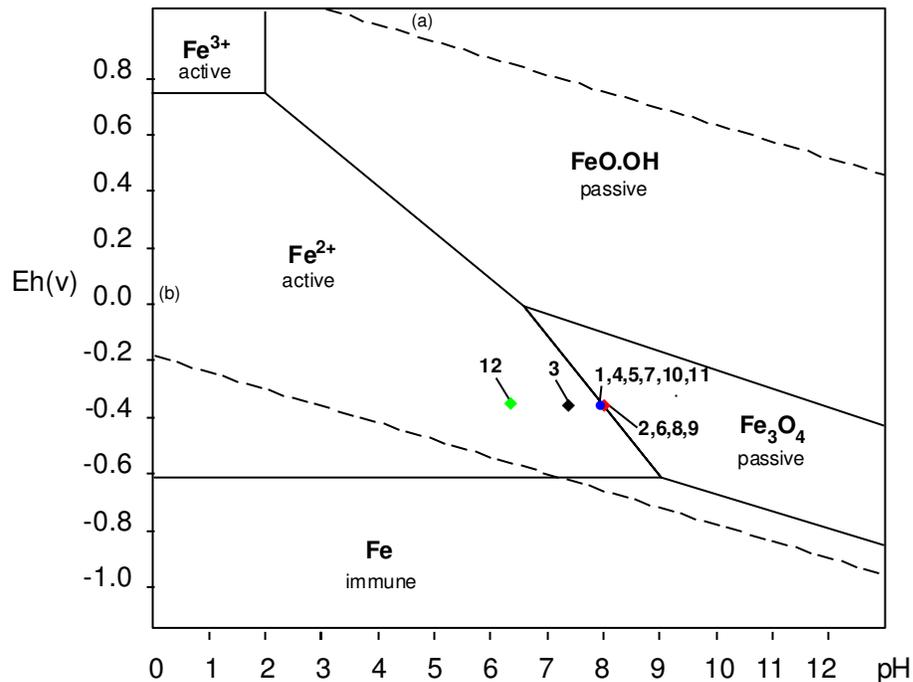
Figure 40. Pourbaix diagram for iron ( $10^{-6}M$ ) in aerobic seawater at  $25^{\circ}C$  indicating the intercepts of the areas measured on the SS site (Richards 2012).

Generally, the areas measured on the SS were covered with relatively thin aerobic concretions (average  $4 \pm 3mm$ ). There appeared to be less hard corals on this wreck compared to the other wrecks and this is probably a reflection of the increased turbidity on the site restricting secondary marine growth.

From the Pourbaix diagram (Figure 40), the intercepts of points **1, 2, 4-11** measured on the SS, lie on the equilibrium line between active corrosion and the passive region, which implies that the typical aerobic corrosion mechanism where the major stable chemical species is the ferrous ion ( $Fe^{2+}$ ) is in equilibrium with the formation of an insoluble corrosion product layer of magnetite ( $Fe_3O_4$ ). This is a very common corrosion state for large steel ships where a large proportion of the vessel remains are still in electrical contact. The intercepts of position **3** (water tank 2) and position **12** (anchor) lie in the active corrosion zone where ferrous ions are the thermodynamically stable chemical species and

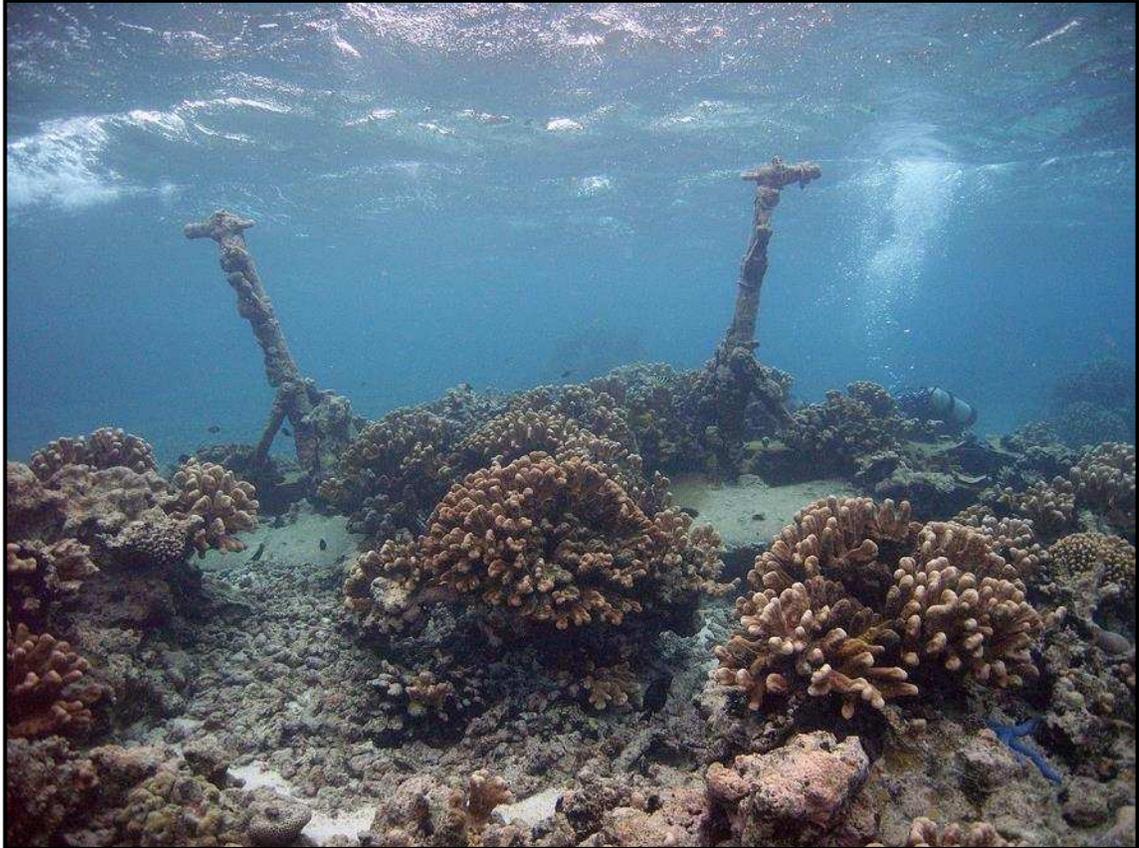
Figure 41. Grumman TBM Avenger (AVR) (Carpenter 2012).

The aircraft remains lie inverted and consist principally of the central area between the prominent wheel struts and the incomplete remains of the main wings. The engine and propeller are absent. The aluminium skin of the wings is corroded and has a number of irregular holes and smaller perforations. There is a disconnected gun turret ring about 20-40m north of the main site. The wheel-well openings remain discernable and the fuselage wreckage is covered in very dense coralline growth. The body and tail plane of the aircraft are also absent. The condition of the aluminium alloy is poor in comparison with those aircraft wrecks located on sandy sediments in calmer areas of the lagoon.

Overall damage to the aircraft structure is not readily distinguishable between crash, storm or potential war damage. The site is shallow (3m) and its reef top position means that it must be affected by turbulent seas generated by storms and cyclones. McKinnon and Carrell (2011) mention that the local surfers use the protruding landing gear as boat moorings and bright, bare aluminium surfaces are evident suggesting some form of interference in these areas. This aircraft is included in the WWII Maritime Heritage Trail – Battle of Saipan and lies within a Marine Conservation Area. Divers and snorkelers are actively encouraged to visit the site provided they follow the local visitation guidelines and do not interfere with the site (i.e. disturb or attempt to remove any cultural or natural components).

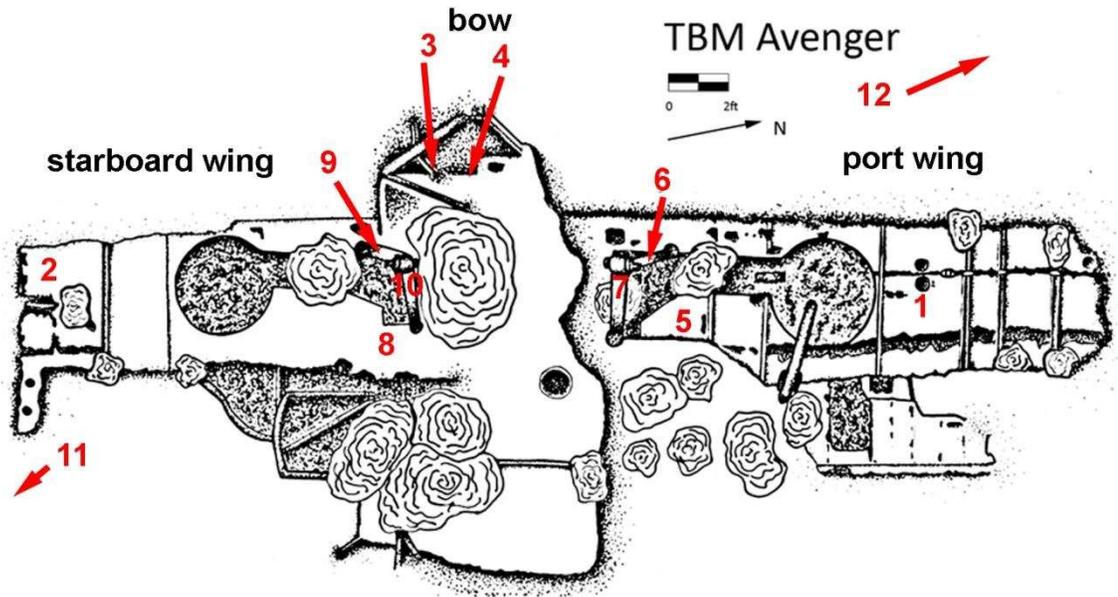
Figure 44. Schematic plan of the TBM Avenger (AVR) indicating the corrosion parameter measurement positions (Richards 2012 after Bell 2010 in McKinnon and Carrell 2011:89).

The corrosion parameters of twelve different areas on the AVR were measured over a 54 minute dive on 20 February 2012. The results are presented in Table 21 and the on-site positions shown in Figure 44. In order to compare the corrosion data collected from the different positions measured on the AVR and ascertain the thermodynamically stable state of the aluminium, the corrosion potentials ( $E_{\text{corr}}$ ) and the pH of the residual aluminium alloy surfaces were plotted on the aluminium Pourbaix diagram in aerobic seawater at 25°C (Figure 45). The temperature of the seawater on-site was 28°C, however this 3°C increase does not significantly affect the nature or equilibria of the chemical species described in this diagram.
