# Management Plan and Public Outreach for WWII Submerged Resources in Saipan

Jennifer F. McKinnon and Toni L. Carrell

2014

Grant Agreement No. GA-2255-11-018  
Final Report

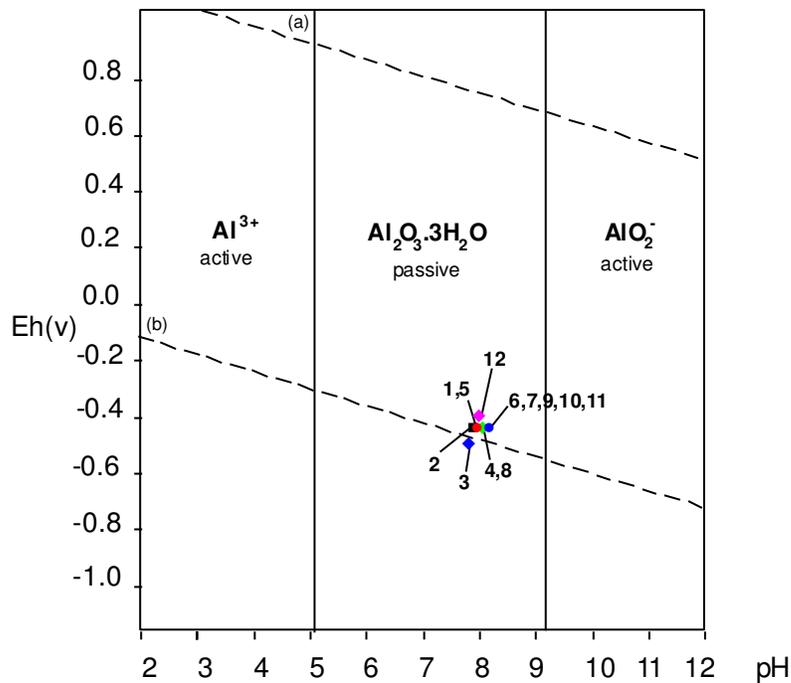
Figure 45. Pourbiax diagram for aluminium ( $3.7 \times 10^{-6} \text{M}$ ) in aerobic seawater at  $25^\circ\text{C}$  indicating the intercepts of the areas measured on the AVR site (Richards 2012).

Generally, the areas measured on the AVR were covered with a very thin (<1mm) mucilaginous layer consisting of proteinaceous and algal based material in combination with hydrated aluminium hydroxide gels. Hence measurements of total depth of concretion and corrosion products ( $d_{\text{total}}$ ) are not applicable for aluminium alloy aircraft. On some areas of the aircraft patches of blue corrosion products, typical of hydrated oxidised copper corrosion products, were observed, indicating the use of a copper - aluminium alloy, such as Duralumin in these areas.

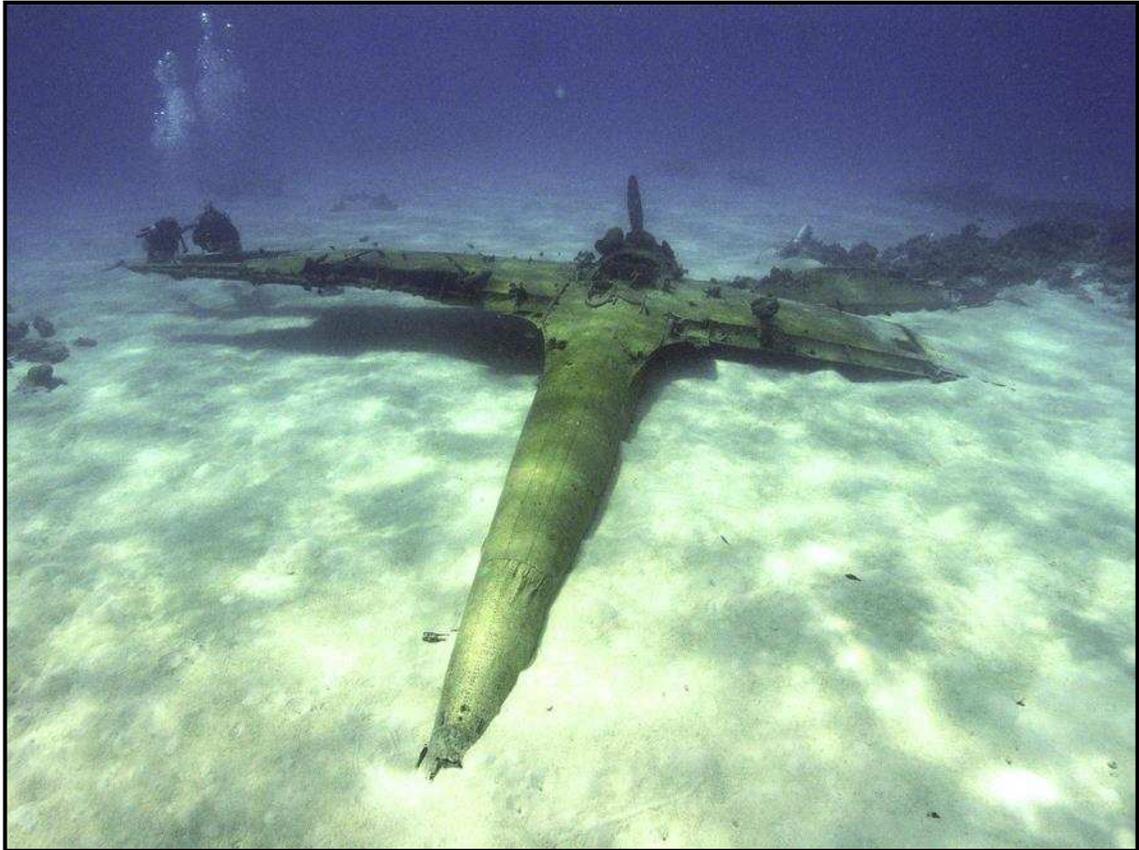
**Figure 46. Aichi E13A (JAKE) (Carpenter 2012).**

The aircraft is relatively intact lying inverted on the seabed. The aircraft is listing to port with the end of the port wing buried in the surrounding sediment and the starboard wing rising above the seabed with no support. One of the two floats is absent the other lies in close proximity to the port wing (Figure 46). The aircraft structures and components, although damaged remain in relatively good condition and still retain strength and resilience as attested by the unsupported starboard wing. A structure with wheels is located a short distance from the tail of the aircraft but does not appear to be associated with the aircraft (McKinnon and Carrell 2011:55).

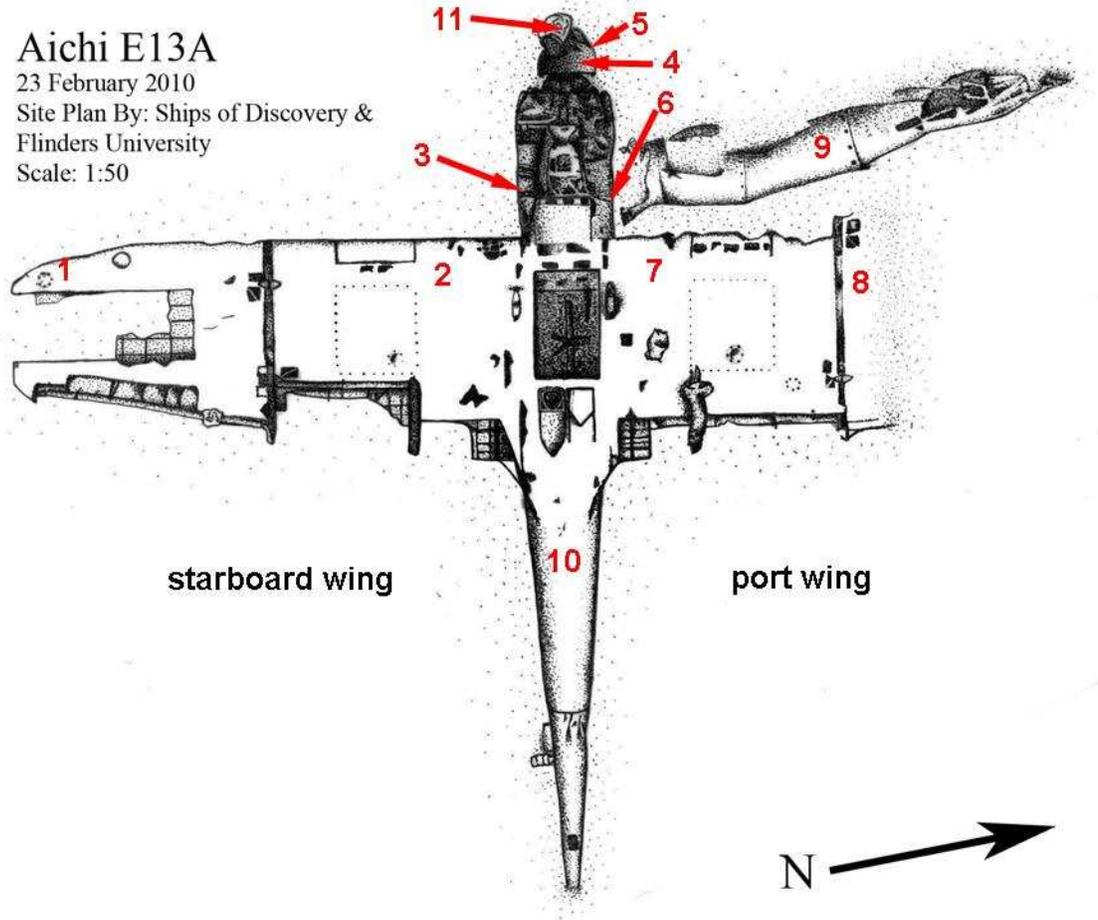
Figure 48. Schematic plan of the Aichi E13A (JAKE) indicating the corrosion parameter measurement positions (Richards 2012 after Bell 2010 in McKinnon and Carrell 2011:56).

The corrosion parameters of eleven different areas on the JAKE were measured over a 44 minute dive on 20 February 2012. The results are presented in Table 23 and the on-site positions shown in Figure 48. In order to compare the corrosion data collected from the different positions measured on the JAKE and ascertain the thermodynamically stable state of the aluminium, the corrosion potentials ( $E_{\text{corr}}$ ) and the pH of the residual aluminium alloy surfaces were plotted on the aluminium Pourbaix diagram in aerobic seawater at 25°C (Figure 49). The temperature of the seawater on-site was 28°C, however this 3°C increase does not significantly affect the nature or equilibria of the chemical species described in this diagram.

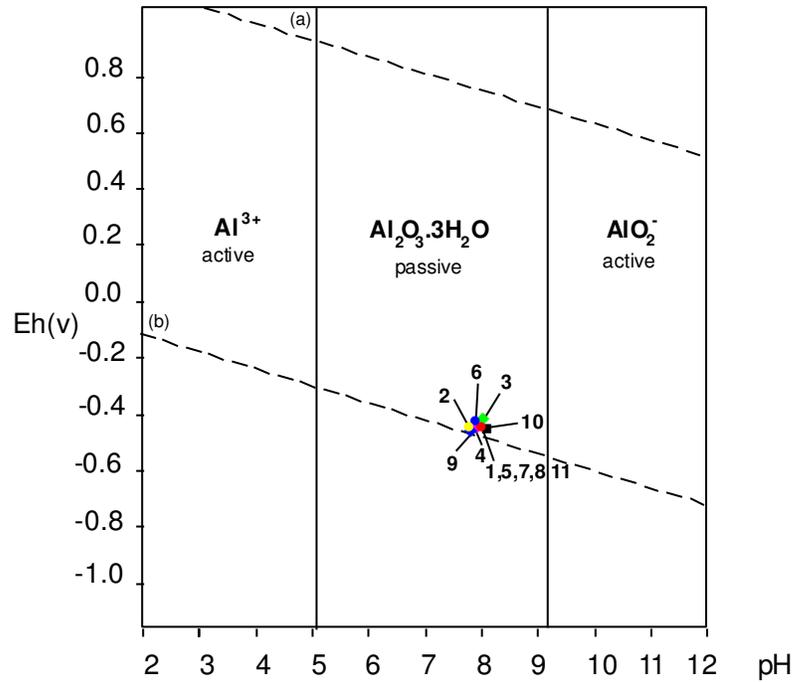
### **Figure 49. Pourbaix diagram for aluminium ( $3.7 \times 10^{-6}\text{M}$ ) in aerobic seawater at $25^\circ\text{C}$ indicating the intercepts of the areas measured on the JAKE site (Richards 2012).**

From the Pourbaix diagram (Figure 49), the intercepts of all points measured on the JAKE, lie in the passive region, where  $\text{Al}_2\text{O}_3 \cdot 3\text{H}_2\text{O}$  is the dominant corrosion product (Equation 2) and forms a continuous passivating layer, effectively slowing the corrosion rate. This is a very common corrosion state for aluminium alloy aircraft in marine environments.

The  $E_{\text{corr}}$  values of eight of the eleven measurement positions, namely **1, 2, 4, 5, 7, 8, 10** and **11** all fall into the average corrosion potential range of  $-0.446 \pm 0.003\text{V}$  indicating that the metal composition of the wings, aft fuselage, propellers and boss head are very similar. Positions **3** and **6**, measured on forward part of the fuselage, had an average  $E_{\text{corr}}$  of  $-0.424 \pm 0.002\text{V}$ , which is 22mV more positive than the other areas, indicating that this section is corroding at a slightly slower rate. This would not be unexpected as this area of the fuselage is in direct electrical contact with what appears to be machinery associated with the engine, where there would be more contact with iron, copper and other less reactive metals concomitantly lowering the overall corrosion rate in this area. Position **9**, which was the disarticulated float, possessed the most negative  $E_{\text{corr}}$  equal to  $-0.463\text{V}$  and the most acidic pH value of 7.83, indicating the aluminium alloy composition of the float is different to the rest of the aircraft and contains less copper and more aluminium making the corrosion potential more anodic and hence, more reactive.

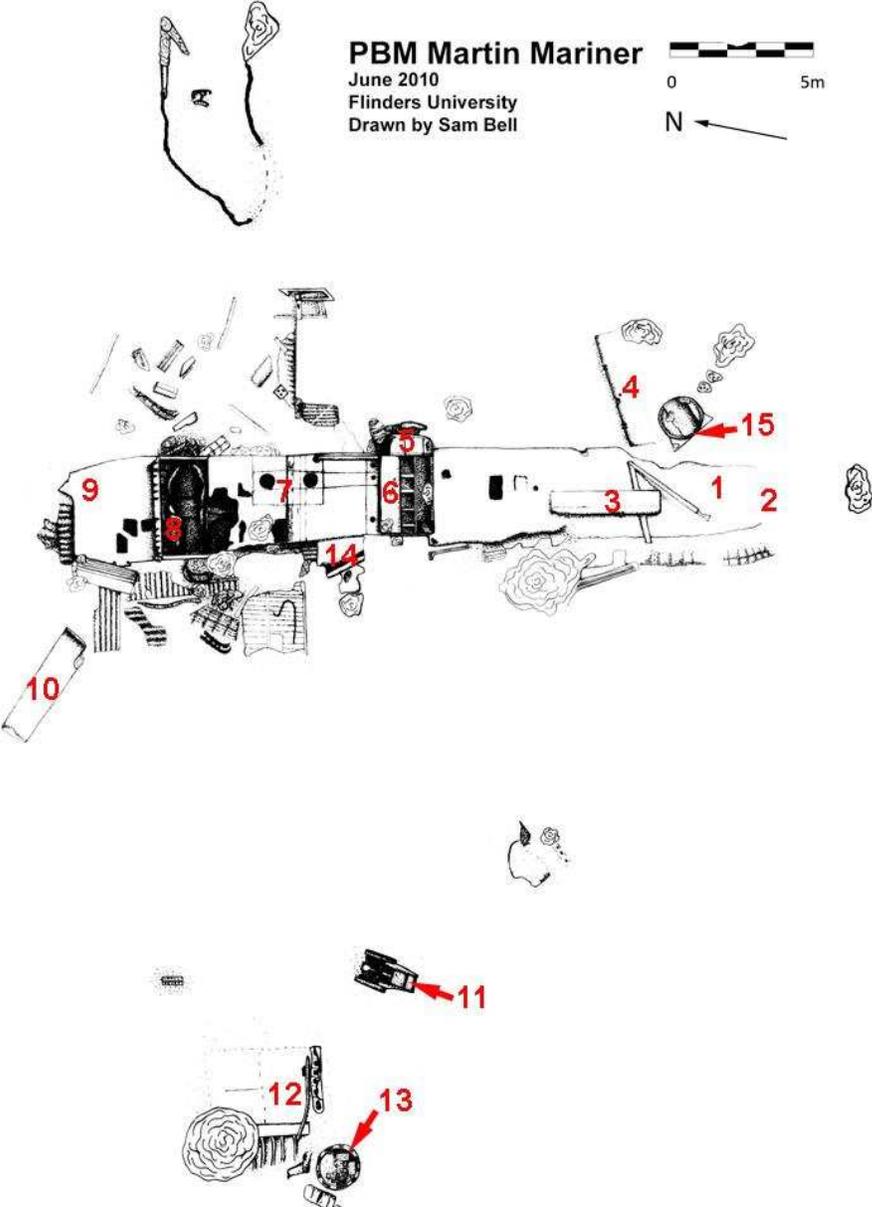
Figure 52. Schematic plan of the Martin PBM Mariner (MNR) indicating the corrosion parameter measurement positions (Richards 2012 after Bell 2010 in McKinnon and Carrell 2011:78).

The corrosion parameters of fifteen different areas on the MNR were measured over a 68 minute dive on 20 February 2012. The results are presented in Table 25 and the on-site positions shown in Figure 52. In order to compare the corrosion data collected from the different positions measured on the MNR and ascertain the thermodynamically stable state of the aluminium, the corrosion potentials ( $E_{corr}$ ) and the pH of the residual aluminium alloy surfaces were plotted on the aluminium Pourbaix diagram in aerobic seawater at 25°C (Figure 53). The temperature of the seawater on-site was 28°C, however this 3°C increase does not significantly affect the nature or equilibria of the chemical species described in this diagram.

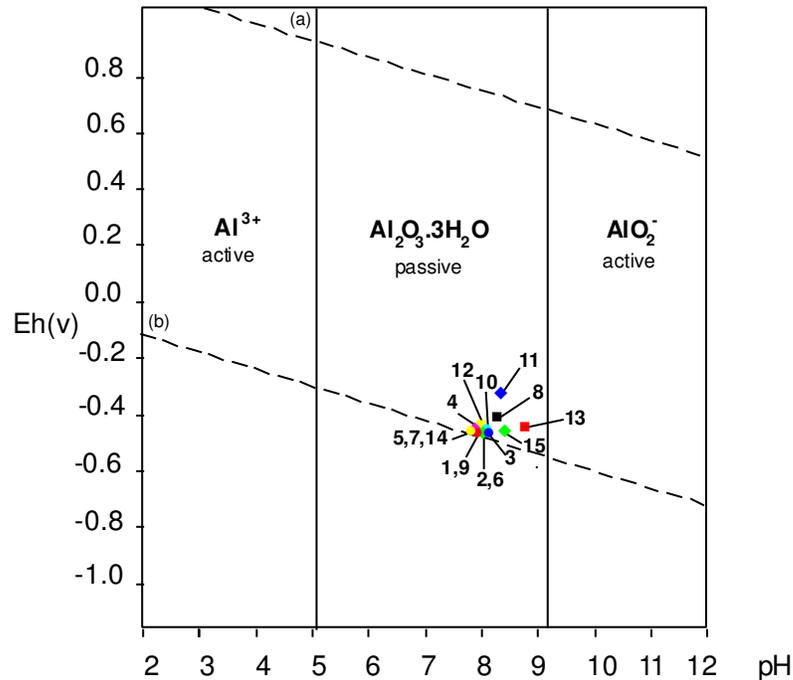
**Figure 53. Pourbaix diagram for aluminium ( $3.7 \times 10^{-6} \text{M}$ ) in aerobic seawater at  $25^\circ \text{C}$  indicating the intercepts of the areas measured on the MNR site (Richards 2012).**

Generally, the areas measured on the MNR were covered with a very thin (<1mm) mucilaginous layer consisting of proteinaceous and algal based material in combination with hydrated aluminium hydroxide gels. Hence measurements of total depth of concretion and corrosion products ( $d_{\text{total}}$ ) are not applicable for aluminium alloy aircraft. On some areas, especially position 7, which was the very corroded area on the dihedral wing, patches of blue corrosion products, typical of hydrated oxidised copper corrosion products, were observed, indicating the use of a copper - aluminium alloy, such as Duralumin in these areas.

From the Pourbaix diagram (Figure 53), the intercepts of all points measured on the MNR, lie in the passive region, where  $\text{Al}_2\text{O}_3 \cdot 3\text{H}_2\text{O}$  is the dominant corrosion product (Equation 2) and forms a continuous passivating layer, effectively slowing the corrosion rate. This is a very common corrosion state for aluminium alloy aircraft in marine environments.

Interestingly, the gun turrets, **11**, **13** and **15** and the damaged nacelle **8**, had an average pH value of  $8.45 \pm 0.20$ , which was more alkaline than the surrounding seawater at pH 8.19 and was much more alkaline than the mean pH of  $7.97 \pm 0.10$  for the rest of the aircraft remains. This significant increase in pH indicates there are higher concentrations of iron associated with these positions and they are being cathodically protected by the corroding aluminium alloy sections, which are more reactive. This is supported by the fact that position **11**, upper deck gun turret and position **8**, the damaged nacelle, which is close association with extensive engine remains had significantly less negative corrosion potentials ( $-0.323\text{V}$  and  $-0.414\text{V}$ , respectively) than the rest of the aircraft remains ( $-0.458 \pm 0.008\text{V}$ ) indicating that most of the associated aluminium alloy had corroded away and the average voltage of the corrosion cell was moving towards the more positive corrosion potential of iron in seawater.

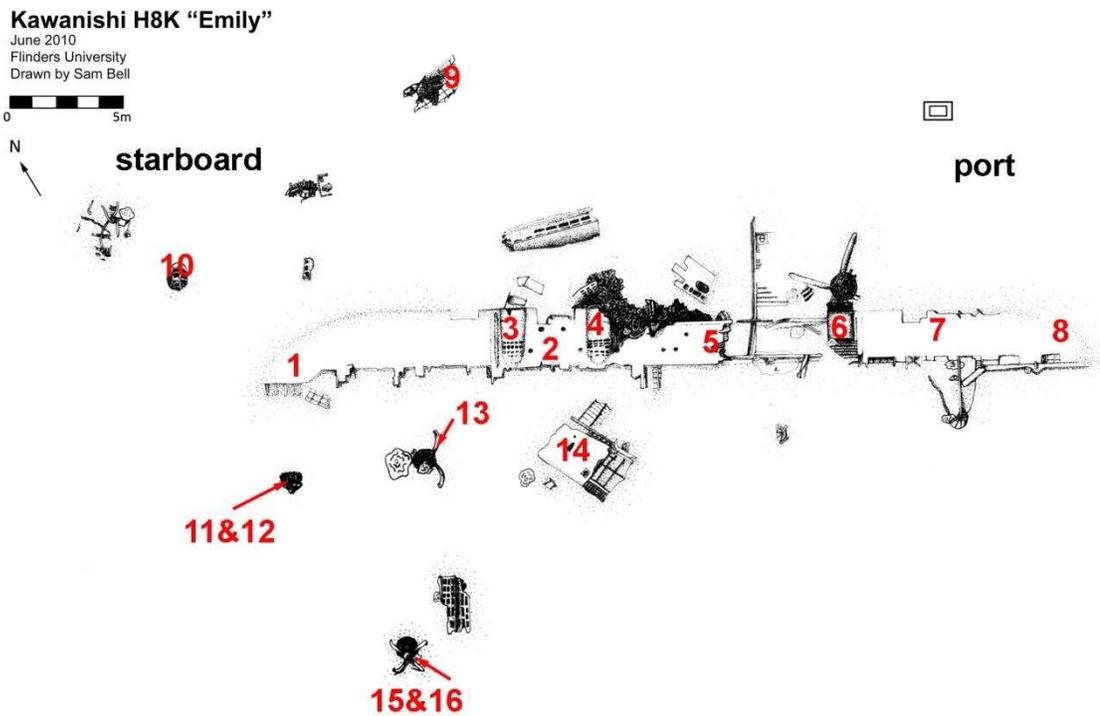
**Figure 56. Schematic plan of the Kawanishi H8K (EMILY) indicating the corrosion parameter measurement positions (Richards 2012 after Bell 2010 in McKinnon and Carrell 2011:63).**

The corrosion parameters of sixteen different areas on the EMILY were measured over a 46 minute dive on 21 February 2012. The results are presented in Table 27 and the on-site positions shown in Figure 56. In order to compare the corrosion data collected from the different positions measured on the EMILY and ascertain the thermodynamically stable state of the aluminium, the corrosion potentials ( $E_{\text{corr}}$ ) and the pH of the residual aluminium alloy surfaces were plotted on the aluminium Pourbaix diagram in aerobic seawater at 25°C (Figure 57). The temperature of the seawater on-site was 27°C, however this 2°C increase does not significantly affect the nature or equilibria of the chemical species described in this diagram.

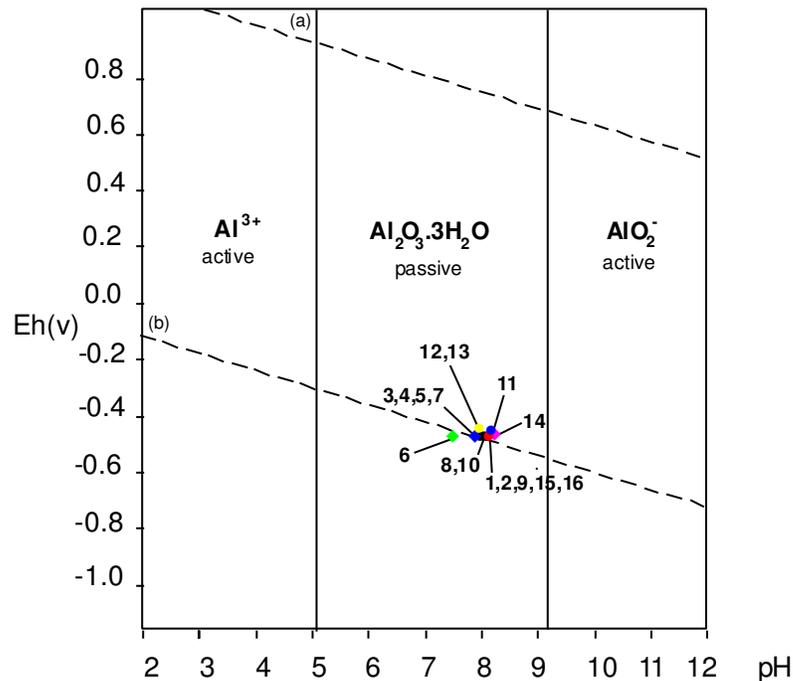
**Figure 57. Pourbaix diagram for aluminium ( $3.7 \times 10^{-6} \text{M}$ ) in aerobic seawater at  $25^\circ\text{C}$  indicating the intercepts of the areas measured on the EMILY site (Richards 2012).**

Generally, the areas measured on the EMILY were covered with a very thin (<1mm) mucilaginous layer consisting of proteinaceous and algal based material in combination with hydrated aluminium hydroxide gels. Hence measurements of total depth of concretion and corrosion products ( $d_{\text{total}}$ ) are not applicable for aluminium alloy aircraft. Unlike the AVR and MNR, there was no observed evidence of the typical blue copper corrosion products on the EMILY.

The average pH value for positions 1 to 8 and 10 was  $7.95 \pm 0.17$  but positions 9, 11 to 16, which possessed more positive  $E_{\text{corr}}$  values, had a more alkaline average pH value of  $8.11 \pm 0.09$ . This increase in pH indicates that the corrosion rate in these areas is less than on the wing and turret and it is likely these areas are being cathodically protected to some extent and/or the composition of the metal contains less reactive elements, such as iron and copper, which is in agreement with the conclusions based on the corrosion potential data.

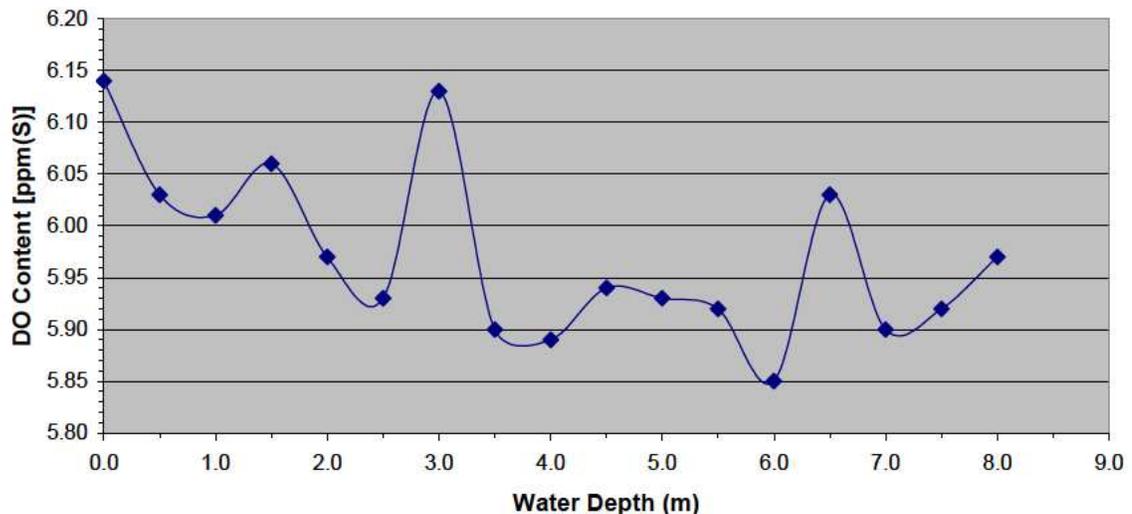
There was no significant change in salinity and temperature with increasing water depth, which is typical of the hydrology of well mixed near coastal marine waters. The average water temperature was  $27.6 \pm 0.1^\circ\text{C}$  and the average salinity of the water column was  $35.6 \pm 0.1\text{ppK}$ , which is within the usual salinity range for the open ocean of 32-37ppK. The average dissolved oxygen content was  $5.97 \pm 0.08\text{ppm}$ . The change in dissolved oxygen concentration with increasing water depth is shown in Figure 59.

Figure 59. Change in dissolved oxygen content with increasing water depth measured on the CRDO site (Richards 2012).

increasing aerobic respiration of plankton in the photosynthetic zone. However, the relatively small standard deviation between the measurements and a decrease of only 0.38ppm over the 9.0m depth range indicates that there is very little variation in the dissolved oxygen content with increasing water depth over such a shallow depth range, which is not unexpected. Hence, this trend coupled with the other physico-chemical measurements, are typical for a shallow, near coastal, open circulation, oxidising marine environment, where corrosion rates are likely to be relatively high.

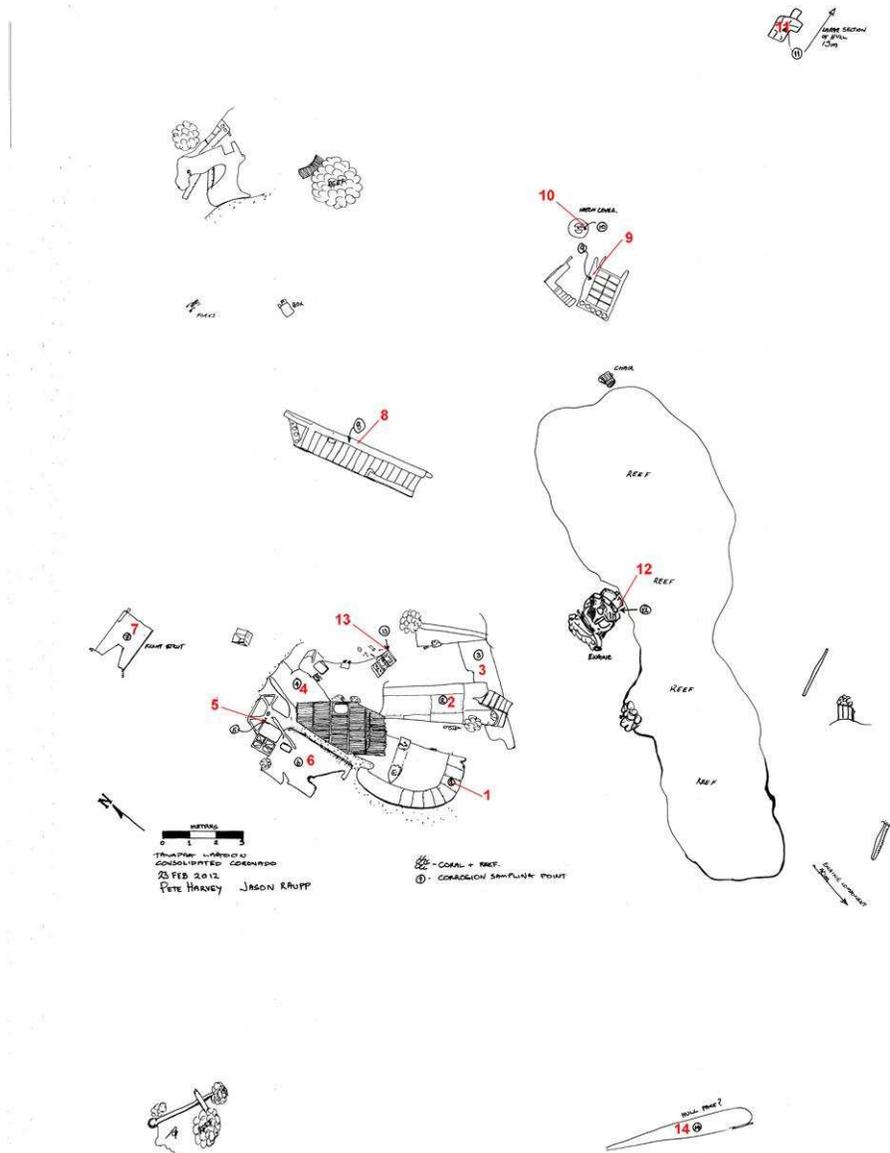
The corrosion parameters of fourteen different areas on the CRDO were measured over a 69 minute dive on 22 February 2012. The results are presented in Table 29 and the on-site positions shown in Figure 60. In order to compare the corrosion data collected from the different positions measured on the EMILY and ascertain the thermodynamically stable state of the aluminium, the corrosion potentials ( $E_{\text{corr}}$ ) and the pH of the residual aluminium alloy surfaces were plotted on the aluminium Pourbaix diagram in aerobic seawater at 25°C (Figure 61). The temperature of the seawater on-site was 28°C, however this 3°C increase does not significantly affect the nature or equilibria of the chemical species described in this diagram.

<b>7</b>	float strut	8.08	-0.499	7.6
<b>8</b>	unidentified piece of wreckage	8.01	-0.451	7.3
<b>9</b>	unidentified piece of wreckage	7.95	-0.451	7.5
<b>10</b>	hatch cover	8.07	-0.466	7.7
<b>11</b>	unidentified piece of wreckage	7.93	-0.480	7.5
<b>12</b>	engine	7.89	-0.460	6.3
<b>13</b>	control panel	7.93	-0.483	7.3
<b>14</b>	float ?	7.99	-0.451	7.8

Figure 60. Schematic plan of the Consolidated PB2Y Coronado (CRDO) indicating the corrosion parameter measurement positions (Richards 2012 after Harvey and Raupp 2012).

The  $E_{\text{corr}}$  values of the measurement positions **1** to **6**, **8** to **10**, **12** and **14** all fall into the average corrosion potential range of  $-0.459 \pm 0.006 \text{ V}$  indicating that these areas have similar metal compositions and are corroding at a similar rate. The average corrosion potential of positions **7** (float strut), **11** (unidentified wreckage) and **13** (control panel) was  $-0.487 \pm 0.008 \text{ V}$ , which is 28mV more negative than the other positions indicating that these areas have different metal compositions (i.e. higher aluminium contents) and are therefore corroding at a higher rate. Unfortunately the average pH values of all groups of measurements all fell within the statistical standard sample deviation so differences in pH cannot be used as an indication of differences in corrosion rates.

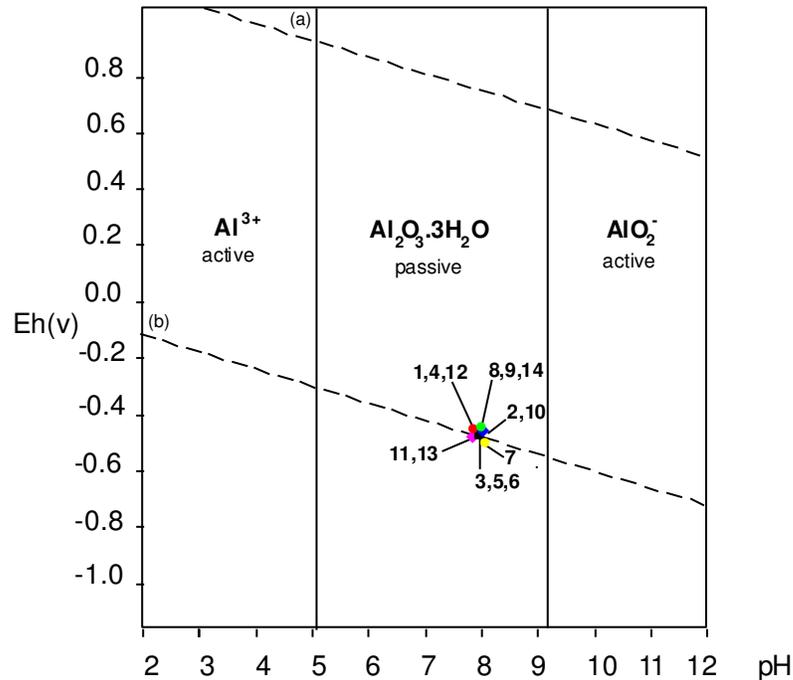
**Figure 61. Pourbaix diagram for aluminium ( $3.7 \times 10^{-6} \text{ M}$ ) in aerobic seawater at  $25^\circ \text{C}$  indicating the intercepts of the areas measured on the CRDO site (Richards 2012).**

From the Pourbaix diagram (Figure 61), the intercepts of all points measured on the CRDO, lie in the passive region, where  $\text{Al}_2\text{O}_3 \cdot 3\text{H}_2\text{O}$  is the dominant corrosion product (Equation 2) and forms a continuous passivating layer, effectively slowing the corrosion rate. This is a very common corrosion state for aluminium alloy aircraft in marine environments.

The surfaces of the aluminium alloy sections of the CRDO were quite corroded and pitting and intergranular corrosion mechanisms had caused significant pitting and perforation of the residual metal. The remains of the CRDO are obviously more deteriorated than the JAKE and EMILY even though they lie in a similar environment at similar depths. However, this is not unexpected as the CRDO remains are more damaged, disarticulated and spread over a wider area, therefore there would be more intergranular corrosion occurring on the CRDO aircraft remains due to increased stress and metal fatigue.
