The Public Inquiry into the Piper Alpha Disaster

The Hon Lord Cullen

VOLUME ONE

Presented to Parliament
by the Secretary of State for Energy
by Command of Her Majesty
November 1990

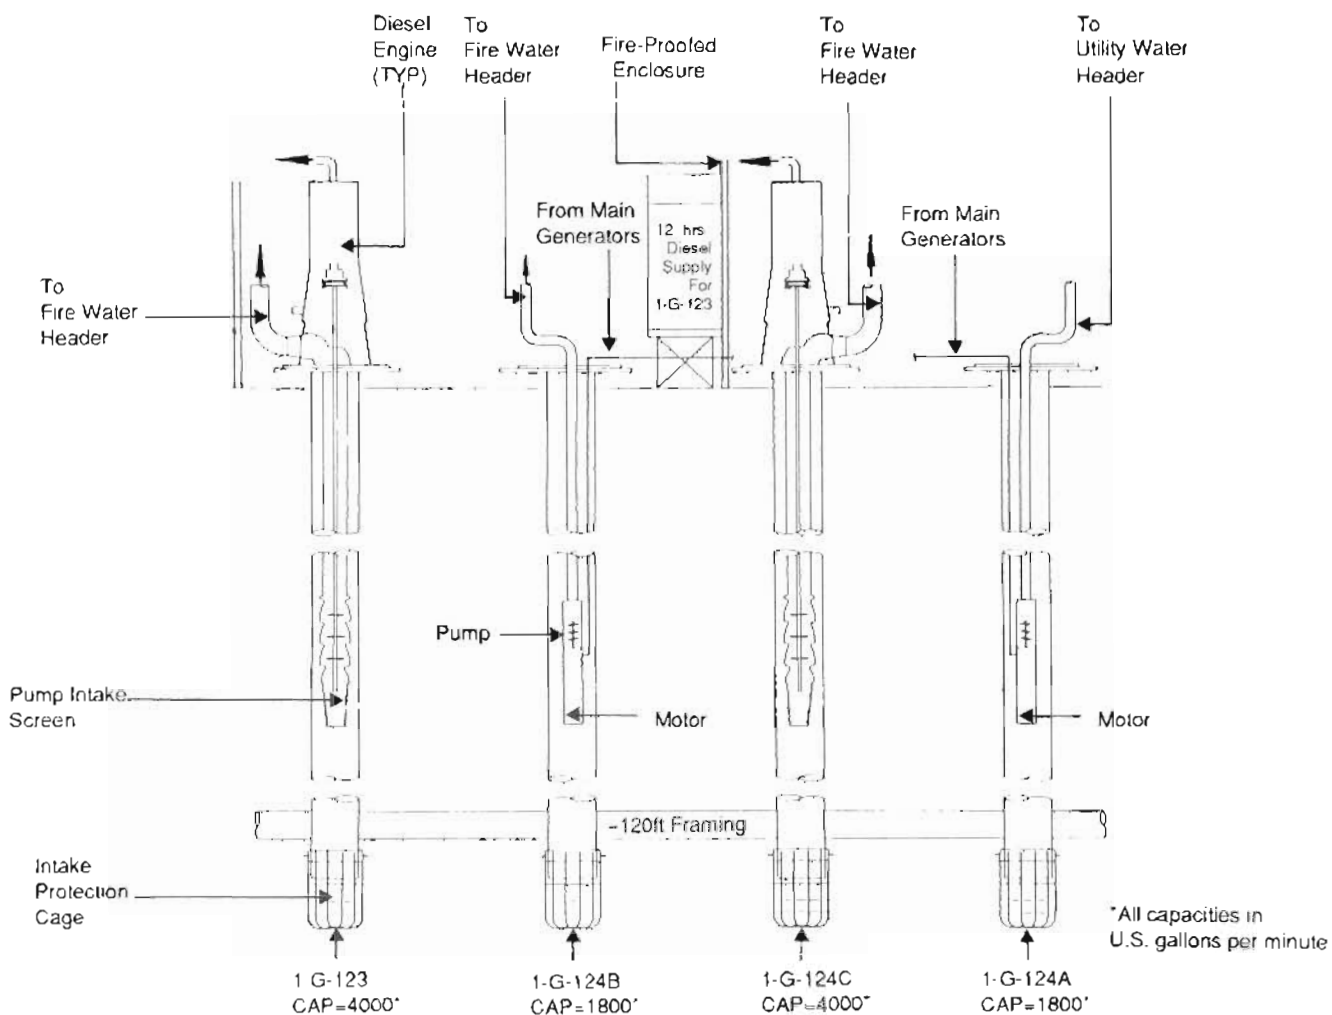
Fig. 3.6 The inlets of the fire pumps.

3.72 Stilling columns for the sea-water supply to the pumps were located on the east side of the platform near leg A4 (see Fig. 3.6). The pump intakes were at a level of about -120 ft. The intakes were some 5 ft apart and were furnished with protection cages to prevent divers from getting sucked in. The stilling columns were 2 ft diameter and the cages the same diameter and about 4 ft long. The 2 diesel-driven pumps, fire pump 1-G-123 and utility/fire pump 1-G-124C, could be put on manual start to protect divers against a sudden flow of water at the pump intakes. If these 2 pumps were on manual start, this was indicated in the Control Room by an alarm light. They could then be started only by going to the pumps themselves and starting them at the local control panel in the fireproof enclosure.

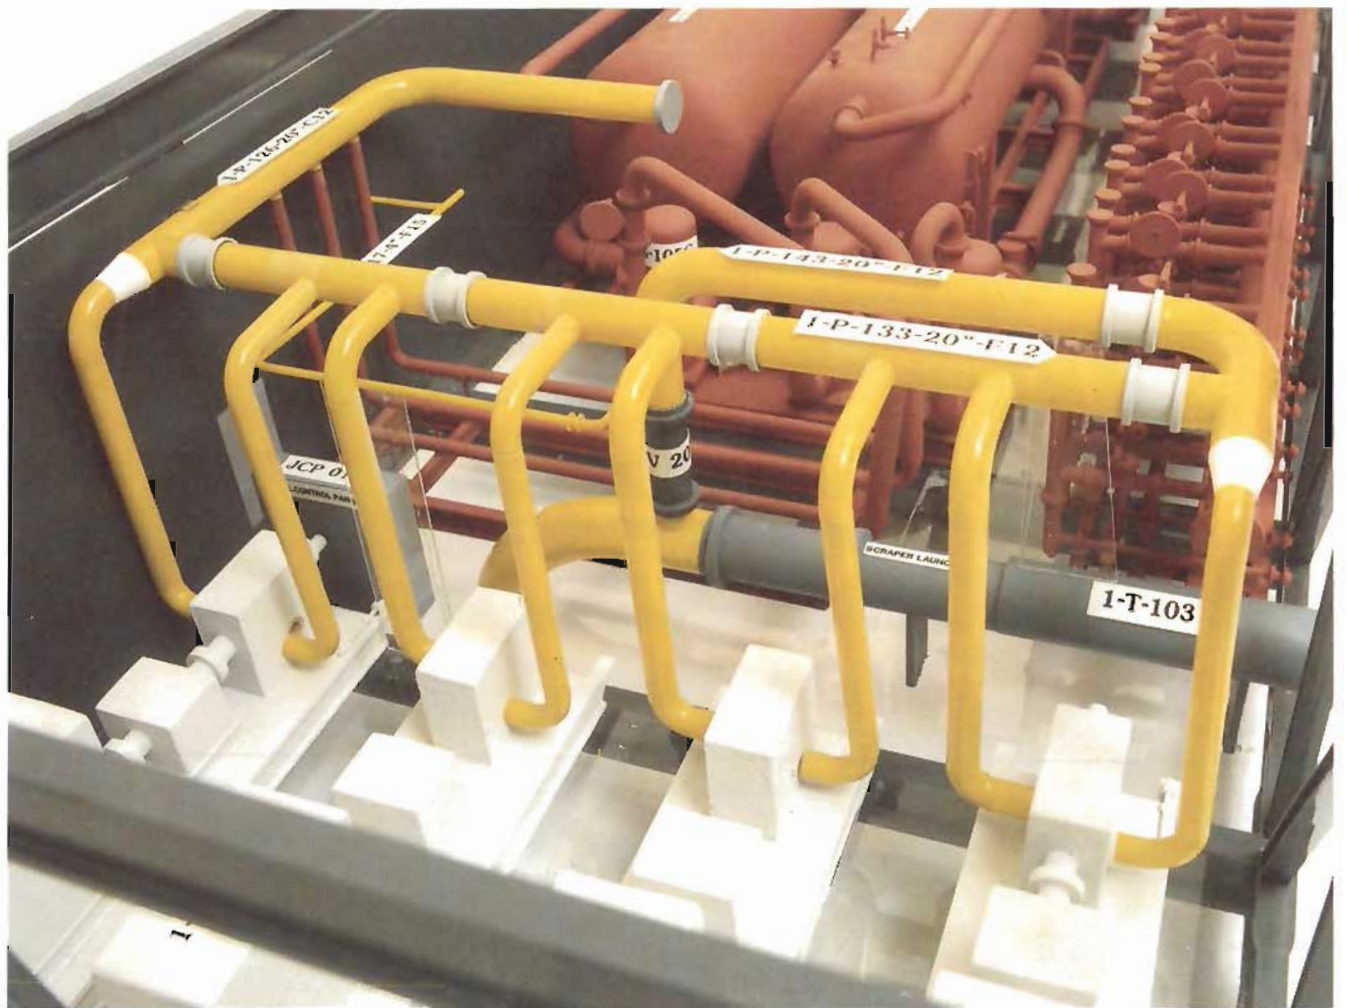
Plate 8 Model of the production modules (1: 33 scale): the main oil line pumps at the west end of B Module. The 4 inch condensate injection line is the small yellow line 2-P-517-4"-F15 coming through the B/C firewall and entering the MOL pump discharge header 1-P-143-20"-F12.

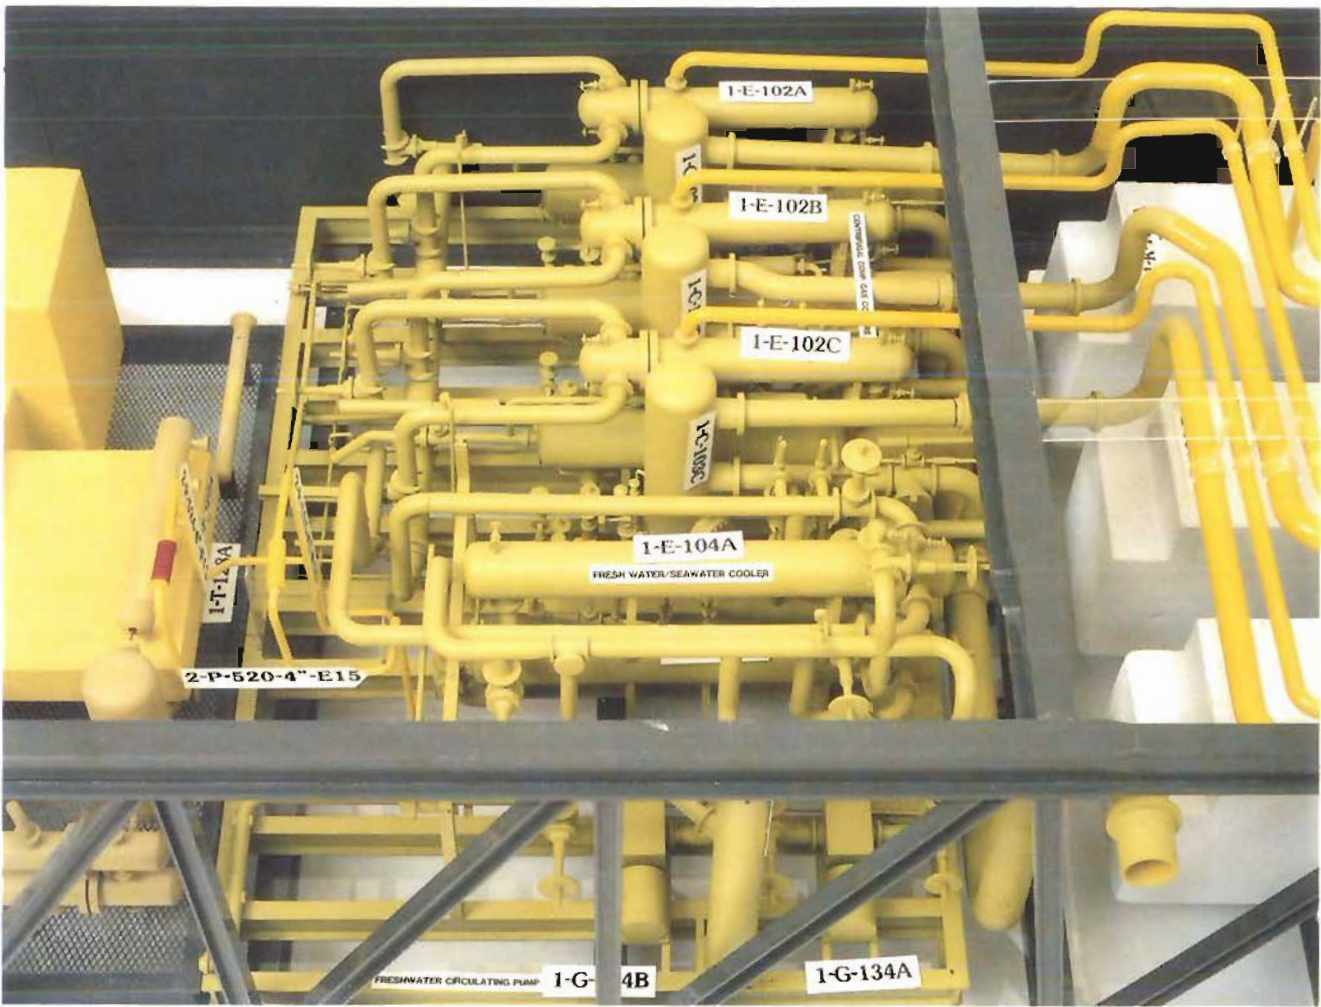
Plate 9 Model of the production modules (1: 33 scale): the centrifugal compressor skid towards the east end of C Module. The location of PSV 504 is marked in red.

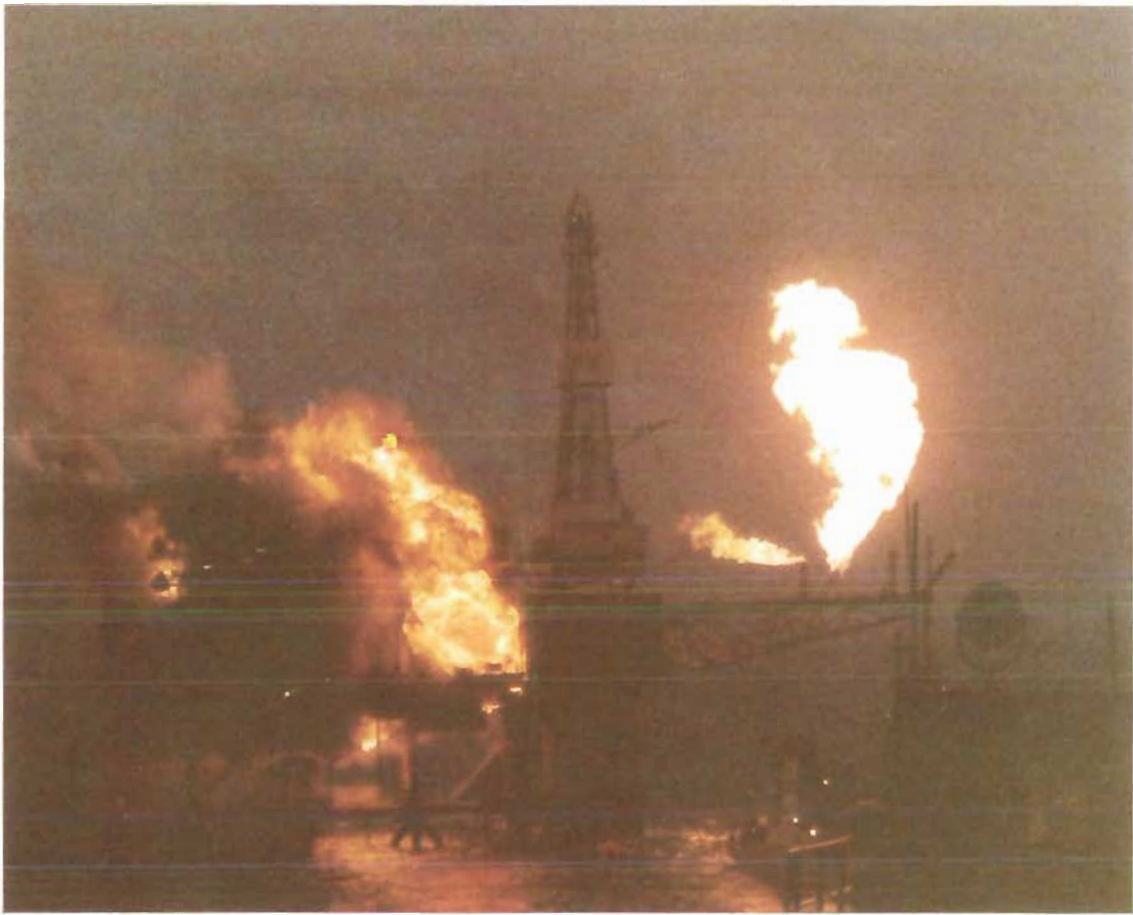
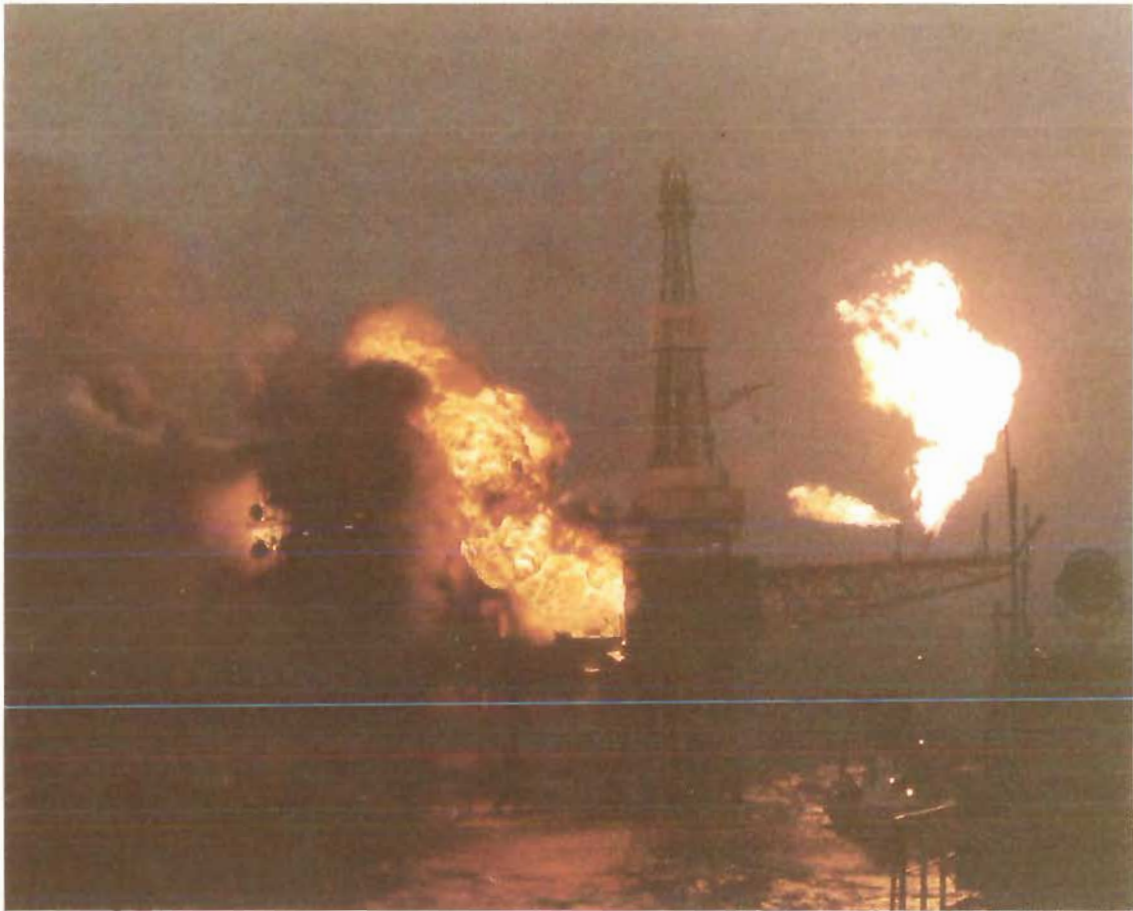
The early fire in B Module: (a) Mr Miller's third photograph; and (b) his fourth photograph.

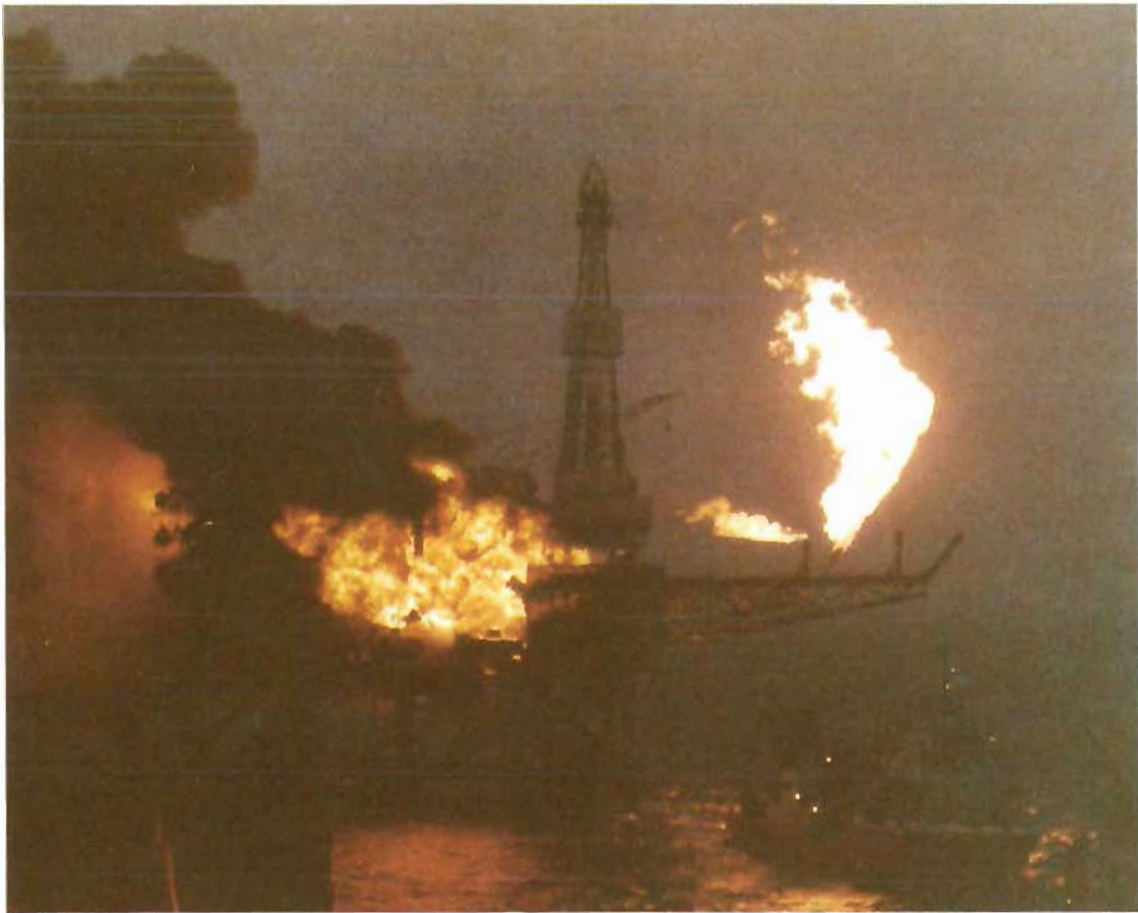
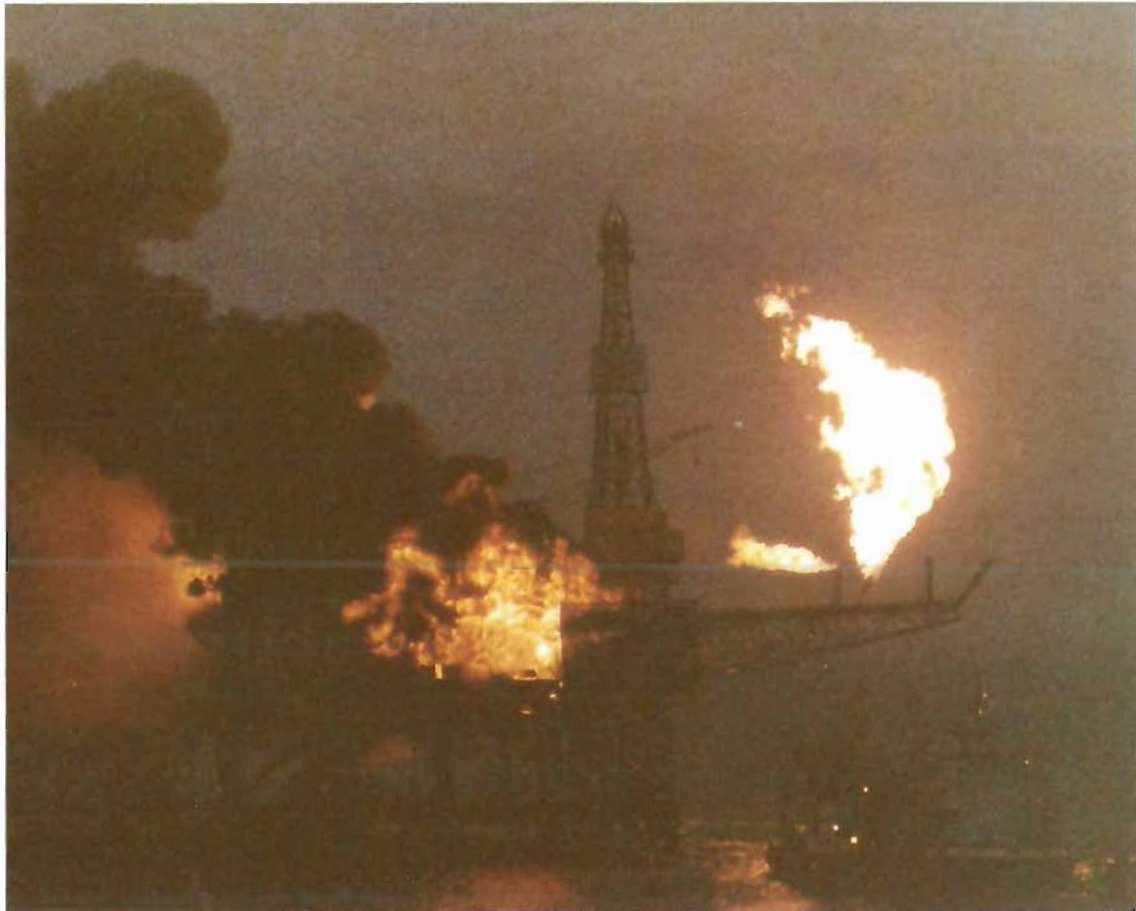
The early fire in B Module: (a) Mr Miller's fifth photograph; and (b) his sixth photograph.

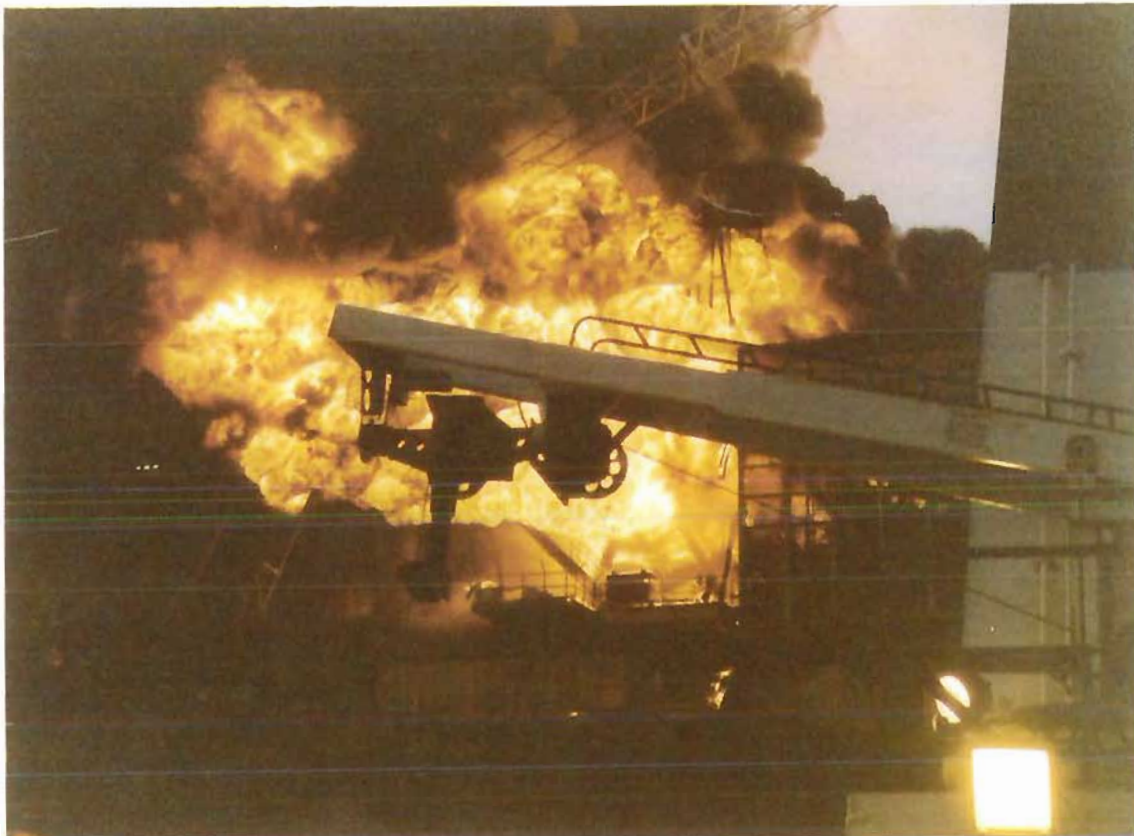
Plate 17(a) The early fire in B Module: photograph taken by Mr Macdonald from the *Lowland Cavalier* at a time estimated as some 30 seconds after the initial explosion.

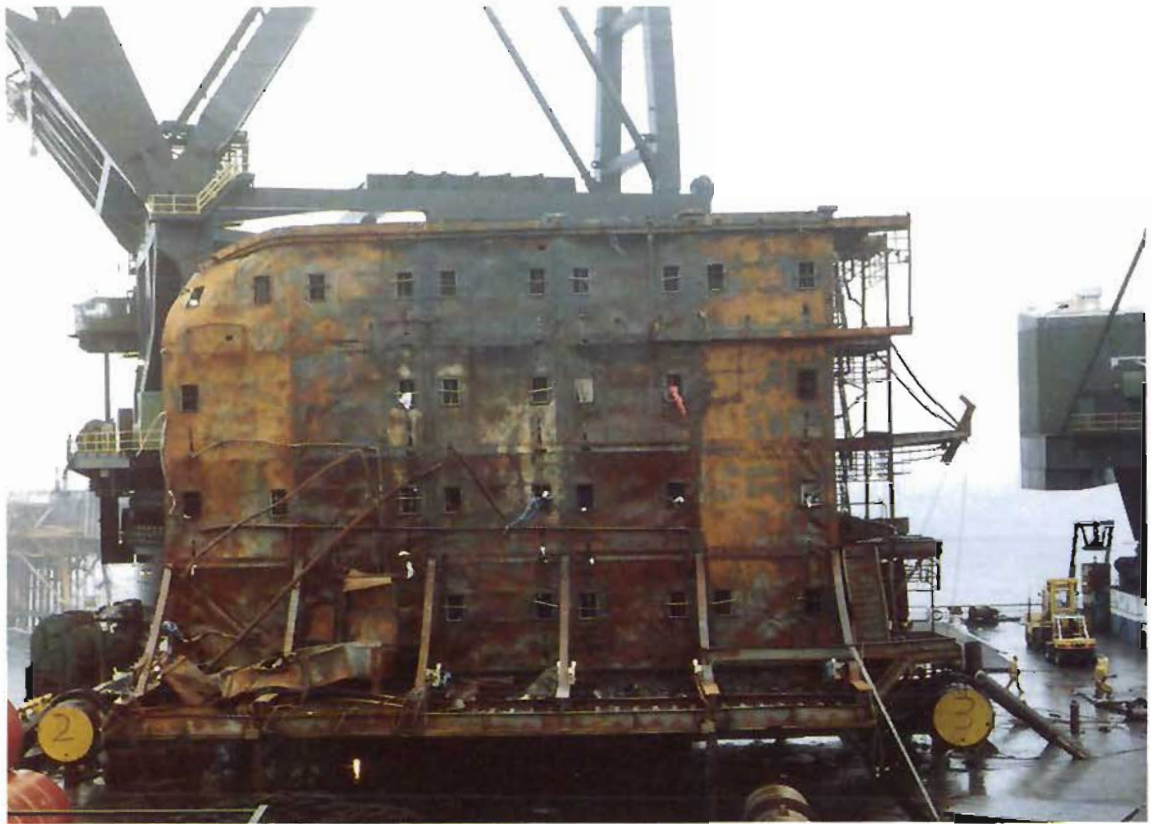
Plate 22(a)

8.32 As regards the ERQ he found that there was evidence of severe external attack by fire on its east and north sides (see Plate 22(a)). There was little evidence of attack by fire elsewhere save at the north-west corner where windows on the north face had

Accommodation modules at Flotta after recovery from the seabed — 1: (a) the East Replacement Quarters (ERQ); and (b) the south face of the ERQ.

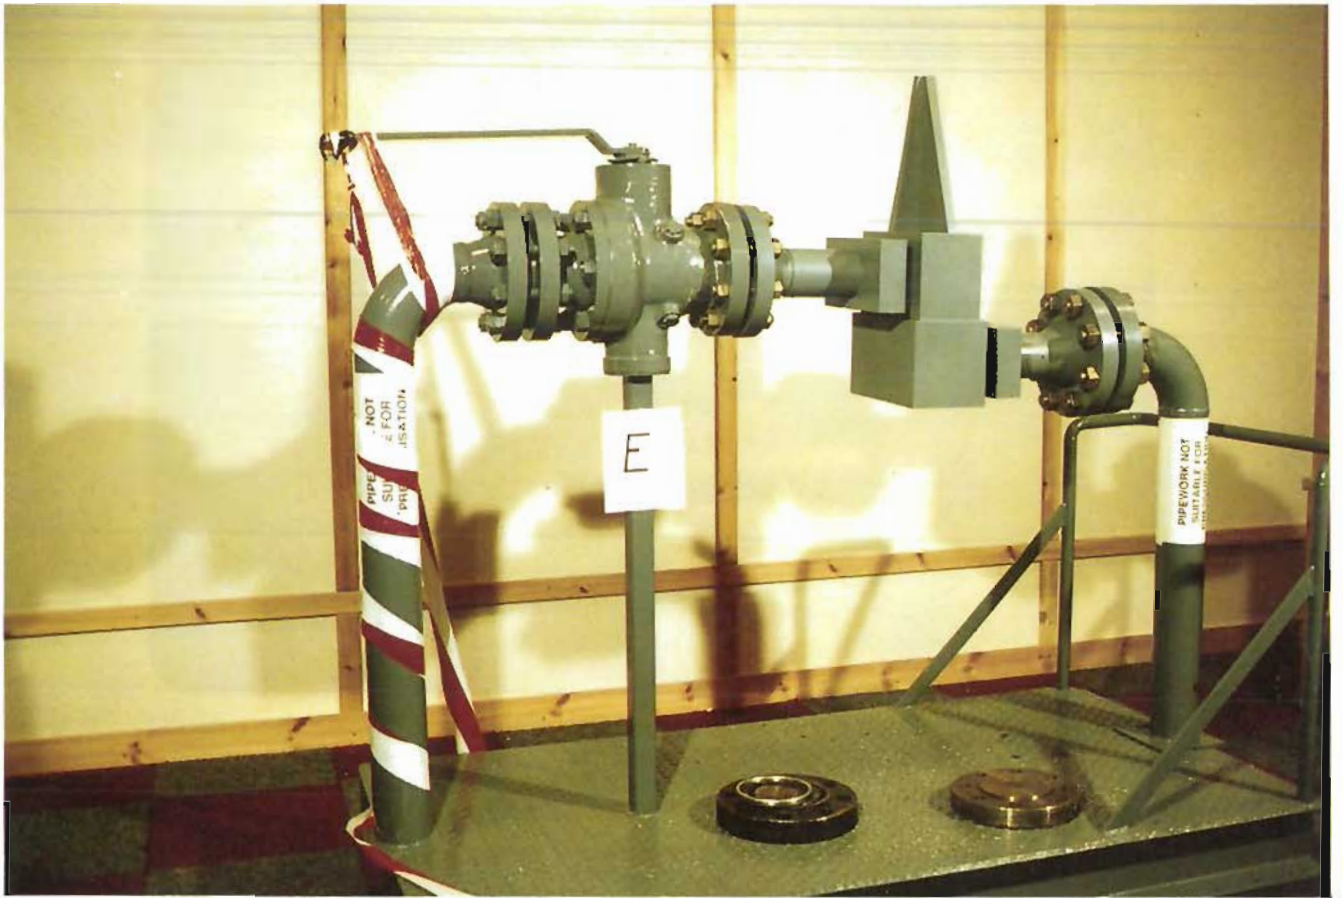
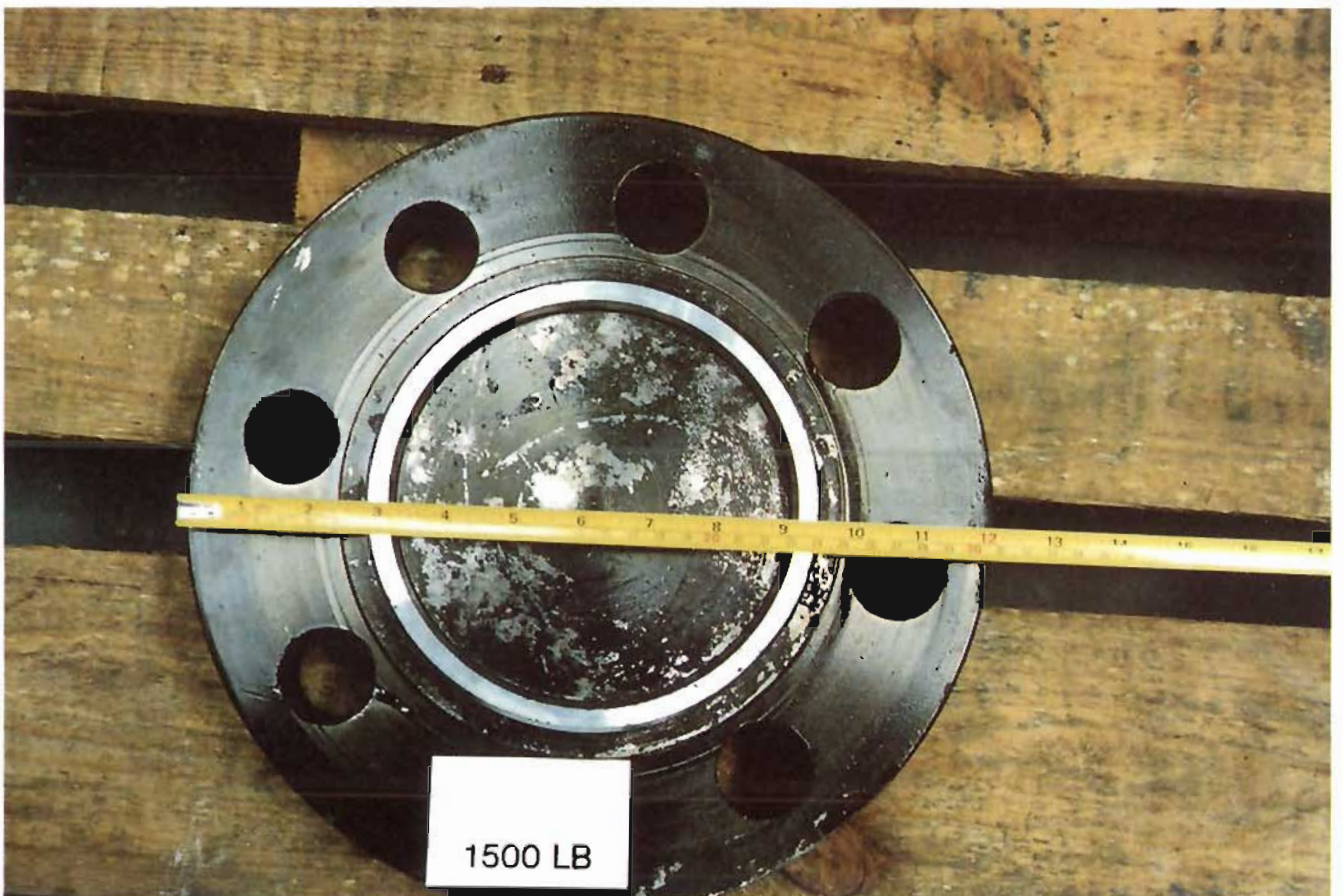
The pipework at the site of PSV 504 in C Module: (a) model of the PSV and pipework; and (b) a 1500 lb flange with ring. The PSV is the wooden mock-up. Its inlet is on the right hand side.

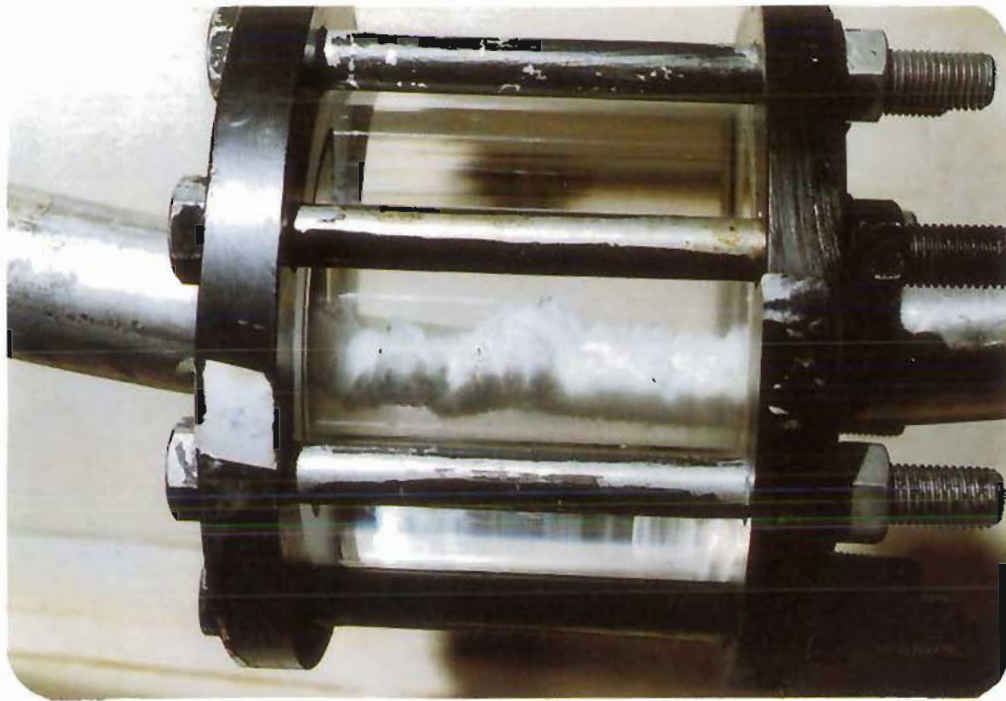
Plate 25(a) Hydrate formation in an observation window of the rotating wheel test rig in the tests conducted by Petreco.

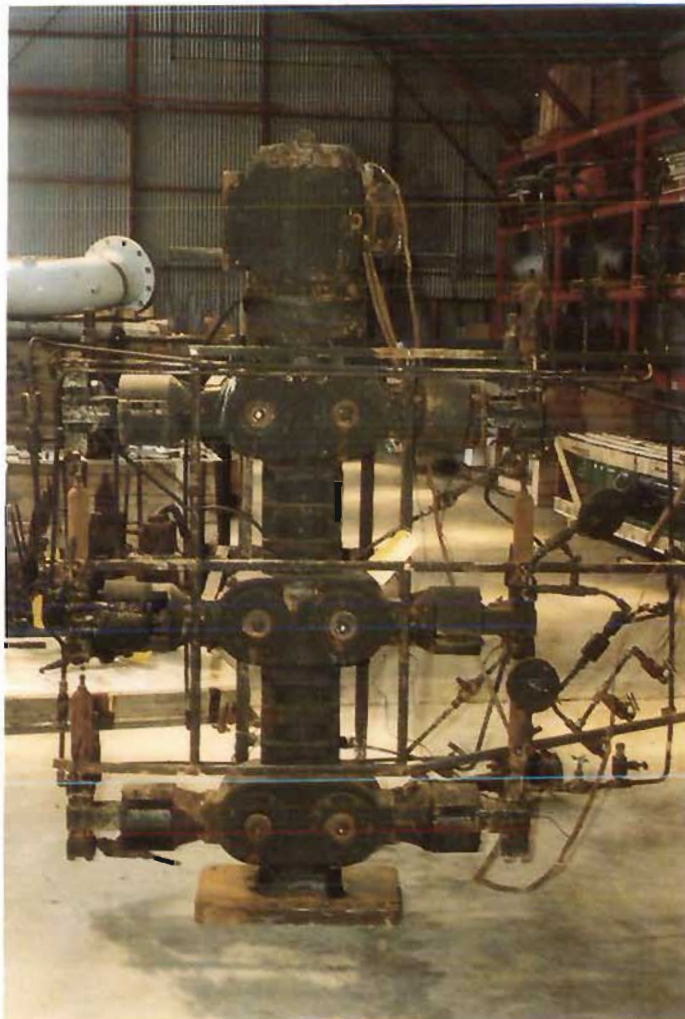
Plate 25(b) The main methanol pump at Peterhead after recovery. As the pump was installed on the platform, the view is that looking north.

F.35 The main methanol injection pump, 3-G-702, was a 6-head injection pump and was located on the skid deck to the east of the drilling derrick and north of the deoxygenation towers. Plate 25(b) shows a photograph of the front view of the pump taken at Peterhead. For the installed pump this was the view looking north. The methanol supply came from a methanol tank, 2-C-201, which had a capacity of about 600 gallons and was kept filled from transportable containers. There was in addition an air-driven methanol pump, 2-G-201, the so-called "windy" pump, which supplied a further set of injection points. There were also 2 pneumatic pumps, the Williams pumps, which could be connected for use as back-ups. The location of the methanol injection points on the plant is shown in Fig J.8. On 6 July there were 2 injection points upstream of the JT valve, one the normal injection point fed from the main methanol pump head D and one a temporary injection point fed by a hose from head F.

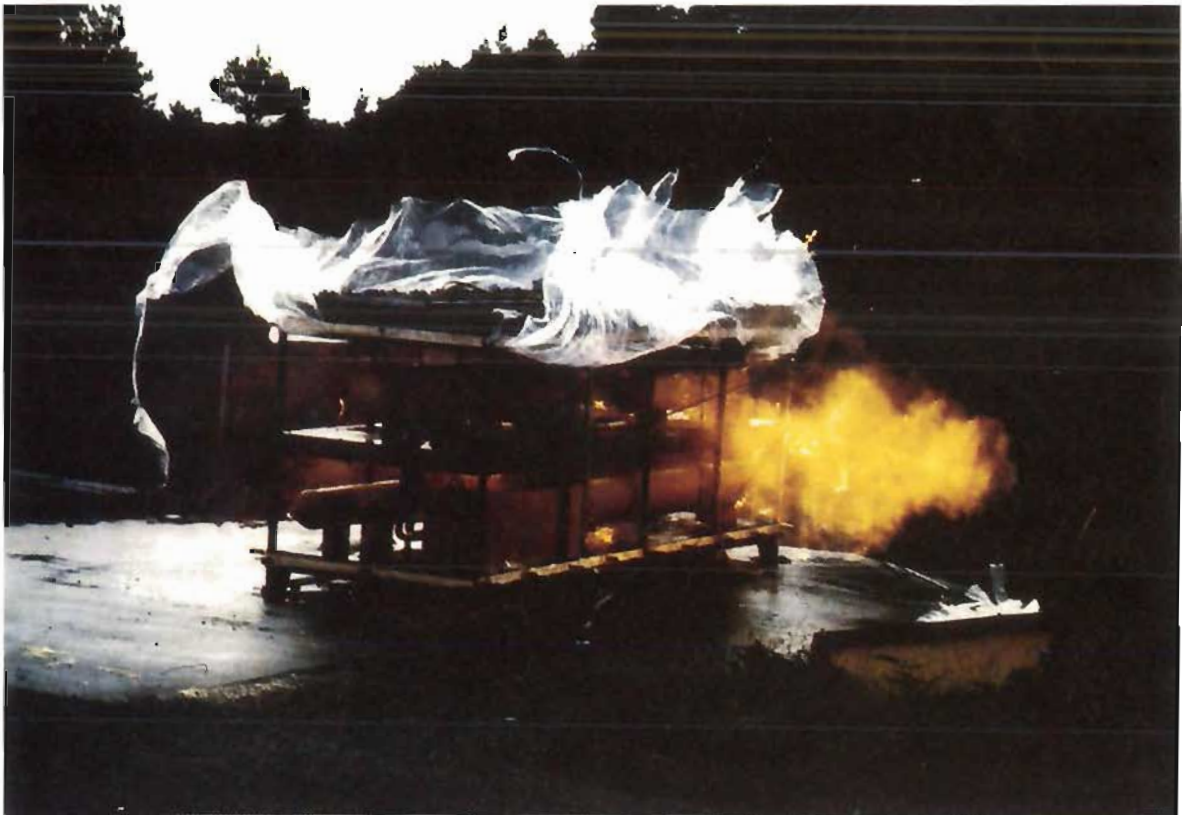
Plate 26(a) Explosion in a scaled down module typical of those conducted by CMI to validate its explosion model.

G.17 The FLACS code has been validated by comparison of results obtained from the code with measurements made in experiments on explosions in scale models of modules. The models used were on scales of 1:33 and of 1:5. A typical explosion experiment is shown in Plate 26(a). The over-pressures predicted by the code lie within plus or minus 30% to a confidence level of some 95% of those measured experimentally. The variability of model experiments themselves is of the same order. It was Dr Bakke's expectation that the measured over-pressures would tend to be greater in full scale tests. The work at CMI has been sponsored by a number of organisations and a number of studies have been conducted on gas explosions in modules of offshore platforms.

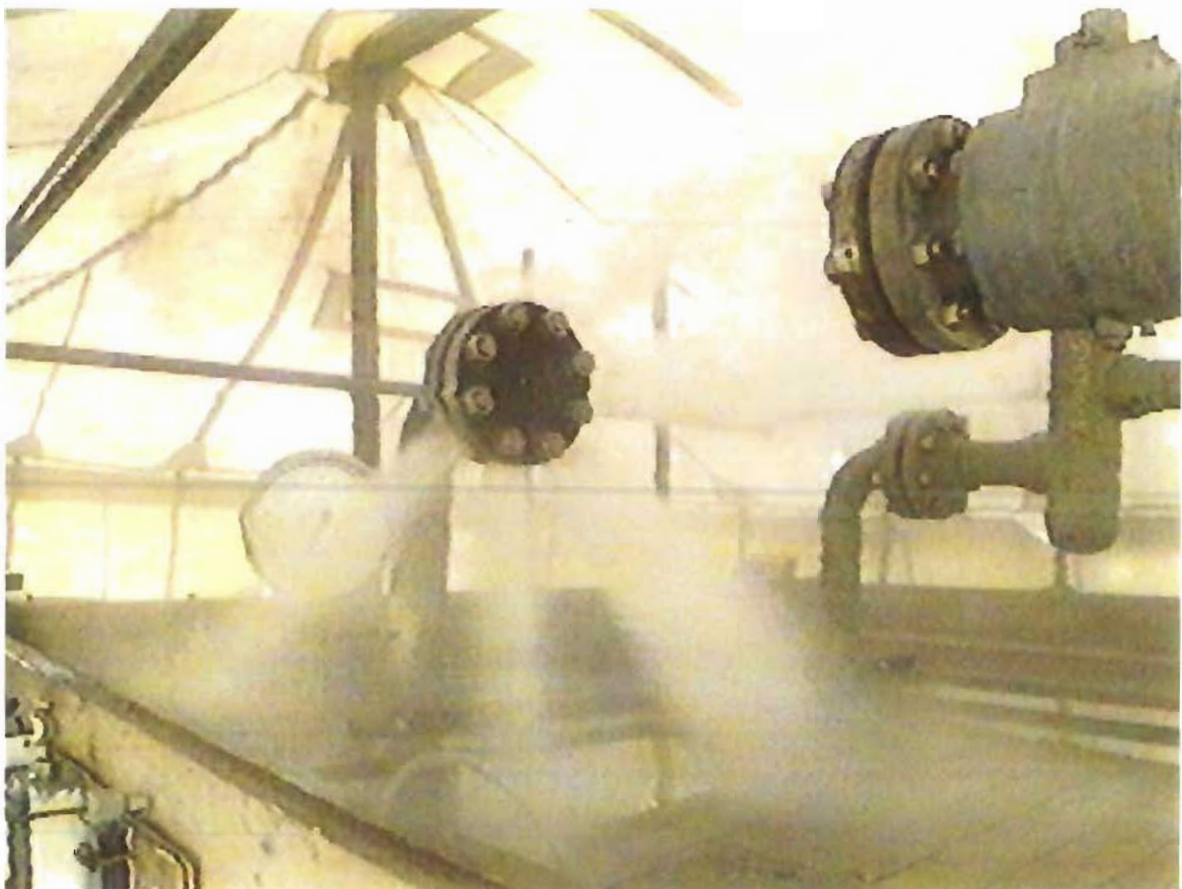
Plate 26(b) Leak from a blind flange assembly in the Nowsco tests.

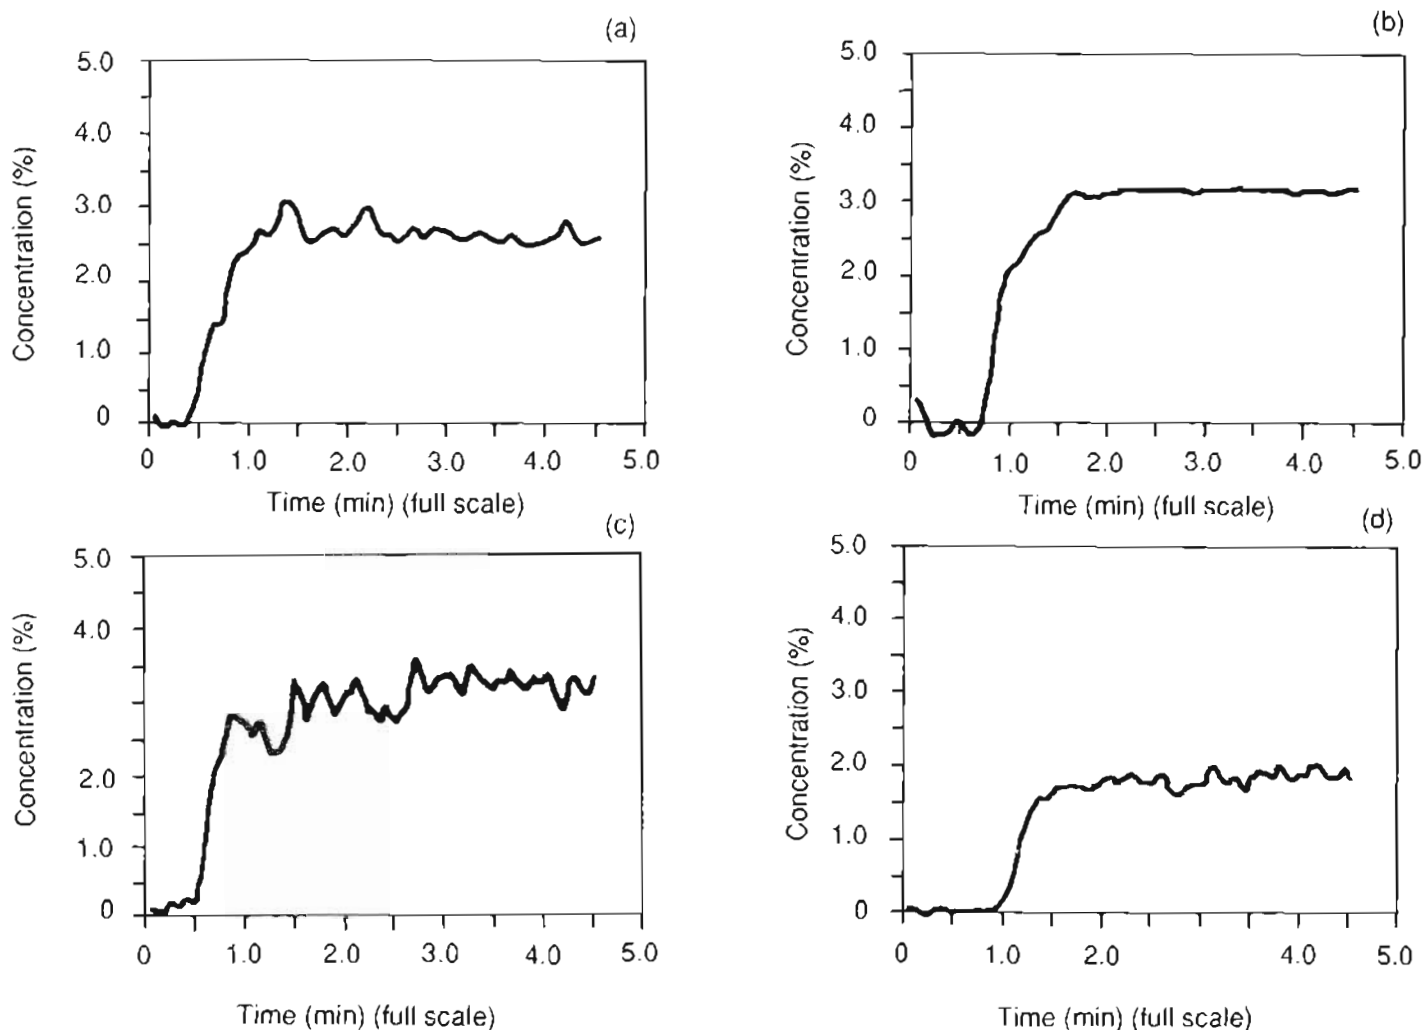
G.12 In the experiments measures were taken using aspirator probes. The response time of these probes was about half a second to a second, in full scale time units. Some typical traces of the concentrations measured in the experiments are shown in Fig G.1. Several features are noteworthy. Firstly, there was an appreciable difference in the final steady-state values. For example, for the 2 runs in series 25 for sensor G103/1 the steady-state values are approximately 2.6 and 3.1, while for sensor G101/2 they are 1.8 and 3.2. The lateral spread of the cloud, and hence the readings of sensor G101/2 tended to show a greater variability. Secondly, there was a high level of noise on the final steady-state value, so that an alarm might be triggered even though the smoothed steady-state value was below the alarm limit. This occurred in series 28. Thirdly, the initial part of the curves constitutes effectively a ramp, rather than a step, forcing function. On the full scale the concentration measured by the gas detector would, after a short initial transient, tend to lag the actual concentration by a time equal to the time constant of the detectors, estimated as 10 seconds. This would apply particularly to the low level alarms. The lag would be rather greater where the high level alarm limit was close to the final steady-state value.

Fig. G.1 Gas concentration-time traces for sensors in repeated runs in series 25 in the BMT wind tunnel tests: (a) and (b) sensor G103/1; and (c) and (d) sensor G101/2.

G.13 It was possible that one or more of the gas detectors in C Module might not have been operational. In particular, the apparent failure of the 2 C2 detectors G101/1 and G101/2 to activate first constrained the interpretation of the test results. The possibility was explored that G101/1 might have been pinned out while work was done on PSV 504. However, there was no evidence that any detector was in fact pinned out.

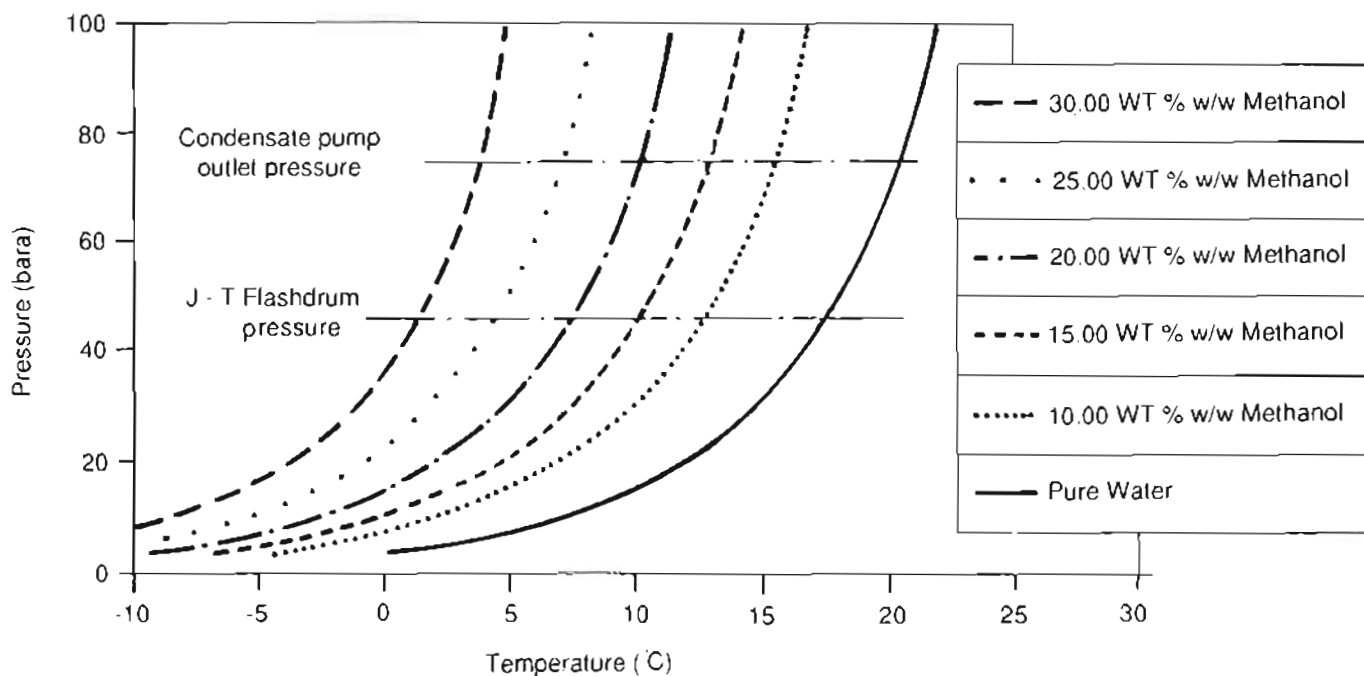
G.36 The possibility of formation of hydrate at the JT valve was considered by Drs Richardson and Saville in their first report on hydrates in general and in their eighth on hydrates at this valve. In their first report, presented by Dr Richardson, they calculated that the hydrate formation temperature just downstream of the JT valve was 62.5°F. They took the temperature at the JT valve as 52.5°F. They estimated that the methanol in the aqueous liquid phase just necessary to prevent hydrate formation at this temperature was 12% w/w. For a temperature of 28-30°F the amount of methanol required in the aqueous liquid phase to inhibit hydrate formation was calculated as 35% w/w. They estimated that given the prescribed methanol injection rates the amount of methanol in that phase would have been 25% w/w. The concentration of methanol would not have been sufficient to prevent hydrate formation.

Fig. G.2 Typical hydrate curves for conditions representative of those on Piper given by Dr Johnsen. Hydrates can form if conditions are above and to the left of the relevant curve.
