# Underwater Inspection of Submerged Elements in Masonry Bridges and Other Old Civil Structures Using Drones

[Rubén Rodríguez Elizalde](#) \*

Posted Date: 7 August 2024

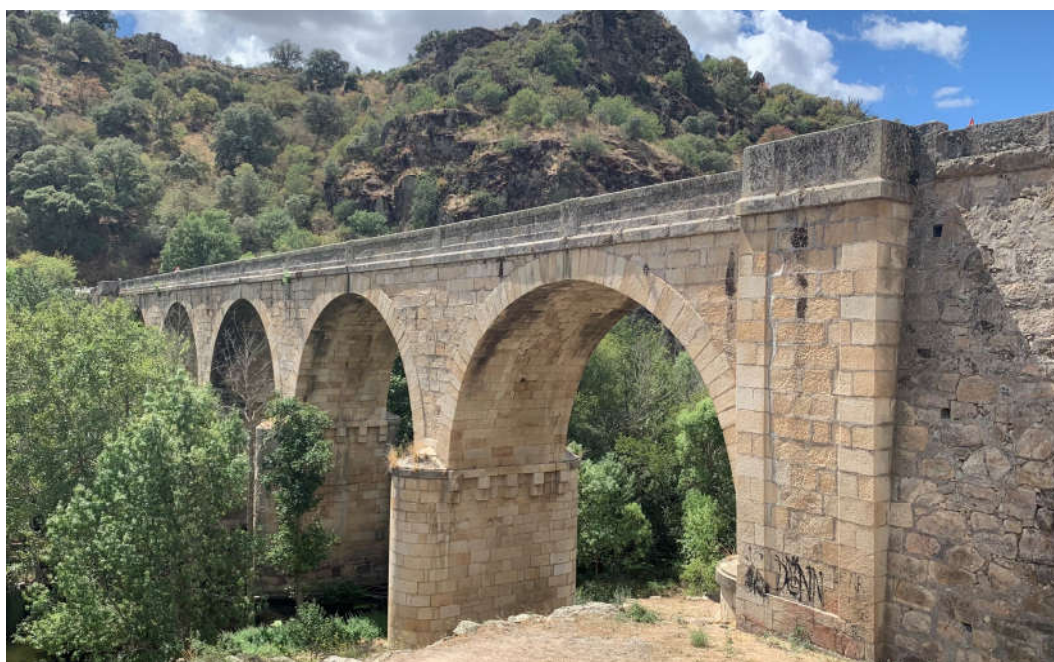
**Figure 8.** Image taken from the northern abutment, on the Zamora side, of the San Lorenzo Bridge (photo by the author).

Unlike the Segura Bridge, the piers here have no additional concrete elements. The underwater drone confirmed the observation made on the non-submerged elements (Figures 10 and 11): the piers rest directly on the ground and the first ashlar rise out of the sand of the riverbed (Figures 12 and 13). As in the previous case, detailed observation allowed us to verify that there were no symptoms of the type that may appear in the superstructure as a result of the main foundation defects: twisting, absolute settlement or differential settlement. A quadcopter drone was used for this purpose.

The underwater drone inspection of the submerged parts confirmed the correct state of the elements underwater: there were no missing granite ashlars and the granite forming the submerged ashlar was in an adequate state of preservation. The presence of stone slabs in various joints between the ashlars and their appropriate location (Figure 12) appeared to help maintain the position of the ashlars by mutual friction against the erosive action of the river. This would have prevented the need to use grouting mortar, which inevitably tends to dissolve or be lost over time due to the washing action of the flowing water.

It was also possible to verify that the lower part of all the submerged piles was in complete contact with the riverbed. This, together with the absence of deformations in the position of the ashlars, allowed us to confirm the absence of undermining under these piles.

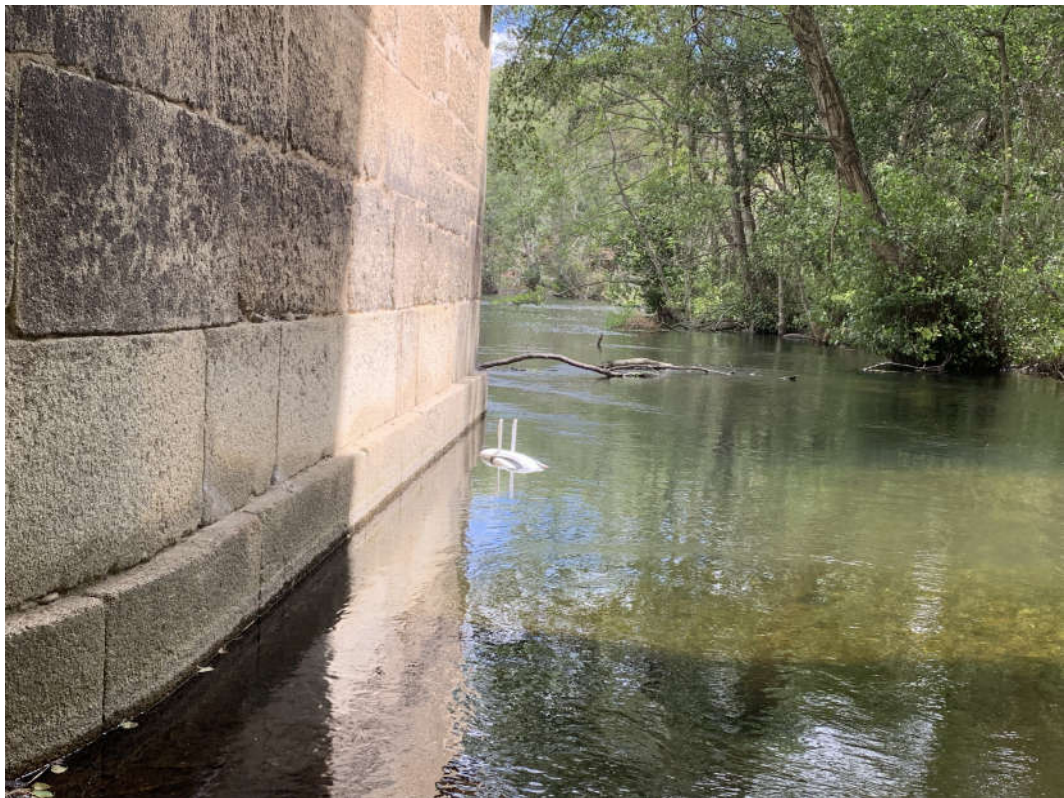
In order to carry out this inspection properly, the pilot had to position himself on a river bank upstream of the bridge, where the riverbed was accessible, and position the drone there (Figure 1), from where it could follow the course and flow of the Tormes River. In this way, it approached the central piers from upstream of the bridge and was able to carry out the inspection properly (Figure 9).

**Figure 9.** Underwater drone approaching one of the central piers of the San Lorenzo Bridge from downstream (photo by the author).

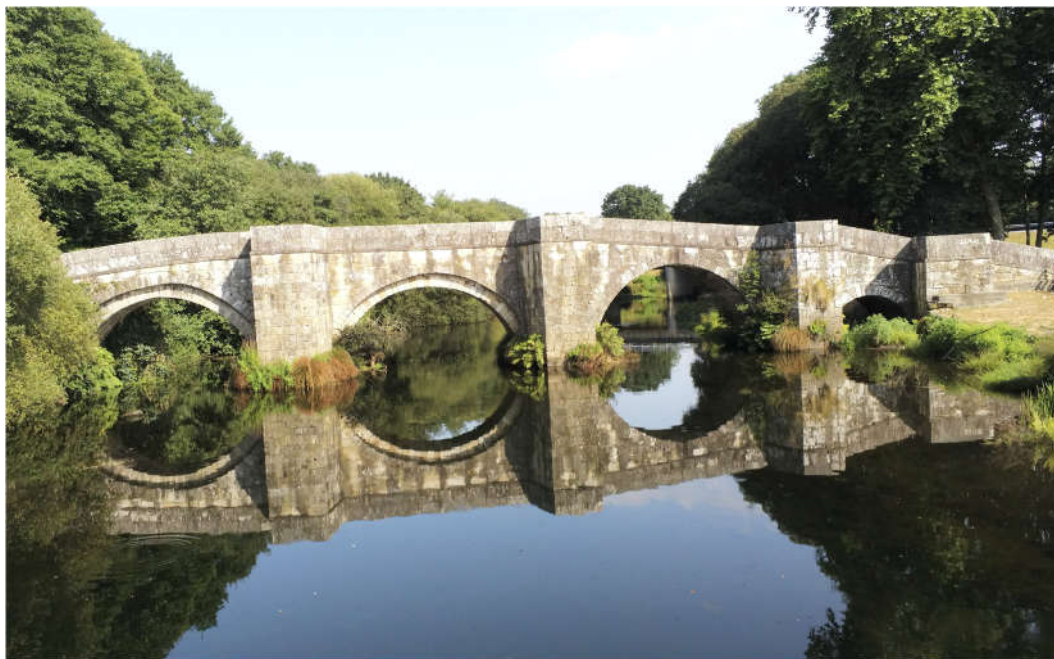
**Figure 14.** General view of the downstream elevation of the Brandomil Bridge, in an image captured by a quadcopter drone (photo by the author).

Prior to the underwater drone inspection, the bridge underwent a complete and meticulous inspection of its visible parts using a quadcopter drone [27]. This inspection made it possible to check that there were no defects in the various visible elements that would indicate that the foundation was not functioning properly.

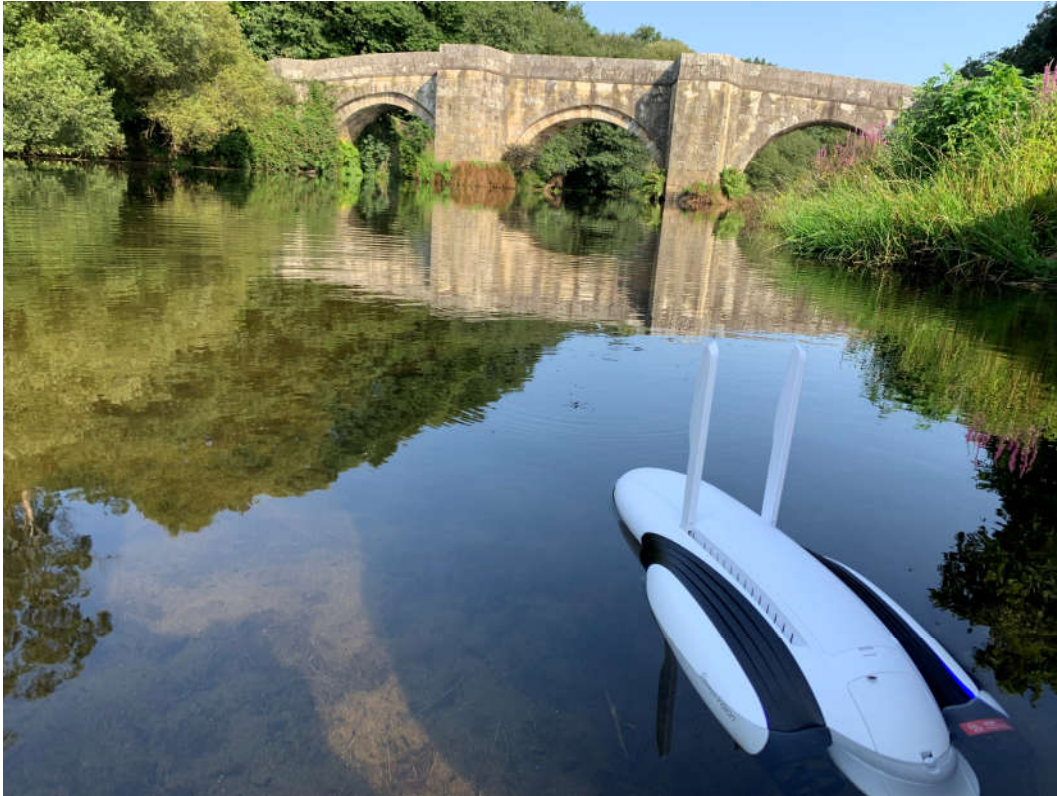
Once again, the underwater drone was launched from a point downstream of the bridge, where the riverbed was accessible (Figure 15), to navigate against the current through the Xallas River towards the stone structure, reaching the bridge to analyse the foundations of the piers built on the riverbed. The drone inspection showed that the submerged part of the elements was in perfect state of preservation (Figure 16) and that there was a slight settlement in one of the bases, which appeared as a lack of linearity of one of the courses of the ashlar. This slight movement must have taken place some years ago, as there was no evidence of any depressions in the vicinity of the foundations, particularly in the area upstream of the element in question.

**Figure 15.** Underwater drone moving along the Xallas River, approaching the downstream side of the Brandomil Bridge (photo by the author).
