Yang R, Kong Q, Ren M, Ji F and Li D
(2023), Statistical and numerical analysis
on characteristics and influence factors
of construction cracks of large-diameter
underwater shield tunnel: a case study.
Front. Earth Sci. 11:1235674.
doi: 10.3389/feart.2023.1235674

Statistical and numerical analysis on characteristics and influence factors of construction cracks of large-diameter underwater shield tunnel: a case study

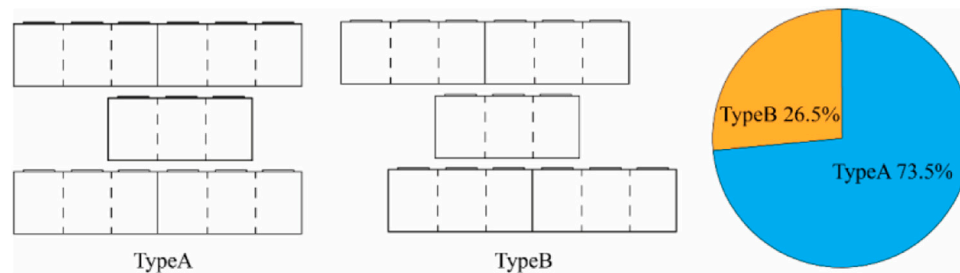
The segments were assembled with staggered joints. Therefore, the segments could be divided into two types, namely, i.e., Type A and Type B according to the positional of the longitudinal joints of the front and rear rings in relation to and the segment of the objective ring, with the exception of the K segment. The proportion of longitudinal cracks in each type of segment is shown in Figure 8. Overall, 73.5% of the longitudinal cracks were observed in Type-A segments.

FIGURE 8 Different types of segment positional relationships between the front and last ring.

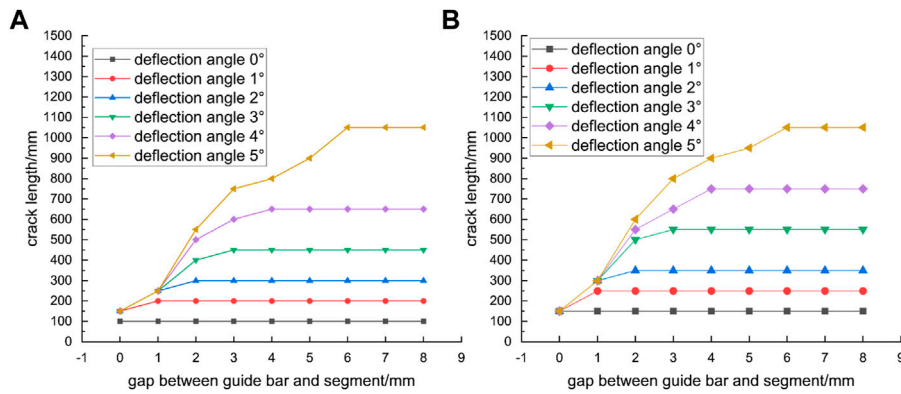
increased with the increasing deflection angle. Figure 17 shows the influence of the spacing between the guide bar and segment as well as the and deflection angle on the crack length.

FIGURE 17 Crack lengths with different segment clearances and deflection angles, jack pressure of 23 MPa (A) left crack (B) right crack.

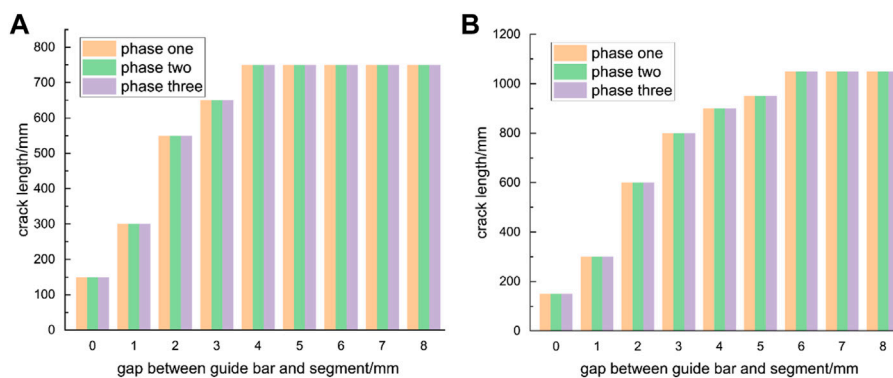
Figure 18 presents the crack lengths in three phases, where the positive cracks in the B4n segment caused by the jack deflection did not develop in the second and third phases. Therefore, the positive cracks caused by jack deflection mainly occurred during the current ring jacking stage, and subsequent tunneling contributed little to the development of positive cracks.

FIGURE 18 Crack lengths in the three phases with deflection angles of (A) 4 and (B) 5°.

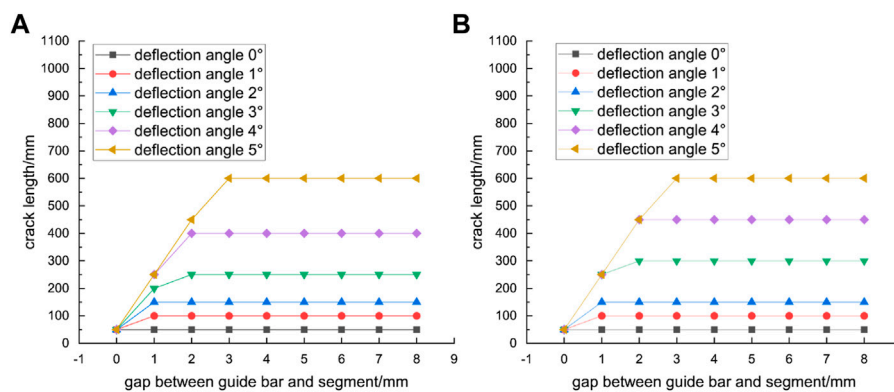
As shown in Figure 19, the crack lengths decreased significantly when the jacking pressure was 14.5 MPa, and the positive cracks were no longer obvious when the jack deflection angle was less than 3° .

FIGURE 19 Crack lengths with different segment spacings and deflection angles, with jack pressure of 14.5 MPa (A) left crack (B) right crack.
