# The Underwater Recovery Excavation at Kekova Adası: Observations on the Tek Ada Shipwreck and Finds

**Keywords:** Kekova Adası, Tek Ada Shipwreck, Skerki Bank Type IV, shipbuilding

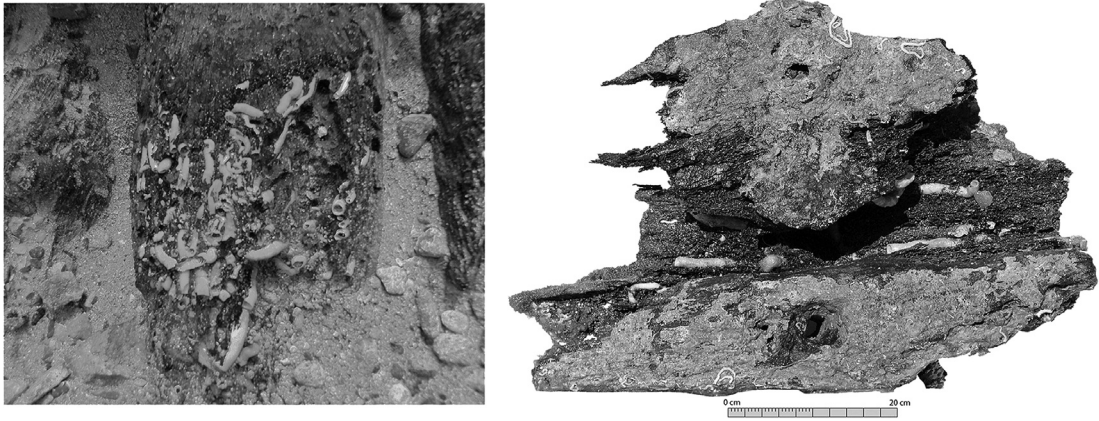
FIG. 3 Damage caused to wooden components by *Teredo Naualis* (Excavation Archive).

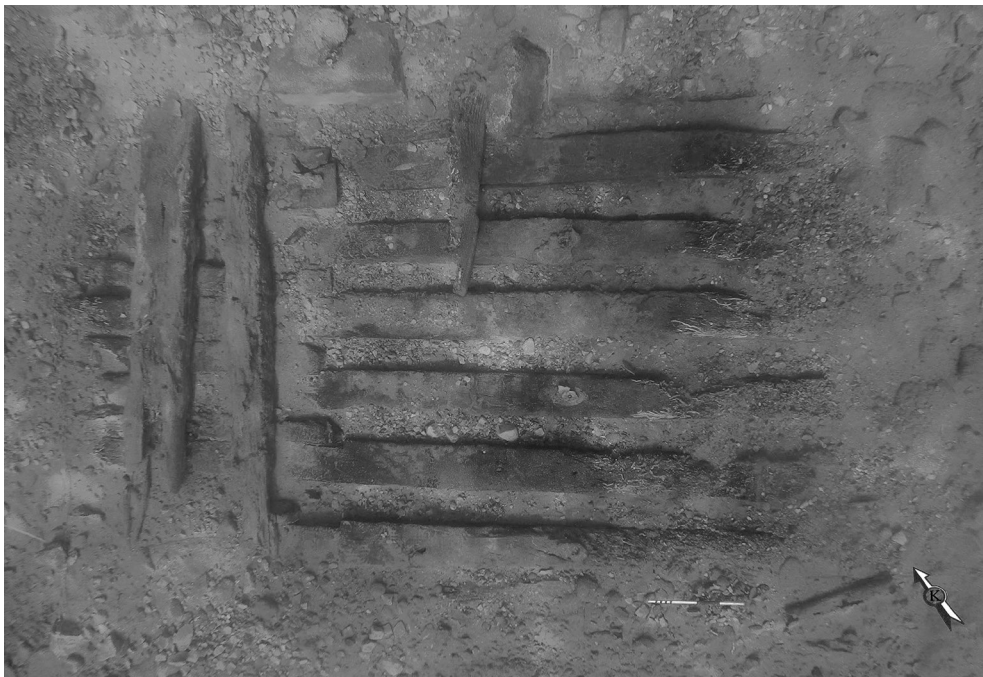
FIG. 5 Section of the hull uncovered during the excavation (Excavation Archive).

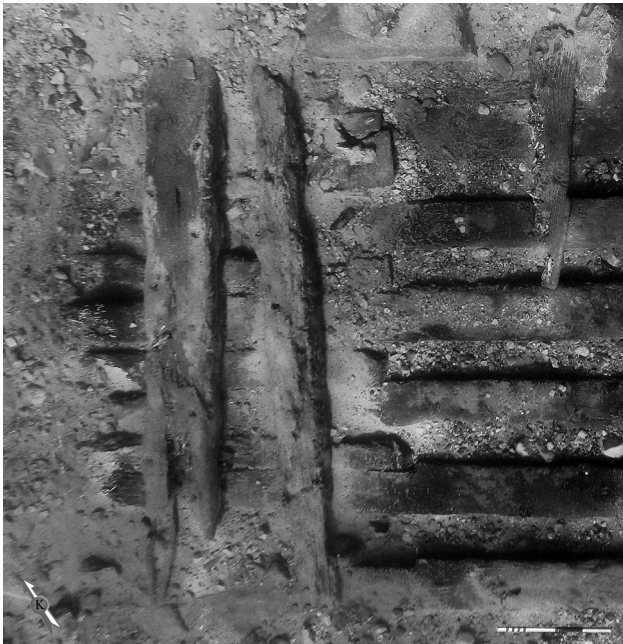
FIG. 8  
Bilge stringers  
(Excavation Archive).

Bilge stringers are the wooden components that join the ship's futtocks from the prow to the aft. They also support the ship's skeletal structure lengthwise. Parts of two bilge stringers (BS1, BS2) with this function were found *in situ* on the Tek Ada Shipwreck (figs. 6, 8). Besides these parts and in addition to BS3 found unattached on the floor timbers coded F5 and F6, independent wooden parts, most likely bilge stringers, were found on the surface in the J7 and K7 grids.<sup>20</sup> The parts that feature intense deterioration on their broken ends have a rectangular profile. On the preserved part of BS1, which is in a better state compared to the other, its height/thickness was measured as 10 cm, length as 1.85 m, and width as 25 cm.

The bilge stringers were placed parallel and approximately 20 cm apart. They vertically intersect the line at which the futtocks and floor timbers are aligned side by side.<sup>21</sup> Despite deterioration, traces of the iron nails joining the bilge stringers together with the floor timbers and futtocks are still visible on the top surface of the bilge stringers (fig. 9). These clearly visible traces of iron nails on the top surface of BS1 are in the form of two rows, 30 cm apart. One of these nail rows joins the bilge stringer to the futtocks, while the other joins the floor timbers to the bilge stringers. Upon examination of the traces belonging to the nails joining the frame system to the bilge stringers, we understood that these nails are rectangular with a 1 x 1 cm sized shank, while the head section is 8 mm high with a diameter of 3 cm.

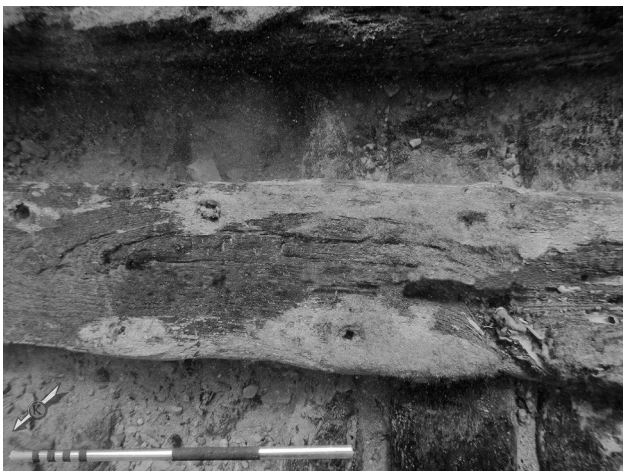
FIG. 9  
Bilge stringer detail  
(Excavation Archive).

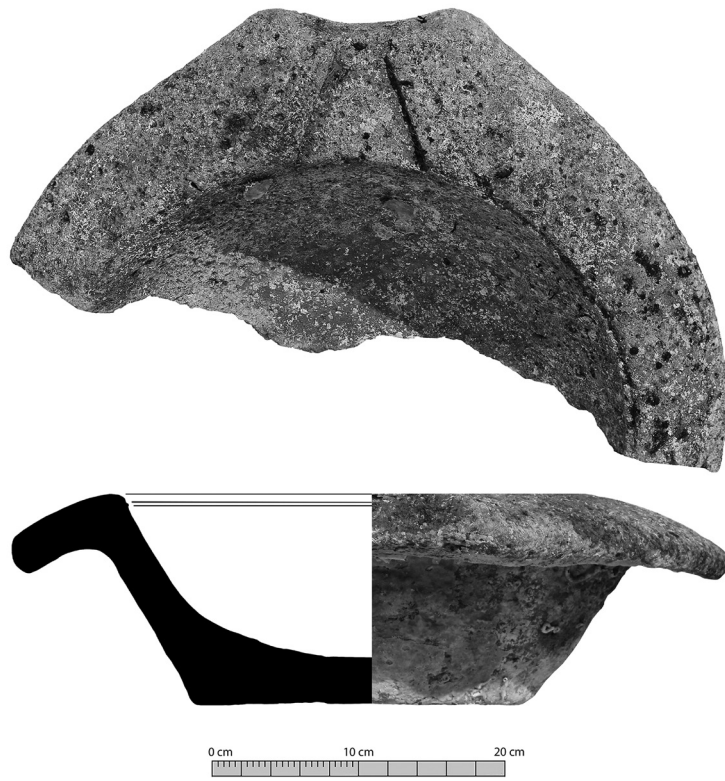
FIG. 13 Hartley Type 2 - Dramont Type 2 mortar fragment (Excavation Archive).

Among these surface findings, a piece of a mortar - used to crush and grind grains and sometimes to crush and mix food - was found on the site (fig. 13). This mortar is sporadically covered with marine growth, with half of it reaching our day in a preserved state. The edge of the rim features a large round rim that widens outward with a spout at the tip. On the outward widening edge of the rim of the mortar, there is a spout that narrows from the inside out. This was made to drain the liquid used during the maceration of the grain.<sup>24</sup> In the section where the passage from the rim to the body starts, there is an obvious groove surrounding the inner edge of the rim, which continues parallel to the spout. While the section of the body going downward after the groove makes a perpendicular angle to the outer side, it is quite curved on the interior. The body that has a relatively deep and quite thick internal wall ends with a flat, round-shaped base. This mortar has a granular surface containing sand, lime, mica, and small abrasive stone particles inside the red and brown colored hard clay but features no seal. The origin of this rim, produced in abundance during the Early Imperial period,<sup>25</sup> is central / middle Italy.<sup>26</sup> Similar examples<sup>27</sup> are named Hartley Type 2 and Dramont Type 2.<sup>28</sup> This type of Italian mortar was spread throughout the Mediterranean region by the Roman legions<sup>29</sup> and

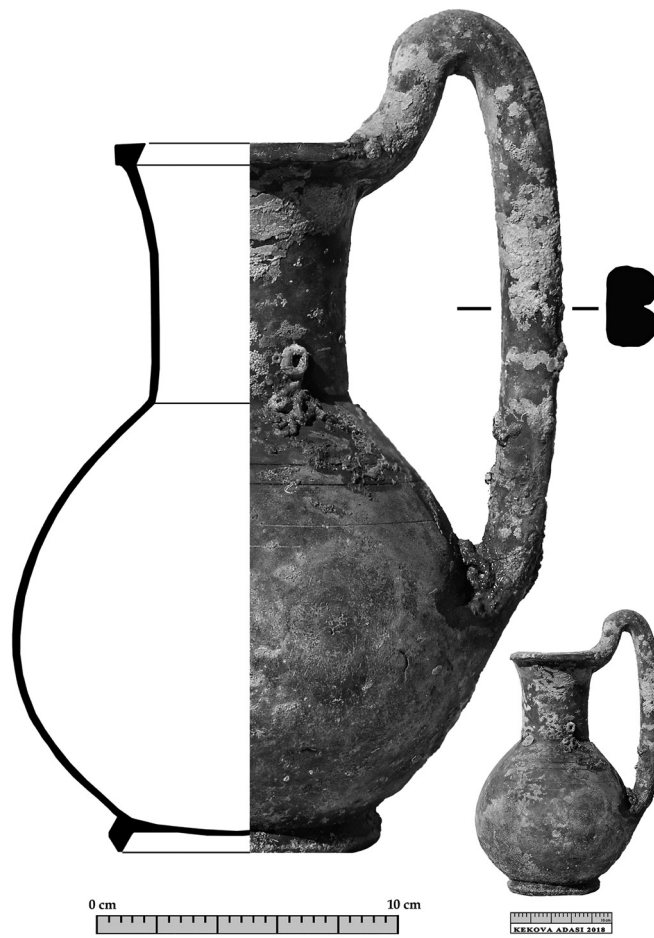
FIG. 15 Jug (Excavation Archive).

A survey was conducted around the shipwreck that considered the possibility that the finds were dispersed due to the flow in the area where the wreck was located. An amphora and one jug were found 1 m apart among the reefs 10 m deep, approximately 30 m west of the shipwreck site. The amphora is sporadically covered in shipworms, and there is a small round fracture on the body. It has parts missing on the whole rim as well as on a part of the neck (fig. 14). Despite all these deficiencies and its thin internal wall, it has reached our day in a very intact state. The amphora has the same internal wall almost everywhere and features a short, cylindrical, narrow neck, and a spherical body that meets this neck with a slight incline. This body goes down straight from the middle section and ends at the bottom with a slightly concave base that has a thin internal wall. The wide-diameter handles of the amphora, placed opposite one another, have a lentoid profile and are attached perpendicularly a little higher above the central body. Stains are forming on this container which has deterioration on its surface. The color of the outer surface ranges between light reddish yellow, light red and light brown. Its clay contains abundant mica additive and smaller white limestone granules. Two examples with a comparative characteristic style were found during underwater surveys conducted in 1994 in the strait called Skerki Bank situated between Tunisia and Sicily. These amphoras, with no similar examples found before then, have been dated between AD 850-1150. There is no certain knowledge on the origin of this type named Skerki Bank Type IV.<sup>31</sup> The jug found in the same location as the amphora was also sporadically covered in shipworms (fig. 15). This container is complete with the exception of a small fracture on the edge of the rim. It features an outward spouted rim, a long and cylindrical neck, a spherical compressed body, and a ring base that was applied afterwards. The dual-banded handle starts from the edge of the rim and forms an elbow after rising 4 cm. It then joins to the middle section of the body with an almost perpendicular angle.
