# The Dungeness Wreck: A Report on a Carvel-Built Tudor Ship from Kent, England

The 2022 discovery of a 16th-century shipwreck at Cemex's Denge Quarry, Kent, offers a significant addition to the limited archaeological corpus of English-built carvel vessels from the Tudor period. This article presents the findings from the recording and assessment of the wreck, drawing primarily on the grey literature report produced as part of the work funded by Historic England, managed by Kent County Council and undertaken by Wessex Archaeology.

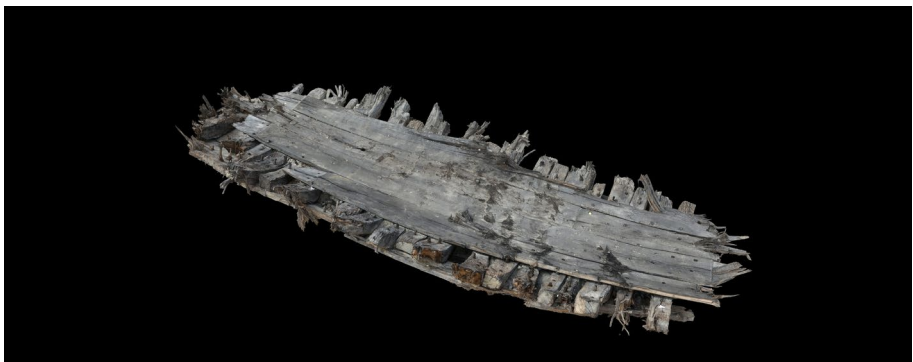
**Fig. 2** Section 5004, is 6.8×2.8 m and is the largest portion of hull preserved, from photogrammetry model

Over 140 ship timbers were recovered by the dredger. The majority were lifted in four substantial, coherent sections of carvel-planked hull (5004, 5005, 5006, 5007), reportedly lifted together on the same day from a single location (Fig. 2). Numerous smaller, disarticulated, and often damaged timbers were later retrieved during gravel processing, though whether these fragments derived from the same spot or from a wider area is uncertain, as the processed material was not separated by batch. Throughout the text, numbers enclosed in brackets [...] indicates the individual timber numbers, which are correspondingly annotated in the figures.

Despite the accidental mode of recovery, the degree of survival is remarkable. If the four large sections are aligned fore-and-aft – without accounting for the missing portions

– they would extend for over 12 m, likely representing a significant proportion of the vessel's original length.

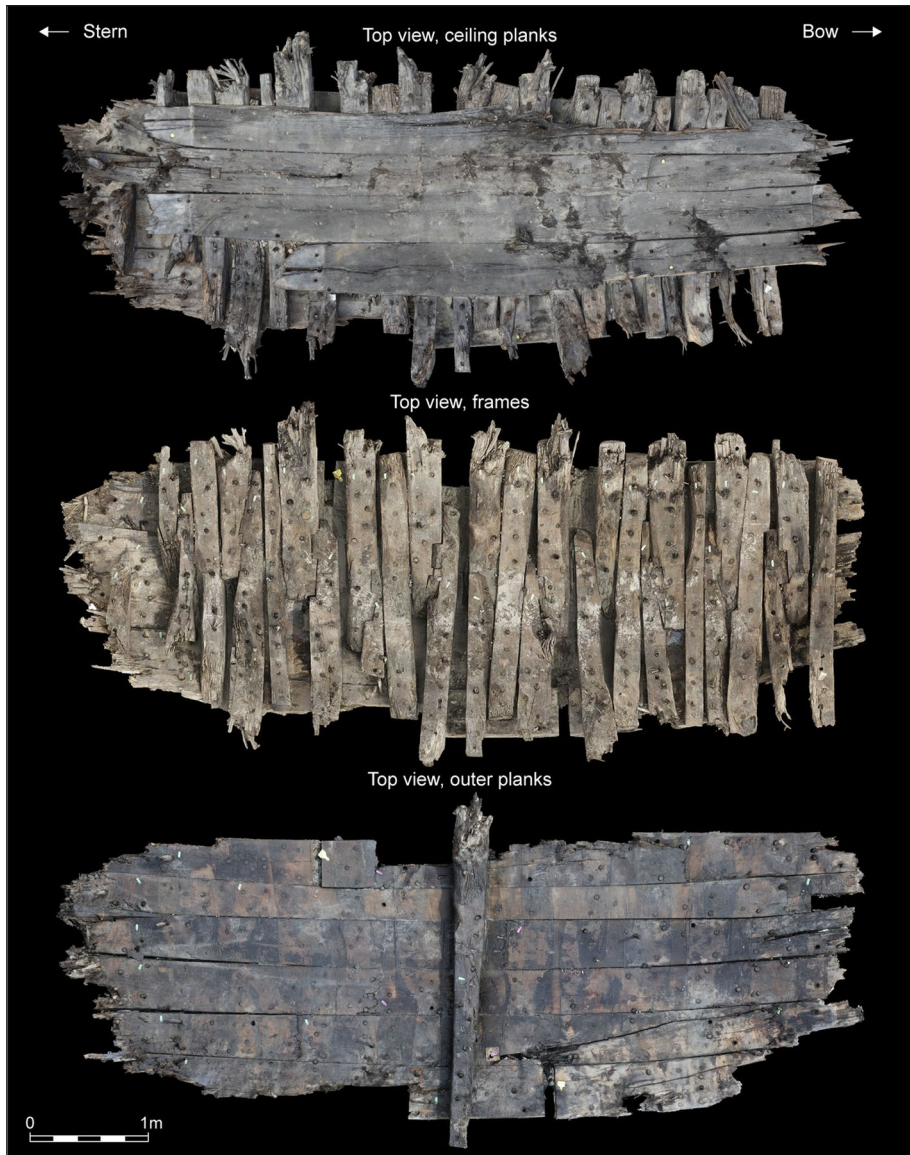
**Fig. 7** Section 5004, top view showing the different disassembly phases, from photogrammetry model

The largest surviving section, 5004, measures  $6.8 \times 2.8$  m and preserves the lower starboard hull from garboard to bilge (Fig. 7). The profile from the keel to the turn of the bilge is rounded, with flatter floors toward the stern. The keel is absent, and the section is truncated amidship in correspondence to where it would have been.

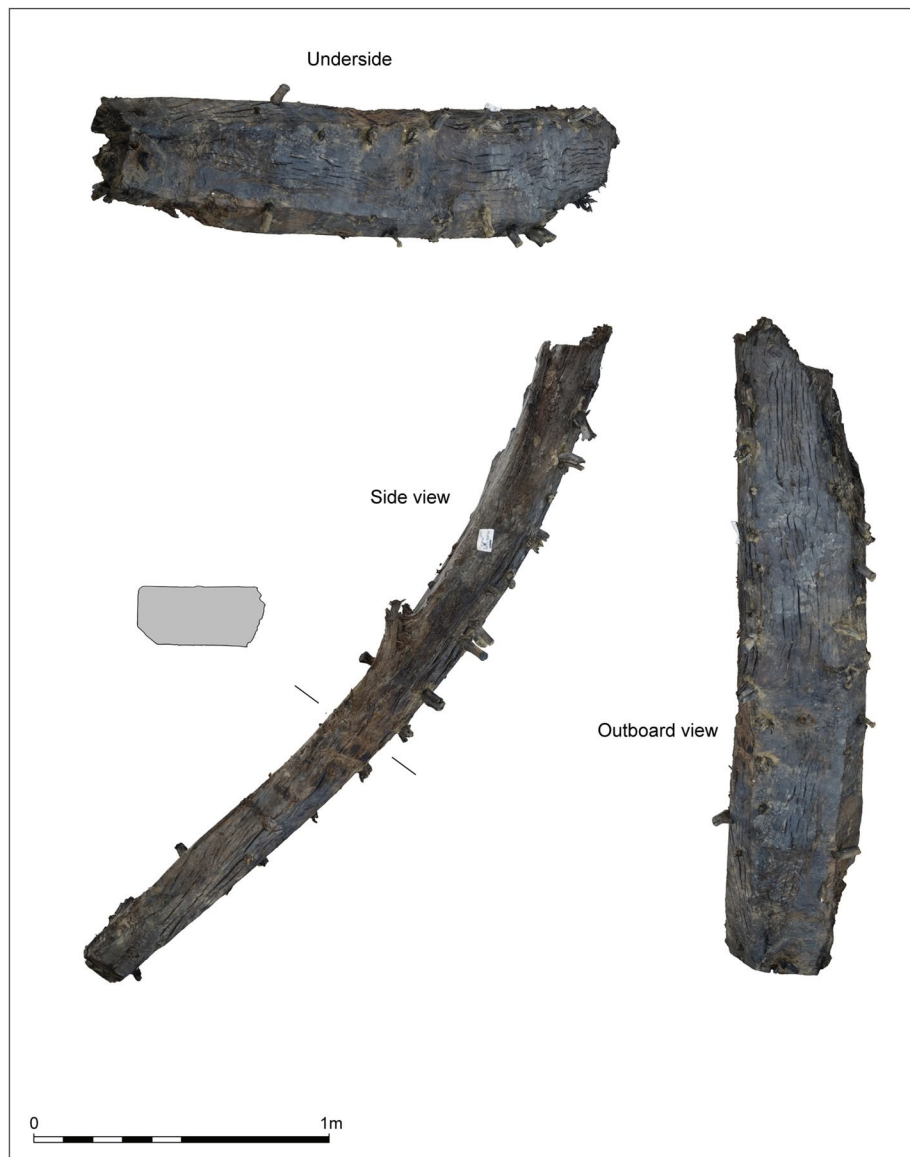
**Fig. 8** Timber [080], apron

The apron [080] is a large, curved slab of oak shaped from a half-log section, measuring 2670 mm in length, 390 mm in width, and 150 mm in thickness (Fig. 8). It is trapezoidal in section, with sides flaring out to a maximum of c. 60 degrees to the horizontal, and widens in thickness as it curves upwards, matching the stem's inner curve. One end is broken while the other has a straight cut. A total of 32 treenails are driven at an angle on its sides (15 starboard, 16 port), many of which are not through or are cut flush on the inner hollowed face. The convex outboard face has the remains of

one central bolt and one at the bottom. Multiple treenails for the hull planking remain intact, protruding up to 70–80 mm from the apron's sides. Two parallel lines carved horizontally across the inboard face probably indicate the location of transversal elements such as rising frames or crotches.
