Advanced Non-Destructive Testing Techniques for Welded Joint Repairs: A Case Study on Improving Inspection Reliability and Structural Integrity Assessment

This study evaluates advanced Non-Destructive Testing (NDT) techniques for detecting flaws in welded repairs of martensitic stainless steel plates, with a focus on Francis turbine runners. Phased Array Ultrasonic Testing (PAUT), Total Focusing Method (TFM), and Eddy Current Array (ECA) technologies were examined to assess repair integrity and identify flaws such as lack of fusion (LOF). The research compares surface and volumetric inspection methods across filler materials, including 410NiMo and 309L alloys, with an emphasis on shallow repairs (<6 mm). Conventional surface inspection methods, like Penetrant testing (PT), were insufficient for detecting subsurface flaws, especially in geometrically complex components. Subsurface flaws missed by PT were successfully identified using ECA and PAUT, underscoring the limitations of conventional techniques. PAUT achieved near-surface analysis with nearly 100% detection rates for deeper flaws, while ECA excelled at identifying partial LOF in shallow repairs. These findings highlight the

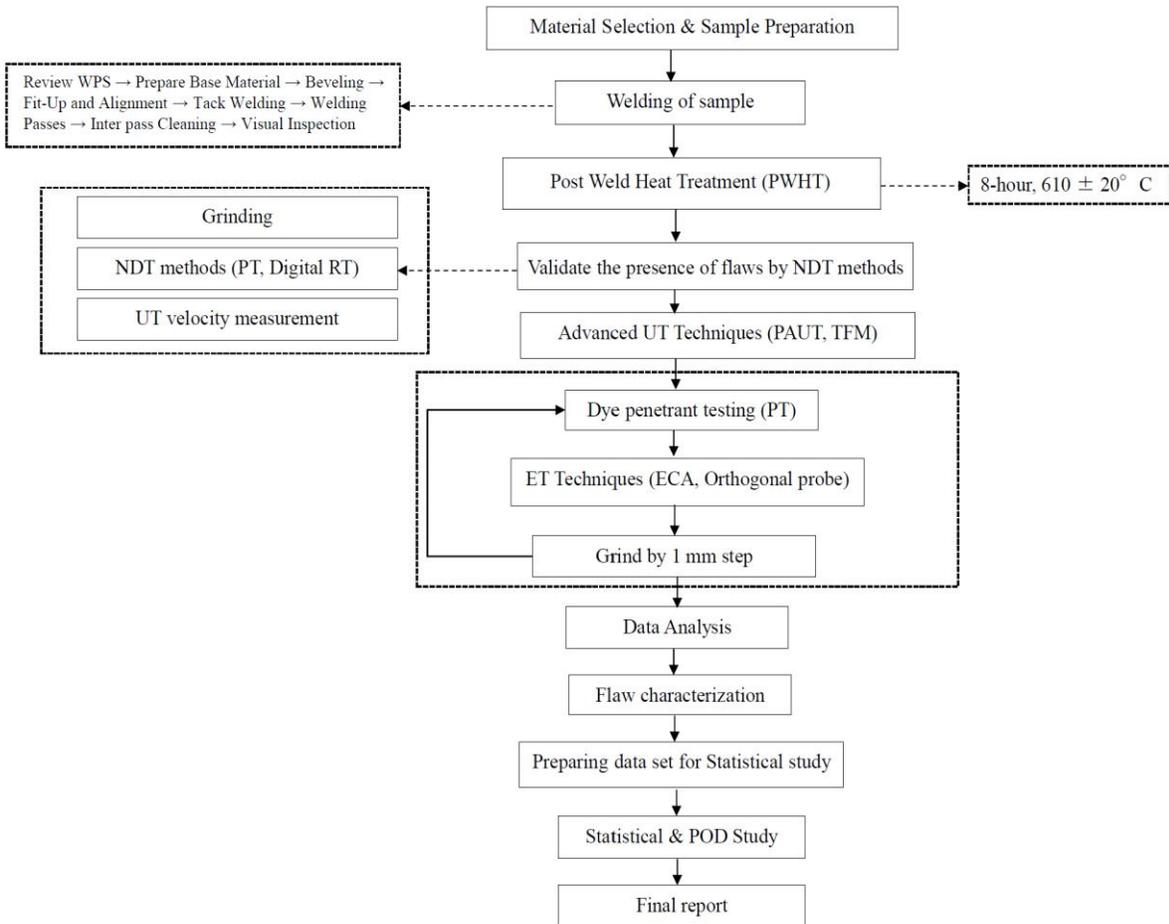
Figure 1. Workflow for current study (Note: PWHT not applied to 410 plates with 309L).

The methodology employed in this study is illustrated in the flowchart presented in Figure 1. It was designed to evaluate a range of parameters that could influence inspection outcomes. The primary objective was to assess the effectiveness of Phased Array Ultrasonic Testing (PAUT) and Eddy Current Array (ECA) technologies in inspecting repairs performed using 309L or 410NiMo filler metal on martensitic steel plates.

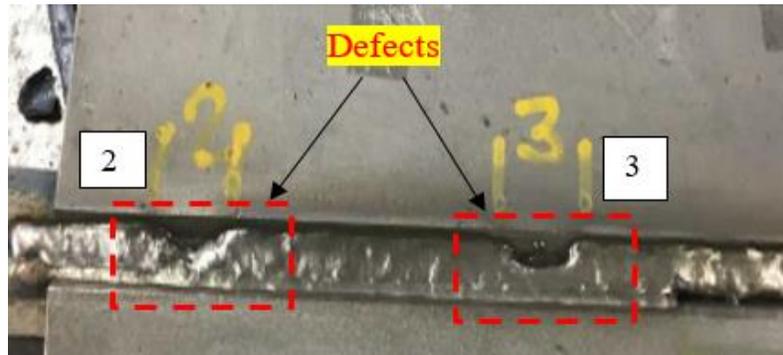
Figure 2. Examples of location of defects #2 and #3 on Plate 309-1.

The design and production of the plates were a collaborative effort between IREQ and the Québec Metallurgy Center (CMQ). CMQ supplied four 410 stainless steel plates, while IREQ provided a 415 rolled steel block. Each plate featured a V-shaped groove profile with a 30° bevel angle. The groove depth was 12 mm for the 410 plates and 18 mm for the 415 plates. Five fusion defects were intentionally introduced into each plate by adjusting the welding torch angle and speed to create a lack of bonding with the grooved wall. The defect lengths ranged from 10 to 25 mm and were distributed as follows:

- **Defect #1:** Located in the bottom pass.
- **Defects #2 and #3:** Located in intermediate passes (2nd pass for 410 plates, 3rd pass for 415 plates).
- **Defects #4 and #5:** Located in the final pass.

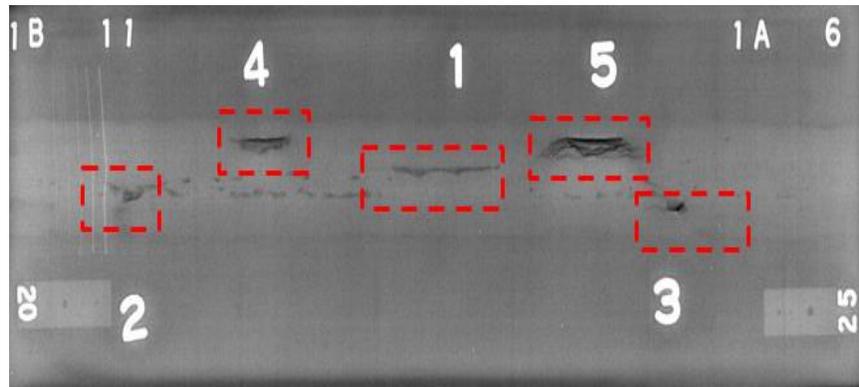
Figure 3. Radiographic Results of Plate 415 with 309L Filler

After welding, the 415 plates were subjected to heat treatment at $610 \pm 20^\circ\text{C}$ for 8 hours. If necessary, the plates were straightened, and the weld beads were trimmed. Notably, near-surface defects in specimen 415/309L cracked during the straightening process, exposing defect #5 at the surface. Subsequently, the plates were subjected to X-ray inspection to verify the presence of

fusion defects, as shown in Figure 3. All 20 expected defects were confirmed, although they were shorter in the 415 specimens. Additionally, some unintentional welding defects were observed.

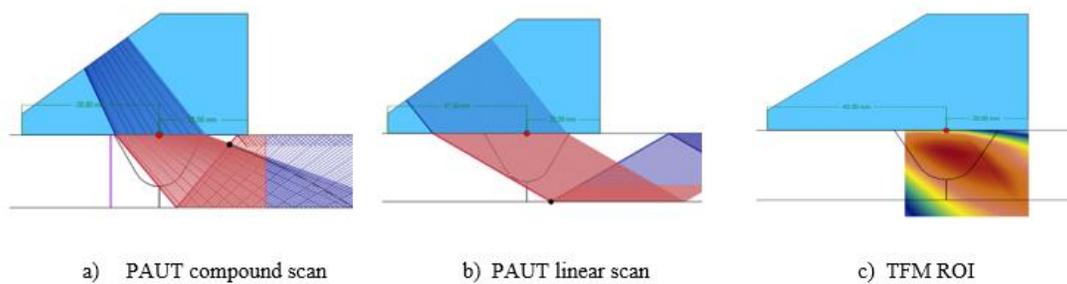
Figure 4. Beam simulation of three ultrasonic array techniques for detecting near-surface fusion defects.

and generated projected views of defects. The primary focus of the inspection was the fusion zone between the groove preparation and the filler metal. Given the plate geometry, inspections were carried out on both sides of the repair, with waves incident normally on the bevel to produce strong echoes returning to the probe (Figure 4).

- **UT Technique #1: PAUT-Compound Scanning:** This technique varied the angle of incidence to generate a fan-shaped beam array, covering angles from 40° to 70° in 1° increments. The range of angles, the number of elements, and the distance from the wedge were determined to ensure full coverage of the region of interest at near-normal incidence with the repair joint.

- **UT Technique #2: PAUT-Linear Scanning:** A fixed angle of incidence of 60° , perpendicular to the groove face, was used. For the 415 plates, two scans were required, and the resulting data files were merged.

- **UT Technique #3: Total Focusing Method (TFM):** Total Focusing Method (TFM) is a data-processing algorithm rather than a conventional beam-forming technique. In this approach, each element in the array was activated sequentially, while all 64 elements continuously received reflected signals [11]. The resulting image depicted ultrasound density, providing a visual representation where voxel colors corresponded to the probability of defect presence.

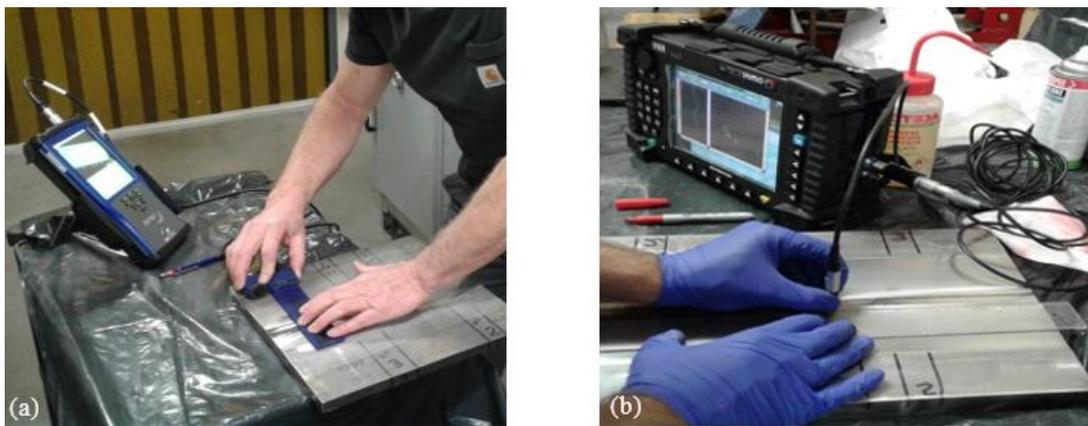
Figure 5. Eddy current testing: (a) ECA Inspection and (b) Orthogonal Probe

Both ultrasonic and ECA scanning were conducted using encoded linear scanning. The scan direction was aligned parallel to the weld axis, with the probe distance from the weld adjusted to ensure the required coverage. The orthogonal probe was manually positioned using a guide along the weld edge, and discontinuities were recorded where signal indications were detected as shown in figure 5.

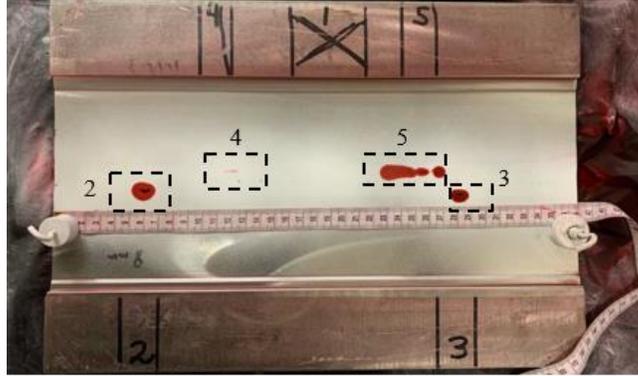
Figure 6. PT of Plate 309-2 at 8 mm Depth.

It is also important to note that during straightening, lack of fusion indications #4 and #5 in specimen 309-2 cracked. Indication #4 did not reach the surface, while indication #5 produced a wide penetrant indication, as shown in Figure 6.

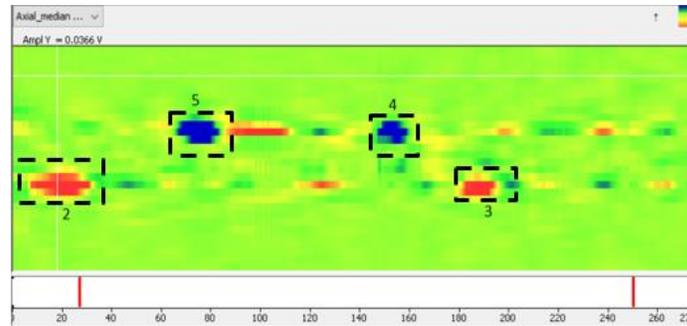
Figure 7. C-Scan ECA at 20 kHz of specimen 309-1 after 2 mm trim; Surface-Connected (blue) and Non-open (red) fusion defects.

Due to time constraints, the influence of permeability and lack of fusion (LOF) on the eddy current signal was not studied in detail. However, it is reasonable to assume that an optimized coil configuration and frequency could effectively separate these two effects, enabling efficient inspection of 309L/415 repairs for the presence of LOF. The eddy current inspection was performed after each trimming operation, concurrently with penetrant testing. Data collected included the presence or absence of indications, their positions, and lengths. This approach allowed for a direct correlation between the eddy current measurements and penetrant testing results. An example of an ECA C-scan is shown in Figure 7, derived from specimen 309-1 after the second trimming. Calibration was performed to ensure that a lack of fusion connected to the surface (positive in penetrant testing) produced a vertically oriented signal phase, resulting in a blue indication. For non-surface-breaking indications, the signal phase rotated due to the skin effect delay, resulting in a red shift. The color variation was proportional to the ligament depth.

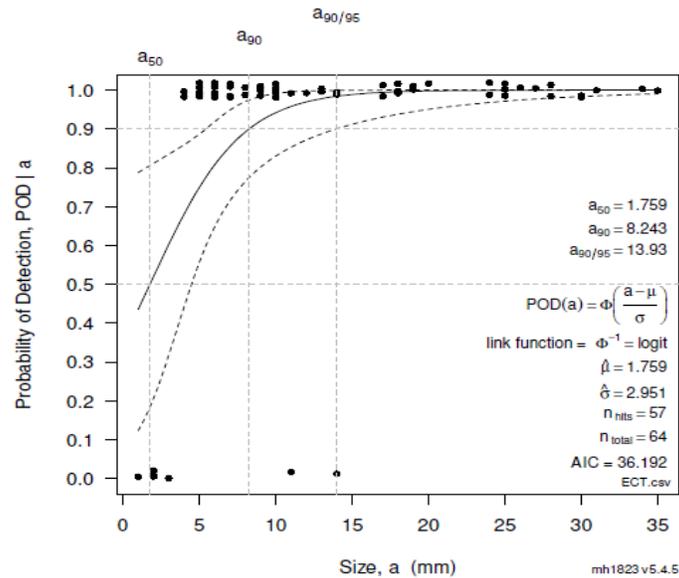
Figure 8. POD Hit/Miss curve using MH1823 Software for 3 mm ECA Probe Detection as a Function of Penetrant Indication Length

A correlation was established between the length of penetrant indications – that we consider as the defect size - and the probability of detection (POD) using the 3 mm ECA probe. The data were analyzed using MH1823 software [15], resulting in a POD curve for surface-connected LOF as a function of defect length. The calculated defect length corresponding to a 90% detection probability was 8.24 mm, as shown in Figure 8. Most ECA-negative indications had lengths of 3 mm or less.

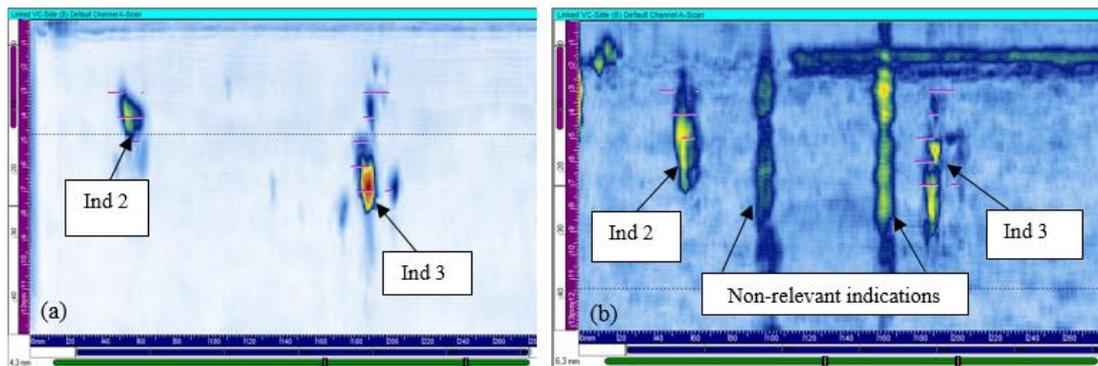
Figure 9. TFM Results for Plate 410 with 309L Filler Material; (a) LW at 5 MHz showing clear flaw details, and (b) SW at 5 MHz showing distorted signals and non-relevant indications; Vertical magenta lines represent the PT results.

Anisotropy was observed during shear wave inspection of plate 410 with 309L filler metal. In Figure 9, Figure (a) shows the response of flaws #2 and #3 using TFM with a 5 MHz compression wave (LW). The flaws exhibit distinct ultrasonic responses with minimal grain noise. The PT results are overlaid as magenta lines on the ultrasonic image. Figure (b) displays the results using TFM with a 5 MHz shear wave (SW). In this case, flaws #2 and #3 appear elongated in the vertical plane, non-relevant indications are present between flaws #2 and #3, and the grain noise is more pronounced.

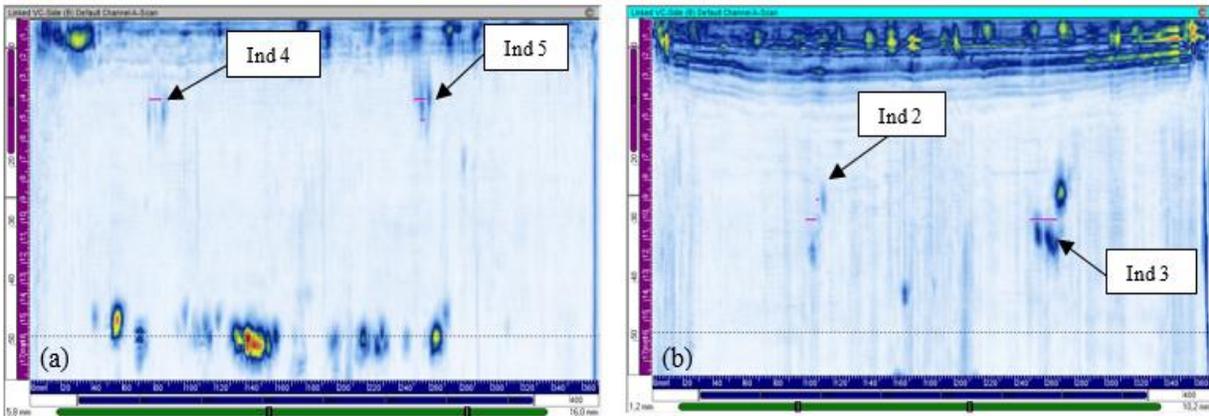
Figure 10. TFM response at 5 MHz for Plate 415 with 410NiMo Filler metal (a) Compression Wave at Skew 90 (b) Compression Wave at Skew 270 (Vertical magenta lines represent the PT results).

The TFM results, shown in Figure 10, demonstrate that the ultrasonic responses for indications #2, #4, and #5 are very weak, falling well below the detection threshold. This observation raises a critical question: could the 410NiMo filler material, with the applied welding parameter variations, exhibit a reduced tendency to form fusion defects?

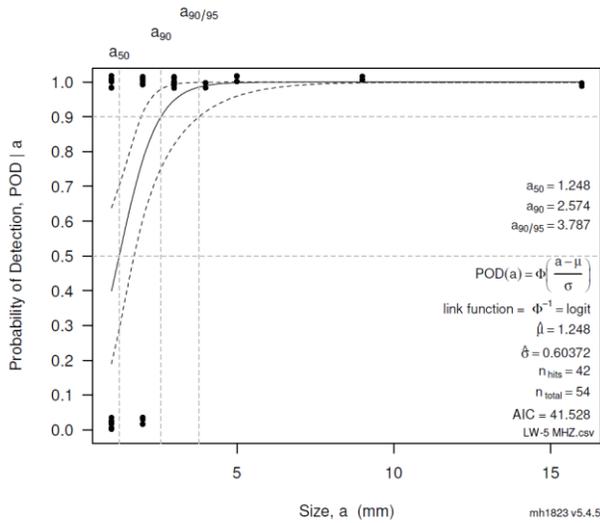
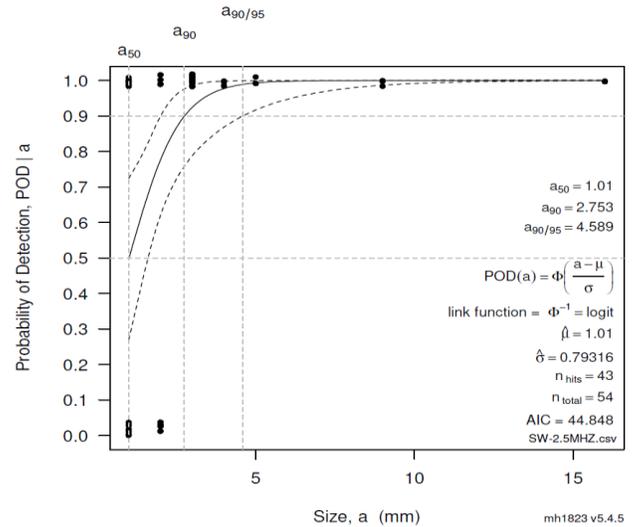
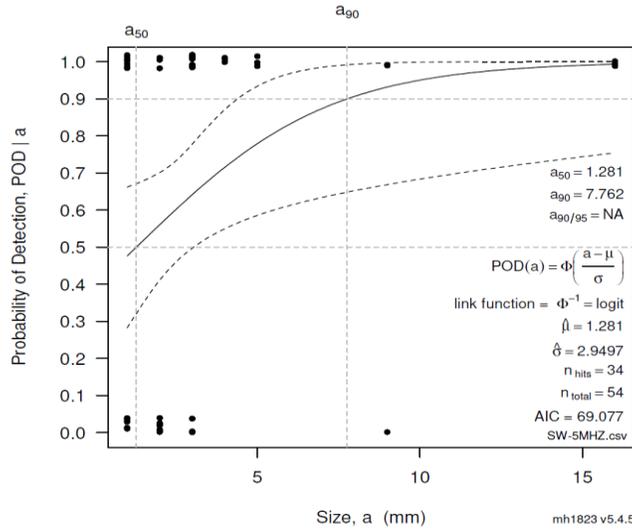
(a) POD curve for longitudinal wave at 5 MHz

(b) POD curve for shear wave at 2.25 MHz

(c) POD curve for shear wave at 5 MHz

Figure 11. POD curves by mh1823 software; All UT array techniques results merged as function of wave mode and frequency (The horizontal axis is flaw height).

Using the lack of fusion (LOF) size determined by stratigraphic PT measurements (red penetrant leaking indication size), the UT array data were processed to compute Probability of Detection (POD) curves as a function of wave mode and frequency. UT array data from TFM, PAUT compound, and linear scans were combined to analyze the detection of known LOF heights. POD curves for the hit/miss algorithm, generated using MH1823 software, are shown in Figure 11. The LOF height required to achieve a 90% probability of detection is 2.574 mm for a 5 MHz compression wave, 2.753 mm for a 2.25 MHz shear wave, and 7.762 mm for a 5 MHz shear wave, as presented in Table 10. The first two mode/frequency combinations demonstrated very similar detection capabilities for embedded LOF in repairs on martensitic steel.
