Thesis for the Degree of Doctor of International Area Studies

An Interdisciplinary Study on the wreck of the USS *Kearsarge* in Roncador Cay

The Graduate School of Korea Maritime & Ocean University

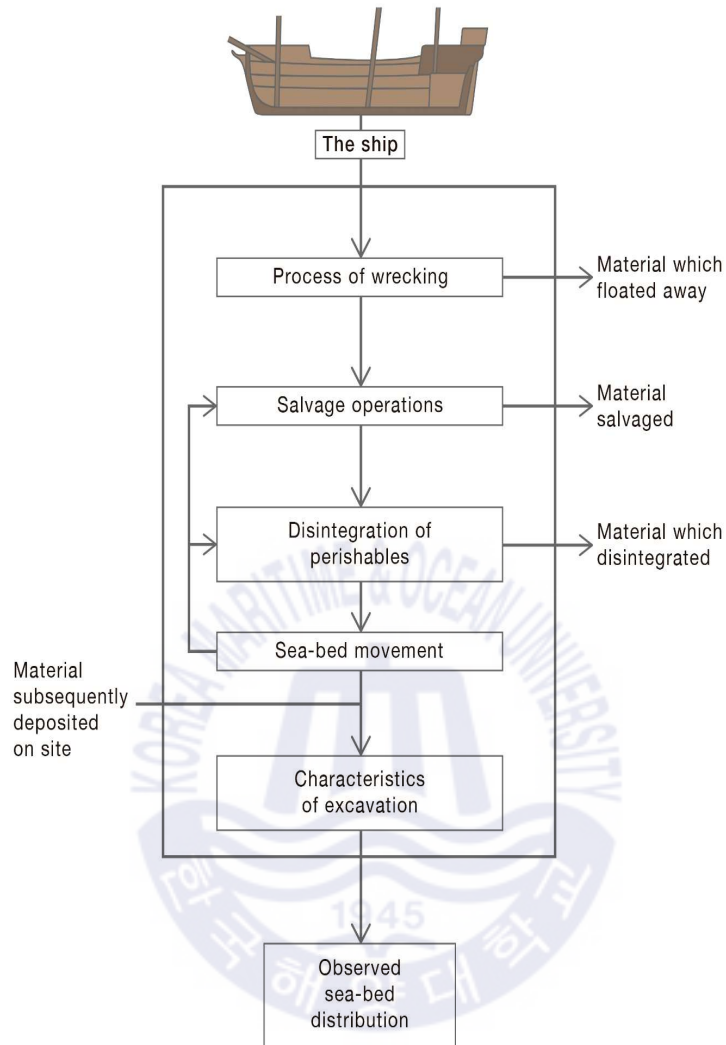
Fig. 2 *Flow diagram representing the evolution of a shipwreck. Based on Muckelroy, 1998:269.*

One of the initial methodologies was established by Muckelroy (1976) for a holistic study of shipwrecks and applied to the *Kennemerland*, a Dutch East Indiaman sailing ship lost in Scotland in 1664 and found in 1971. He defined five processes influencing the shipwreck for maritime archaeology: the processes of wrecking, salvage operations, the disintegration of perishables, seabed movement, and the method of excavation⁶¹⁾ (Fig. 2). Also, the geomorphological process is an important research component to interpret the wreck on the seabed and is a crucial component in researching the origins of historical shipwrecks when primary sources are limited to approach the causes or in attempting to interpret them. Also, the site formation process includes ocean conditions and sediment in the marine environment contributing to the wreck site.⁶²⁾

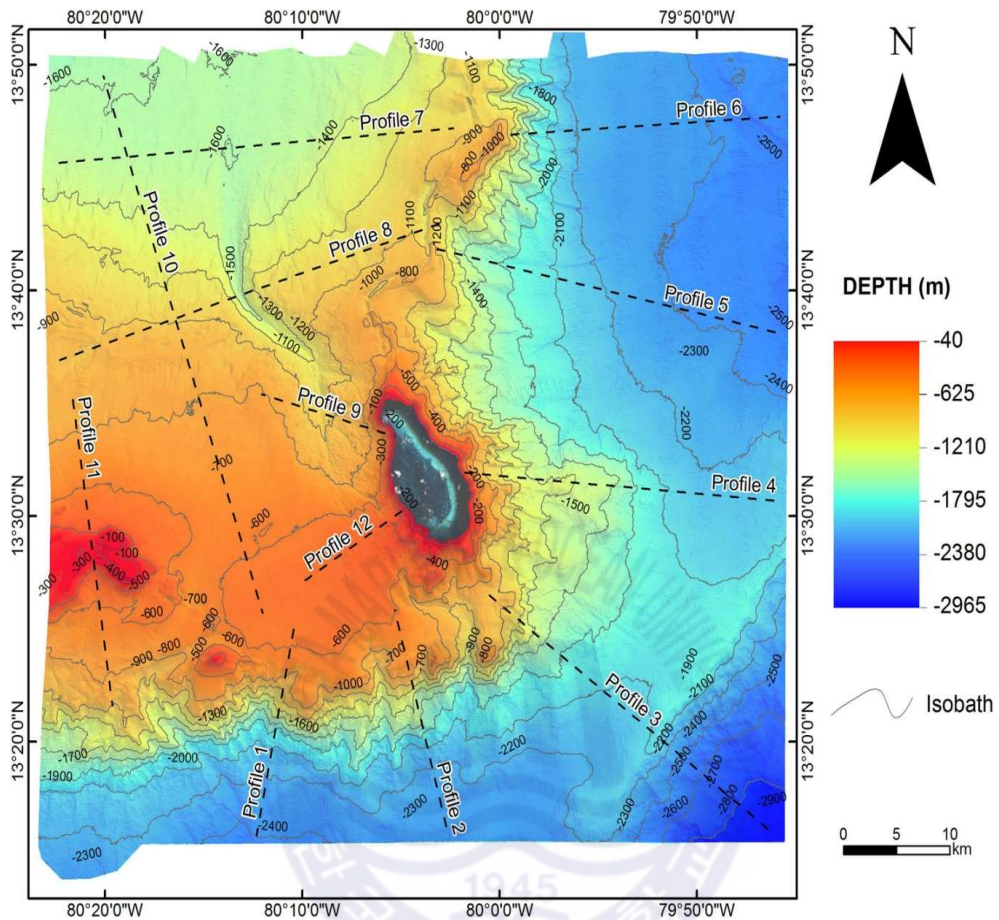
Fig. 15 Bathymetric model, with gray scale hillshade behind, of Roncador Bank and adjacent areas (Idárraga-García and León, 2019).
