RESEARCH ARTICLE

Risk assessment of war wrecks – a comprehensive approach investigating four wrecks containing munitions in the German Bight/North Sea

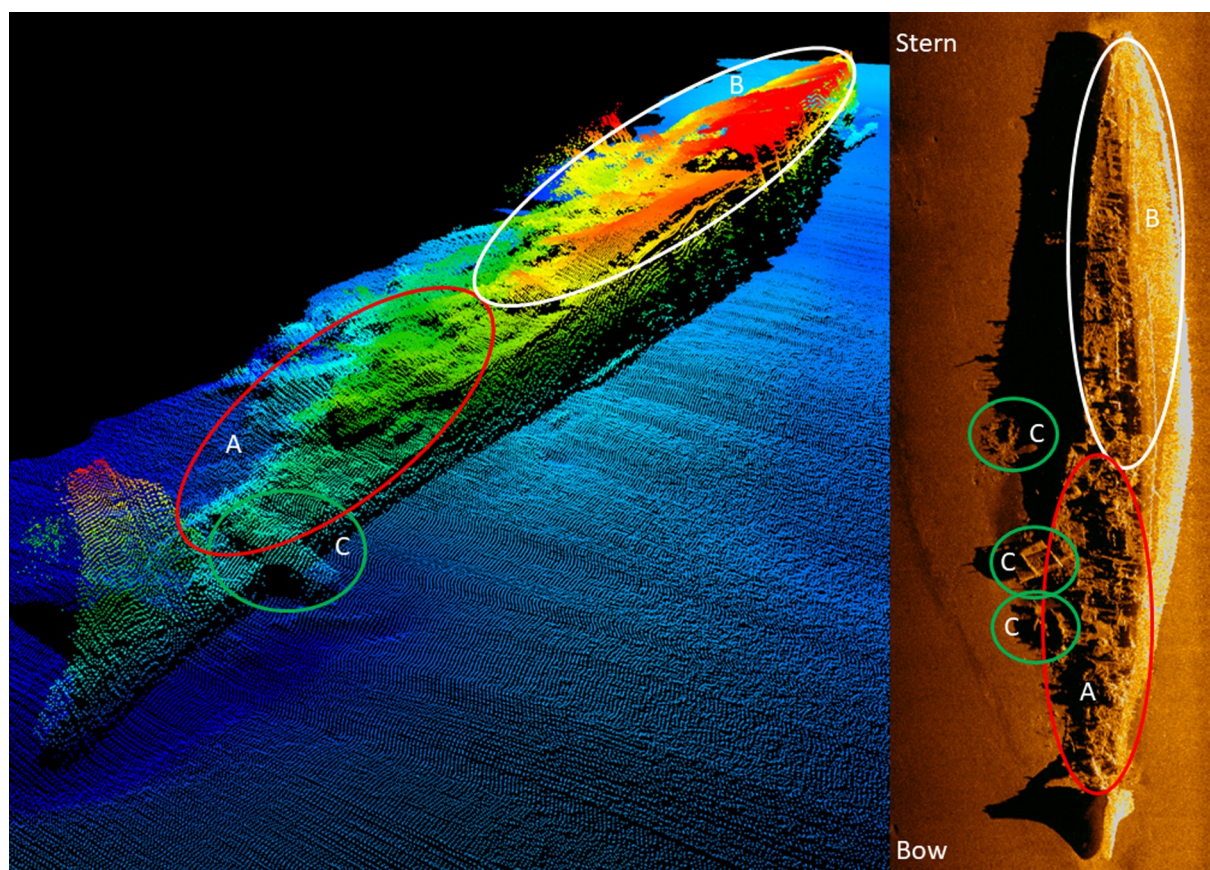
FIGURE 7 3D animation of AUV multibeam echosounder (left) and 2D animation of AUV side scan sonar (right) from the wreck site of the SMS HELA. Red circle (A)=damaged fore ship area, white circle (B)=well preserved midship area and aft, green circle (C)=unidentified objects. (Scans provided by DLR).

protrudes to a height of ≈ 7 m at the bow and ≈ 5 m in the aft from the surrounding sediment. Bow and prow are well preserved, but the fore ship is completely damaged. It seems that the entire fore ship area up to the level of the former waterline and up to the area of the former bridge is affected by this destruction. In this area the ship's front munition chamber was situated, as well as the torpedo rooms. The midship area, aft and stern are relatively well preserved. In the stern area, the wreck seems to be preserved possibly up to the level of the former upper deck. The stern itself seem also intact and raised slightly from the sea bottom. Because of this, the portside propeller shaft is visible. The state of preservation of the starboard propeller shaft is not clear. This also applies to the unclear presence of the propellers in general. In the destroyed fore ship area, many larger and smaller fallen objects, which are not identified yet, can be seen.

be at least recognisable (Figure 7). Clearance or salvage actions on the wreck are not assignable in the wreck biography so far. However, as especially the fore ship area is conspicuously damaged, blasting actions were probably carried out here in the past. Eyewitnesses of the sinking on the other hand mentioned that it looks like the fore ship would break apart but then sunk very quickly while the aft section was already under water.⁶ This could be also a reason for the destruction in the fore ship area. Although no evidences for a break can be seen in the scan-data so far.
