# Underwater Archaeological Survey of the SS *Samuel J. Tilden* Wreck (Bari, Italy)

## Abstract

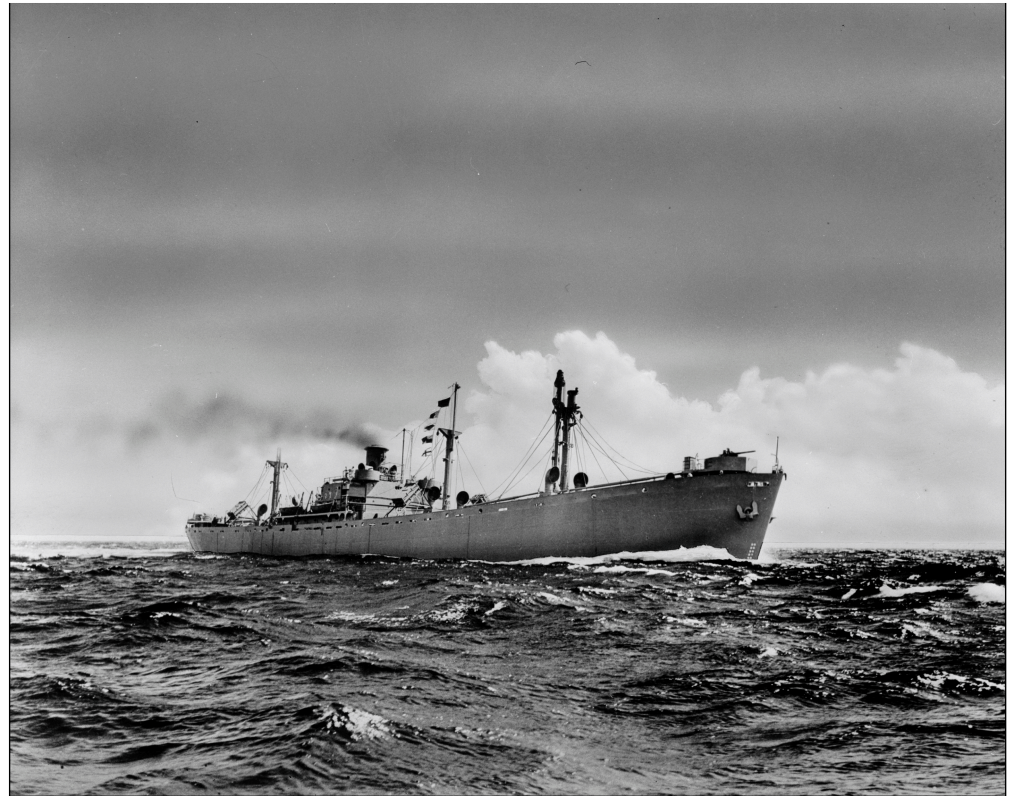
**Figure 2.** U.S Liberty-class cargo ship SS *Star of Oregon* (EC2-S-C1) built by the Oregon Shipbuilding Company of Portland, Portland, OR, USA. *Tilden* was built in the same shipyard (source: US Office of War Information, OWI, Washington, DC, USA).

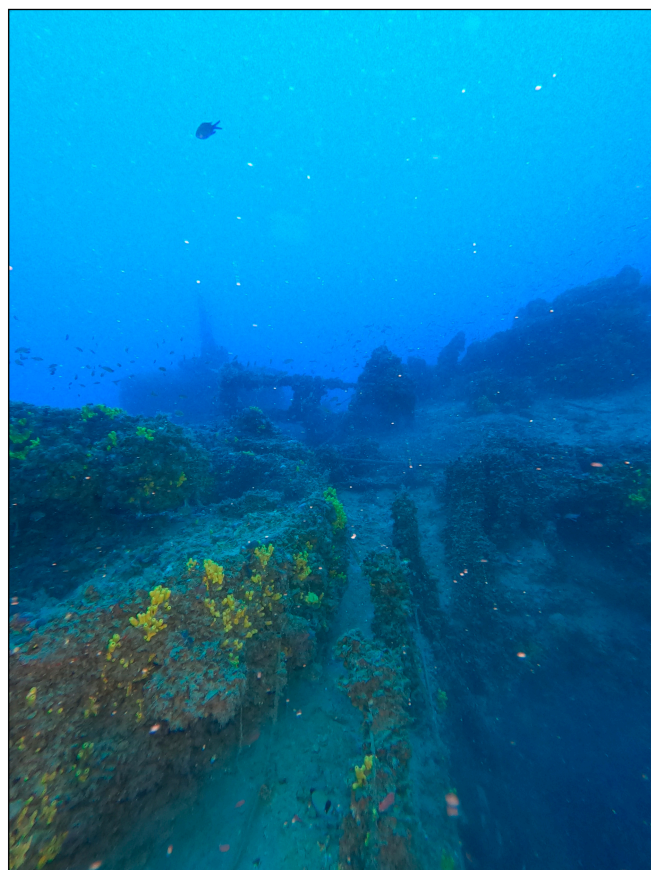
**Figure 5.** Detail of the *Tilden* wreck deck, July 2025 (authors: Arma dei Carabinieri Diving Units).

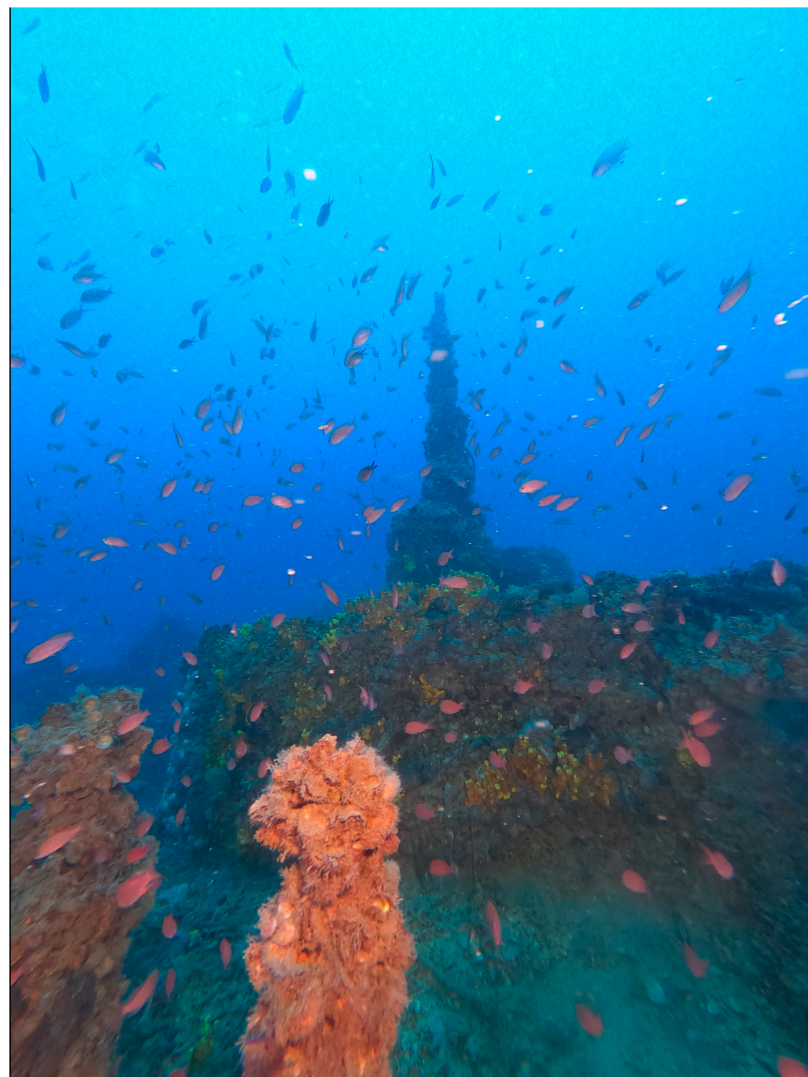
**Figure 7.** Detail of the *Tilden* wreck, July 2025 (authors: Arma dei Carabinieri Diving Units).

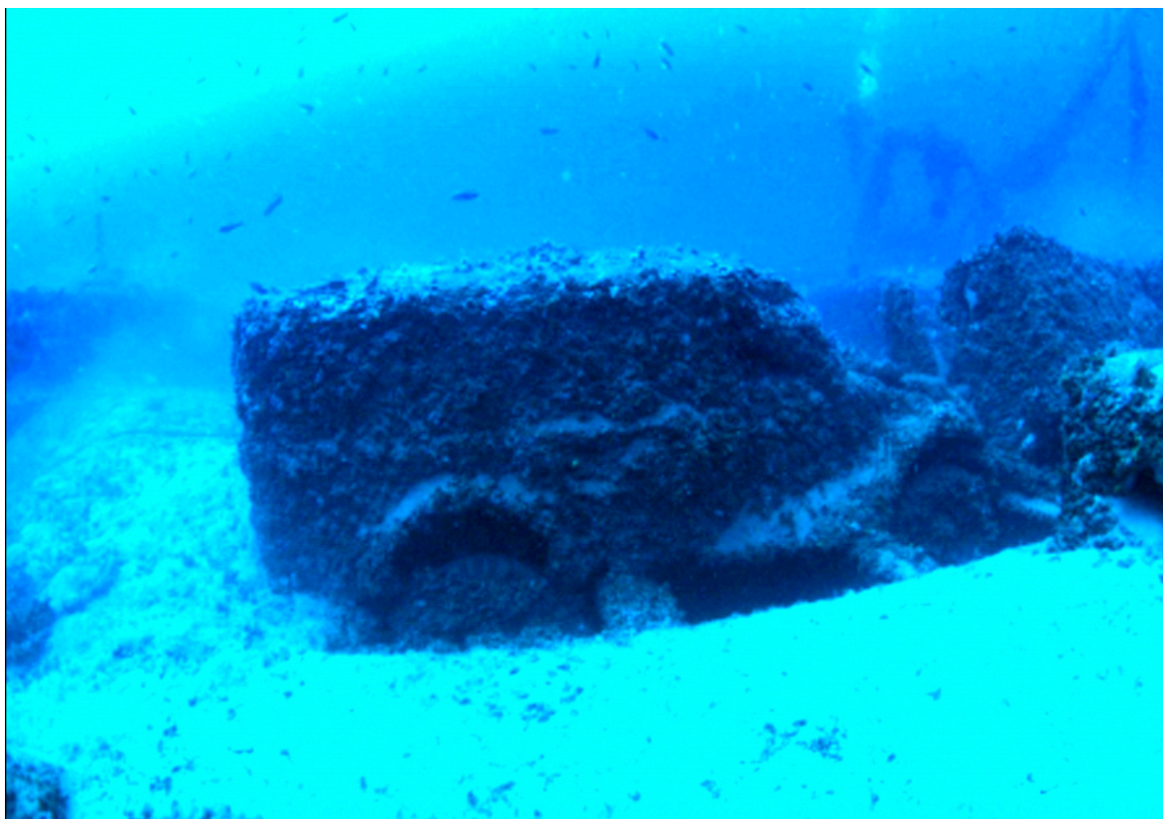
**Figure 12.** Detail of a vehicle, perhaps an ambulance, on the aft deck of the *Tilden*, 2011 (authors: Arma dei Carabinieri Diving Units).

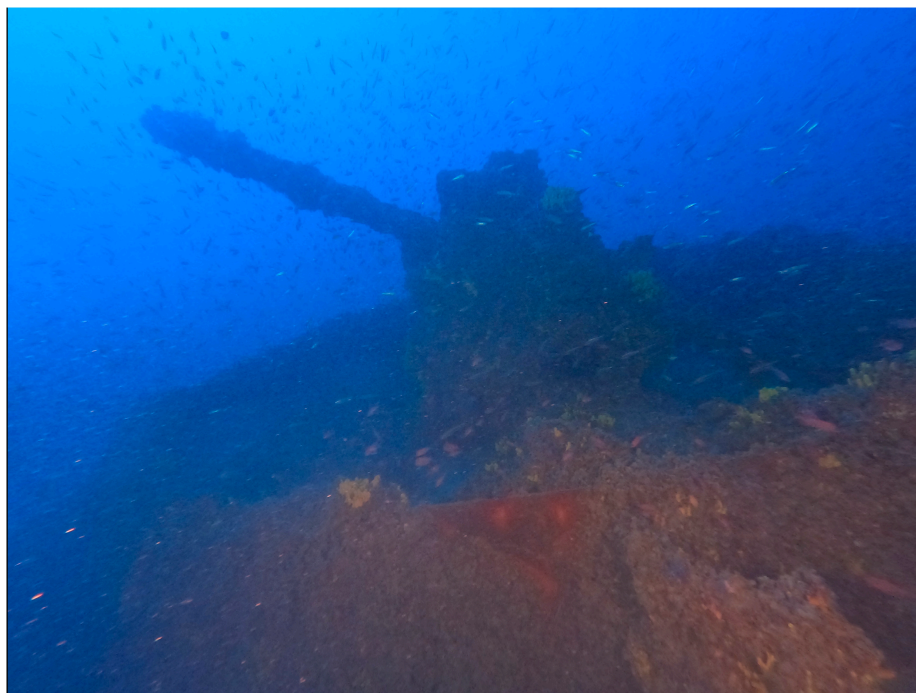
**Figure 14.** Detail of the *Tilden* wreck—20 mm Oerlikon machine gun, July 2025 (authors: Arma dei Carabinieri Diving Units).
