# Non-Destructive Techniques for the Condition and Structural Health Monitoring of Wind Turbines: A Literature Review of the Last 20 Years

**Citation:** Civera, M.; Surace, C. Non-Destructive Techniques for the Condition and Structural Health Monitoring of Wind Turbines: A Literature Review of the Last 20 Years. *Sensors* **2022**, *22*, 1627. <https://doi.org/10.3390/s22041627>

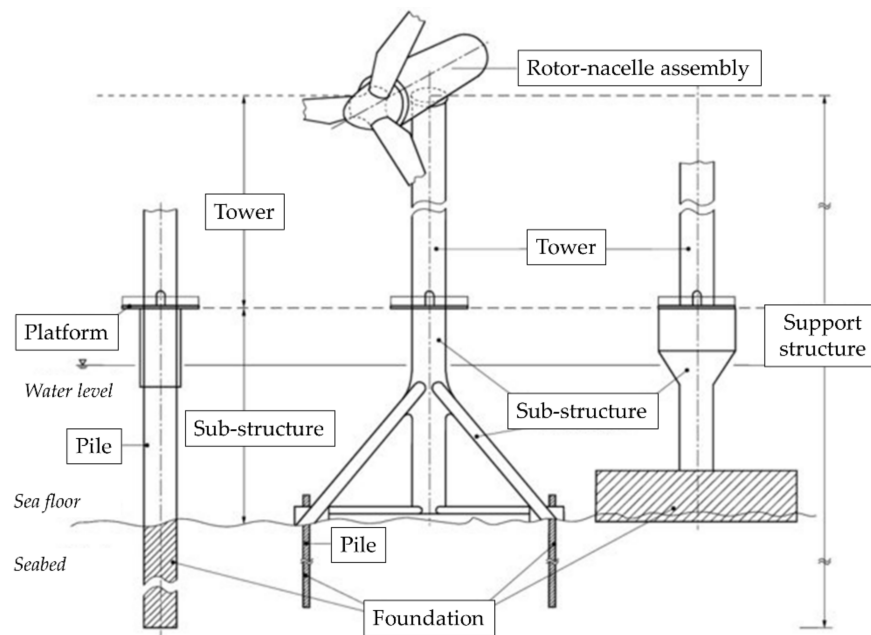
**Figure 4.** Structural components of a fixed offshore HAWT according to IEC 61400-3-1.

It must be mentioned that offshore HAWTs, differently from their onshore counterparts, include a further group of structural elements, which are included below the platform and above the sea floor (Figure 4). These components are particularly at risk due to their location under water or—even worse—in the splash zone, immediately above/below the mean water level and highly subject to corrosion. Furthermore, being submerged, they cannot easily be visually inspected if not using divers or manned/unmanned underwater inspection robots. They are also subject to marine growth and other potentially damaging environmental conditions such as wave, tidal, and current forces.

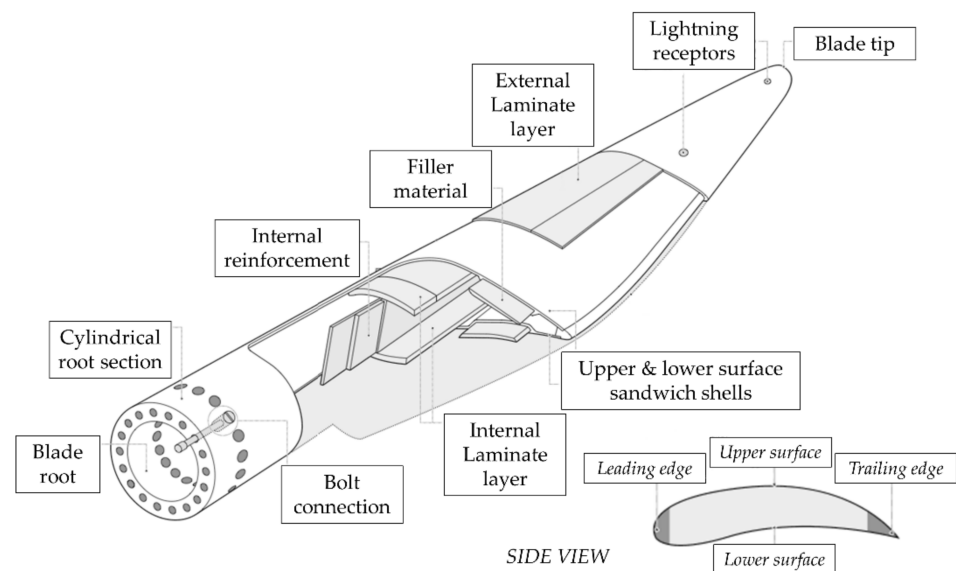
**Figure 5.** Key components of a typical wind turbine blade. The upper and lower surfaces are also known as the suction (or windward) and pressure (or lee) sides, respectively. The blade root bolt connection shown here is a classic T-bolt type.

The blade design is actually quite complex, with several different components and materials as pictorially described in Figure 5. This complexity makes them particularly susceptible to manufacturing defects, which indeed were estimated in Ref. [36] to account for ~51% of all blade damages (with debonding and voids in skin core being the most common defects at 20% and 18%, respectively).

The blade tip and trailing edge (refer to Figure 5) are generally designed and shaped to minimize aerodynamic noise, which makes them thin and particularly prone to the occurrence of mechanical damage. A full-scale static test showed that a 40 m-long E-glass/epoxy composite WT blade can bear tip deflections up to 11 m under flap-wise loading before structural collapse [47]. This large flexibility, however, may cause the blade tip to hit the HAWT tower under exceptional wind conditions. Due to its cross-section, the blade is much stiffer edge-wise. In conclusion, seven categories of damage are considered as the most common ones in composite blades; these are reported in Table 1.

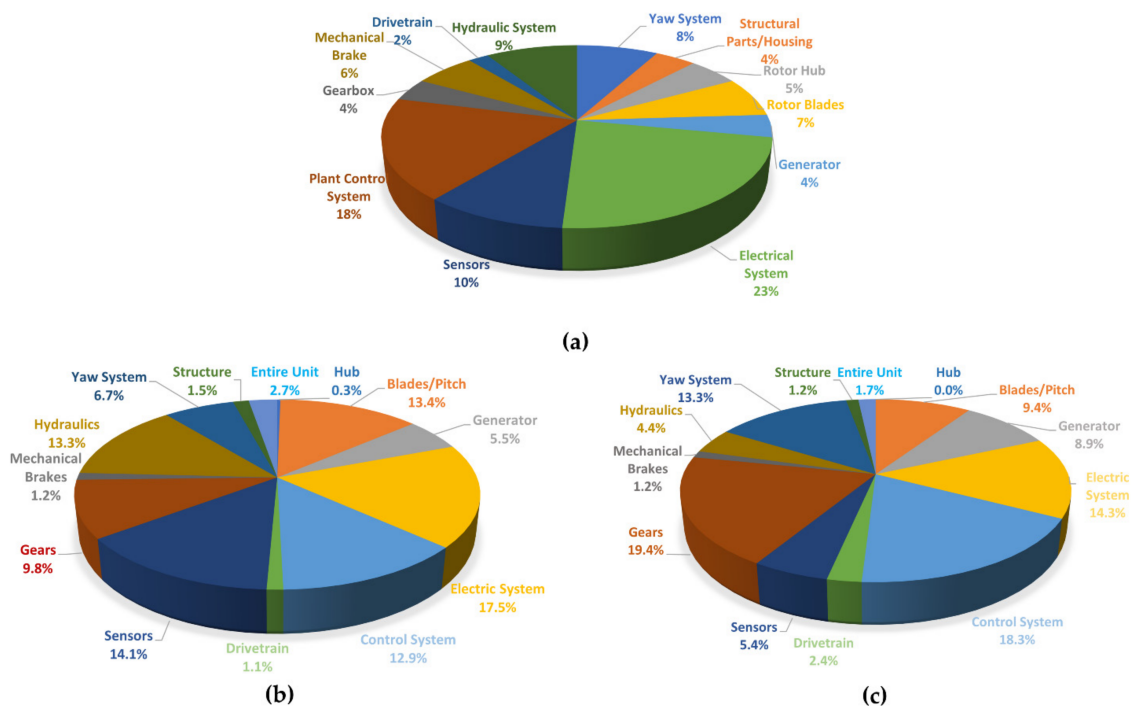
**Figure 7.** Damage and failure statistics. (a) Percentage of unforeseen malfunctions as recorded in Germany for 1500 wind turbines. Based on data retrieved from Ref. [42], collected over 15 years (34,582 events). (b,c) percentage distribution of the total number of failures and downtime for WTs. Based on data retrieved from Ref. [43], collected from several sources in Sweden, totalling about 600 WTs from 2000 to 2004 (1202 events, 156,202 h). The nomenclature used in the original sources is reproduced for all charts.

In general terms, structural components are much less likely statistically to be subject to damage and failure than mechanical and electrical components. This is shown in detail in the statistics in Figure 7. For the tower, typical failure mechanisms are caused by bolt loosening induced by dynamic loads [40]. However, as can be seen from Figure 7b, WT blades are the structural elements most affected by damage. This is due to their higher complexity, particular materials, and exposition to strong dynamic loads. The static load-carrying elements (tower structure and substructure, plus foundations) are considered to be less damage-prone. Among the many potential causes of their catastrophic collapse, the structure of the metallic tower is subject to all the classic risks of thin-walled shells, e.g., buckling. Even concrete-made towers may suffer total collapse due to damage at the base (at least one case was reported in Germany in 2000 [41]).

Recalling Figure 7b,c, one can see that the mechanical failures (including brakes, gears, drive train, and generator) are preponderant in terms of both total failures and downtime. For this reason, the majority of scientific research focuses on the CM of these components housed inside the nacelle.

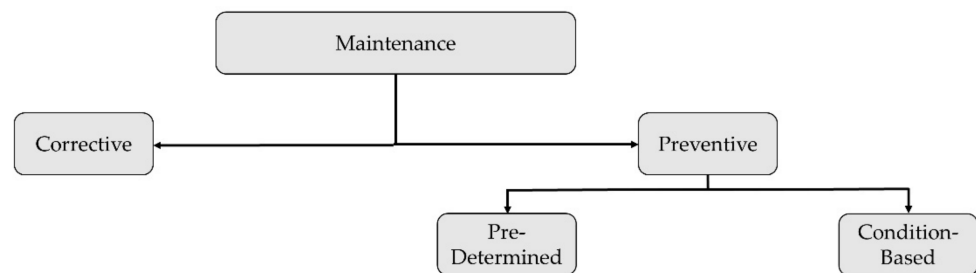
**Figure 8.** Maintenance strategies according to EN 13306:2017.

Preventive maintenance can be further divided into pre-determined (time-scheduled) and predictive (condition-based) maintenance. This scheme is the one currently set by the current European standard, as dictated by the norm EN 13306:2017 (depicted in Figure 8).

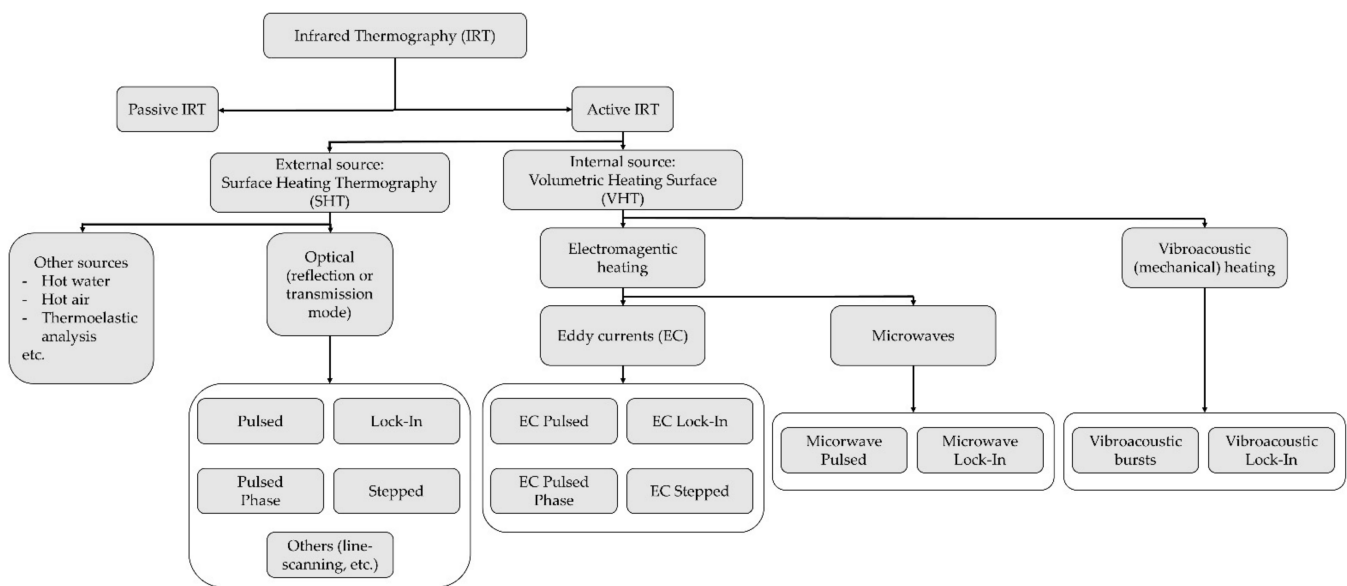
**Figure 10.** The main IRT techniques available as of 2021.

Some VHT approaches include EC pulsed [163], pulsed phase [162,164], stepped [165], and lock-in [166] thermography, as well as microwave pulsed and lock-in thermography [167]. Most of these strategies can be performed with ultrasonic waves too; another less widespread alternative is the ultrasound-burst-phase thermography [168]. The links between these VHT techniques and their SHT counterparts, mentioned before, are graphically displayed in Figure 10.

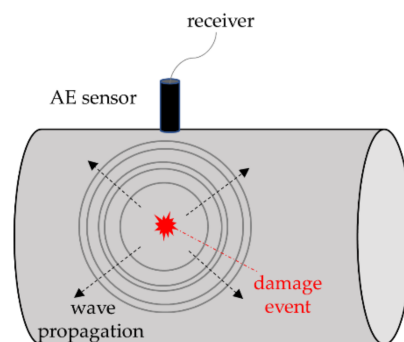
**Figure 11.** The basic concept of AE event detection.

The key concept of AE is that, when an internal crack propagates, it releases energy in form of acoustic waves. Debonding, delamination, crushing, and other kinds of damage produce localized, transient changes in the stored elastic energy as well. These elastic waves are therefore also known as stress release waves [50] and travel inside the material. AE testing is based on their detection. This basic procedure is sketched in Figure 11.

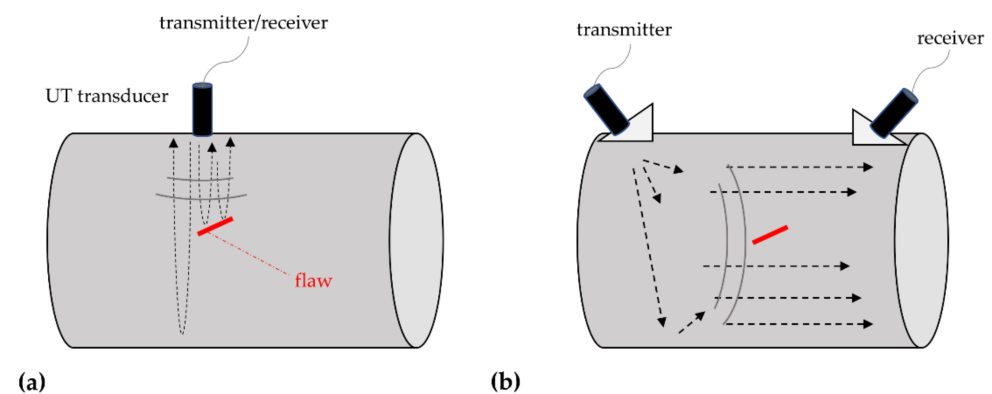
**Figure 12.** The basic concept of UT. (a) conventional, i.e., through the thickness (reflection mode), (b) guided waves. (through transmission mode).

The working principles of conventional and guided wave UT technologies are represented in Figure 12. Both can be used in reflection mode (with one transducer, analysing the ultrasound echoes) or transmission mode (with one transmitter and one or more receivers). The key concept is that when the (volume or surface) wave interacts with an inhomogeneity, it is partially reflected backwards and partially transmitted forward, with the transmitted wave being attenuated in its amplitude and delayed in its phase (due to the detour around the inhomogeneous area or the different propagation velocity inside it). These differences in amplitude and phase are also quantitatively related to the damage extension [276].
